## Performance of Fire Sprinkler Systems in the 2014 South Napa Earthquake: Computational Modeling with Validation by Laser Scans

S. Takhirov<sup>(1)</sup>, K.M. Mosalam<sup>(2)</sup>, F. Cakir<sup>(3)</sup>, S. Günay<sup>(4)</sup>

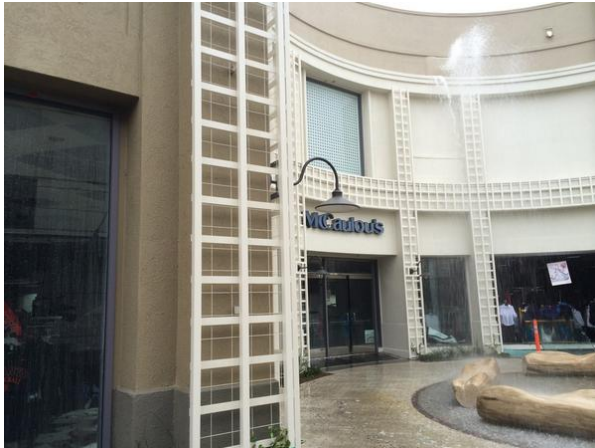
Photograph of store while water flooding was taking place

Fig. 1 – External observations of fire sprinkler system failure in the two-story retail store

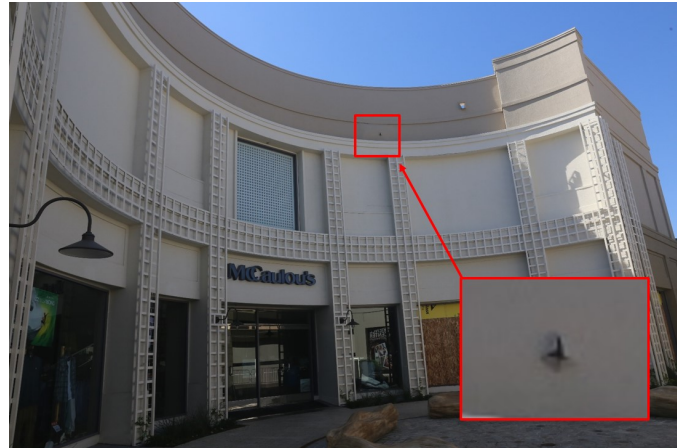
Photograph of store after water was turned off (pressure of a water head punched a hole in the parapet)

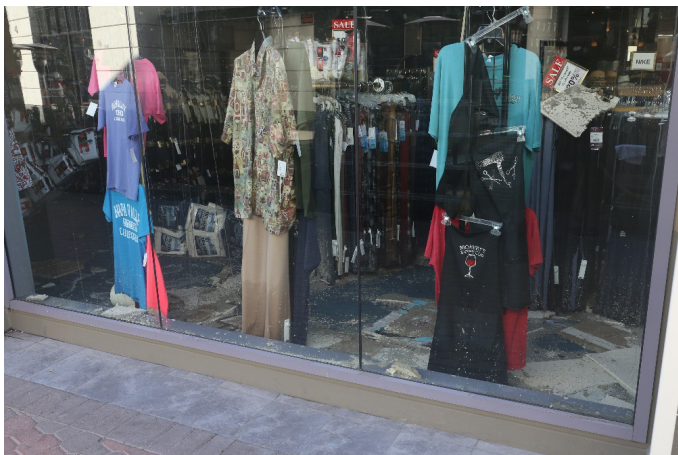
Soaked and partially dissolved lay-in panels on the floor and merchandise

Fig. 2 – Visual observations of the first floor content damage due to water leakage from the second floor

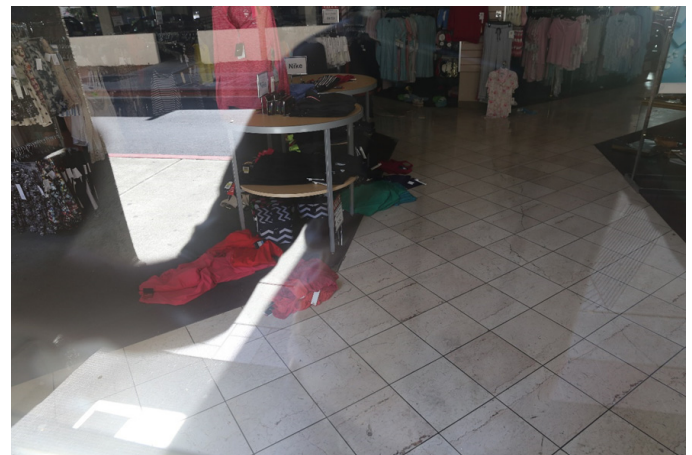
Flooded floor with merchandise on the floor

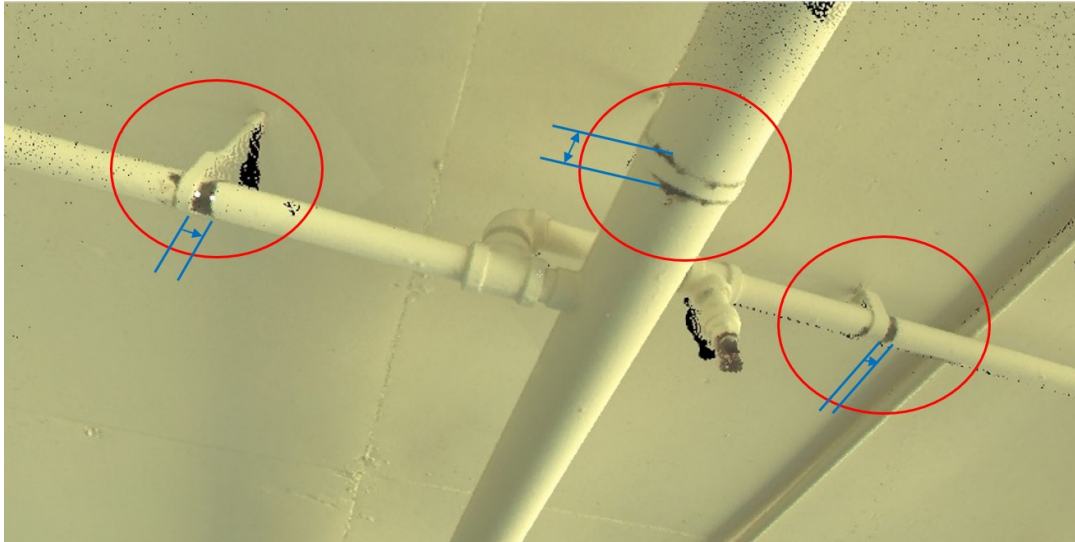
Fig. 5 – Zoomed view of the point cloud (colored by photo images)

A plan view of the point cloud showing details of the piping system is presented in Fig. 4b. A zoomed in portion of the point cloud is shown in Fig. 5. The point cloud is colored based on real colors of the system captured by a still imaging camera built into the scanner. It shows residual displacements of the piping system that can be clearly estimated by the exposed amount of unpainted part of the pipes that used to be hidden by bracket of a hanger rod. The superposed ellipses show the bracket locations and the double headed arrows show directivity of the motion. All details of the piping system were captured and documented by the laser scanner including: (1) location of each pipe in space including residual deformations, if any, (2) the diameter of the pipe, (3) the location of the hanger rod in space, (4) the diameter and length of the rod, (5) the residual displacements along the longitudinal axis of the pipe, ... etc. Some of the examples of subsequent measurements from the point cloud

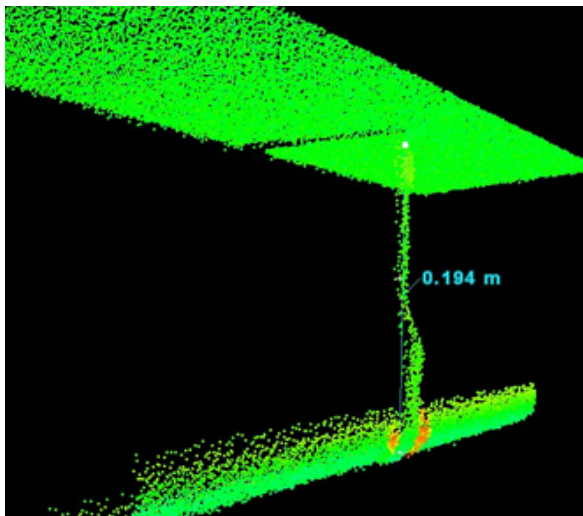
Length of hanger rod

Fig. 6 – Sample local measurements from the point cloud

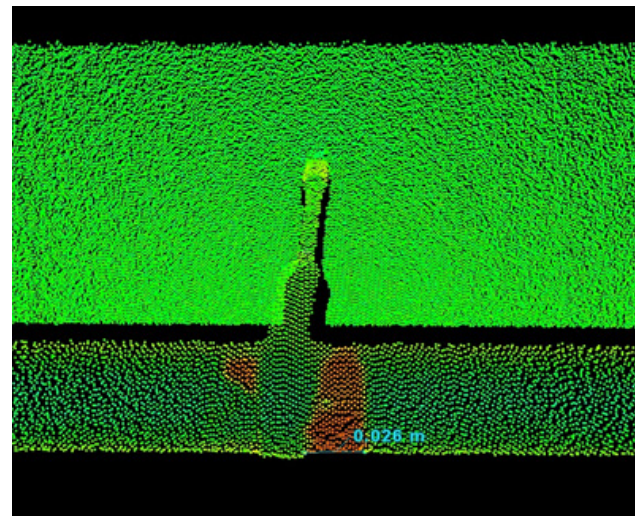
Residual displacement based on exposed unpainted surface and paint scratches

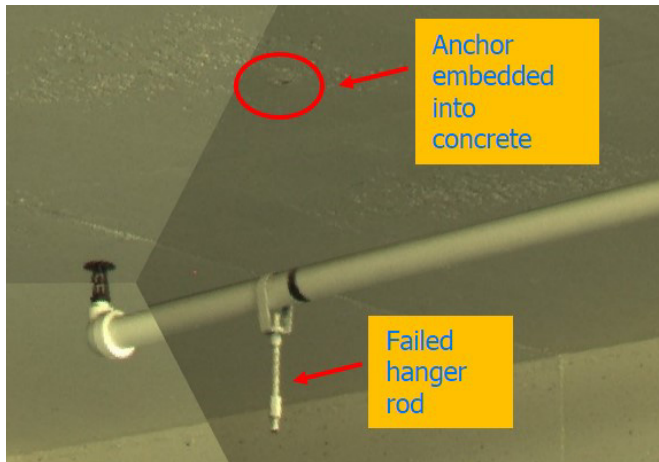
are provided in Fig. 6. Two major failure modes were identified as presented in Fig. 7. The first mode (Fig. 7a) is most likely related to ultra-low cycle fatigue in the hanger rod that is subjected to limited number of large cycles. The second type of failure (Fig. 7b) is most likely related to excessive pull-out load and/or under-designed depth of the installed anchors. All failure locations were accurately captured by the laser scanner.

Failure of hanger rod at anchor

Fig. 7 – Typical failure modes captured by laser scanner

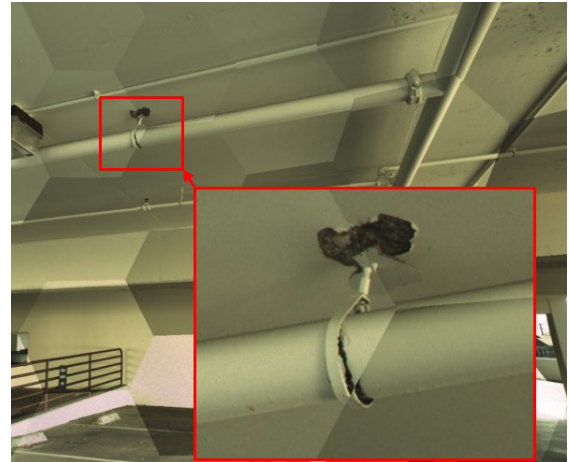
Hanger rod and its anchor pulled-out from concrete floor

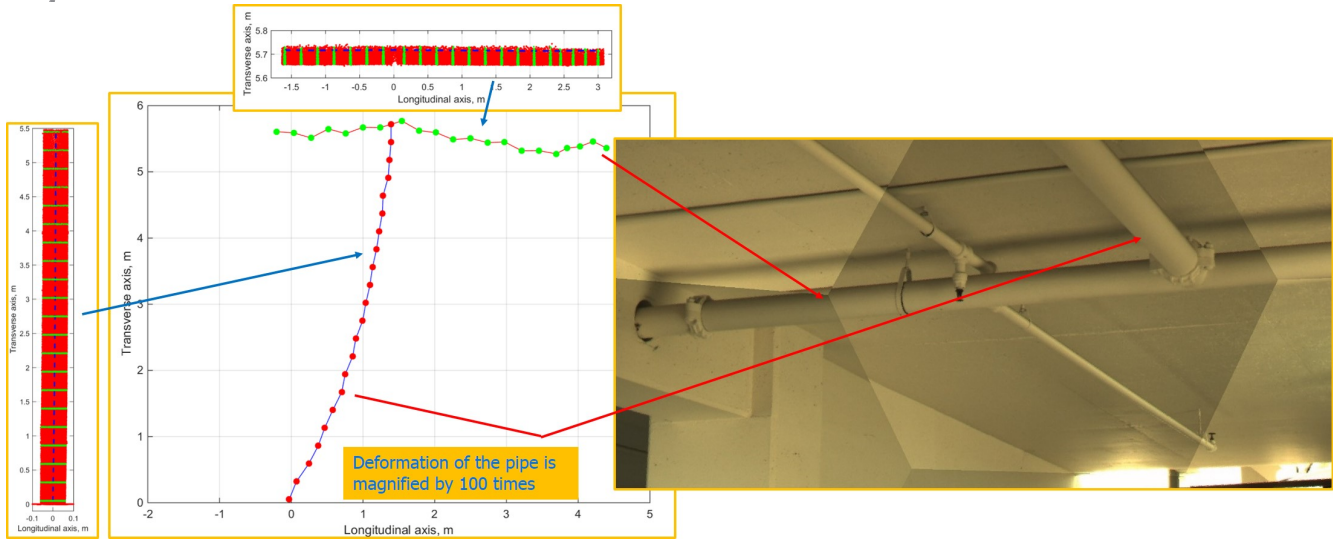
Fig. 10 – Residual deformation of the pipe estimated from the point cloud

Residual deformations of the piping system were distributed throughout the system. The deformation was quantified by separating the point cloud of each individual pipe and examining its shape in space. Matlab [7] was used to slice the point cloud of the pipe in the transversal direction and to best fit the section to a circle. The center of the circle was assumed to be located on the axis of the deformed pipe at the cross section of the pipe. The slices were repeated at multiple locations with pre-defined periodicity of 1.5 times the pipe's diameter. A

typical result for the main pipe right next to its connection to one of the walls of the structure is presented in Fig. 10. The results are amplified by a factor of 100 to make the residual deflection of the pipe visible.

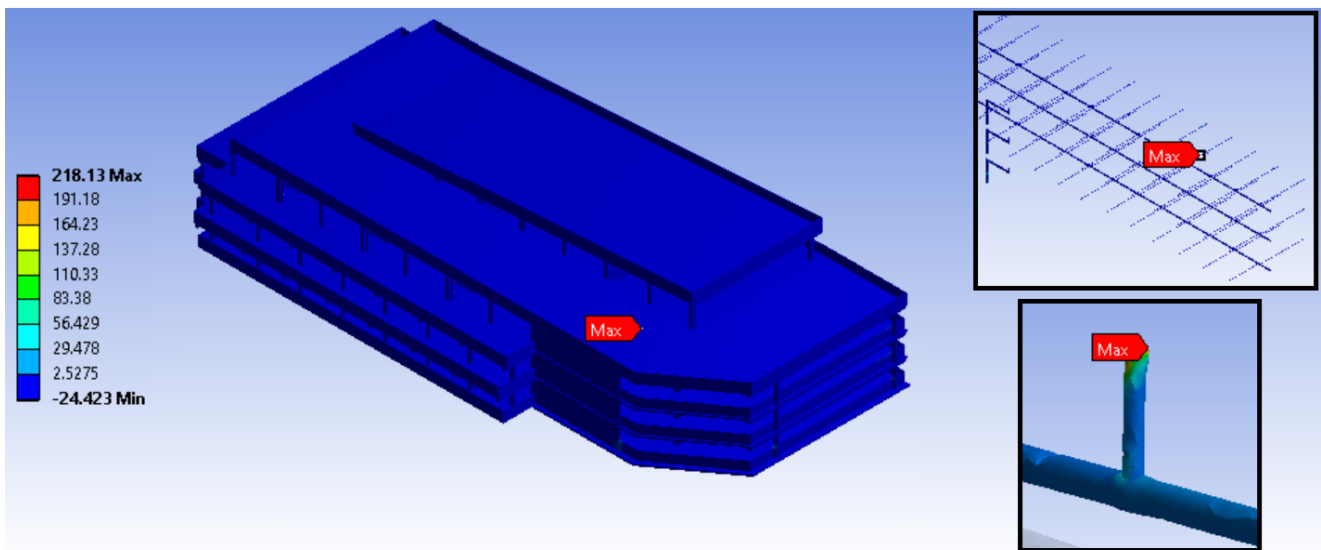
Fig. 19 – Maximum principal stresses from the time history analysis of the parking structure (MPa)

The time history analysis shows that the critical stresses are observed primarily at the upper section of the hanger rods. The maximum principal stresses (tension) are especially notable at the upper parts of hanger rods with a value of 218.13 MPa (Fig. 19). The minimum principal stresses (compression) are also observed at the hanger rods that carry the piping system in the ceiling section of the reinforced concrete structure with a value of 190.54 MPa (Fig. 20). The results of the analyses show that the stresses are likely to yield the steel pipes and possibly result in local or global buckling. Finally, the maximum lateral displacements take place at the top section of the structure and middle section of the piping system with a value of 16.76 mm (Fig. 21).
