ANALYSIS OF STEEL TANKS IN CHILE SUBDUCTION EARTHQUAKES

P. Pineda⁽¹⁾, G. R. Saragoni⁽²⁾

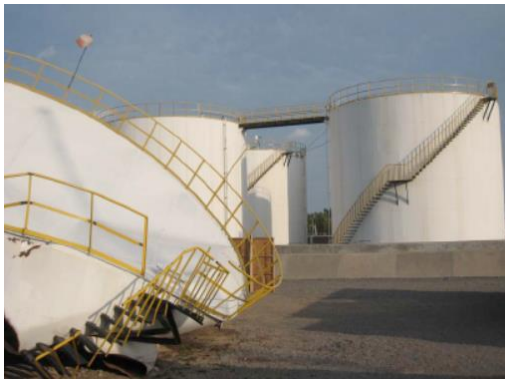
Figure 7. El Maule 2010, Chile earthquake. Collapsed water tank nearby liquid fuels tanks, Santiago Airport.

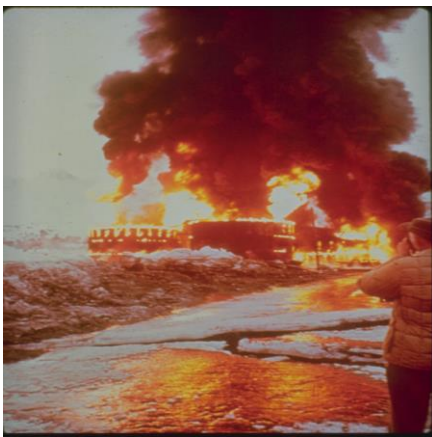
Figure 19. Burned tank five hours after the 1964 Alaska earthquake with a large fire across the coastline [26].
