COMPARATIVE ASSESSMENT OF PERFORMANCE OF SCHOOL BUILDINGS IN THE 2015 GORKHA (NEPAL) EARTHQUAKES

Abstract

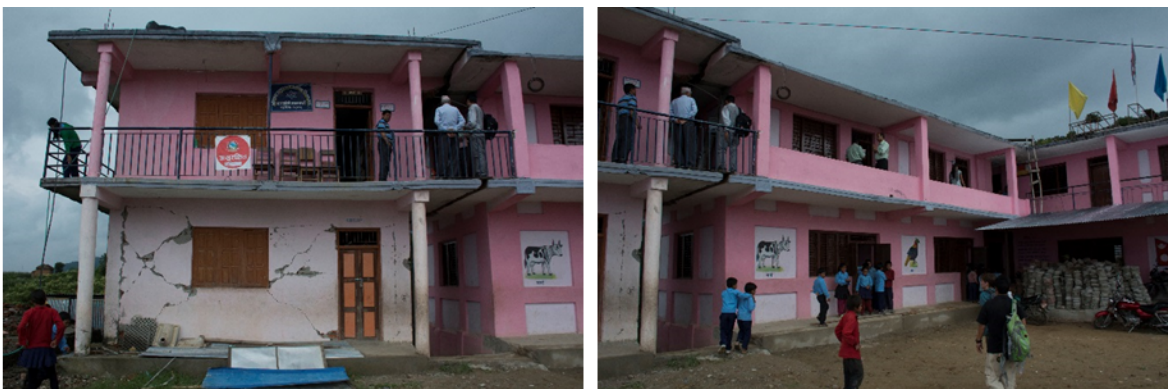
In some cases, different blocks in the same school site provided comparative assessment between buildings. These blocks usually were built from different resources using different method. Figure 3 shows an example of Kathmandu school site where blocks with different construction system behave in the earthquake. Here, two blocks built at same time performed very differently as one block was of unreinforced masonry wall upgraded later for seismic enhancement and other block with reinforced concrete. The reinforced concrete block with no seismic upgrade was moderately damaged and received a red tag. It will need to be repaired before it can be reused for classrooms. The block on the right was recently retrofitted with splint and bandage. It was undamaged and immediately able to be reopened.

Fig.3 – Two blocks in same school received different damage in the earthquake.

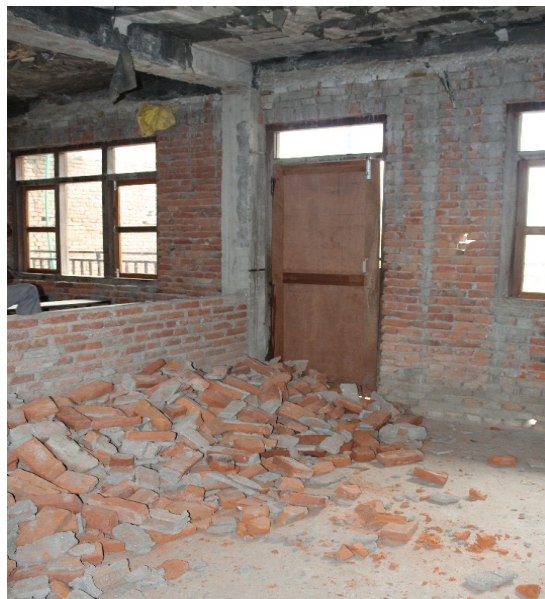
Infill walls had unreinforced brick or stone walls which form exterior walls or to partition classrooms. During the earthquake, many cracked where connected with beams and columns. Others developed more noticeable damage at corners or even diagonal shear cracks. At the schools observed, the infill walls did not have vertical or horizontal reinforcing steel to support them, a common practice prescribed by international building codes and NBC as well. When they cracked, as is expected in an earthquake, they became unstable because of the lack of reinforcing or other means of holding the walls in place.

These infill wall cracks, although considered minor damage from a structural engineering perspective, were a serious problem in schools (Figure 4). Teachers and principals would demonstrate by pushing on the cracked walls, causing the walls to visibly move. With the risk that these walls could topple over and crush occupants in large aftershock or future earthquake, many schools with infill wall damage were given ‘red tags’ by Ministry of Education inspectors. A seemingly minor damage relegated untold thousands of students and staff to temporary learning spaces and tents.

Fig. 4 - School building 101-1 experiencing only moderate shaking deemed unsafe.

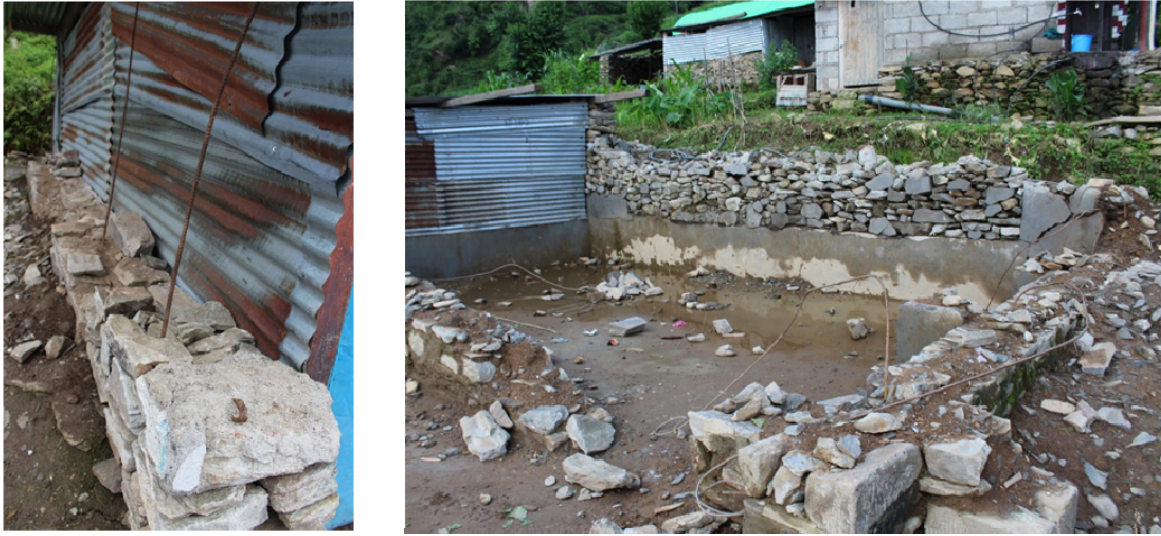
The second design, derived from NBC provisions added vertical reinforcing bars at every wall and openings corner within stone and mud mortar walls. We found bands used in some of the schools built with this design, but not others. In all schools observed with this design, the bars proved ineffective and the stone fell away from the bars. These buildings completely collapsed (Figure 5).

Fig. 5- A Ministry of Education template design, which called for vertical rebar to be placed in stone walls, completely collapsed in every block assessed with this design.

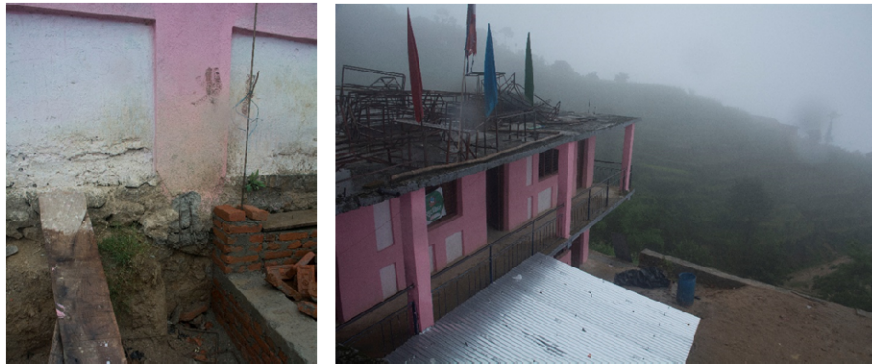
While the four retrofitted schools in Kathmandu and Bhaktapur were undamaged, we found several lapses in design or construction at one of the Kathmandu retrofits during our detailed visual assessment. At the base of the walls, the masons had created a stitch band beam. However the band was discontinuous on one side of the block; vertical bars came down and poked out of the bottom (Figure 6). While this school performed well in this earthquake, retrofit design and construction flaws may lead to unnecessary damage in larger events. In the left photo, vertical bars poke out the bottom of a retrofit band. A horizontal retrofit band at the bottom of the wall is missing on this side of the building. On the roof top, the vertical bars are secured by only small patches of concrete, partially covered in the photo by discarded school benches. The masonry columns supporting the roof overhang were not strengthened in any way and remain unsupported below the balcony overhang. On the roof, vertical bars continued up through the ceiling slab and were bent over only a short distance. The ends of the vertical band bars were covered with a small 16-inch patch, leaving only 8 inches for bars to be bent in each direction. The distance was too small to allow the bars to develop their full strength during an earthquake. In a stronger earthquake, the bars would have popped through the small roof batch. More globally, the retrofit addressed the masonry walls of the school only. The retrofit did not jacket and strengthen masonry columns on the second floor balcony or add supports below the masonry columns. Without strengthening these masonry columns, these masonry columns could crumble in a larger earthquake, leaving the overhanging ceiling and floor slabs unsupported and in real danger of collapsing during the earthquake or when students filed out to evacuate.

Fig.6 – Several design and construction flaws observed in a recently upgraded school building in Kathmandu.

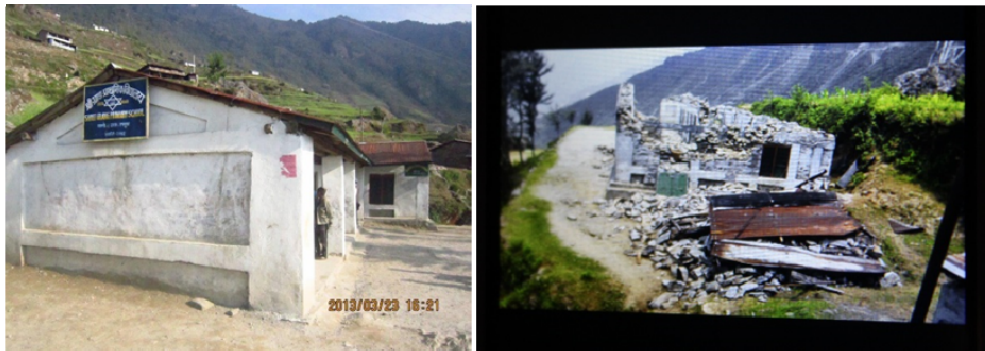
A retrofit of a rubble stone school in Rasuwa fared even worse – it completely collapsed. The block had been retrofitted by a major INGO using stitch banding technology and the community had been told the school would be safer than any new construction. The project included little training and oversight, and even less adaptation to the limitations of the brittle stone building material. The donor organization sent a trained mason to the site for only two days to train local workers, none of whom had professional training as masons. During the middle of the construction process, the donor’s engineer came only once, briefly. Local workers found it impossible to adapt the stitch band retrofitting technique to stone masonry; they simply could not drill through the stone walls to stitch bands together, but the project implementation had no plan for adjusting the technology or stopping an unsafe solution. The result was a catastrophic collapse (Figure 7). Donor-funded retrofit of a stone and mud mortar school in Rasuwa collapsed in the earthquake, as the principal captured and showed us on his smart phone. The left of Figure 6 was before earthquake and right is just after the earthquake. The rubble had been removed by the time of the survey. Little training of masons and nearly non-existent technical oversight ensured that when masons struggled to implement the retrofit design, the problems were not caught and rectified. The principal estimates 120 out of 140 students and staff would have died. Had technical experts been involved in community outreach, they may have better understood the challenges of stone retrofit in a remote village and may have modified or abandoned the project for something more likely to result in a safe school.

Fig.7 – Complete collapse of retrofitted school building in Rasuwa.

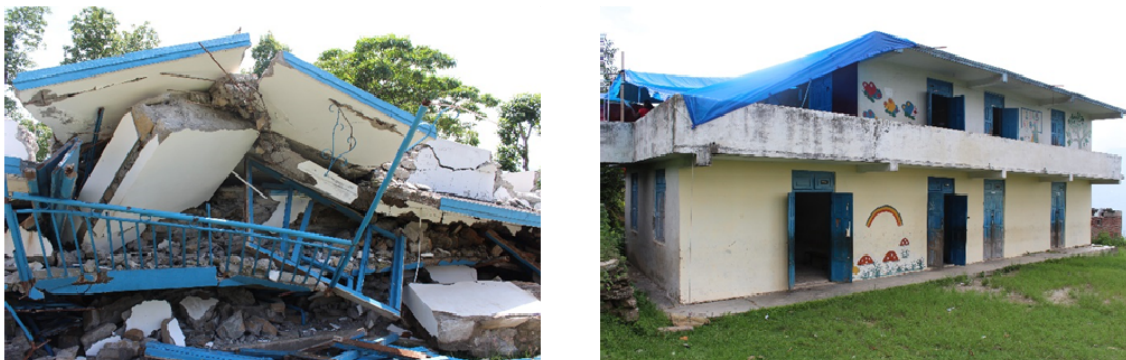
Where local masons were appropriately trained and where trained engineers oversaw the construction practice by very frequent visits or continuous onsite presence, school performed beautifully. They were completely undamaged and few signs of poor construction practice were evident. In figure 8, the first was built without technical support. The second was built after the community was given an orientation on earthquake safe construction and local masons were trained in safer construction techniques. An engineer and lead mason, both with experience in earthquake-safe school construction, carefully oversaw the process. After the earthquake, the second was operational; even the terrace had been covered and converted into a makeshift workshop for the local community. Clearly, the social supports of training and oversight are crucial to achieving safe school construction in Nepal.

Fig.8 – Two neighboring schools in Sindhupalchowk both built through international donor support but taking different approach of community outreach for technology transfer.

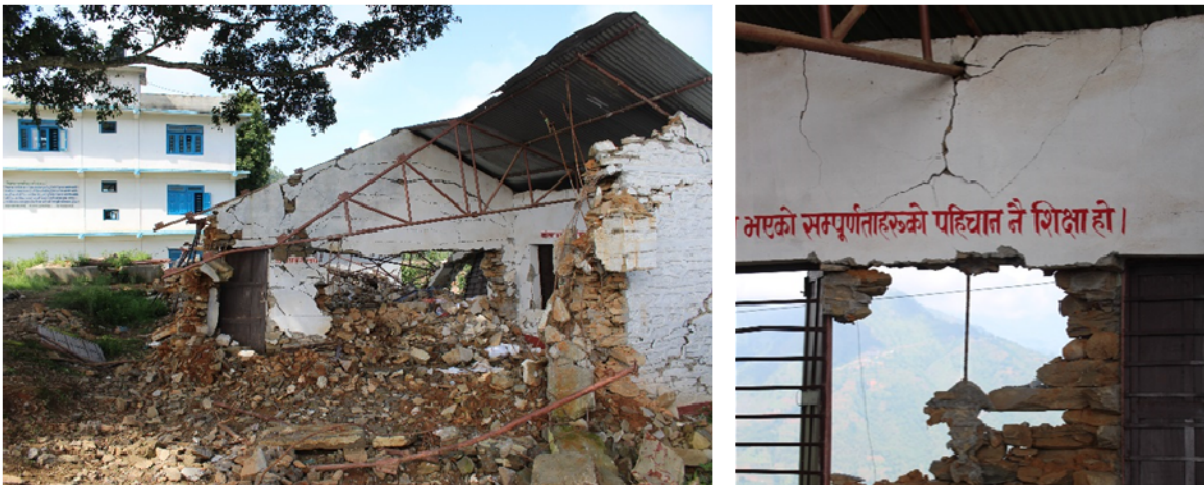
Most of the stone houses collapsed in the communities we surveyed. Most schools built with stone and mud mortar infill or load-bearing walls also collapsed, including the retrofitted school (albeit without appropriate training and oversight). Only when rubble-stone was used with cement mortar and as an infill wall for a reinforced concrete frame school building, did we observe rubble stone that had not partially or completely collapse. In Figure 9, a teaching resource centre on school grounds was built with stone and mud mortar. The masons employed earthquake-safety measures, such as a reinforced concrete lintel band and vertical reinforcement in the walls. However, even with these measures, the heavy shaking in Sindhupalchowk caused the stone building to collapse swiftly and completely. It may be difficult to rebuild safe schools out of this brittle material unless alternative technologies are developed, tested and extensive mason training and strict oversight are feasible during construction. A rubble stone teaching resource centre co-located on a school site provides additional reason for caution. The resource centre completely collapsed even though it had been built with important the earthquake-safe construction techniques commonly advised for load-bearing stone and brick construction. The resource centre had a lightweight roof, a reinforced concrete lintel band, and vertical reinforcement in the walls, though it did not appear to have a sill level band or corner stitches.

Fig. 9 - Complete collapse of stone masonry teaching resource centre building with concrete bands.

The widespread rubble stone collapses, even in a case where a lintel band and vertical reinforcement had been used, suggests that constructing safely with rubble stone is fraught with difficulties. Further research is needed to understand how other rubble stone schools with earthquake-resistant features fared and what technical and social intervention seem to have worked well. However, until further testing or comprehensive field assessment, extreme care should be taken in building infill or load-bearing walls with this material in permanent, transitional, or temporary school buildings. Further, even if safe and appropriate technologies for rubble stone are identified, school reconstruction with this material will need to be carefully supported with robust programs for training, oversight and community outreach so that safety is achieved in actuality and communities can trust that these stone buildings will not collapse.
