## STUDY ON DAMAGE AND SEISMIC PERFORMANCE OF TIMBER BUILDINGS DAMAGED DURING THE RECENT LARGE EARTHQUAKES IN JAPAN

T. Tsuchimoto<sup>(1)</sup>, N. Kawai<sup>(2)</sup>, T. Nakagawa<sup>(3)</sup>

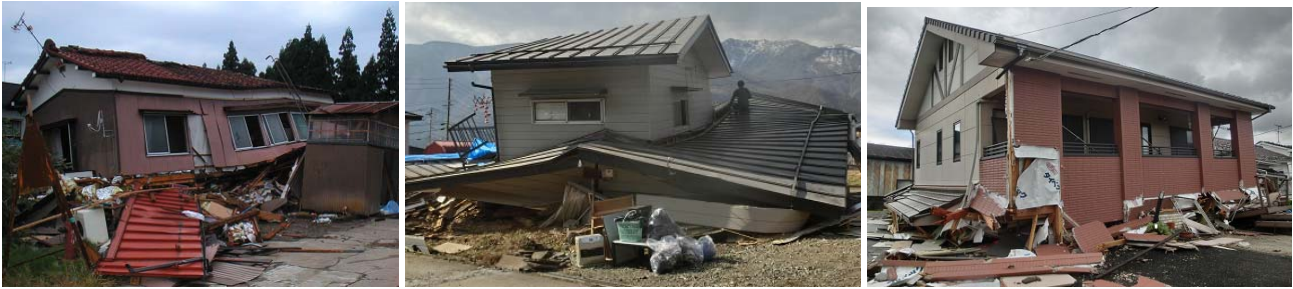
One of the most severe damage is the collapse of the whole 1st story which was observed in most major earthquake, as shown in Photo 1. There are several reasons, and the main cause is because the wall length is not enough for the seismic force. Under the many of the seismic disaster, the collapse occurred selectively in the relatively old house. The typical old houses have the heavy mud wall and roof tiles and are also built under the old seismic regulation. Most of the detached wood houses assured the seismic performance by the shear wall length in Japan. The seismic regulation providing the required wall length were revised by the repeated seismic disaster. It was the reason why the old houses suffered heavy damage selectively. However, the several new houses built after 2000 collapsed and many new houses suffered the damage under 2016 Kumamoto Earthquake. Now, the reason is under discussion, and it was one of the reason for the ground motion of 2016 to be stronger than the other earthquake.

(a) 2004 Chuetsu Earthquake      (b) 2014 Kamishiro Fault Earthquake      (c) 2016 Kumamoto Earthquake  
Photo 1 – Collapsed wood houses

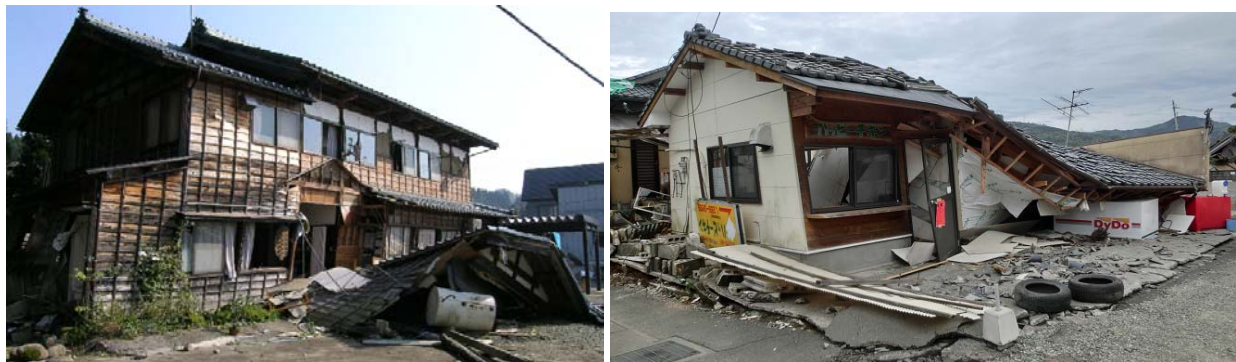
As the second significant damage, there is the partial collapse, as shown in Photo 2. It is considered that a part of the house doesn't have enough wall length for the input seismic force and the other part has enough wall without enough strength of the horizontal diaphragm the joints between both parts. As a result, the partial collapse has occurred.

(a) 2004 Chuetsu Earthquake      (b) 2016 Kumamoto Earthquake  
Photo 2 – Partial Collapse of wood houses

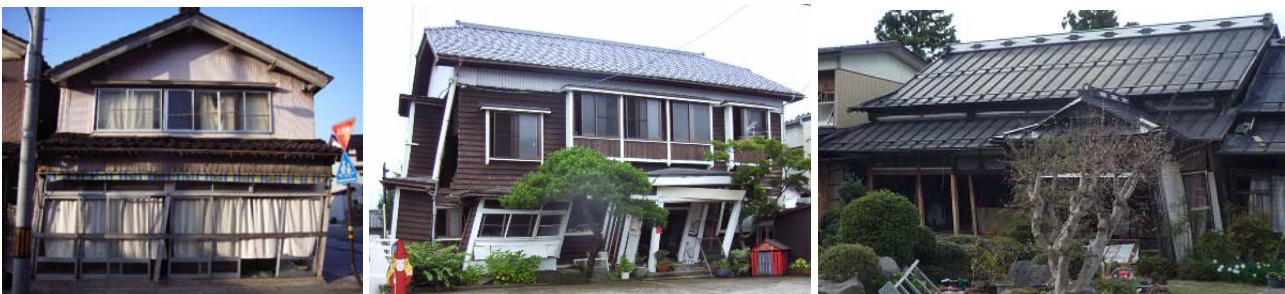
As the more type of damage, the large story drift has left for the wood house, as shown in Photo 3. It is considered that the wall length was not enough for the seismic, but was enough for the house not to collapse. About  $1/30$  rad story drift are visible and defined as safety limit in Japan. But the limit of collapse is considered to be over  $1/5$  rad due to the past field surveys of the seismic damage and the several static load tests [1] to collapse.

(a) 2007 Noto Peninsula quake      (b) 2007 Chūetsu Offshore quake      (c) 2011 Great East Japan Earthquake  
Photo 3 – Wood houses with large residual story deformation

of 1/120 rad is the allowable story deformation of Japanese building code for timber constructions. In Noto Peninsula Earthquake (c) and Chuetsu Offshore Earthquake, these are in the same tendency except for a few plots. The arrowed plots in (d) is the timber construction shown in Photo 3 (b) and has the reason why many books make the seismic force unexpectedly large because of the change of usage from hospital to library.

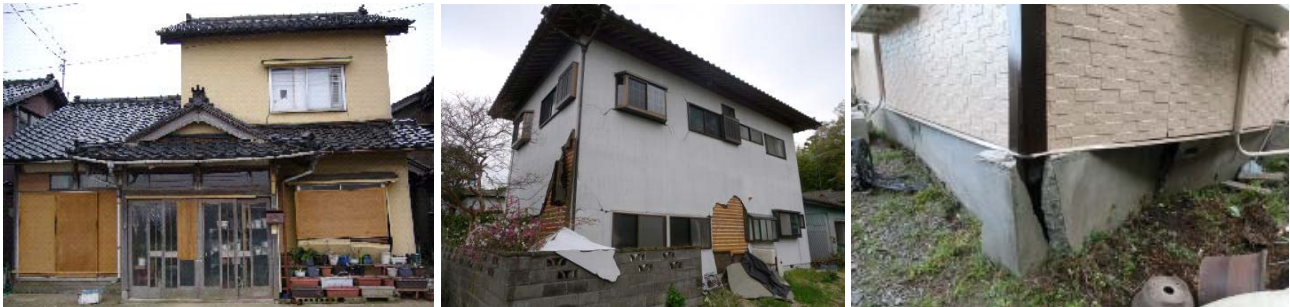
The damage which has never extended to the whole building is called as the partial or light damage and shown in Photo 4. The partial or light damage is various and includes the damage on the openings, the exterior finishing materials or the foundation. Many of the partial or light damage is repairable within relatively low cost.

(a) 2007 Noto Peninsula Earthquake (b) 2011 Great East Japan Eq. (c) 2016 Kumamoto Earthquake

Photo 4 – Wood houses with partial or light damage

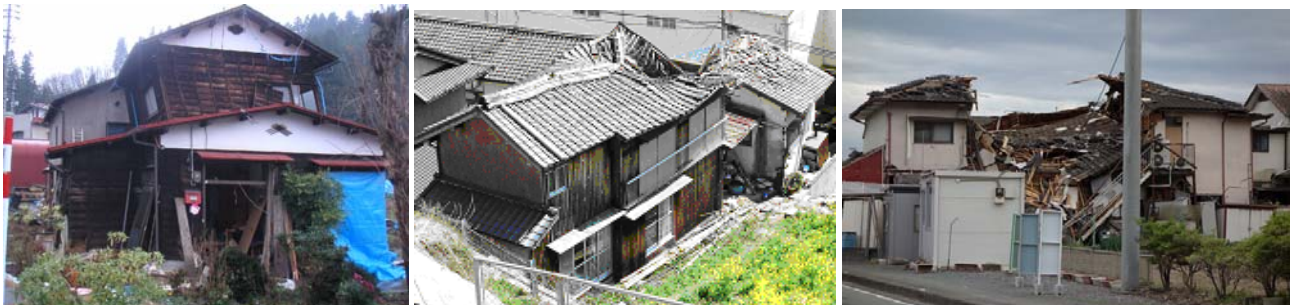
The damage on the 2<sup>nd</sup> floor was almost less than that on 1<sup>st</sup> floor. But the only 2<sup>nd</sup> floor suffered severe damage exceptionally, as shown in Photo 5. The reason of the damage of (a) was considered that the brace whose number was very few due to small area of 2<sup>nd</sup> floor wasn't jointed effectively to the column and beam and missed its bottom from the beam due to the initial seismic input, and that the seismic performance were reduced significantly. It is the reason of (b) why the roof system of the house was damaged by the termite which could attack not only the wet wood but also dry wood. The reason of (c) has never been clarified and the damage like (c) was often seen in 2016 Kumamoto Earthquake.

(a) 2004 Chuetsu Earthquake (b) 2005 Fukuoka Earthquake (c) 2016 Kumamoto Earthquake

Photo 5 – Wood houses with partial or light damage

On the other hand, in 2004 Niigata Chuetsu Earthquake (b), several wood houses with the wall sufficiency ratio of about 100 % or more suffered the damage with the residual deformation of about 1/10 rad or more. It is the reason why the seismic intensity of 2004 Niigata Chuetsu Earthquake was 7 and stronger than the other three earthquakes. However, the arrowed plots in (b) is the wood house shown in Photo 5 (a) and has the reason as mentioned in the section of 3.5.
