## SEISMIC ASSESSMENT OF A COMPLEX EARTHEN STRUCTURE: ICA CATHEDRAL (PERU)

This paper discusses the structural performance and addresses the seismic assessment of Ica Cathedral, which is one of the four buildings involved in the ongoing Getty Seismic Retrofitting Project, under the auspices of the Getty Conservation Institute (GCI). The aim of this work is the evaluation of the dominant mode shapes of the structure as predicted by the model, and also the comparison with the dynamic identification performed during the on-site visit conducted during May-June 2015, by a team from the University of Minho, the reproduction of the existing structural damage using advanced numerical analysis and the safety assessment of the structure in its current condition. These tasks are challenging due to the complexity of this historical building and to the numerous unknowns on the morphology and material properties. In fact, the Cathedral is composed by two sub-structures: an external (mostly) earth envelope and an inner timber frame.

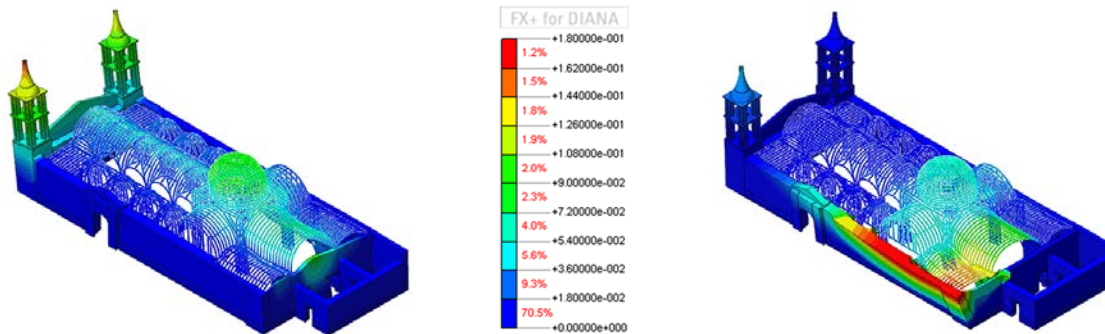
As the most critical failure mechanisms in the model of the masonry envelope were identified in the XX– and YY– directions, the seismic behaviour of the combined structure was evaluated by performing two mass proportional lateral loading analyses in these two directions, after having introduced the self-weight. The results obtained from the nonlinear analysis under self-weight show high value of displacements in the barrel vaults and in the main dome ranging from 1.0 cm to 2.0 cm. No cracking is observed throughout the masonry envelope, indicating that there is no onset of plasticity in the masonry under self-weight. The distribution of displacements observed for the combined model when lateral load is applied in the XX– and YY– directions is presented in Fig. 4.

Fig. 4 – Distribution of displacements observed for the combined model under the maximum lateral loads applied in XX- (right) and YY- (left) directions. Unit: m

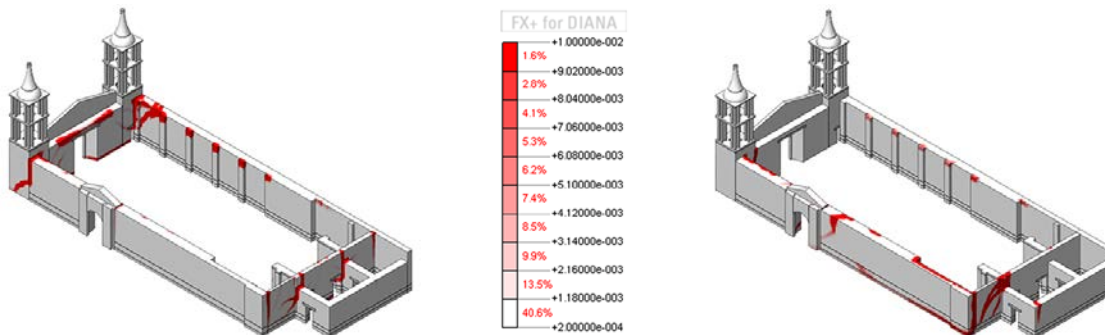
The maximum lateral load that can be applied to the numerical model in the XX– direction is 0.45g. The failure mechanism in the masonry envelope is identified as the out-of-plane failure of both the front façade and the bell towers. The crack pattern in terms of tensile strains shows vertical separation cracks occurring in the connection between the bell towers and the lateral longitudinal walls, and diagonal cracks propagating throughout the adobe wall adjoining the southern bell tower. Besides, flexural cracks can be observed at the base of both the bell towers and the front façade. Extensive tensile damage is also seen where the walls of the altar are connected to other adjoining walls (Fig. 5). When the lateral load is applied in the YY– direction, the maximum lateral load-carrying capacity was calculated with a value of 0.28g. The failure mechanism in the masonry under this loading consists of the out-of-plane failure of the northern lateral longitudinal wall. Extensive tensile damage is observed in these regions: flexural cracks occur throughout the length of the longitudinal wall – at the

rubble stone base course and in the interface between adobe masonry and the fired brick base course – and cracking progresses significantly from the connection between the northern bell tower and the front façade through the base of the former (Fig. 5).

Fig. 5 – Crack pattern in terms of tensile strains observed for the combined model under the maximum lateral loads applied in the XX- (right) and YY- (left) directions

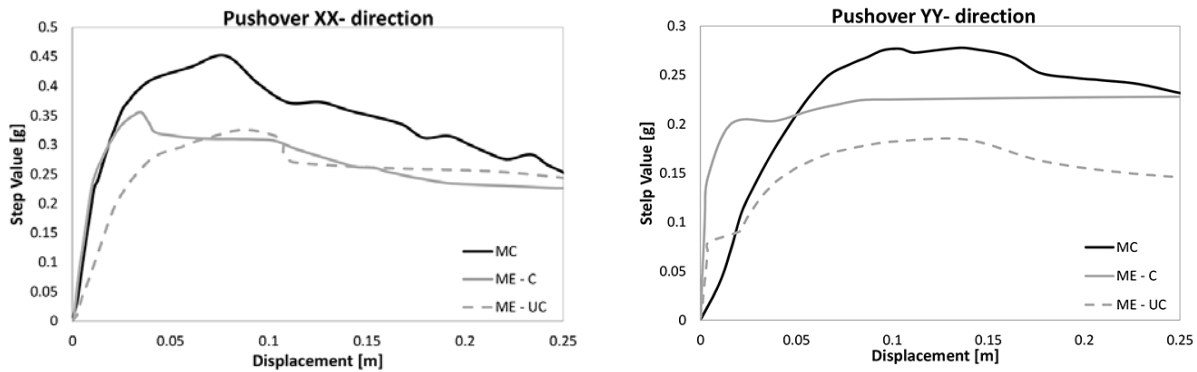
The behaviour of the combined model (MC) under lateral loading in the XX– and YY– directions is summarized in Fig. 6 in terms of load displacement diagrams. The respective load displacement diagrams obtained from the models of only the masonry envelope, calibrated (ME – C) and uncalibrated (ME – UC), are also plotted with them. In particular, the control points were assumed as the nodes where high values of displacements were observed: a node at the top of the northern bell tower and one at the top of the north-western corner were considered for plotting the load displacement curves of the different models under lateral load in the XX– and YY– directions, respectively. According to the obtained results, the combined model presents higher values of lateral load-carrying capacity when compared to the models of only the masonry envelope, in both the directions. A similar initial stiffness is observed for ME – C and MC under lateral load in the XX– direction. On the other hand, an appreciable decrease in the initial stiffness is seen for MC as compared to ME – C when lateral load is applied in the other direction. While a moderate difference of lateral load-carrying capacity is observed for ME – C and ME – UC (about 10%), MC shows an increase in seismic capacity of about 25% as compared to ME – C, in both the directions considered. The obtained results point out that the interaction between the two sub-structures affects significantly the seismic behaviour of the entire structure of Ica Cathedral.

Fig. 6 – Comparison of the load displacement diagrams obtained for the combined model (MC) and the model of only the masonry envelope, calibrated (ME – C) and uncalibrated (ME – UC)

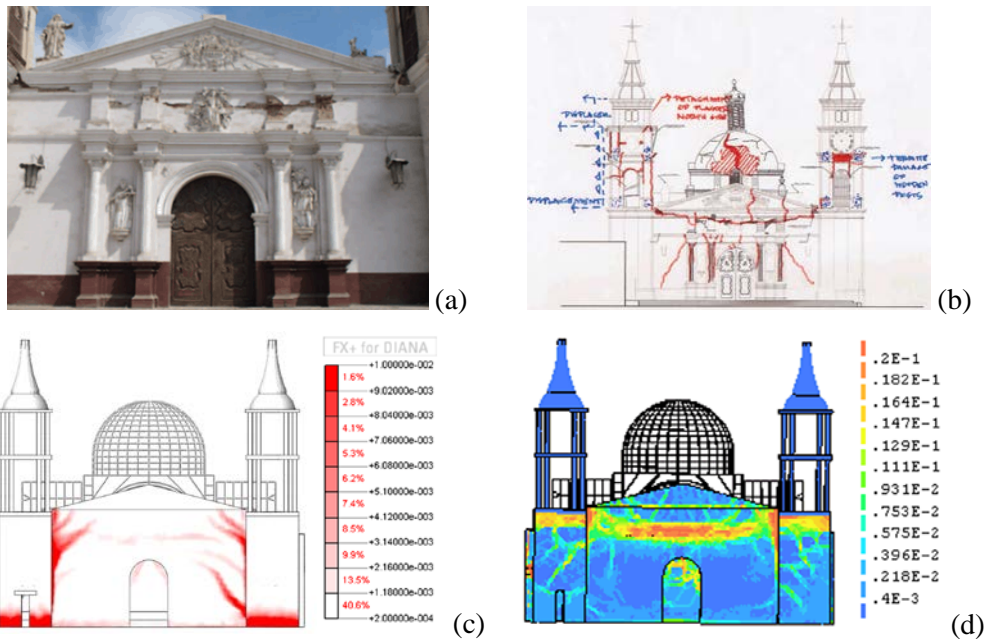
artificial accelerograms – which were uncorrelated, i.e. peaks in acceleration do not occur at the same time with respect to each other – were applied to the combined model in two orthogonal directions to each other (X and Y). The loading-unloading diagrams plotted for the masonry of the combined model in the two orthogonal directions in which the accelerograms were applied indicate that masonry lost its loading-unloading capacity and severe damage occur in the structure under the applied dynamic loading. A correlation of cracks obtained in the numerical model subjected to dynamic loading was carried out with the existing damage observed in-situ. Critical cracking present in the structure after the earthquakes were obtained in the numerical model, such as parallel cracking in the adobe masonry of the northern lateral longitudinal wall, diagonal cracks in the front façade and separation cracks at the base of the pediment. It should be mentioned that the nonlinear dynamic analysis reproduced cracks existing currently in the structure which were not obtained from pushover analyses (Fig. 7).

Fig. 7 – Correlation of cracks observed in the numerical model and in-situ: (a) detail of the damaged front façade [1], (b) crack survey [1], (c) crack pattern from pushover analyses and (d) crack pattern from nonlinear dynamic analysis

Although the structural behaviour seems to be reasonably well represented by independent structures, the linear and nonlinear analysis performed on the combined model of the Cathedral demonstrated that the building is influenced by the interaction of the timber structure with the masonry envelope. The connections between the two sub-structures are a critical factor influencing significantly the structural behaviour of the Cathedral. An increase in seismic capacity of about 25% was observed for the combined model under lateral load in both the directions, when compared to the calibrated model of only the masonry envelope. The lower bound capacity of the combined model was found in the transversal direction, with a value of only 0.28g – much lower than the PGA considered in the code for the region of Ica [17]. Global strengthening is therefore required in order to avoid the out-of-plane mechanisms identified for the most vulnerable regions of the structure, in particular for the north-western corner of the Cathedral, by means of tying, collar beams and/or proper connections between the two sub-structures.
