## **THE BEHAVIOR OF THE STEEL STRUCTURES TO EARTHQUAKES – EXPERIENCE FEEDBACK**

### ***Abstract***

Using the reports of the post-seismic missions realized by AFPS for thirty years (for 1985 – Mexico) and articles and other publications concerning earthquakes that have not been the subject of site visits, an assessment on the behavior of steel structures to earthquakes is proposed.

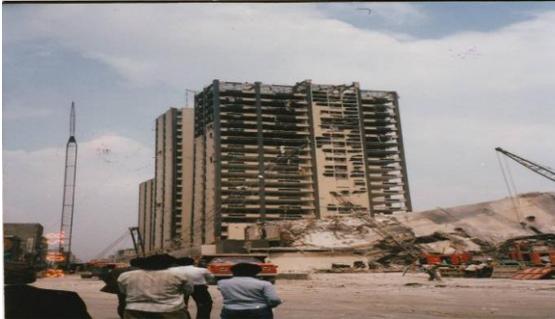
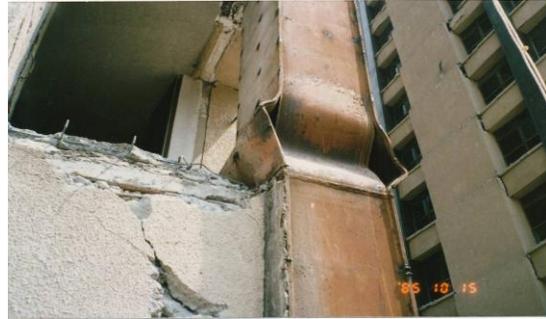
Fig. 6 Pinô-Suarez Complex – Mexico City Earthquake, 1985 - AFPS Mision Report

It was five recent buildings, 3 central buildings of 20 floors and two buildings of 14 floors (Fig. 6 - left photo). The first 20 levels tower collapsed on the 14 levels, the other towers being severely damaged on their

sides: the frames are deformed significantly and a column of the second tower had a localized buckling at the bottom connection (Fig. 6 – right photo).

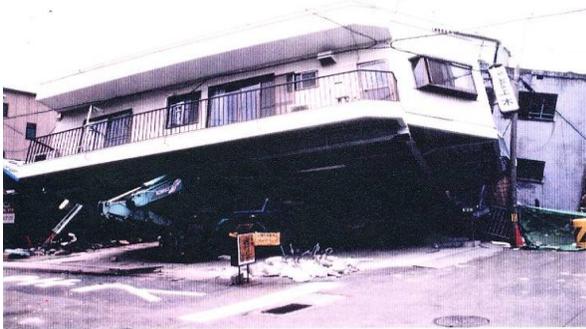
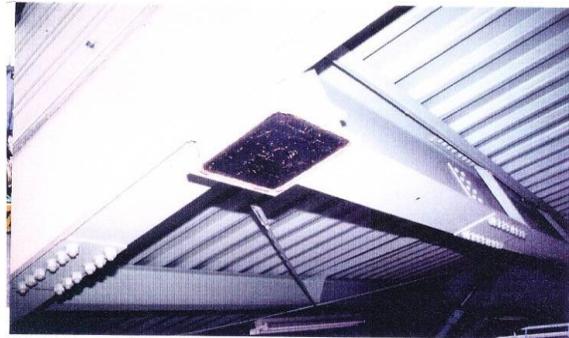
Fig. 7 Collapsed building - Kobe Earthquake 1995, Japan - AFPS Mission Report

The ruin of this structure (Fig. 7 – left photo) may be due partly to the lack of bracing and also to the poor quality of the welding work. Indeed, Fig. 7 – the right photo shows a detail of a plate onto which the columns were welded. The break was made at the weld.

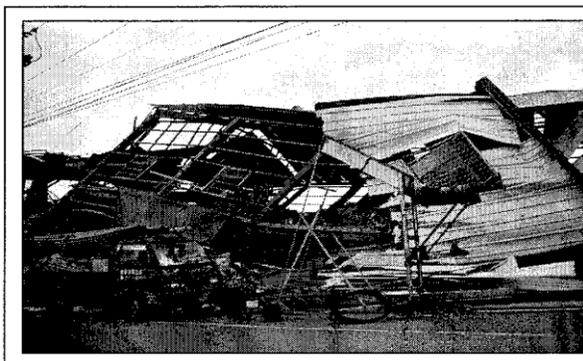
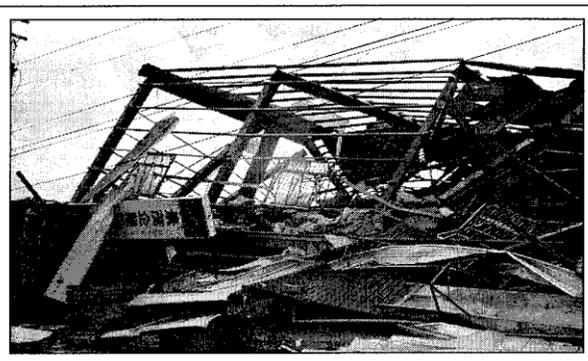
Fig. 8 Buildings collapsed - Chi-Chi Earthquake 1999, Taiwan - AFPS Mission Report

**- Collapse of two old steel structures (Chi-Chi Earthquake, Taiwan of 21/09/1999-magnitude 7.3)**

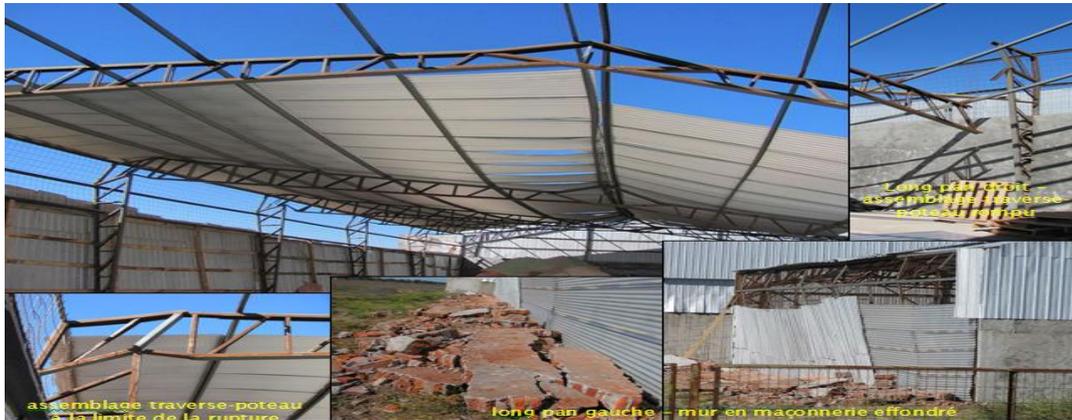
Fig. 9 Collapsed of a steel industrial hall in Chillan - Chile Earthquake 2010 - AFPS Mission Report

The complete collapse of the roof occurred following the failure of the connections beam - column (Fig. 9). Observing the structure reveals that several key factors played a role in this collapse:

- Design fault of the truss beams and columns, of which the uprights and diagonals are made up of relatively slender angles, as well as strong eccentricities in the working drawing,
- Fragility of the connections beams - columns,
- Insufficient maintenance of the building, resulting in significant corrosion which can affect the strength of structures, especially of the welds.

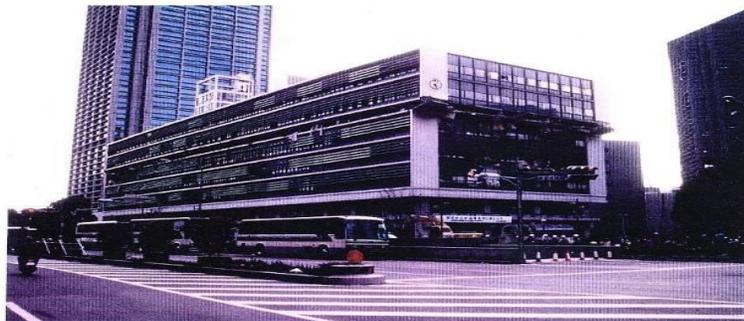
Fig. 10 City hall of Kobé - Earthquake of Kobé on 1995, Japan – AFPS Mission Report

The loss of an intermediate floor was a failure mode quite commonly encountered in Kobe. The lowest floors of some buildings of 8 to 10 floors are constructed using a steel structure coated in concrete for protection against fire. The upper levels are realized with classic reinforced concrete columns. The ruin of these buildings occurred in the connection area of the two types of structures. This is the case, in particular, of the old city hall of Kobé that contains 8 levels. On the photo of Fig. 10 we notice that this building lost its 6th floor.

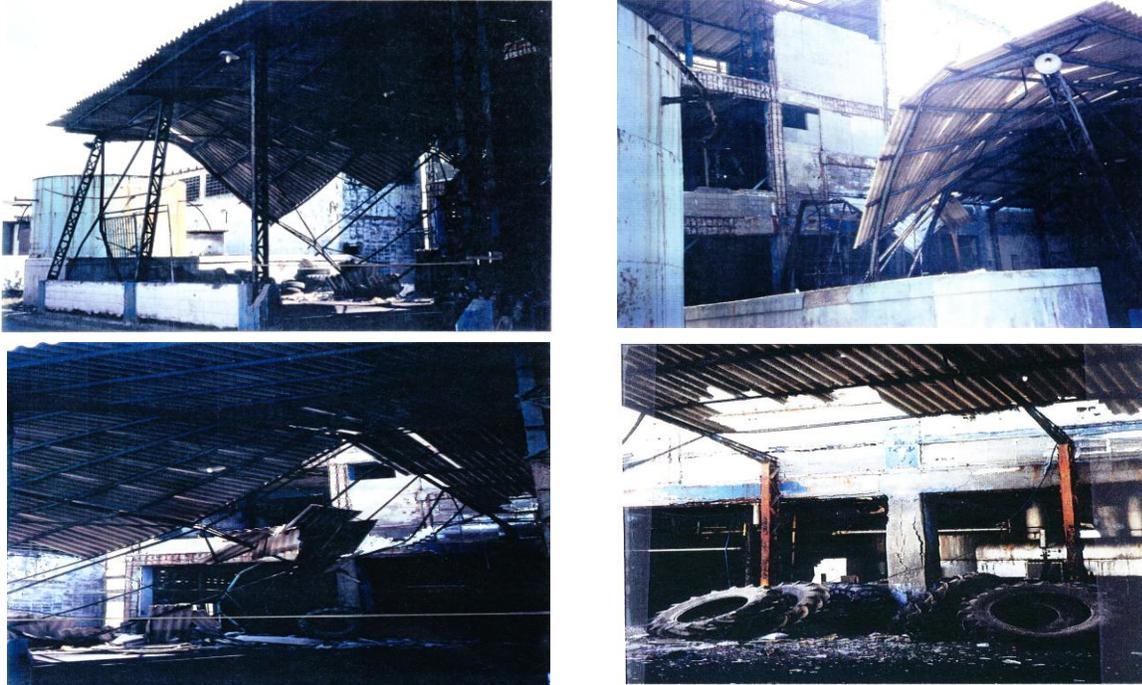
Fig. 11 Steel industrial halls - Earthquake of Cariaco 1997, Venezuela - AFPS Mission Report

Important disorders were observed. They are largely attributable to strong corrosion of metal profiles in marine and tropical environment. The earthquake only played a trigger role here on a structure in limit of stability (Fig. 11).

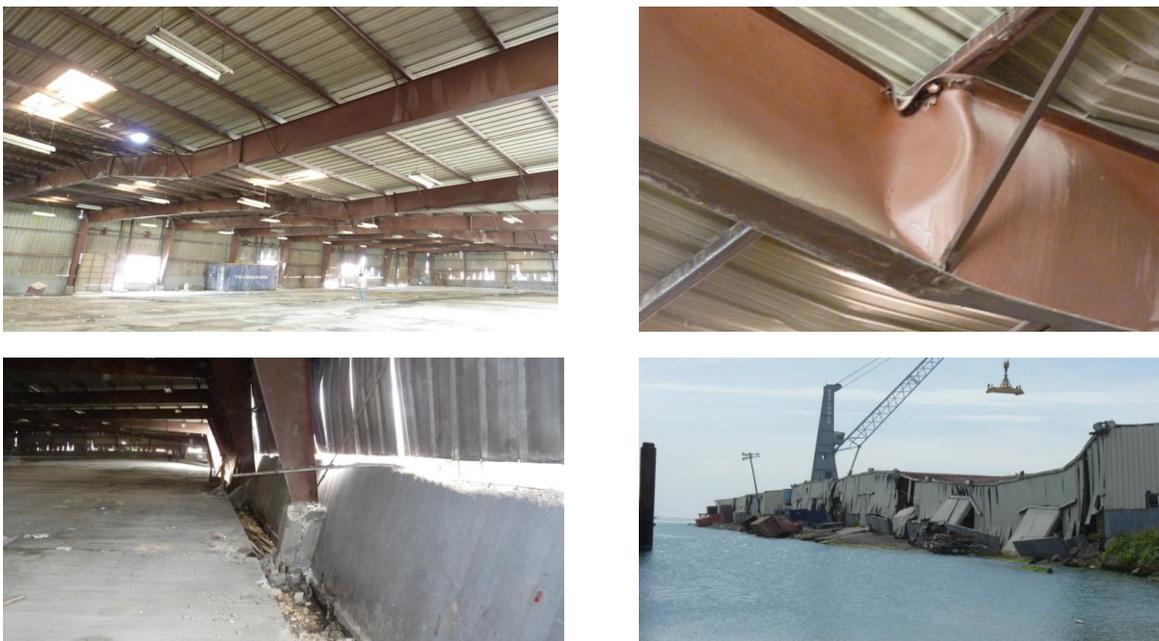
Fig. 12 Port of public trading - Haiti Earthquake of 2010 - AFPS Mission Report

The port suffered the liquefaction phenomenon that caused the sliding of the platform, with consequences such as the movement of reinforced concrete foundations and the dislocation of the anchorage of the steel frame. The effects of liquefaction were added to a poor design: absence of deep foundations and the columns of the frames not resting on the ground but on the little concrete columns.

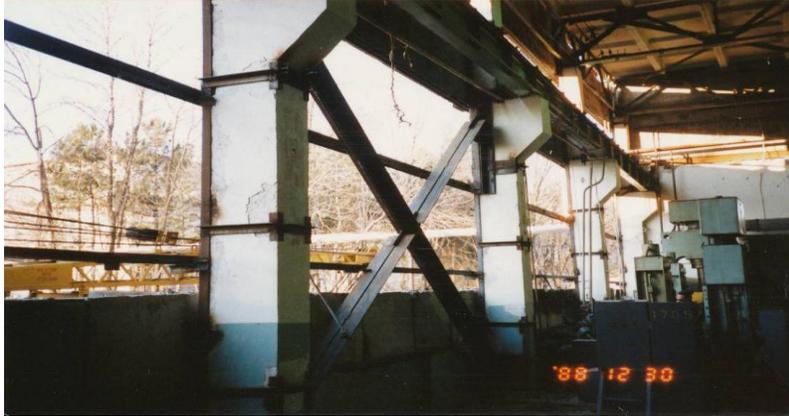
Fig. 13 Industrial building – Spitak Earthquake, Armenia 1988 - AFPS Mission Report

Constructions for heavy industrial use are produced in Armenia in frames with corbels or using heavy steel structures, with cross bracing, and provided with cladding masonry or precast reinforced concrete panels. Cladding generally fell apart, while the moment resisting frames remained intact, although some local buckling has been reported (Fig. 13).

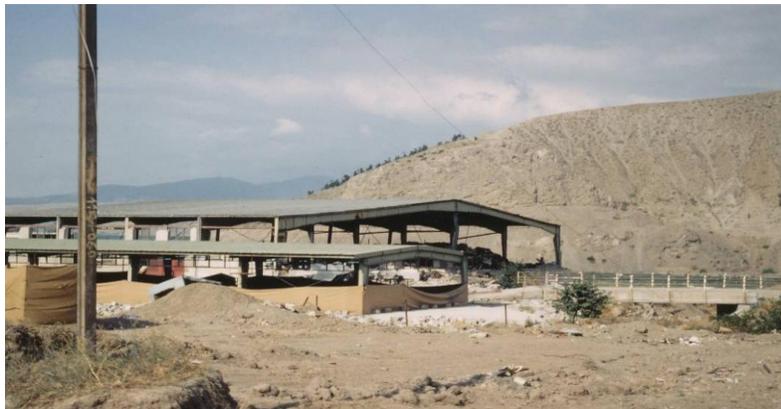
Fig. 14 Industrial building – Manjil Earthquake, 1990 Iran - AFPS Mission Report

Some industrial warehouses with a range of about twenty meters, are built with large scale mechanic welded elements, assembled on site by well-kept plans of bolting (Fig. 14). Such buildings have not suffered any damage, except perhaps that due to the collapse of materials stored up high.

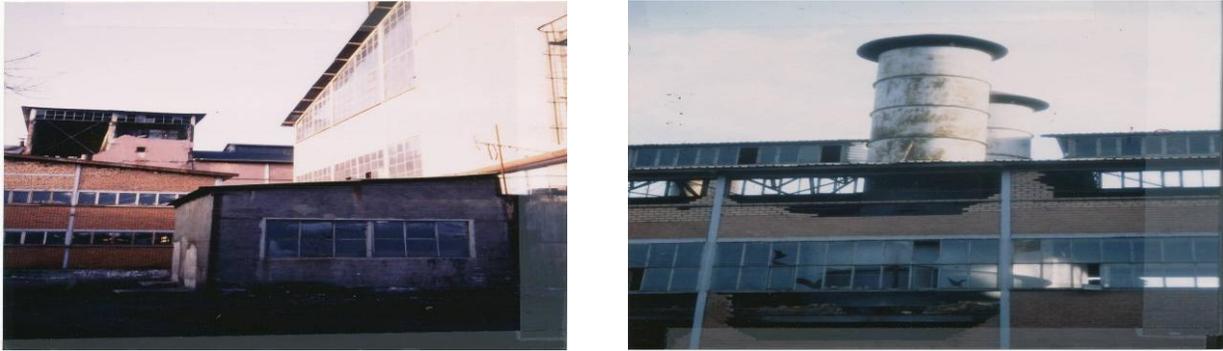
Fig. 15 Sugar Factory - Erzincan Earthquake of 1992, Turkey - AFPS Mission Report

A number of buildings from 1 to 2 levels maximum in steel structure and masonry fillings performed well in the earthquake – Fig. 15 - left photo.

A more important building - a big warehouse with a steel structure - lost most of the windows and fills on its long sides, without presenting structural elements that reached a state of ruin – Fig. 15 - right photo.

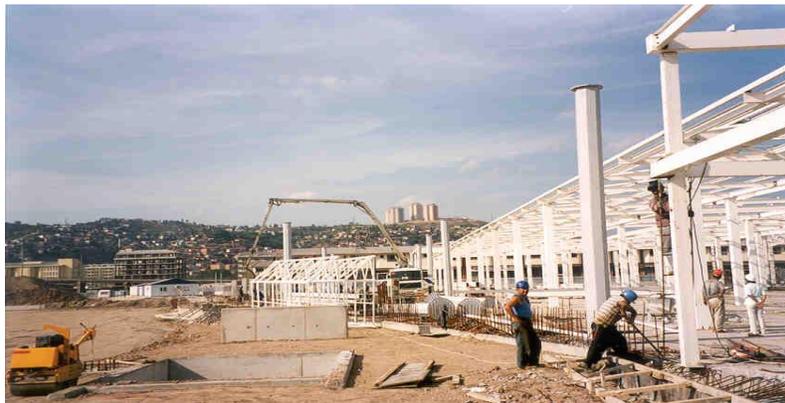
Fig. 16 The construction of the Carrefour store in Izmit - Kocaeli-Izmit earthquake of 1999, Turkey - AFPS Mission Report

The building has not been damaged in the earthquake (Fig. 16).

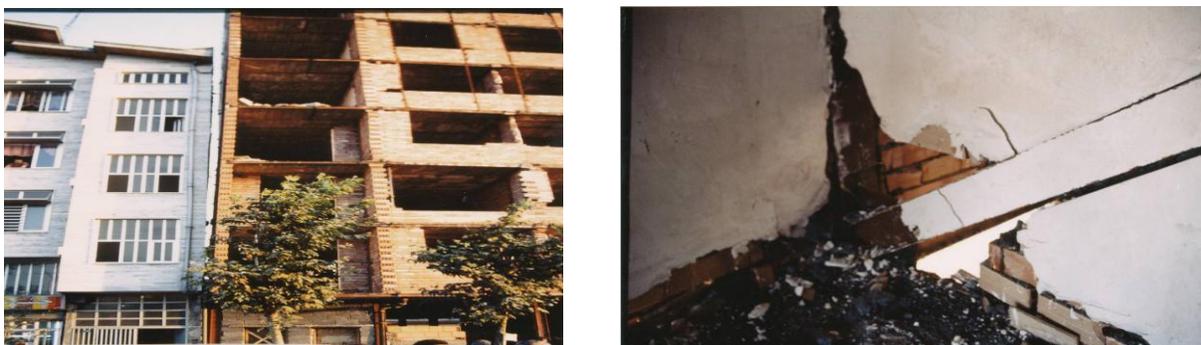
Fig. 17 Steel frames building - Menjil Earthquake 1990, Iran - AFPS Mission Report

In the city of Rasht, some buildings of 7 or 8 storeys were built shortly before 1980; one of them, that was under construction, remained in the state of a welded frame and with floors with some brick infills, bracing being provided by “X”-braces. All the connections are rather specific to a bolted construction, but the bolts are replaced by discontinuous welds. The building moved a lot in the earthquake. Significant damages are observed (see photos – Fig. 17), with inclinations of several centimeters per floor for various columns, breaking of bracing cross welds on the columns, with buckling of compressed braces.

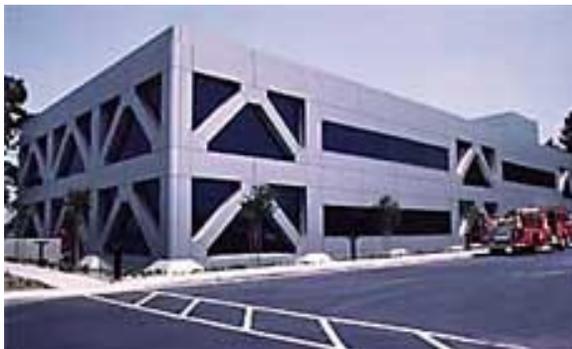
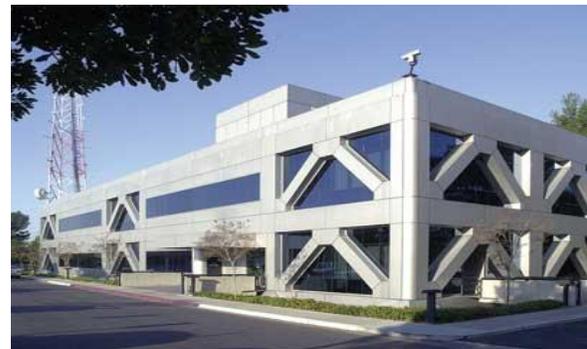
Fig. 18 Fire Command Center - Northridge Earthquake of 1994 - USA - AFPS Mission Report

The Fire Command Center and Control Facility (Fig. 18) is an important element in the organization of emergency services in Los Angeles in particular following an earthquake. The building, steel frame braced by concentrically braced frames, consists of a ground floor and a floor. It rests on supports - 32 laminated elastomeric, evenly spaced under the structure. The behavior of the building in the Northridge earthquake was very good.

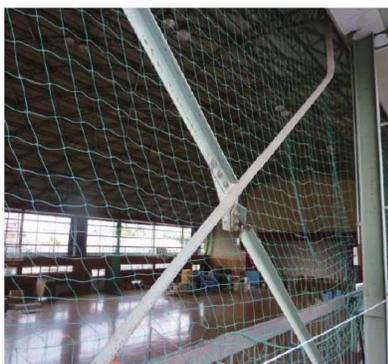
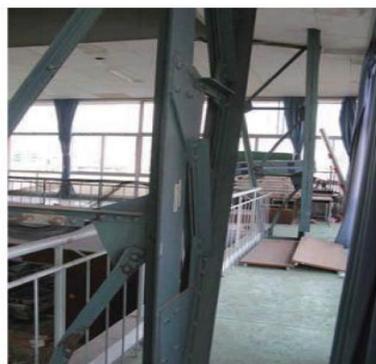
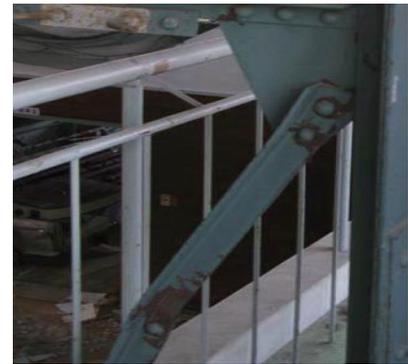
Fig. 19 Gymnasiums - Tohoku Earthquake 2011, Japan - Hokkaido University Report

Buckling of brace member (Fig. 19 – left photo) and fracture of brace joint (net section fracture at bolt hole – Fig. 20) were observed at the steel Gymnasiums. The buckling of some diagonal member of latticed column was also observed. These latticed columns have the characteristic of being at simple diagonal working in traction and compression in the case of reversal of the sign of solicitation. The pronounced buckling is to be attributed to a high level of slenderness of the diagonal (Fig. 19 - photos of the center and left).

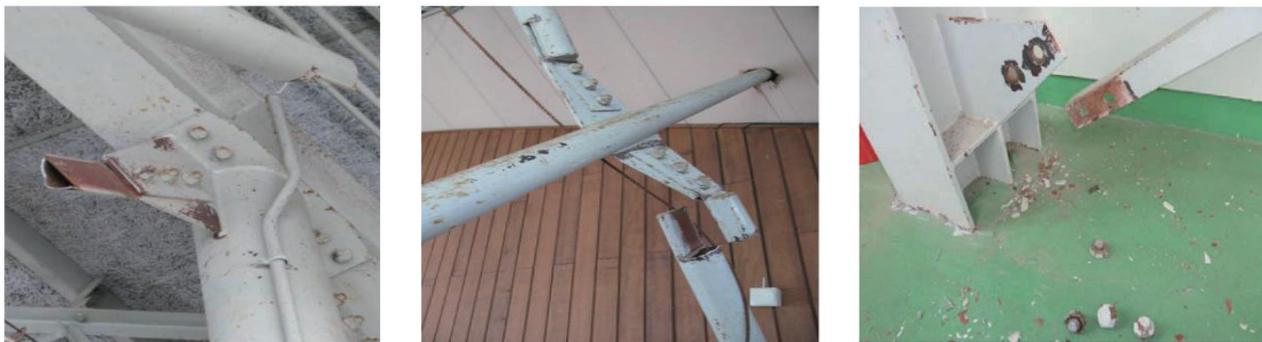
Figure 21. Gymnasium - Tohoku Earthquake 2011, Japan - Hokkaido University Report

Angle section was often used for many brace members, but circular hollow section steel was also used for brace members. For the Ibaraki Gymnasiums the fracture of brace welded connection was observed: fracture at column top (Fig. 21 – left photo) and fracture at brace crossing (Fig. 21 – photo of the center). Cracks were first propagated along the weld on one of the two faces of the pocket, causing a carry loads on the second half of the tube, which has broken by traction. The right photo of Fig. 21 shows bolts in shear fracture in another gym.

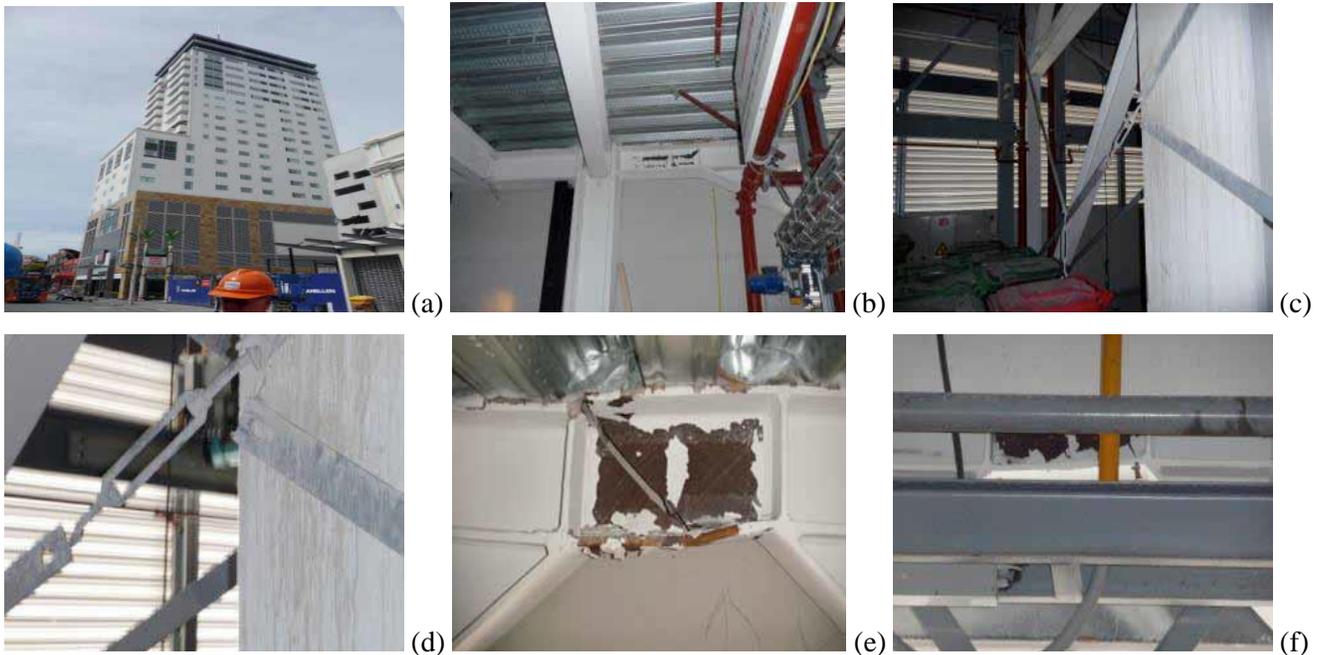
Fig. 22 The "Pacific Residential" tower, Christchurch - Canterbury University Report (Photos by M. Bruneau)

Paint flaking and residual link shear deformations were observed in the EBS links at the lower floors.

The EBF at all other levels were hidden in architectural finishes, and absence of damage to those finishes suggested limited inelastic deformation, except at level six where a few of the hotel room doors along the corridor could not be closed, which suggest greater residual deformations at that level.

A fractured link was discovered under the floor of this level (Fig. 22 e), in the northwest corner of the building. This element is visible behind the atrium in the corner of the nearest building in the photo (Fig. 22 a).

(a) Overview; (b) Paint flaking in the EBS links; (c) and (d) Fracture of a brace member at the level of the cars elevator; (e) EBF link fractured at the atrium; (f) Residual link shear deformations in the EBS links.

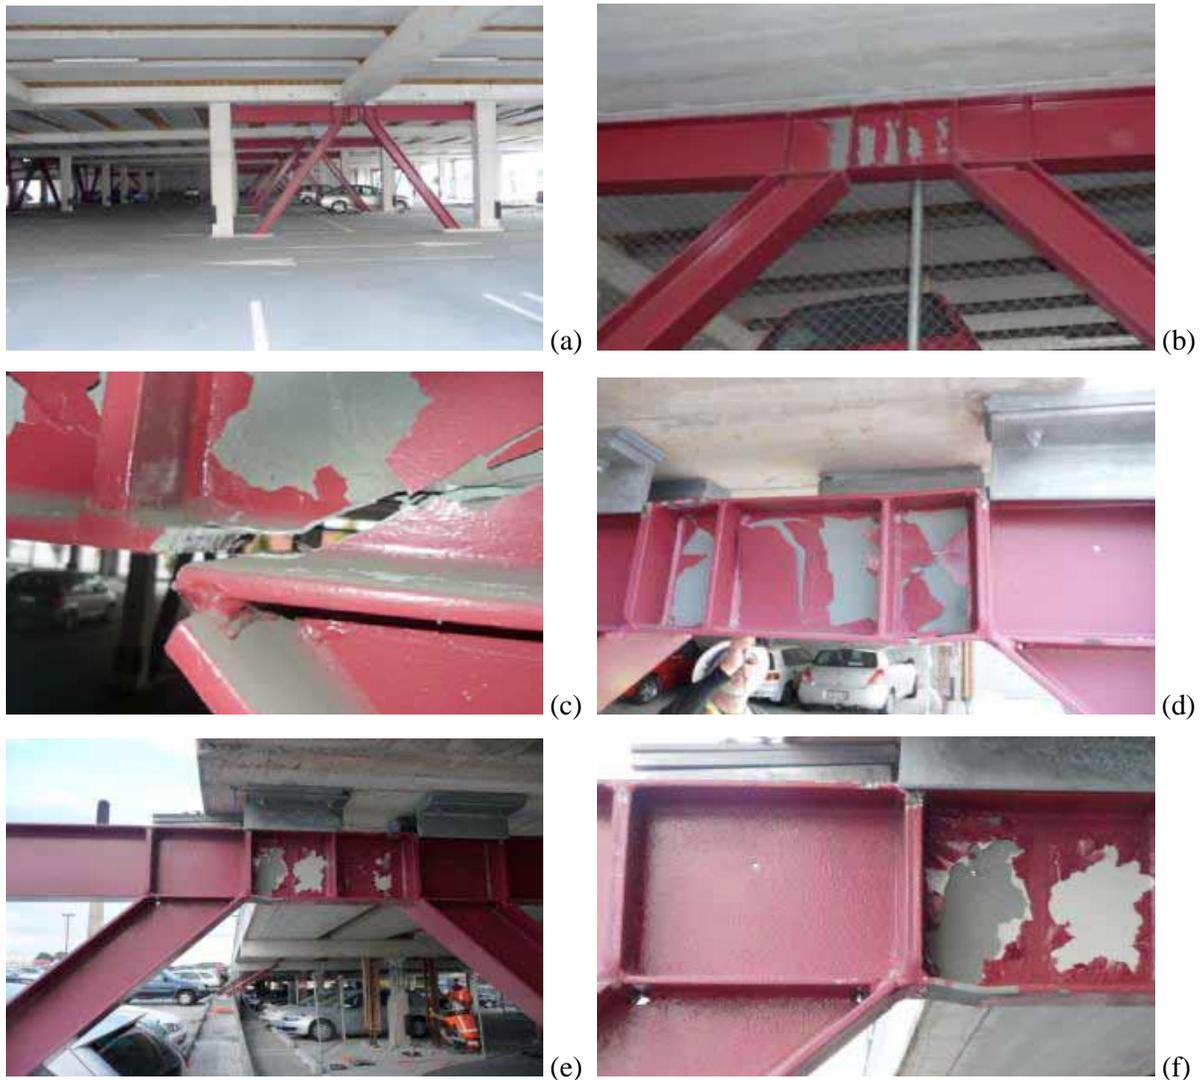
Fig. 23 Parking garage on St Asaph St et Antigua St, Christchurch - Canterbury University Report (Photos by M. Bruneau)

The EBFs in this hospital parking garage closer to the epicenter performed well, although some link fractures were observed in two braced bays (Fig. 23).

The fractures, as shown in close-up in Fig. 23(c) were of particular concern as these were the first fractures recorded in EBFs worldwide. Further puzzlement was added by the fact that the fracture plane, shown in Fig. 23 (c), indicated a ductile overload failure rather than a brittle fracture. However, the likely explanation lies in the offset of the brace flange from the stiffener. This offset is shown in Fig. 23 (c) and means that, when the brace was loaded in tension, the axial tension force in the brace fed into the active link/collector beam panel zone through a flexible beam flange rather than directly into the stiffener. This meant that the junction between the unstiffened beam flange and the beam web was overloaded, leading to fracture between these two surfaces and this fracture spreading across the beam flange through the web.

The lateral bracing of the active links in the building shown in Fig. 23 was only in the form of a confining angle on each side of the top flange, as shown in Fig. 23 (d) and 23 (e). No lateral movement or twisting of the ends of the active links was observed, indicating that the lateral restraint provisions had been adequate despite only being applied to the top flange and for EBFs not integral with the slab above.

(a) Redundancy provided by multiple EBF bays ; (b) Evidence of EBF link yielding ; (c) Fractured link at lower level EBF ; (d) and (e) Evidences of inelastic deformations at top level EBF ; (f) Close-up view of same.
