MUISNE, ECUADOR 2016: ONCE AND AGAIN RELEARNING ABOUT THE ROLE OF THE MISCALLED "NON-STRUCTURAL" MASONRY WALLS

A. Urich⁽¹⁾

Abstract

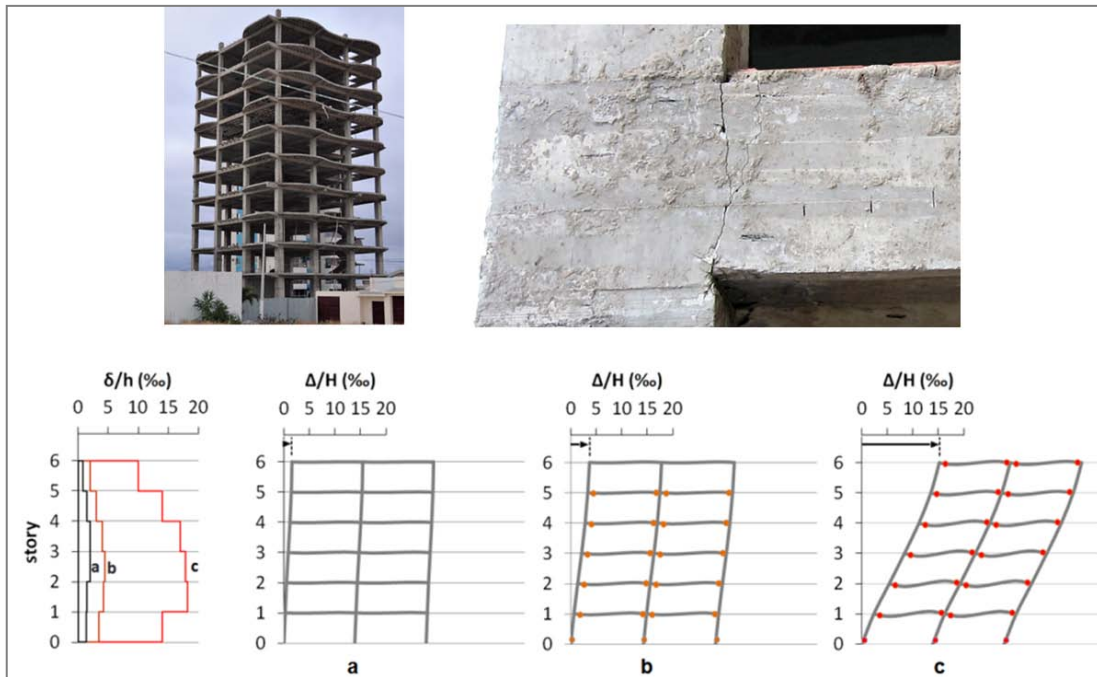
It's really hard to find totally bare frames in Ecuador, only a few buildings under construction in which the internal partitions have not yet built. In these cases, cracks in beams due to typical flexural plastic hinges were observed, as expected in ductile structures (Fig. 2) The damage shown in the picture is moderate, indicating that the building experienced probable drifts in the order of $d/H = 6$ a 10%, at low-to moderate deformation after the yield strength of the steel but still far from the permissible drift of 20%.

Fig. 2 – Performance of bare reinforced concrete frames

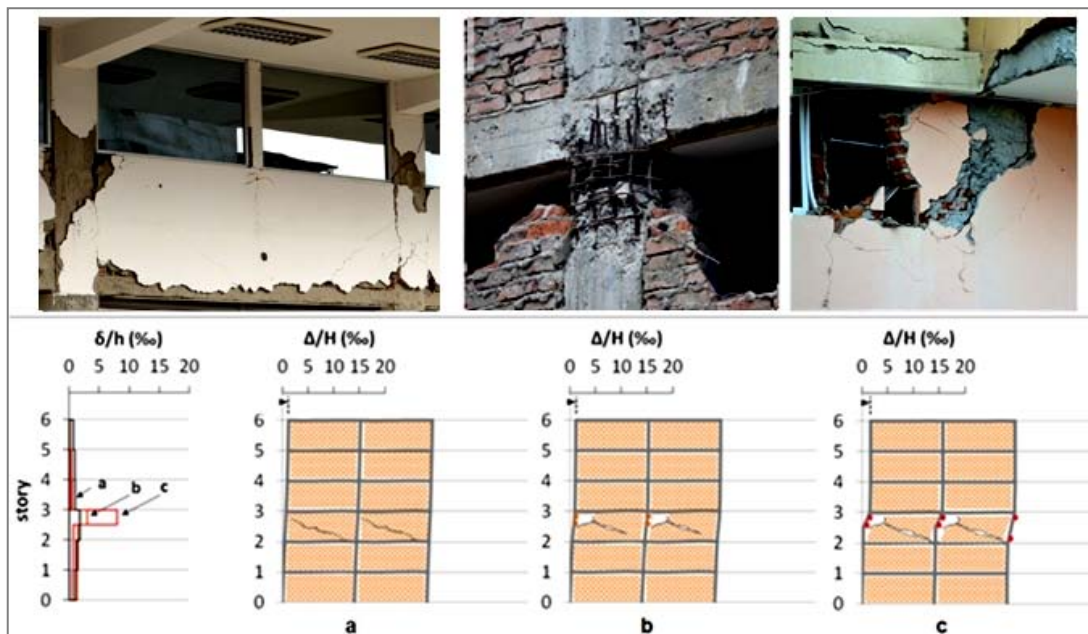
It is probably the biggest problem in earthquakes worldwide. The classic mechanism by the presence of walls that restrict only a portion of the column, leaving another free portion was observed; but the emphasis in this paper is in the many cases of captive columns in places where their occurrence was not predictable in the original configuration of the building, since the wall covered the entire height (Fig. 3). In these cases, the walls when partially broken, which usually is at very low drift (less than 2 to 3‰), induce the same mechanism as if a window would have been in this place.

Fig. 3 – Captive column mechanisms

The classical explanation of the captive column is that the shear stress increases proportionally to the reduction of the clearance of the column, but this is not all that happens; in addition, the stiffness and the ductility are also affected, both local (structural members) and global (entire structure); even worse, all of the seismic demand is concentrated only in these columns, the shorter ones. Considering all these variables, a structure can be 20 times more vulnerable, or worse, than that with free columns. In fact, it is possible that the failure starts, not only at the large deformations imposed by earthquakes, but even at small deformations by variations in the ambient temperature. More details on these statements may be consulted in another paper by the author [31].

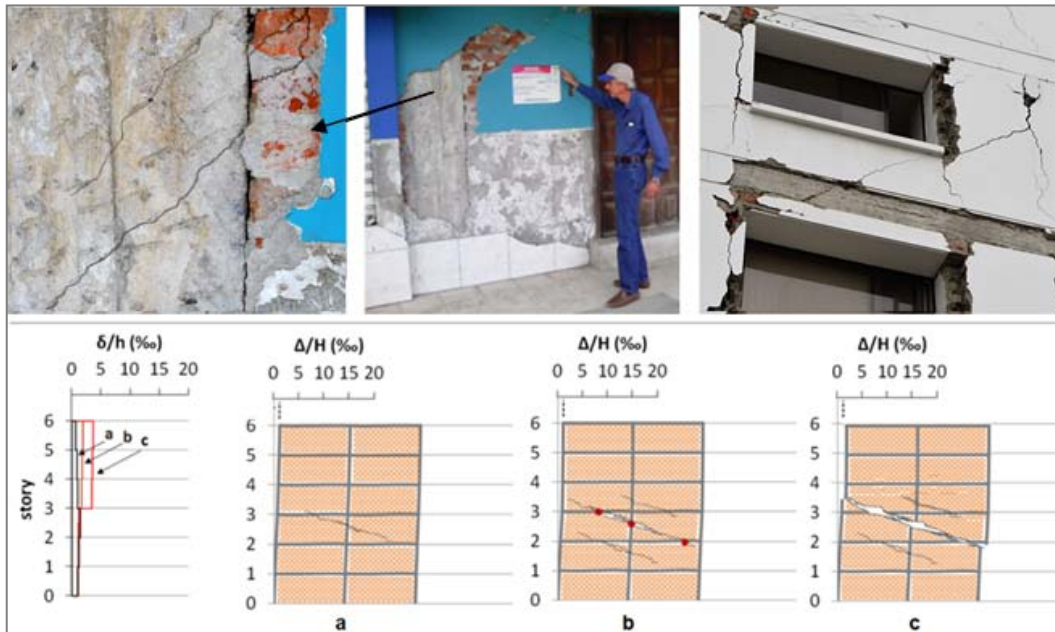
It is shown how the crack in the wall continues in columns or beams as if they were a structural unit instead of two different elements (Fig. 4). It is an extreme case of short column where the free portion tends to zero once the walls are cracked. In the case of horizontal structural members is a sort of captive beams or slabs. These problems may start at drifts as low as 1 to 2‰.

Fig. 4 – Performance when shearing failure is directly transmitted from the wall to the structure

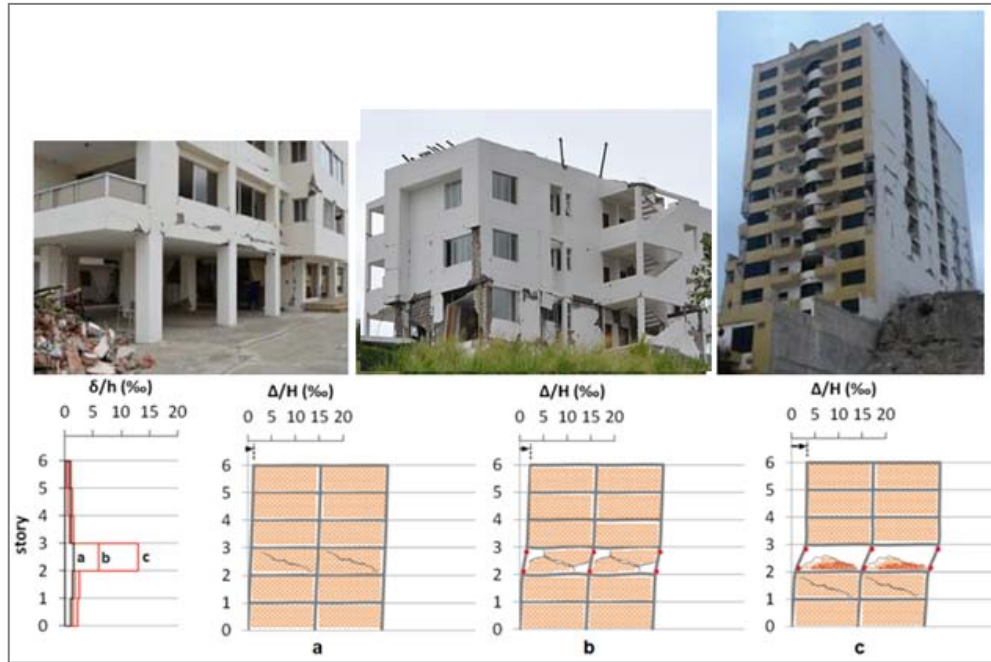
The classic ground open story was observed; but again, the emphasis is on the large number of houses and buildings where the extreme damage in one or two stories contrasts to the sound condition of the others; this shows the formation of the mechanism even in the presence of walls in the affected stories (Fig. 5). The observed symptoms indicate a significant drift in the stories where the damage is concentrated, while the absence of cracks in the walls of other floors indicates that drifts were very low, less than 2‰.

The soft/weak story takes place due to an excessive flexibility or low strength in levels with fewer walls, or where they are broken first, while the rest of the building behaves in practice as a rigid body. This does not necessarily occur only at the ground floor as it is referred to in most of the literature, but it can occur at any level of the building, in some cases, mechanisms of 2 or 3 stories are presented, such as the building shown at the top right of the Fig. 5. It could be said that this is a captive building, in analogy to captive column. Previous studies [32] have estimated that the soft story can increase up to 15 times the drift demand in the affected level, compared to the bare frame.

Fig. 5 – Soft/weak story performance

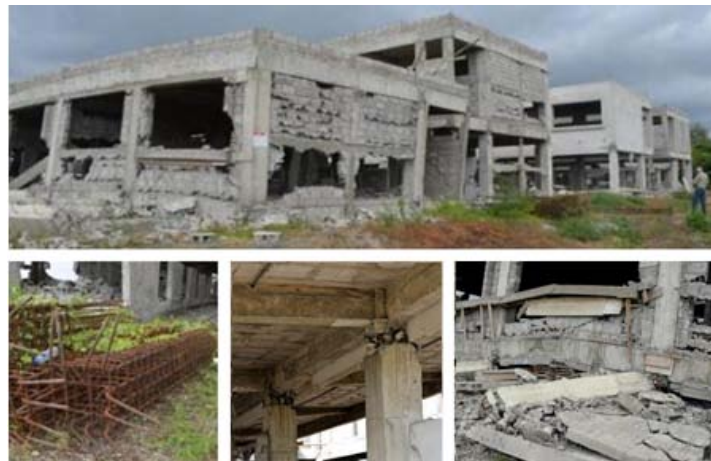
The Jama School, which was under construction, is shown (Fig. 6). It consists of four identical buildings, all of two levels; one collapsed and the rest were very close to collapse. Soft/weak story on the first level appeared, even though it also had walls. Concentrated damage (plastic hinges) at the ends of the columns, both the collapsed module and the standing ones are shown; good detailed of reinforcing steel is also shown, which did not prevent plastic hinges were in columns rather than beams. Definitely, the masonry partitions in contact with the beams restricted their free deformation, turning then to the strong-stiffer members, over the columns. It is important to highlight that many of the buildings that collapsed in Ecuador behaved the same way, fortunately, it had not yet begun the class season, as the building was about to be inaugurated.

Fig. 6 – Collapse of Jama School (new building under construction)

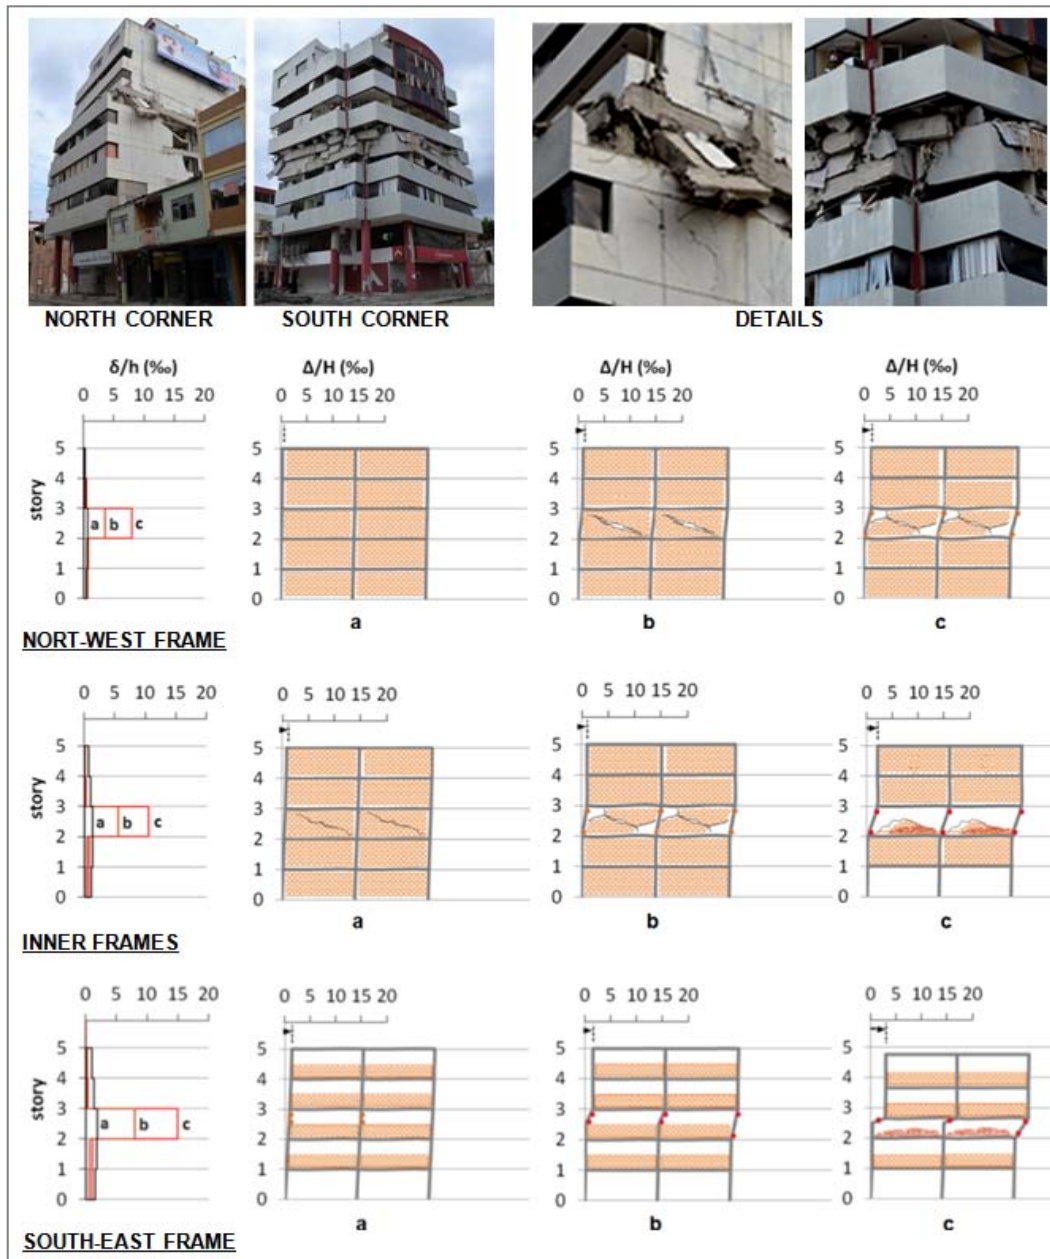
Fig. 7 – “Del Pacífico” Medical Center: torsional plan, captive column and soft story acting together

An emblematic case in Ecuador in which torsional plan took place is shown Fig. 7 above, with the aggravating conjunction of the soft story and captive column. It is noted that the walls of the north facade extend to the entire height of the building, while the rest of the facades are freer; parapets are also distinguished in contact with columns in the other three facades. Then the possible sequence of collapse is described: (a) the highest density of walls in the west facade attracts the stiffness center, concentrating the maximum shear stresses to this area and increasing deformation demand toward the opposite facade, which enhance the captive column in that place; (b) the failure of the "short columns" occurs, stiffness falls in that area and the torsion is empowered, transferring greater shear stresses to the northwest side and increasing the deformation demand on internal frame members; (c) finally, the collapse of the entire affected level, *which results in soft/weak story that*

was not evident in the original configuration of the building, in this case involving two levels (for simplicity, schemes in figure do not show all levels). By the final position of the building and other symptoms, estimated drifts outside the collapsed area were probably less than 4 to 5‰; that contrasts to the extreme displacement at collapsed levels.

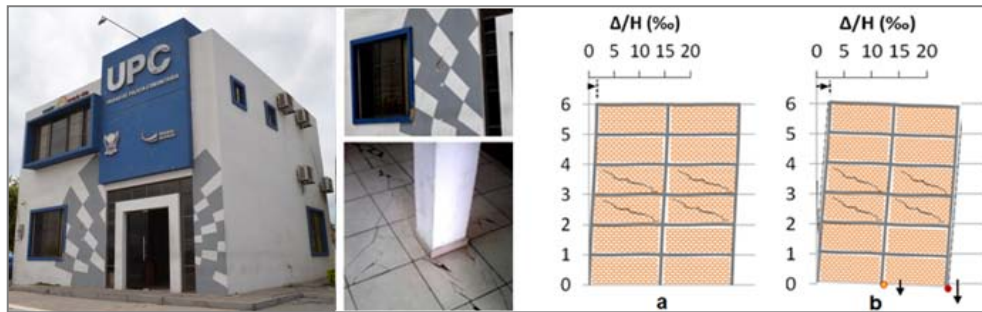
Some buildings had no damage, neither the superstructure nor the walls, except some minor cracks to masonry elements. In these cases, the building behaved as a rigid body, concentrating the deformation demand under the supposed base level, affecting foundations. The Fig. 8 shows an example where the extensive cracks on floors denotes this behavior. One of the possible reasons is the increasing reactions due to the effect of diagonal struts through the masonry infills.

Fig. 8 – Foundations system failure

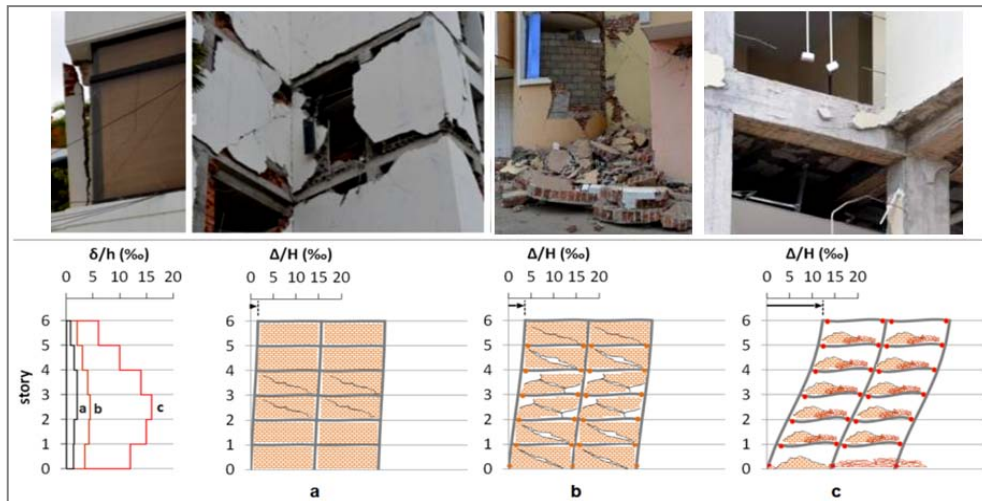
A great destruction of masonry walls was also observed, even in buildings where no structural damage was evident (Fig. 9). It notes that the level of destruction in walls shown in the pictures can occur at much lower drifts than those accepted by current codes, even before ductile energy dissipation mechanisms in the structural members are reached.

Fig. 9 – Extreme damage to partitions when performance is dominated by the frame structure

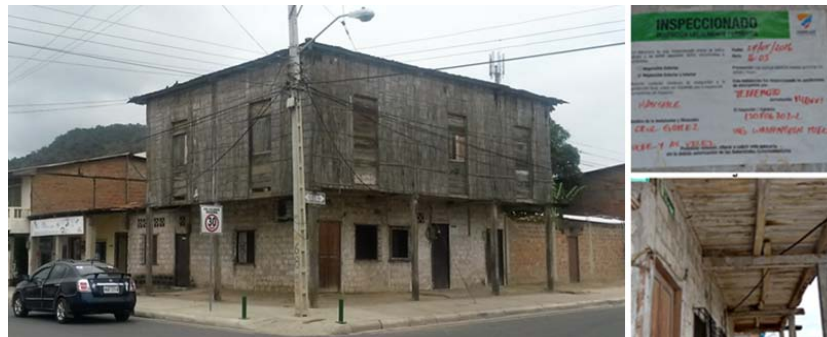
Next to collapsed buildings, were also many others that didn't have any damage, neither the structure, nor the partitions. Such is the case of the house shown in Fig. 10, located in San Vicente. This house was built over 100 years ago, as indicated by its owners [34] who invited us to get in, very proud of the green label displaying its facade. It was also informed that the house has performed the same way on several earthquakes before. It has two stories with a very flexible wood structure, the partitions are of masonry at the first floor and wood and cane, much more flexible and lighter, on the upper level. This shows the benefits of masonry for low-light buildings.

Fig. 10 – Ancient building of wood and masonry with no damage
