The April 16 2016 M_w 7.8 Muisne Earthquake in Ecuador – Preliminary Observations from the EEFIT Reconnaissance Mission of May 24 - June 7

Abstract

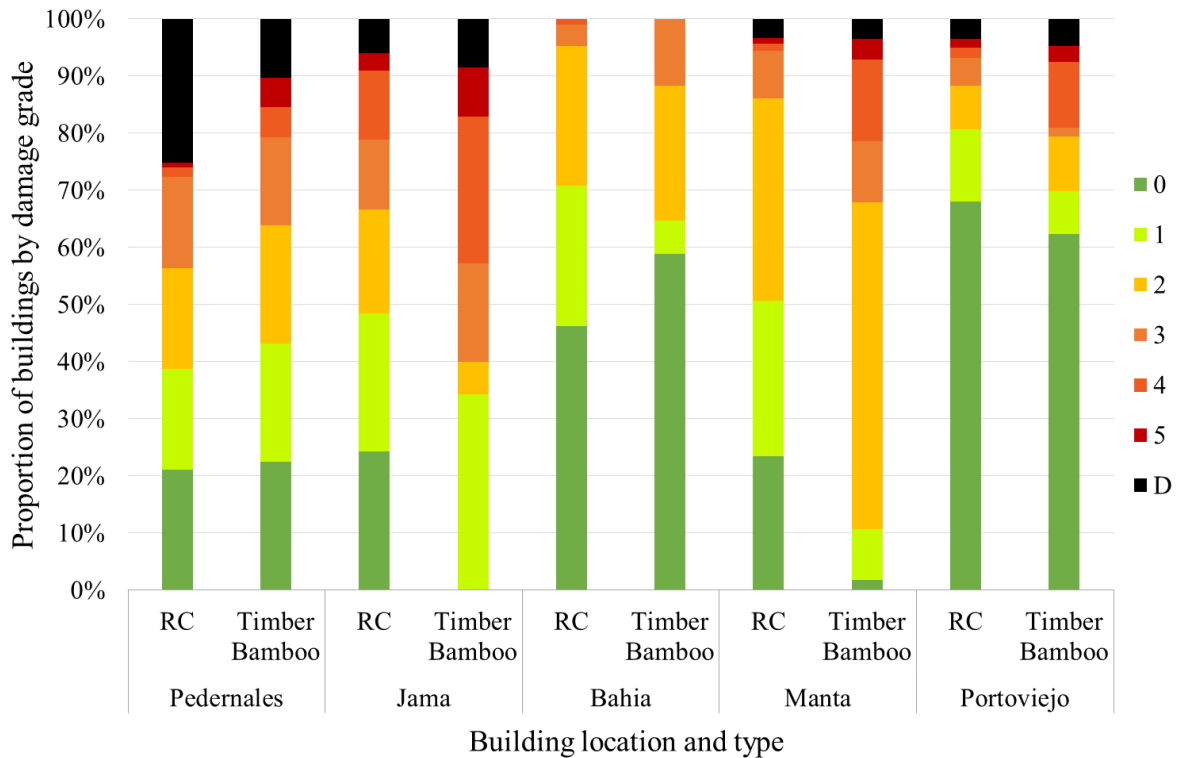
Figure 2 – Damage survey results by area and by EMS-98 damage grade (“D” denotes demolished).

The proportion of buildings surveyed at different damage states is summarised in Figure 2. Even considering the caveats above, Figure 2 indicates that RC buildings experienced greater levels of damage than timber/bamboo buildings, and in addition that Pedernales experienced the greatest level of damage out of the towns the team visited.

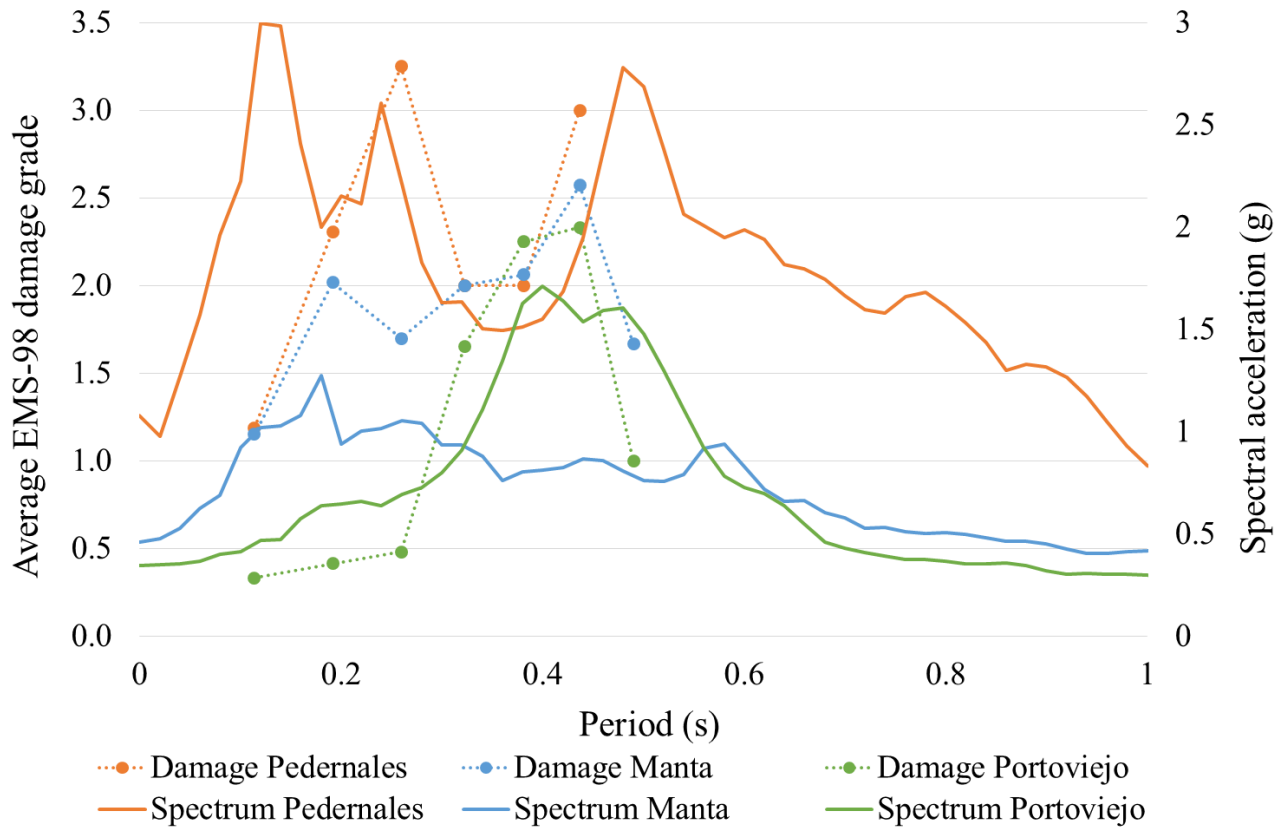
Figure 3 – Relationship between response spectra from recorded ground motions [14] and surveyed damage.

Figure 3 compares the spectral accelerations recorded at stations in Pedernales, Manta, and Portoviejo, with the average damage grades of RC and timber/bamboo structures of different heights surveyed in those locations whose fundamental periods are estimated using Eurocode 8 [15]. In Portoviejo the damage correlates well, and similarly in Pedernales except for the first peak (at just over 0.1s). For Manta, the correlation is weaker although it is difficult to tell without any major peaks in the recorded spectral acceleration. This comparison tends to confirm the expected relationship between shaking frequency and damage to structures of certain height.

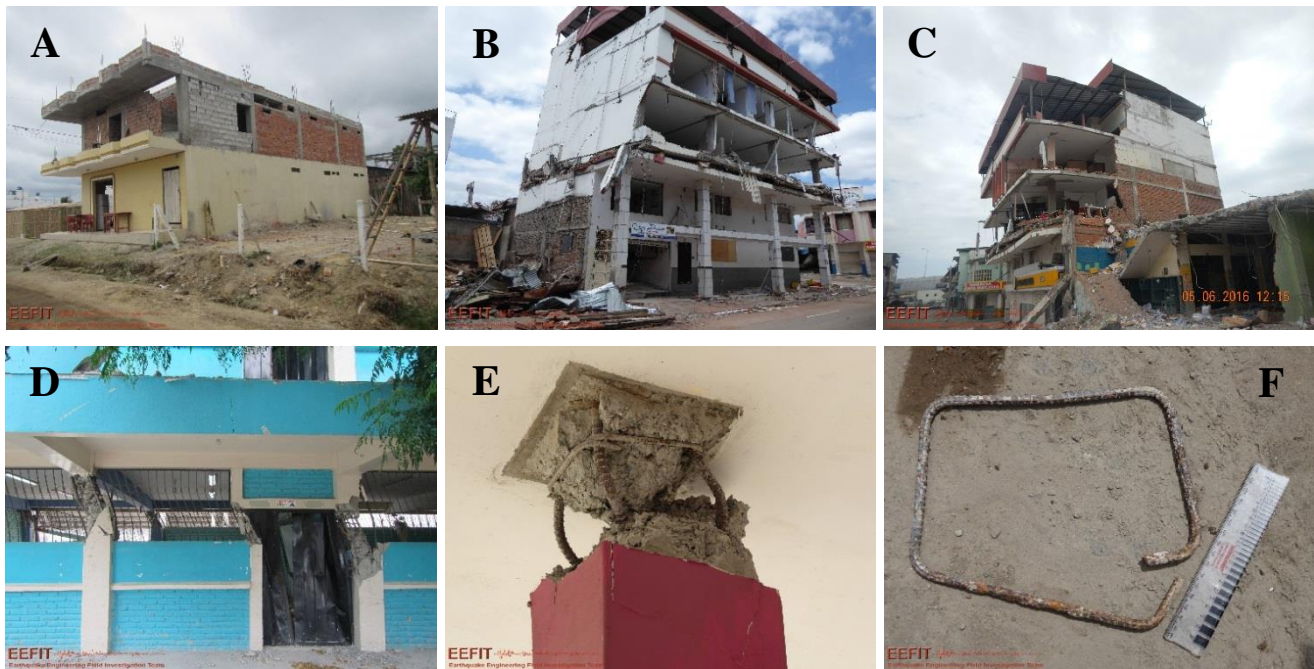
Failure at upper levels: Upper floor soft/weak storey failures were observed in a number of buildings. It is suspected that this could be due to constructing upper floors long after the bottom floors are completed (as extensions of the building when new resources become available or when new needs arise; see Figure 4A). The joints between new and old are typically poorly executed with insufficient lapping of the rebar, resulting in local reduction in capacity promoting failure in these areas (Figure 4B). This localised upper storey damage may also be attributed to all rebar being lapped at one height, resulting from the use of the same length bars in all

columns. Additionally, some upper storey failures could be attributed to changes in plan or elevation at specific levels, resulting in a weak/soft storey.

Inadequate design and detailing of RC moment frames: RC moment frames in seismic areas require several key considerations to ensure they behave safely in an earthquake: 1) Sufficient overall moment and shear capacity, 2) Columns' flexural strength should exceed that of the beams, such that flexural failure occurs first in the beams, 3) Columns and beams should be stronger in shear than in flexure, such that a ductile flexural failure mode occurs before a brittle shear failure mode, and 4) Adequate detailing of the reinforcement in all elements. Damaged RC structures observed generally failed some or all of these requirements (see Figure 4C).

Figure 4 – Two-storey building with columns' rebar left sticking out of roof for future extension (A). Weak/soft storey failure at upper level (B). Inadequate design/detailing of RC frame and infills (C). School building with short column failure (D). Column head failure showing insufficient and poor shear design and detailing (E). Column link with no 135°-bend (F).

Short columns: This failure mode was seen in a number of buildings, with a reoccurring detail of high level windows for the full length of the frame bays (see Figure 4D).

Inadequate design and detailing for shear: In many RC buildings surveyed there was poor detailing of shear reinforcement, with sparsely-spaced links and with poor/no anchorage of these links into the columns (i.e. no 135°-bends in links; see Figures 4E & 4F).

- Improved knowledge and application of basic fundamental structural and seismic design principles
- Better reinforcement detailing, notably detailing of links and rebar overlaps, and increased cover
- Better masonry infill walls and bed joints, better seismic connections to frames, and better materials
- Superior construction quality standards, especially concrete
- Better building maintenance, especially for timber or bamboo structures

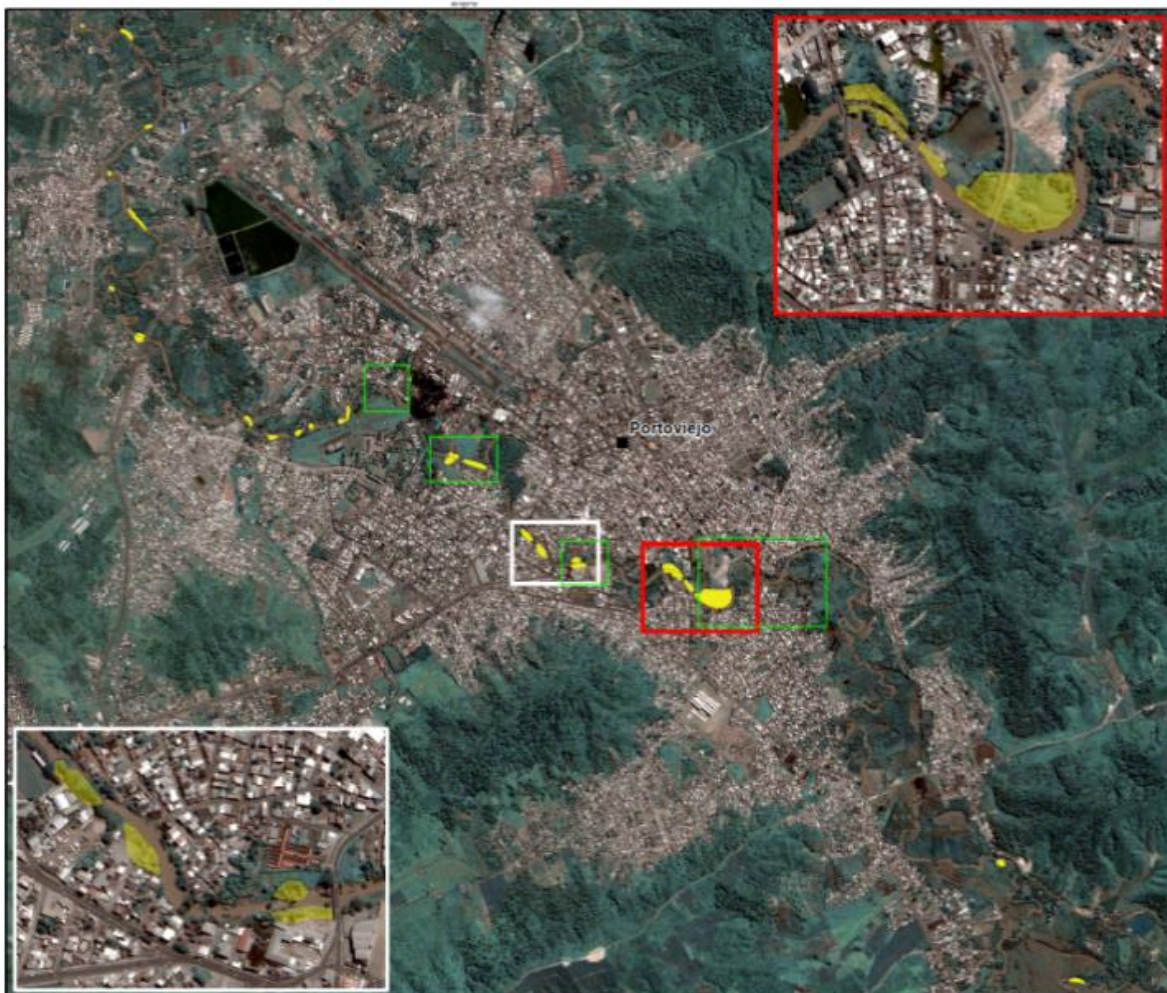
Figure 5 – Portoviejo landslides (in yellow) identified from satellite imagery (British Geological Survey).

As part of the team’s landslide reconnaissance, a ground-truthing exercise was undertaken in collaboration with the British Geological Survey (BGS) to provide field validation for their preliminary landslide assessment, initiated by a request from the UK Department for International Development (DfID) and based on satellite imagery from UNITAR/UNOSAT [17]. Photographic and drone imagery were taken on site and interviews were conducted at locations of identified landslides. 13 sites were surveyed in Portoviejo [18] and 17 in the vicinity of Bahía de Caráquez [19] as part of this exercise. Guided by the BGS satellite images, the team visited these locations and provided observations (see Figure 5 & Table 1 as an example for Portoviejo).

During the survey, the team confirmed that the satellite-imagery interpretation had been mostly successful in correctly identifying landslides in the areas surveyed. A few small-scale additional landslides to those mapped in the rapid co-seismic preliminary assessment were observed and a couple of locations associated to greater uncertainty in the assessment were confirmed not to correspond to landslides after all. On the other hand, satellite-based analysis made it possible to identify extensive landslides attributed to liquefaction mapped along the Chone Estuary, close to Bahía de Caráquez, that were difficult to access due to dense vegetation and instable soil boundaries. Following the map and talking to the local community, the team was able to corroborate the preliminary assessment, observing signs of landslides such as drift of trees in the estuary.
