GEOTECHNICAL ASPECT OF DAMAGE CAUSED BY THE 2016 KUMAMOTO EARTHQUAKE

K. Konagai⁽¹⁾

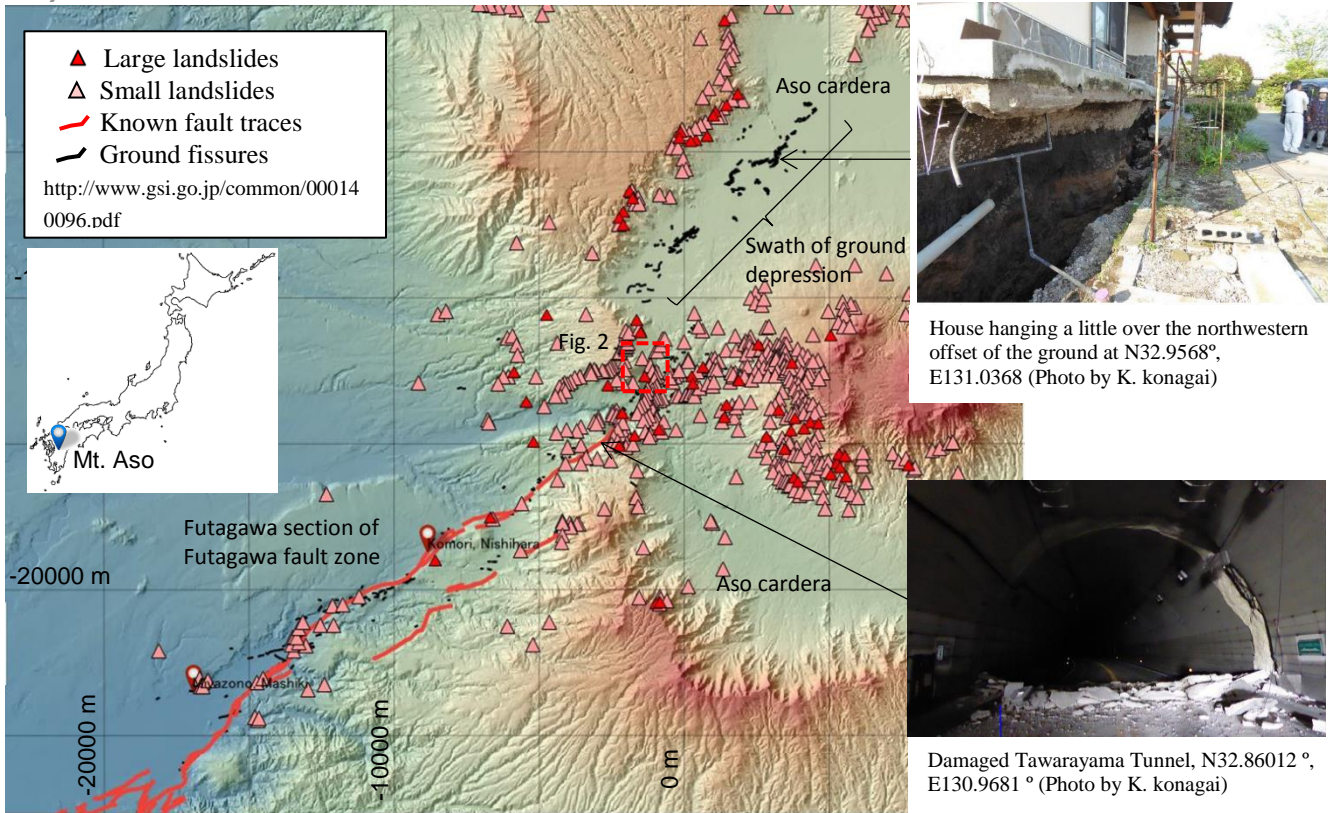
Fig. 1 Aerial photointerpretation of cracks and landslides that appeared on the ground surface (Coordinate reference system: JGD2000 / Japan Plane Rectangular CS II)

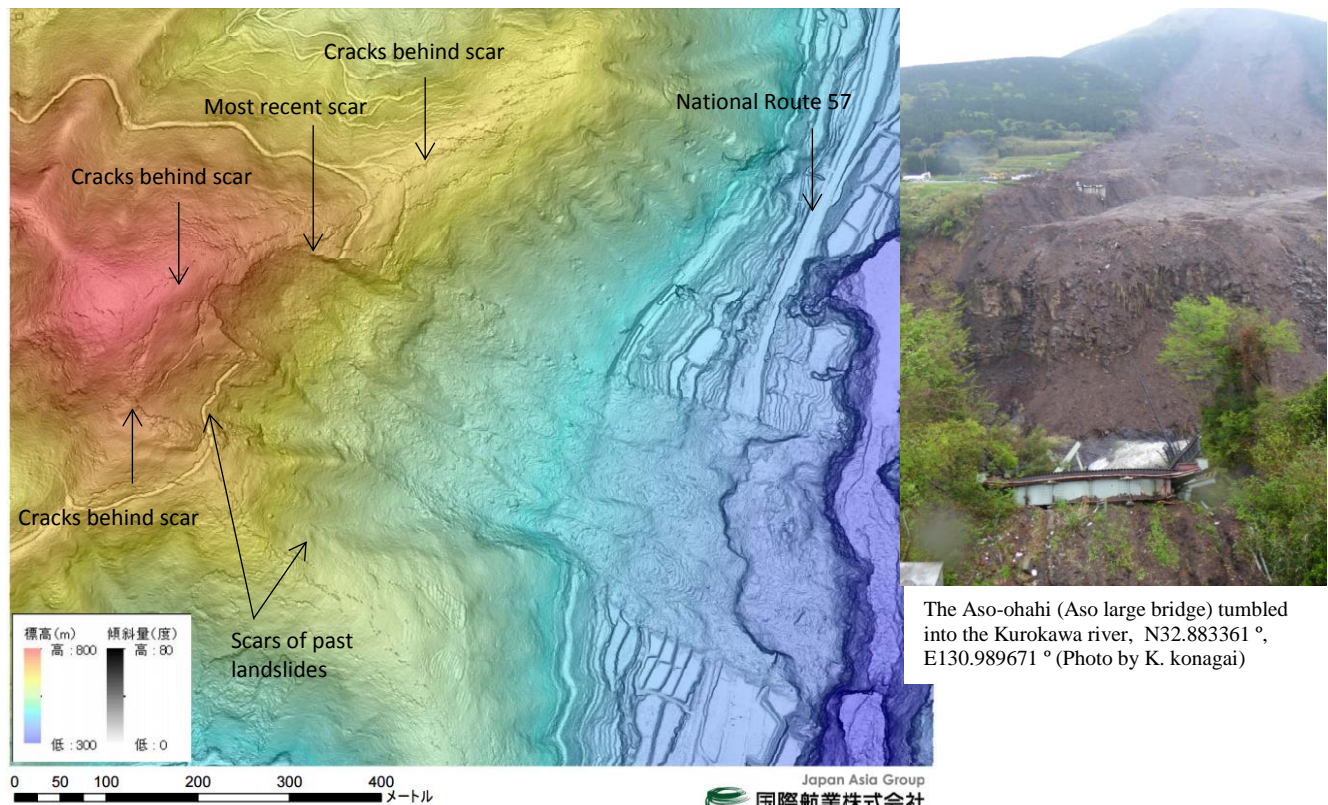
LiDAR, Laser based altimetry, can penetrate through tree canopy, revealing detailed feature of bare earth left behind by past natural hazards, and the LiDAR image of the mountain slope along the outer rim of the Aso crater shows evidence of past landslides as well as the most recent one that has hit an important location for traffic, transmission lines and a waterway leading to a penstock (Fig. 2). Moreover cracks are seen along the exposed scar indicating future risk. Ministry of Land, Infrastructure, Transport and Tourism, MLIT, thus, has a plan to remove a greater part of the unstable soil mass remaining behind the exposed scar. However this will be a long-lasting project, and MLIT is currently taking a 2 billion JPY urgent countermeasure stabilizing the uppermost slope face of 30,000 m² and constructing 7m high and 300m long retaining wall near the toe of the slope using un-manned construction machinery to protect reconstruction works for national route 57 and Hohi railway line.

Fig. 2 Scars of past and most recent landslides and cracks appearing behind the scars indicating future risk (LiDAR image from Kokusai Kogyo Co. Ltd., http://www.kkc.co.jp/service/bousai/csr/disaster/201604_kumamoto/index.html)
