CASE HISTORIES OF GEOTECHNICAL ENGINEERING DAMAGE FROM THE 2016 M_W 6.0, M_W 6.2, and M_W 7.0 KUMAMOTO EARTHQUAKES

The authors conducted two surveys in the devastated areas: one during April 16-17, and the other during May 11-14, 2016 as part of the GEER team efforts to document the effects of the earthquakes (GEER Report, 2016). Five major case histories were identified as a part of the GEER reconnaissance. This report summarizes this earthquake sequence and these case histories.

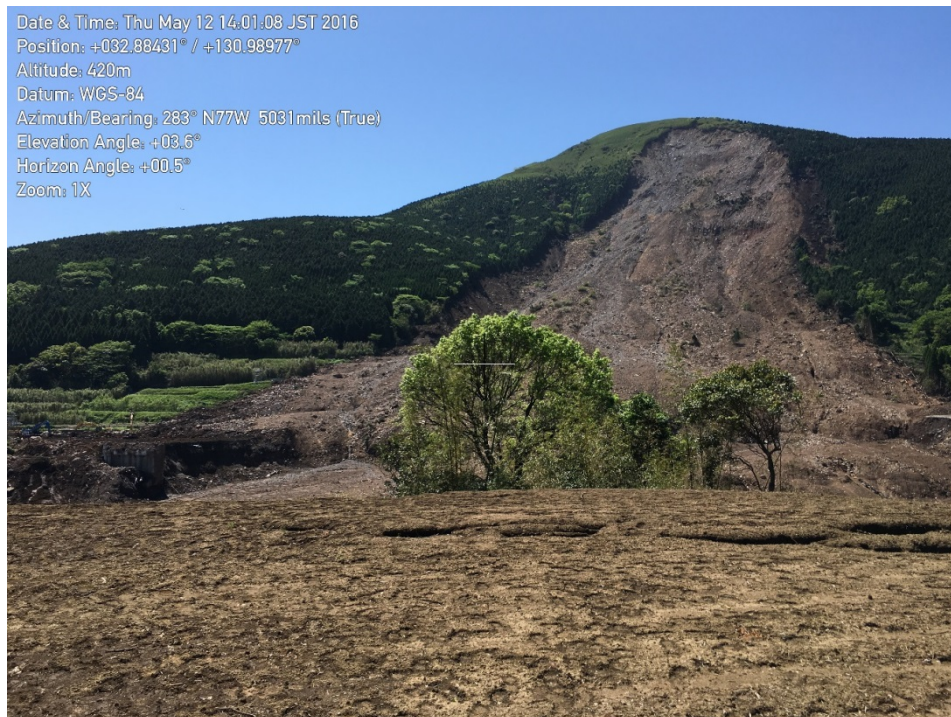
The Great Aso Landslide was likely the largest landslide that occurred as a result of the Kumamoto Earthquakes. The head scarp of the landslide was approximately 350 m higher in elevation than a canyon that ran directly beneath the landslide area. The horizontal distance from the head scarp to the canyon was approximately 700 m (Fig. 4). A bridge previously crossed the canyon directly beneath the landslide, but was destroyed in the earthquake, presumably by this landslide. The remnant of one of the abutments is visible. There was also significant slope failure of the canyon wall slopes throughout this area, independent of the overlying Great Aso Landslide. The Great Aso Landslide source area is mapped as Pyroxene Andesite Lava, lava flow and dike (Pa) in a 1:50,000 “Geological Map of Aso Volcano”.

Fig. 4. Front view of the Great Aso Landslide that likely destroyed a bridge, the remnant abutment of which is visible on the left side of the photo.

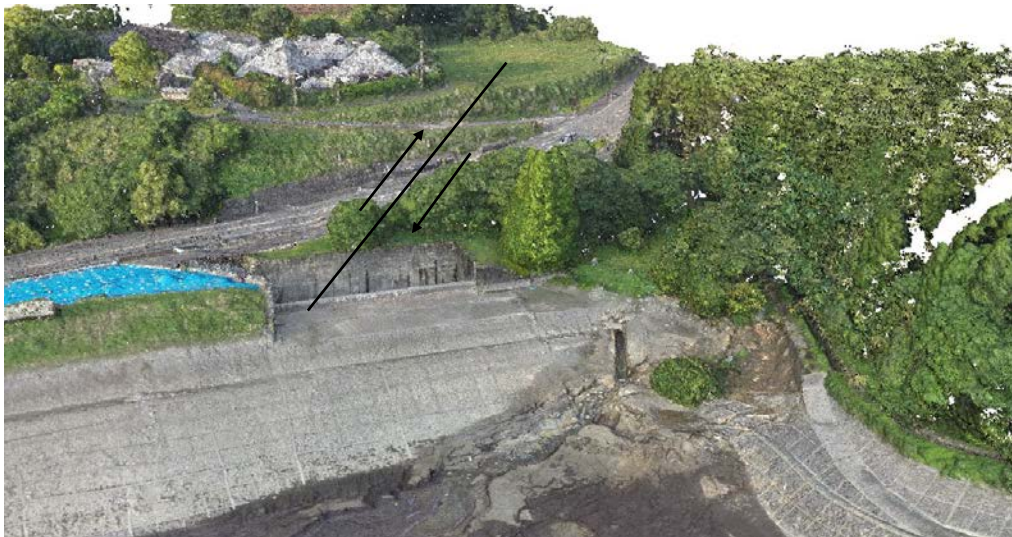
The Futagawa fault ruptured through an approximately 0.5 km long by 0.25 km wide water reservoir. The fault rupture passed through the western flank of the reservoir and through the main spillway. No catastrophic release of water occurred. However, the reservoir experienced significant damage, both as a result of the surface fault rupture and as a result of the strong ground motions. This presents a valuable case history of the response of dams to surface fault rupture.

Fig.5 Three-dimensional (3D) model of the spillway generated by UAV data.

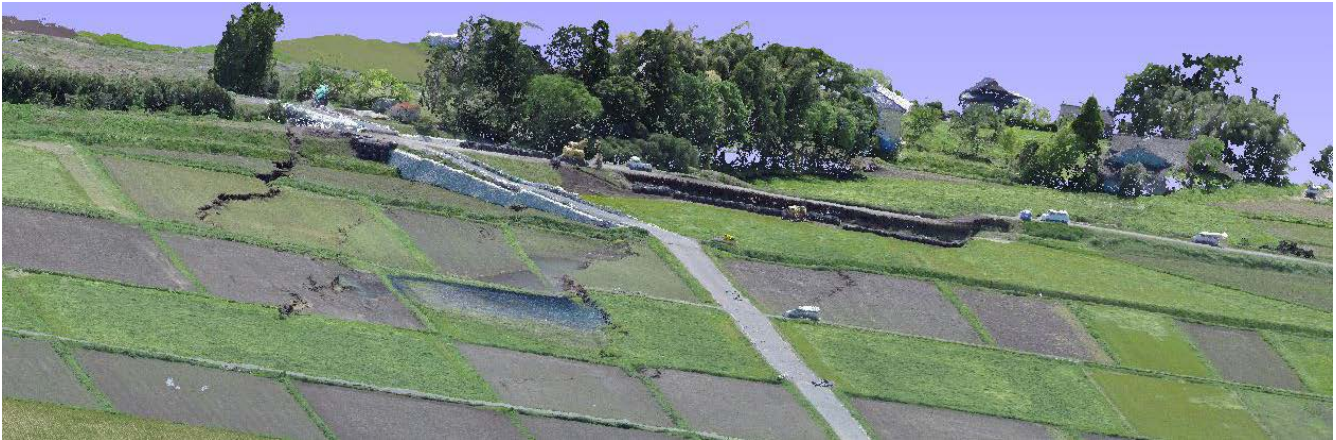
In the Aso Caldera, an approximately 10 km long “zone of depression” resulted from the Kumamoto earthquake mainshock. The zone of depression was typically 30 m to 110 m wide with roughly vertical offsets on each side of the depression zone of about 0.5 m to 2.5 m with a minor strike-slip component. The cause of the zone of depression is of interest. Potential causes include liquefaction, earth compaction, lateral spreading, and fault rupture (Figure 6). Lin et al. (2016) postulate that the depression zone is actually a graben formed by co-seismic rupture of two normal faults within the Aso caldera.

Fig. 6 Portion of the depression zone shown in the 3D point cloud model developed from UAV.

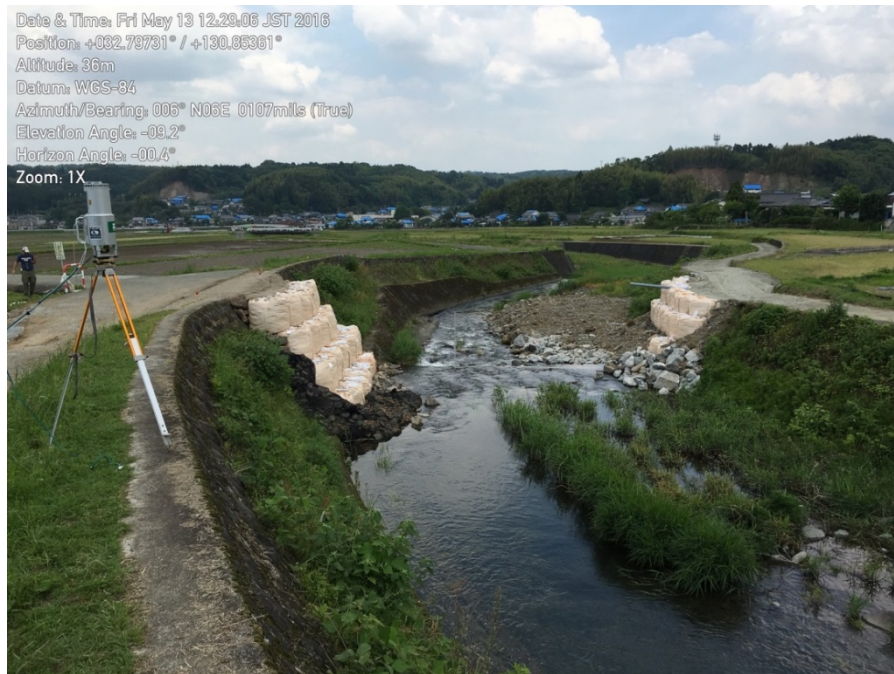
Although the canal was not full of water at the time of the earthquake, the damage observed by GEER was relatively minor, despite measured fault displacements of about 57 cm horizontal and 28 cm vertical. A second, conjugate fault, with opposite direction strike-slip motion, also happened to cross the canal embankment at roughly the same location, making the deformation field relatively complex. The estimated displacement on this fault was about 29 cm horizontal and 13 cm vertical.

Fig.7 The terrestrial LiDAR setup and damage to the canal embankments. The main fault crossing is at the location of the repairs visible in the photograph.

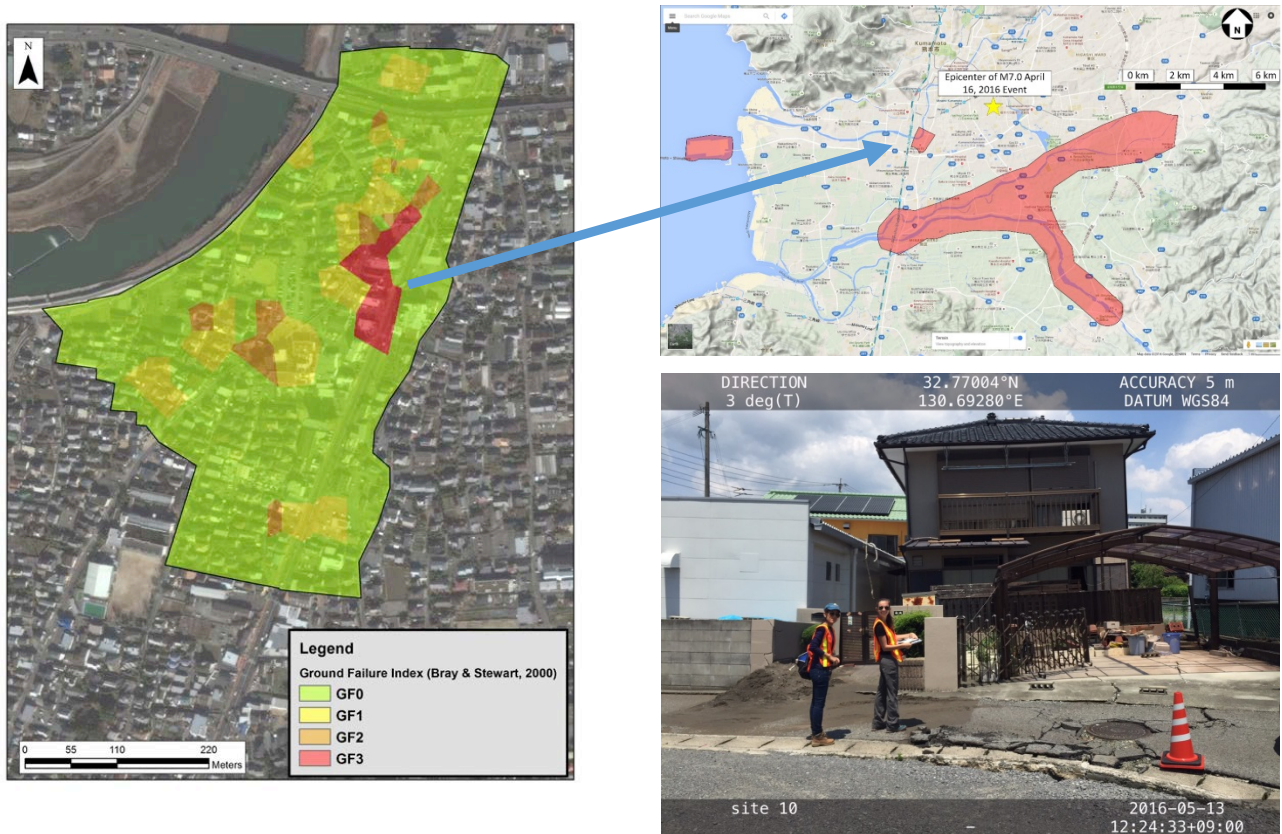
One of the striking features of this earthquake was the relatively low number of liquefaction sites observed given the extremely strong ground motions recorded throughout the Kumamoto region and the large areas mapped as young alluvial deposits. GEER did visit a number of sites where liquefaction was observed, and other reconnaissance teams also observed a number of areas of liquefaction (shown in Figure 8). However, much more liquefaction-induced damage was expected based on the team's experience documenting liquefaction after earthquakes of such intensity in alluvial deltaic areas. A detailed map of liquefaction-related damage to building structures observed by GEER is provided in Fig.8 in addition to a picture of one example building affected by liquefaction.

presence of plastic (non-susceptible) soils within or between layers of loose sand, age of the soil deposit, and volcanic geologic origin of the sediments. The GEER team expects that the soil plasticity, resulting from the volcanic origin of the sediments, is the most likely cause. The authors recommend that further studies (e.g., soil borings, laboratory testing, and extensive in-situ testing) be conducted at liquefaction and particularly non-liquefaction sites, where liquefaction would otherwise have been expected, to determine the causes of limited liquefaction evidence and effects resulting from the Kumamoto Earthquakes.

Fig.8 Maps produced by GEER of observed liquefaction and related damages in the Kumamoto region and picture of building settlement and tilt due to soil liquefaction in the south-east corner of the Shirakawa River (building settlement with respect to the surrounding ground in the order of 10 cm and tilt of 2 degrees).

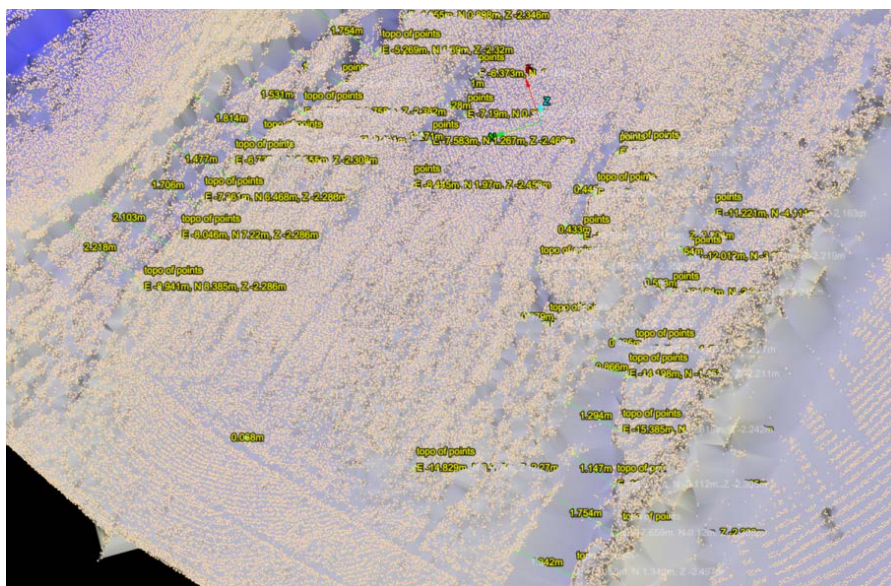
A LIDAR scan was taken at the north side of field exhibiting largest ground cracking (Figure 9). This area was boarded by a concrete lined drainage canal to the north, and the river to the south. Based on observations, including limited damage to the drainage canal at the north, the team believes the majority of movement was south toward the river. In the residential area north of the small canal, several extension features were observed in sidewalk blocks and around buildings, indicating a slight movement of this area toward the river.

Fig.9. Measurements of lateral spread elevations and fissure locations from LIDAR data at Mashiki town.
