INFLUENCE OF CONSTRUCTION MATERIALS ON SEISMIC PERFORMANCE OF BUILDINGS AFTER ECUADOR M7.8 EARTHQUAKE

F. Yepez⁽¹⁾, O. Yepez⁽²⁾, X. Vera⁽³⁾, S. Nikolau⁽⁴⁾

Abstract

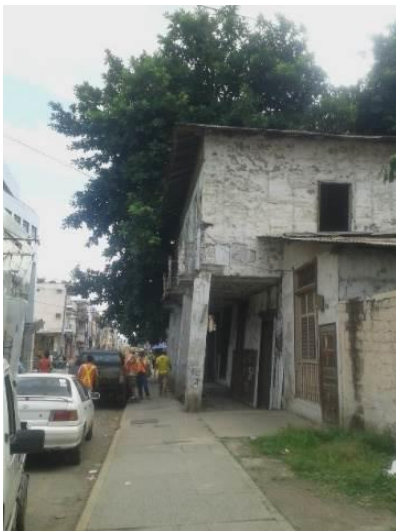
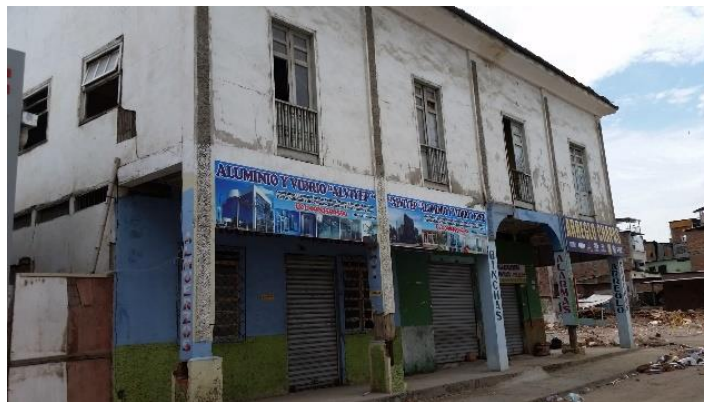
This group refers to all structures having wooden columns, beams, floors and roof system, using wooden partitions or a combination of clay bricks and concrete block units as components of masonry partitions walls. This type of construction is relatively old and has typically some external portals, permitting people's circulation on streets (Fig. 2). In some cities of Ecuador, and for some specific areas (commercial areas typically), external portals are mandatory according to some local architectural regulations. Wooden partitions are commonly using wooden cane with some internal wooden structural elements for giving stability under vertical loads. Masonry walls instead, are made by clay bricks in a vertical position (it means that horizontal side of a brick has the shortest area, which is in contact with other bricks for conforming wall, procedure that is not recommendable at all due to instability problems of the unit and of the wall panel). Sometimes such walls are built using concrete blocks or a combination of clay bricks and concrete blocks. Both wooden and masonry walls are usually covered by cement mortar (Fig. 2).

Fig. 2 – Typical wooden structures in the area, using wooden columns, beams, floor and roof system, and wooden cane, clay brick and/or concrete block units for masonry walls and partitions. External portals are common in order to permit people's circulation on streets

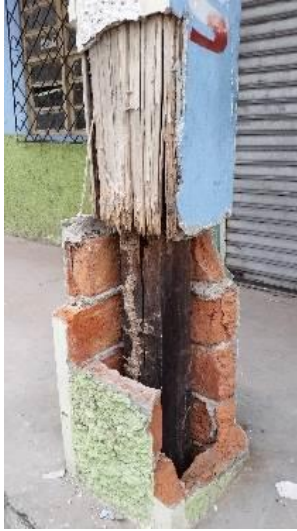
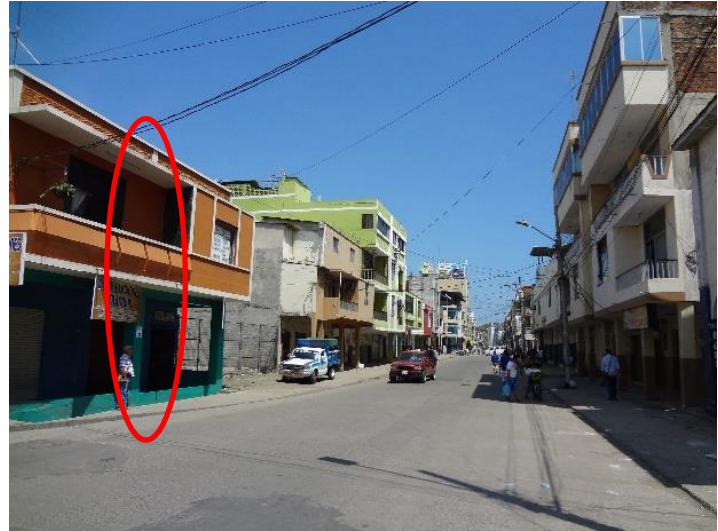
One important aspect related to this type of construction, especially in some commercial areas of the cities in the region, is the use of wooden structural columns surrounded by 6cm wide clay bricks, creating an air chamber of 8 to 15cm wide between columns and bricks (Fig. 3). Such air chamber is sometimes filled by sand. At the end, bricks are externally covered by cement mortar and painted. Therefore, from outside there is a false sense of the existence of 30 to 50cm wide concrete columns. This false columns are part of the external façade of the building creating a new/modern building style. Apparently, the purpose of this practice is to give a false

sense of safety, permitting to expand the original size of the building in horizontal and vertical way, avoiding municipality control and increasing seismic vulnerability exponentially.

Fig. 3 – (Left) False clay brick column surrounding an existing old and deteriorated wooden column, covered by cement mortar and paint. (Right) Some non-engineered expanded constructions creating columns without continuity in all floors

In general, this type of construction belongs to the so called “non-engineered” structures, which has been built directly by the owners, using labor without technical supervision. Many of them are old; wooden frames are deteriorated, cracked, with evidence of insect attack, therefore, losing its main resistance (Fig. 3). Many of them have suffered horizontal and vertical expansions in time, sometimes of several floors. In some specific cases, it is also possible to find evidence of some non-engineered strengthening works, creating new reinforced columns and beams for building a new floor or floors over an existing wooden structure, not showing continuity from the bottom to the top of the structure (Fig. 3).

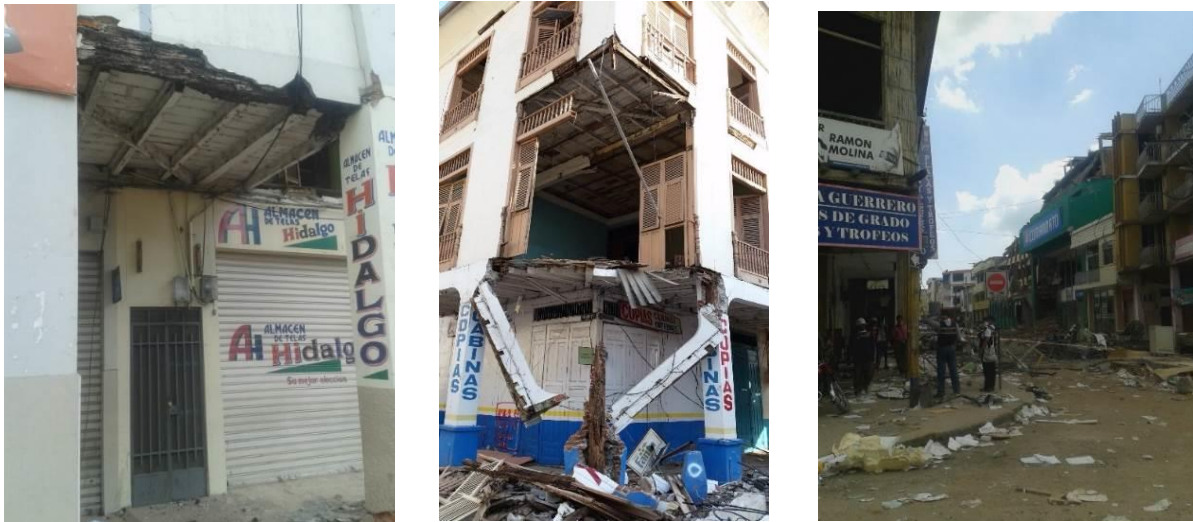
It is possible to conclude that this type of buildings is highly vulnerable to seismic actions. It was expected several great failures in this typology in the area. Earthquake permitted to discover this vulnerability, as it is possible to observe in Fig. 4, where not only wall failures occurred but also the actual grade of degradation of wooden materials in columns, beams and connections were observed, perhaps informing that those buildings were at the end of their service life, before the seismic event.

Fig. 4 – Grade of deterioration of wooden elements discovered after earthquake. Perhaps, service life ended before the quake

In the case of moderated damaged wooden structures, it is possible that dynamic soil response of the area and/or better structural configuration helped to avoid heavy damage or collapse. Nevertheless, such type of vulnerable buildings should be carefully assessed in order to avoid future damage or collapses in future seismic events.

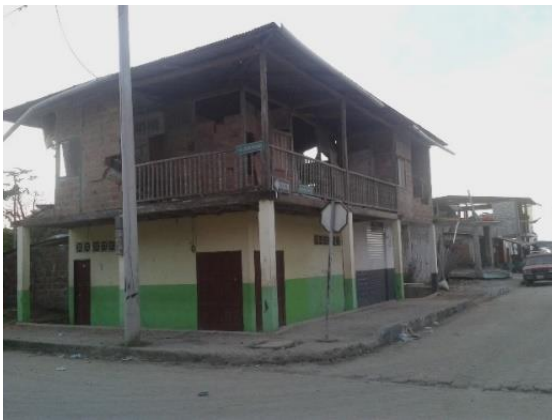
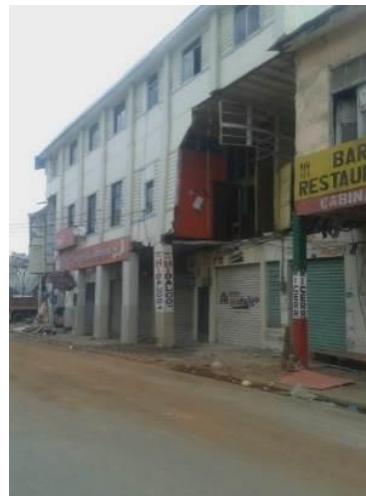
In other cases, low floor stiffness, masonry weight and very poor connections between structural wooden elements were factors affecting dynamic response and causing collapse of some wooden buildings. In Figure 4 and 5 it is possible to observe some damaged wooden structures having a combination of thin clay bricks and concrete block units, creating slender partitions covered by cement mortar made using sea sand, without engineering considerations. Out-of-plane masonry failures were frequently found.

Fig. 5 – Damaged wooden structures with slender partitions made by thin clay bricks and/or concrete blocks

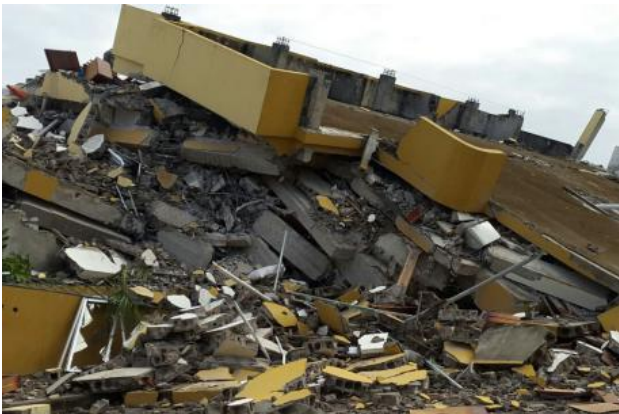
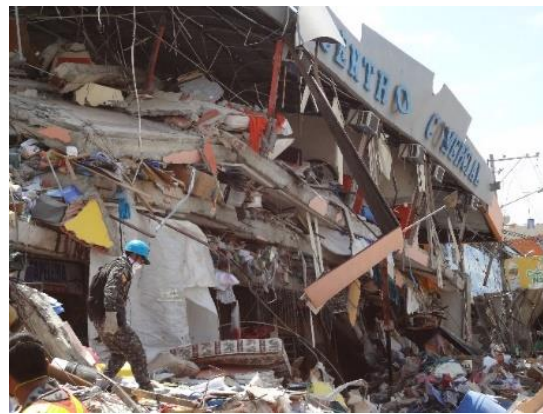
After some important economic development during the last decades in many cities around the epicenter, due to success of tourism, fishing, exports and other related industries, there was a high pressure in the housing market, hotel infrastructure, vacation facilities, roads, etc., which transmitted such pressure to other economic activities such as services, transportation, food, commercial exchange, etc., attracting people from rural areas to cities, increasing number of family members and housing, commercial and financial buildings demand. Under those conditions, existing structures (some of them built using engineering design and construction considerations) were expanded in both, horizontal and vertical way, in order to try to attend the mentioned demand. In most cases, existing building owners did not consider technical advice and increased construction area without thinking on earthquake risk. One or more floors were built over existing constructions, without any seismic risk consideration. There are a lot of examples of dramatic collapses of residential, commercial and hotel buildings after the earthquake, two of the most famous are showed in Fig. 6. The figure at the left shows the most important hotel building in Pedernales, which had only two floors years ago but it had five before the earthquake. The figure at the right shows a commercial building in Portoviejo presenting the same problem pattern; its collapse caused 92 fatalities (entire families) after the earthquake.

Fig. 6 – Hotel in Pedernales (left) and commercial building in Portoviejo (right). Both were expanded by the owners and converted from low rise to medium rise buildings without engineering considerations. The building at the right caused 92 fatalities (entire families) due to its collapse after the earthquake

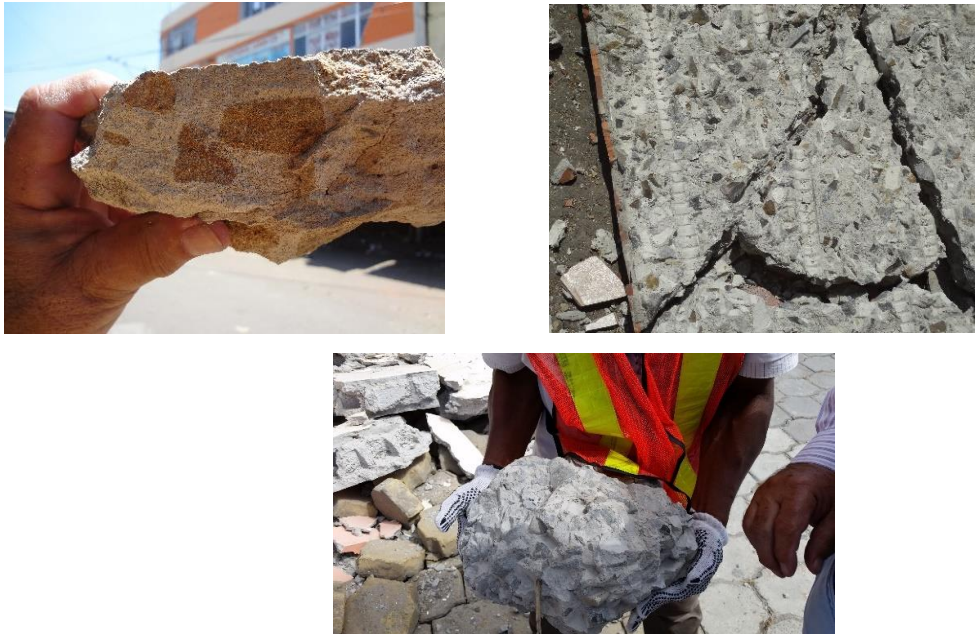
Fig. 7 shows the typical type of concrete used in damaged and collapsed buildings in the area. Evidence of high percentage of coarse aggregate with a high rate of segregation and lack of compaction can be found. The use of sea sand as total or partial fine aggregate in concrete mixes was noted. The combination of those factors with others: low water/cement ratios, high porosity and chloride content have provoked an important grade of corrosion (even total destruction) of steel bar reinforcement.

Fig. 7 – Characteristics of concrete in damaged and collapsed structures. (Up-left) Large coarse aggregate with high segregation and large amount of mortar. (Up-right) Detached concrete coating with low amount of mortar, showing very low or lack of adherence with steel deformed bars. (Down) Large amount of coarse aggregate with very few mortar

Procedures for construction and materials quality assurance also have to be implemented and regulated by national and local authorities, and all professionals, workers and owners shall understand their importance. In this regard, the use of sea sand (from the ocean or from areas that were under the sea years ago) for concrete production must be prohibited immediately.

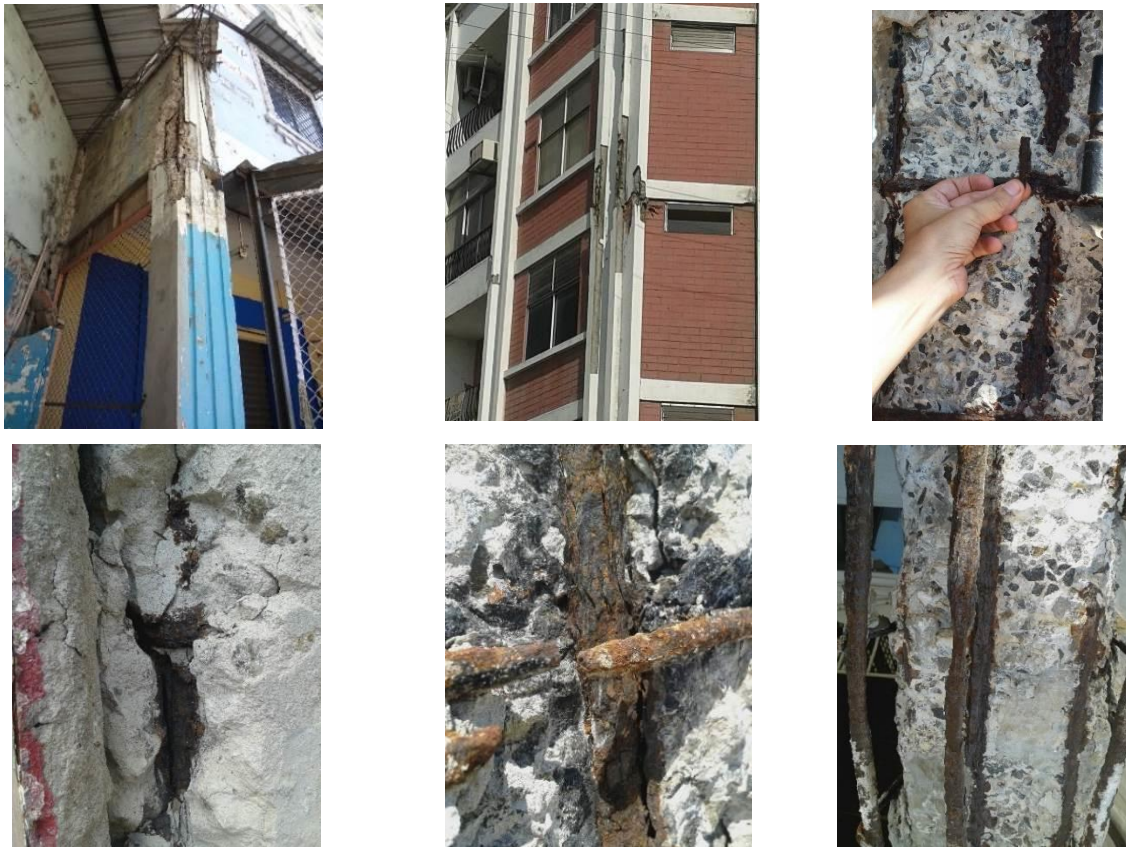
In Fig. 8 it is possible to observe the strong high corrosion level of the steel reinforcement in an aggressive environment (smooth and deformed steel bars inside a high porosity concrete made using sea sand in a coastal region). In some cases, corrosion is in so highly advance stage that all steel reinforcement has been converted into iron oxide and it was possible to completely destroy column steel bars using hand fingers. In such cases, reinforced concrete was converted into plain concrete and collapse of structures under earthquake was more than expected.

Fig. 8 – Strong corrosion in steel reinforcement (deformed and smooth bars) in old and new structures. Column steel bars can be destroyed completely using hand fingers

According to the results, chloride content of samples could exceed the ACI 318 limit in until 30 times. Those values are consistent with the extremely high level of corrosion and degradation of steel bars observed. This problem was confirmed by analyzing samples using a SEM analysis. Fig. 9 is showing a fine aggregate particle, which surface contains Mg, K, Na and Cl in more than 5% atomic ratios.

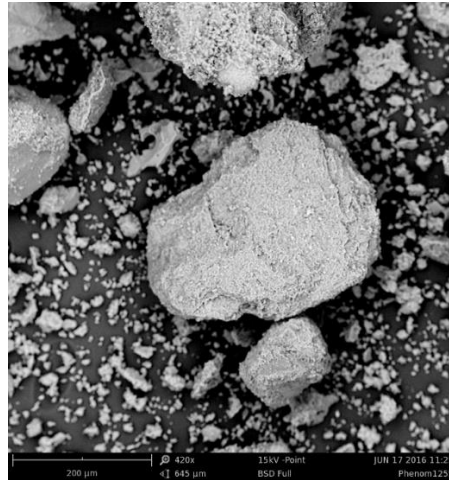
Fig. 9 – SEM analysis of a fine aggregate particle in mortar samples of collapsed buildings. Its surface has shown Mg, K, Na and Cl of about 5 to 8% atomic ratio.

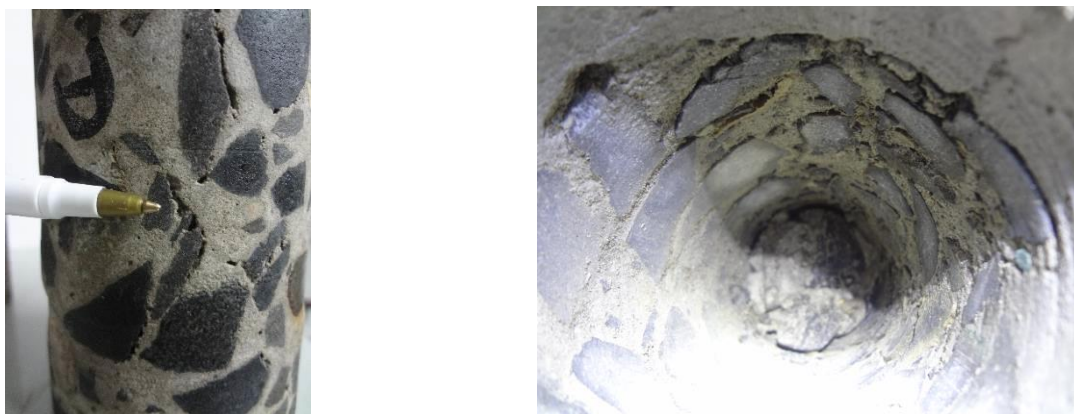
On the other hand, a very interesting effect was also detected in many concrete core samples obtained. Mylonitization (existence of fine materials around coarse aggregates due to the formation of some types of rock in a strong tectonic deformation environment) around coarse aggregates was detected, creating an isolated interphase between aggregates and cement paste, not permitting to have a homogeneous concrete core. This phenomenon caused that concrete samples in many buildings be destroyed during drilling, at the time of the extraction or at the time to prepare and cut samples before testing. When it was possible to test such samples, many cracks were found in such interphase between coarse aggregate and cement paste. In Fig. 10 it is possible to observe mylonitization effect in samples before testing. Sometimes, when this effect was strong, it was possible to destroy the sample using hand fingers or a pen. A view of concrete inside a column after core extraction is also presented in Fig. 10, demonstrating mylonitization effect that dramatically affected concrete integrity.

Fig. 10 – Mylonitization of coarse aggregate in concrete core samples before testing (left). Mylonitization effect inside a structural column after core extraction, showing tremendous impact in concrete integrity (right)

After testing, compression failure was governed by cracks in that problematic interphase, causing very low strength results, as low as 8-12 MPa. Cracks in the mentioned interphase was also observed in many reinforced concrete structural elements in many damaged buildings (Fig. 11). Sometimes, undamaged mortar cover is hiding internal concrete cracks in the core. This finding means that many buildings could be classified as undamaged and even have internal concrete damaged, increasing seismic vulnerability dramatically. If the earthquake had have few more seconds in duration, statistics of heavy damaged and collapsed buildings could have been much higher.

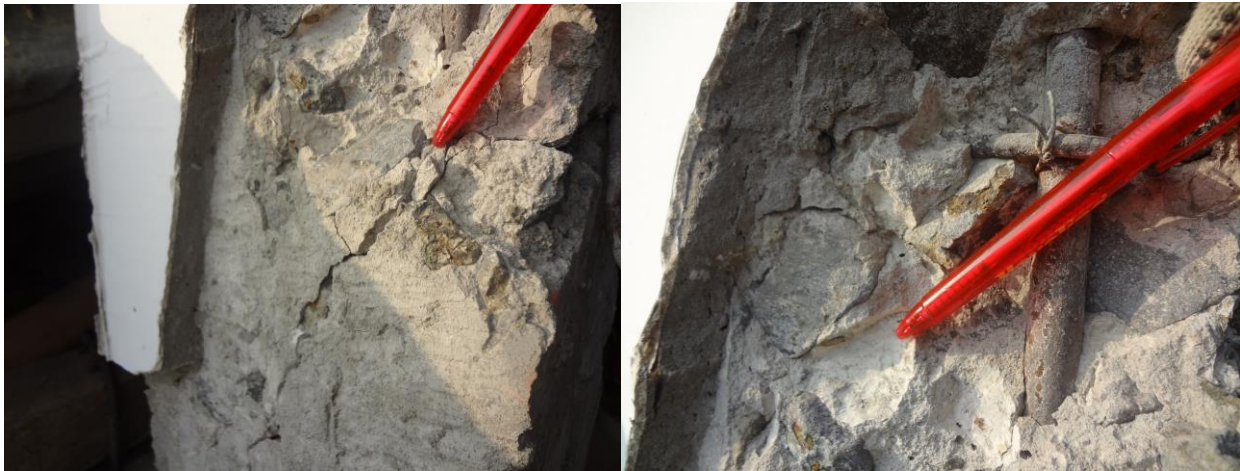
Fig. 11 – Internal concrete cracks covered by undamaged wide mortar cover, hiding mylonitization effect in concrete columns of damaged buildings

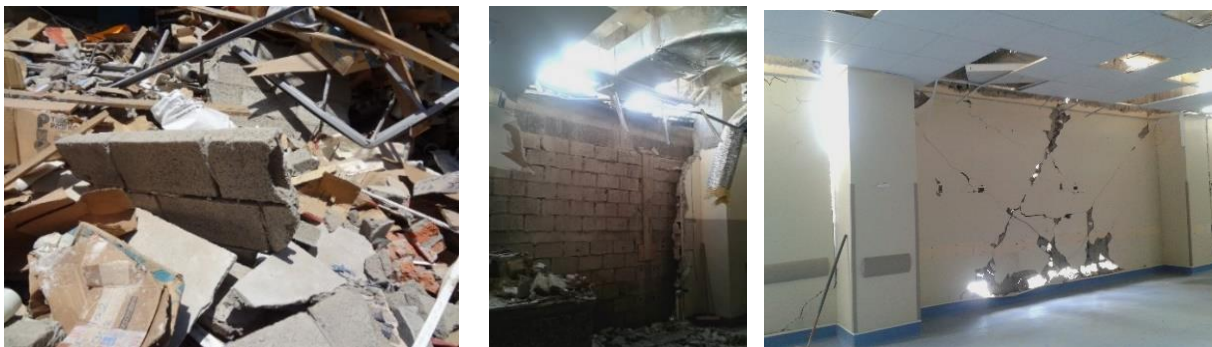
Fig. 12 shows characteristics of concrete block units used for masonry walls. They seem to be handcrafted, using the same type of concrete described before, sometimes with the addition of volcanic rocks (pumice) as a coarse aggregate. Fig. 12 also shows incomplete mortar works between block units, weakening walls. It is usual to find very long and high slender wall panels without bracing system for mitigating out of plane failure risk.

Fig. 12 – Characteristics of concrete block units used for masonry walls. Thin masonry walls with incomplete mortar handwork between units and very long and high masonry panels without bracing system.
