STRUCTURAL OBSERVATIONS - M7.8 - APRIL 16, 2016 ECUADOR EARTHQUAKE

Abstract

1. Introduction

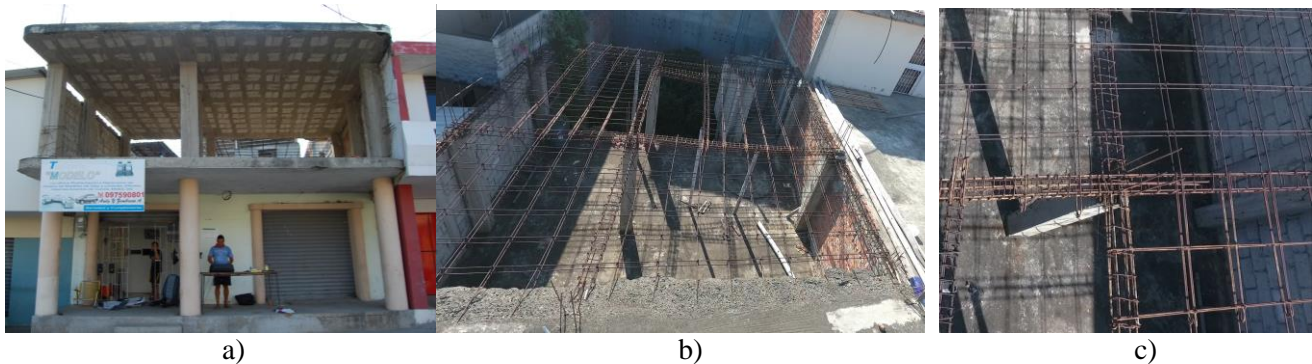
Fig. 3: a) Residential building under construction with two-way waffle slabs in Tarqui, Manta. (GPS coordinates: 0°57'28.67"S, 80°42'32.41"W). b & c) Details of beam reinforcement near a beam-column joint in the back of the house (GPS coordinates: 0°57'28.67"S, 80°42'32.41"W). (Photos by GMSLLP & Droneando ©)

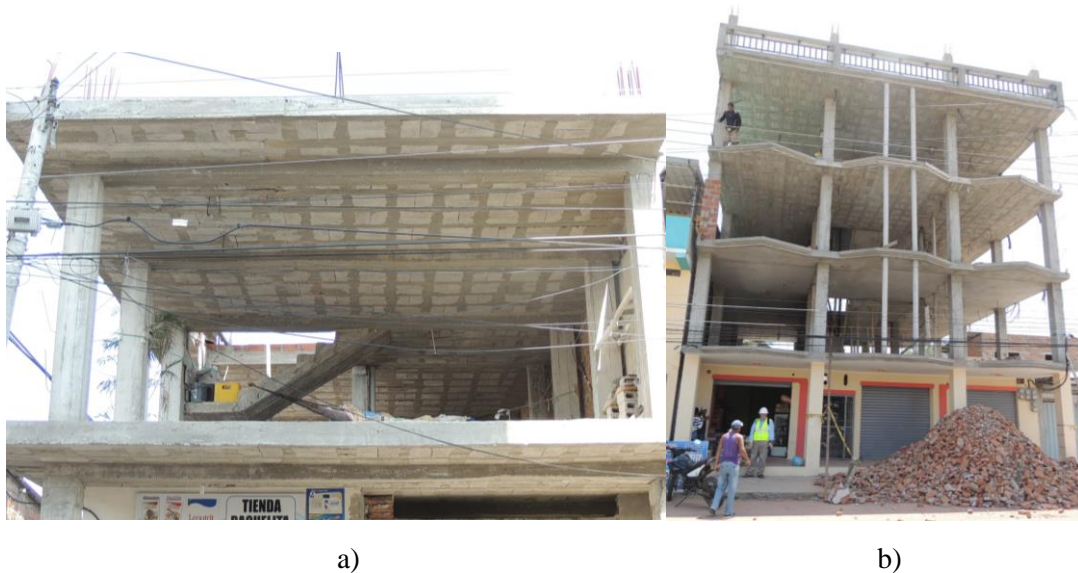
Fig. 4: a) New construction where the form blocks can be observed in the waffle slab in Tarqui, Manta (GPS coordinates: 0°57'27.3"S, 80°42'32.9"W). b) Residential building under construction with two-way waffle slabs in Manta (GPS coordinates: 0°57'8.1"S, 80°42'26.9"W). (Photos by GMSLLP)

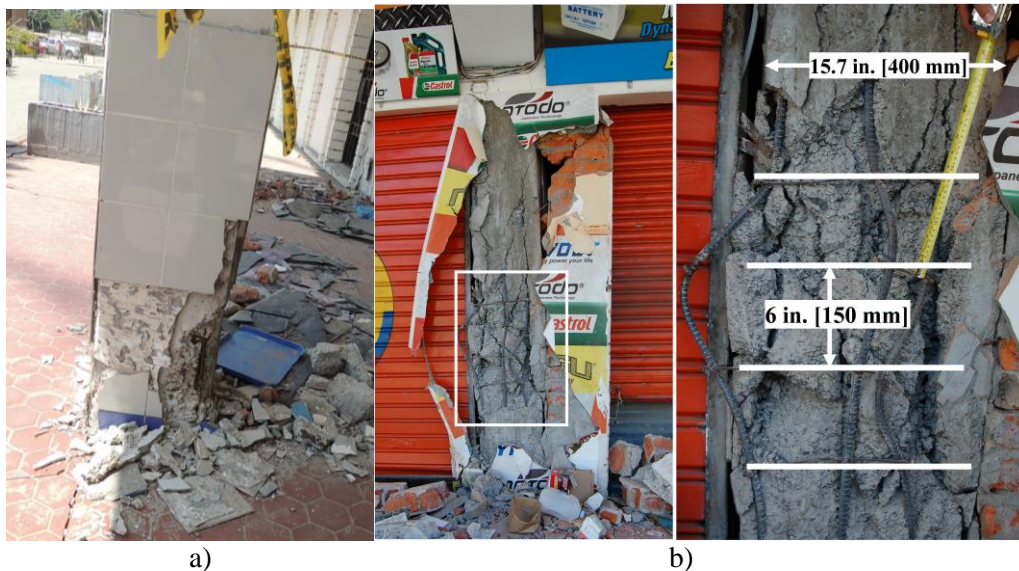
Fig. 5: a) A first floor column in the three-story Hotel Las Gaviotas in Tarqui, Manta. There is significant spalling which can be attributed to both previously corroded steel and the seismic demand imposed by the earthquake (GPS coordinates: 0°57'5.7"S, 80°42'48.5"W). b) Small-diameter-hoop spacing details of a first floor unconfined column in a four-story commercial building in Tarqui, Manta (GPS coordinates: 0°57'14.9"S, 80°42'53.9"W). (Photos by C. Arteta Torrents)

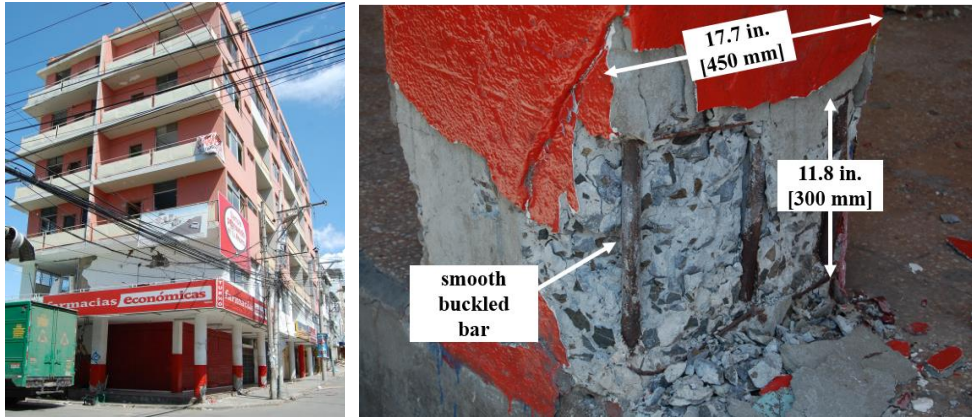
Fig. 6: Damage at the base of six-story mixed-occupancy building in Tarqui, Manta. There is significant spalling at the bottom of the first floor columns, exposing smooth longitudinal rebar and hoop spacing of approximately 2/3 of the column width. (GPS coordinates: 0°57'14.55"S, 80°42'53"W). (Photos by C. Arteta Torrents)

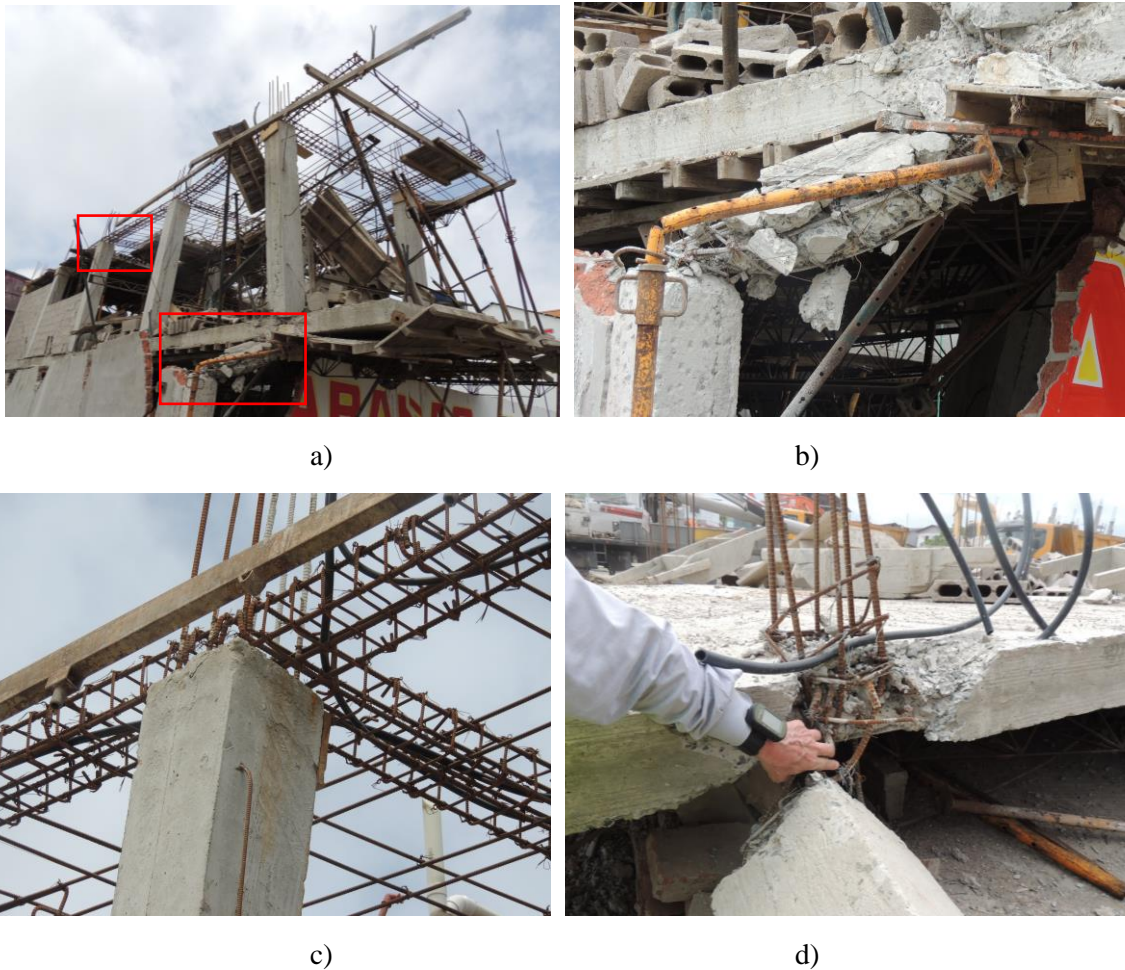
Fig. 7: a) & b) Failure of first floor columns in a building under construction in Canoa. The column has large stirrup spacing. c) The slab to column connection at the edge shows a lack of dowels and therefore provides no structural integrity (GPS coordinates: 0°27'42.67"S, 80°27'20.67"W) (Photos by GMSLLP & C. Arteta Torrents) d) Failure of first floor columns in building under construction in Canoa. The slab to column connection at the edge shows a lack of dowels and therefore provides no structural integrity (GPS coordinates: 0°27'42.67"S, 80°27'20.67"W) (Photos by GMSLLP)

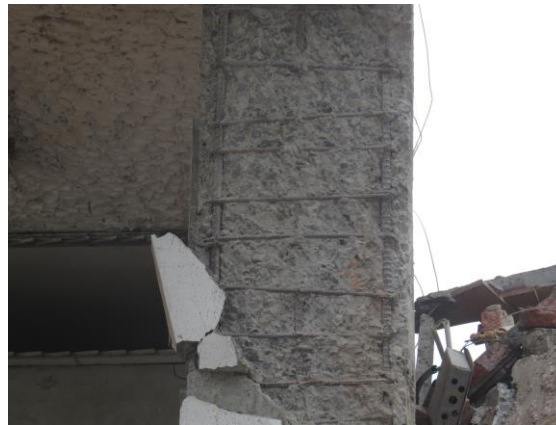
Fig. 8: Column with spalled-off concrete cover and evidence of healthy a core thanks to closely spaced perimeter hoops and cross-ties. Zona Cero in Portoviejo. (GPS coordinates: 1°3'13.53"S, 80°27'8.60"W) (Photo by E. Miranda)

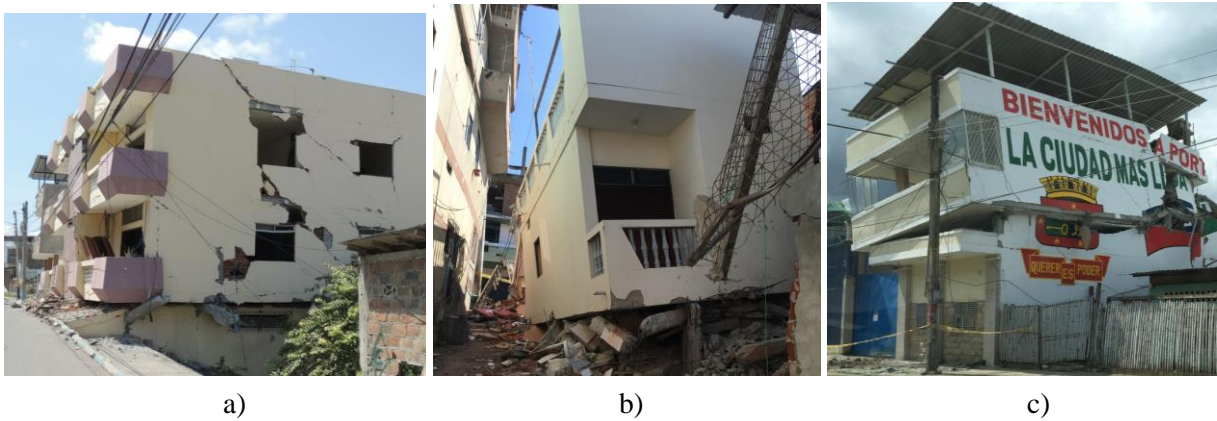
Soft story damage: Various buildings had a commercial first floor with residences on the upper floors. Several of these had soft story damage where one or two floors had been completely crushed. Significant hinging of the first floor columns occurred in some of these damaged structures which may have been due to the change in stiffness at the compromised story. Typically, the compromised story was surrounded by stiffer stories with larger masonry infill densities. These stiffer stories were located either above or above and below the compromised stories.

Fig. 9: Soft story failure. a) The first floor of this building in Manta collapsed. Some of the rebar in the columns that failed were corroded. Additionally, the columns were not confined (GPS coordinates: $0^{\circ}57'14.8''S$, $80^{\circ}42'31.6''W$). b) The first floor of this building in Tarquí, Manta collapsed. Column confinement was not apparent (GPS coordinates: $0^{\circ}57'29.9''S$, $80^{\circ}42'42.1''W$). c) The second floor of this building in Portoviejo collapsed (GPS coordinates: $0^{\circ}57'29.9''S$, $80^{\circ}42'42.1''W$). (Photos by GMSLLP)

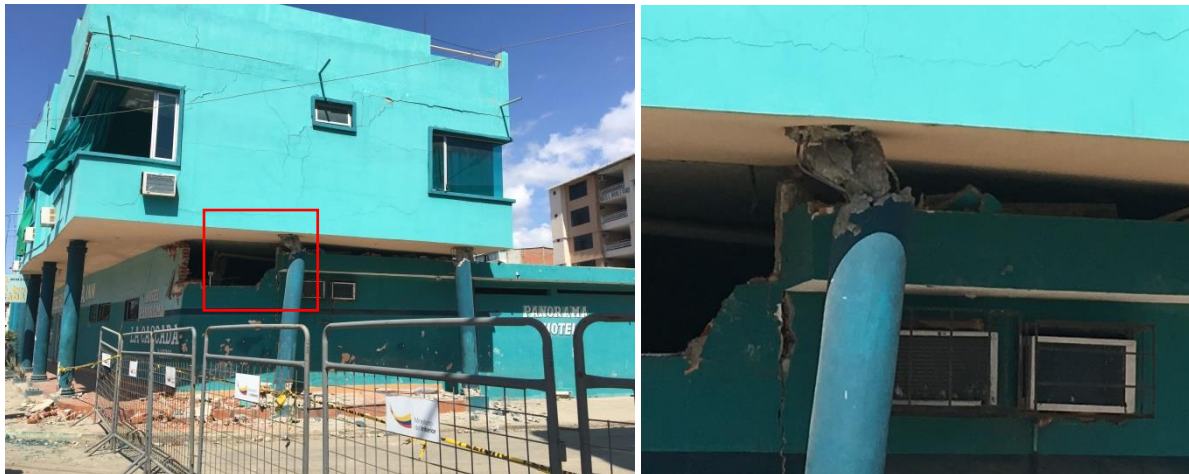
Fig. 10: Plastic hinging in the first floor columns of this residential building with first floor commercial occupancy in Tarquí, Manta (GPS coordinates: $0^{\circ}57'7.1''S$, $80^{\circ}42'55.3''W$).

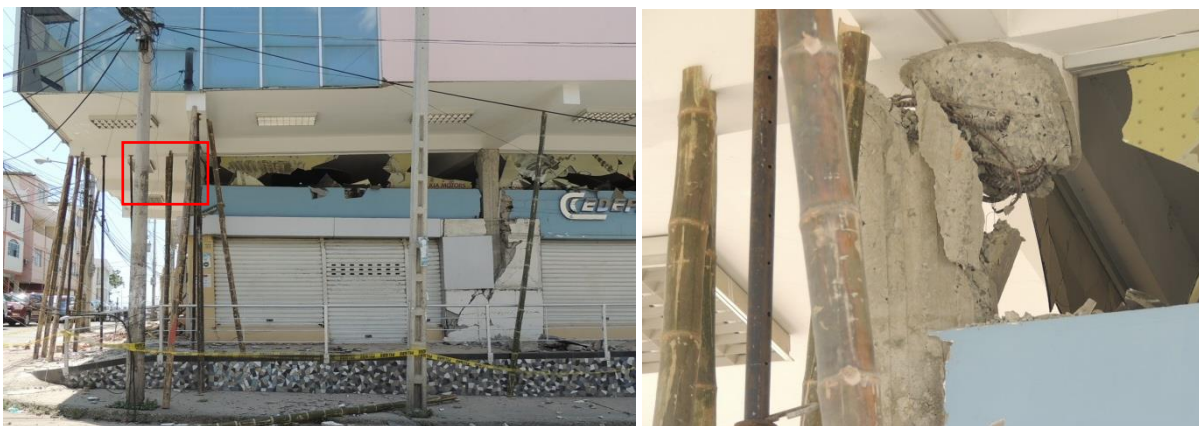
Fig. 11: Plastic hinges formed in the first floor columns of this building in Manta (GPS coordinates: $0^{\circ}57'9.5''S$, $80^{\circ}42'49.4''W$). (Photos by C. Arteta Torrents)

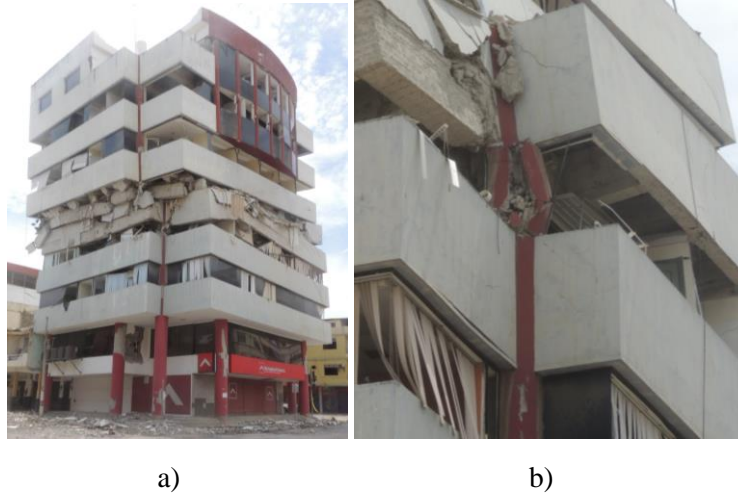
Captive columns: For some buildings, the stiff partial-height nonstructural masonry walls or concrete blocks between columns restrained the column height. This exacerbates the shear demand on the column when plastic flexural demand concentrates at their ends.

Fig. 12: a) The fourth and fifth floors collapsed in this residential building in Portoviejo (GPS coordinates: 1°3'13.53"S, 80°27'8.60"W). b) The concrete blocks restrained the column height, causing captive column failure for this column. (Photos by GMSLLP)

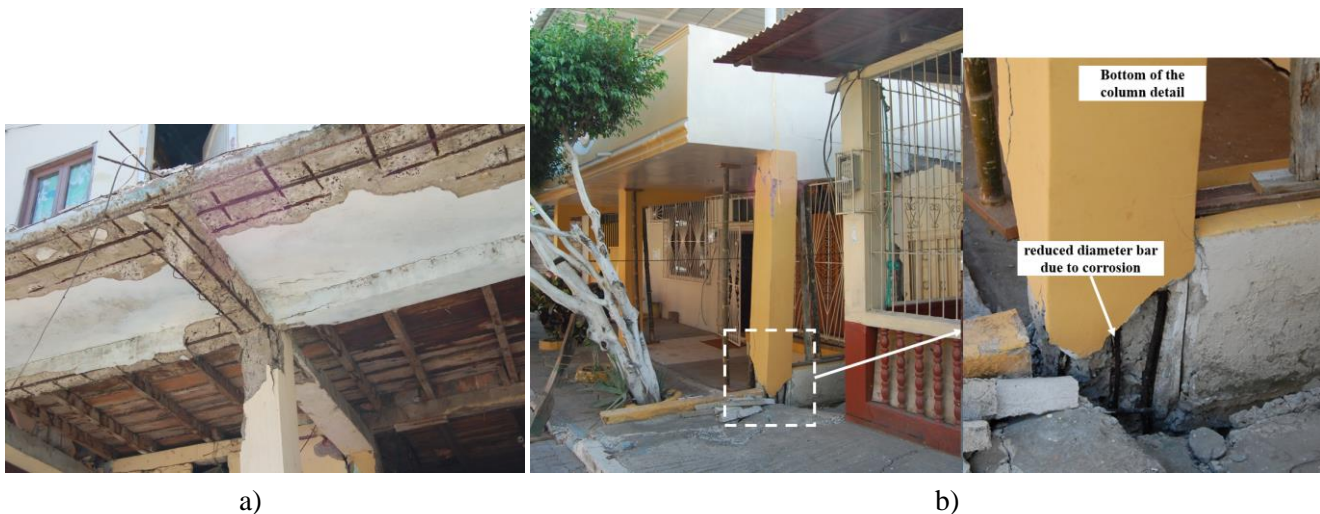
Rebar corrosion: There was significant corrosion observed in the rebar in reinforced concrete structures. This was likely caused by the common practice of using of salty sand and/or salty water in the concrete admixture. The corrosion could have also been caused by the extended exposure of the rebar prior to pouring concrete. Observations in the field indicate that for some structures, the diameters of bars of longitudinal and transverse reinforcement were reduced due to corrosion.

Fig. 13: a) Rebar corrosion in a beam-column connection, and slab reinforcement in a three-story building located in Tarqui, Manta (GPS coordinates: 0°57'7.94"S, 80°42'41.90"W). b) Rebar area reduction at the base of a column and failure due to soil liquefaction in a two-story house located in Tarqui, Manta (GPS coordinates: 0°57'19.77"S, 80°42'40.68"W). (Photos by C. Arteta Torrents)

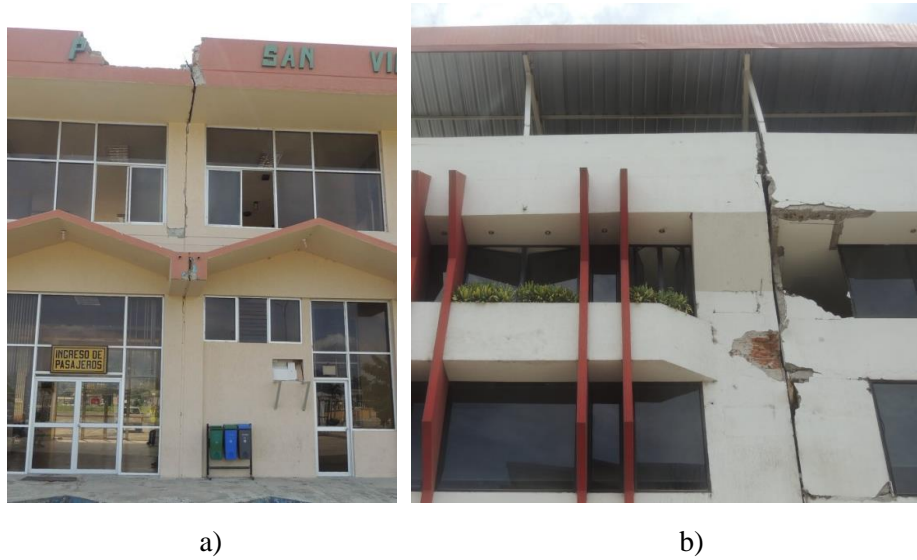
structures that had no evident seismic gap. During the earthquake, the building drifts caused them to pound against each other which caused severe damage in columns, and/or caused permanent displacement for some buildings.

Fig. 14: a) Pounding of independent buildings at the Bahia Airport (GPS coordinates: $0^{\circ}36'5.3''S$, $80^{\circ}24'27.0''W$). b) Pounding of two buildings in Portoviejo. The reconnaissance team observed that the roof metal deck is continuous at the separation (GPS coordinates: $1^{\circ}3'11.6''S$, $80^{\circ}27'8''$)

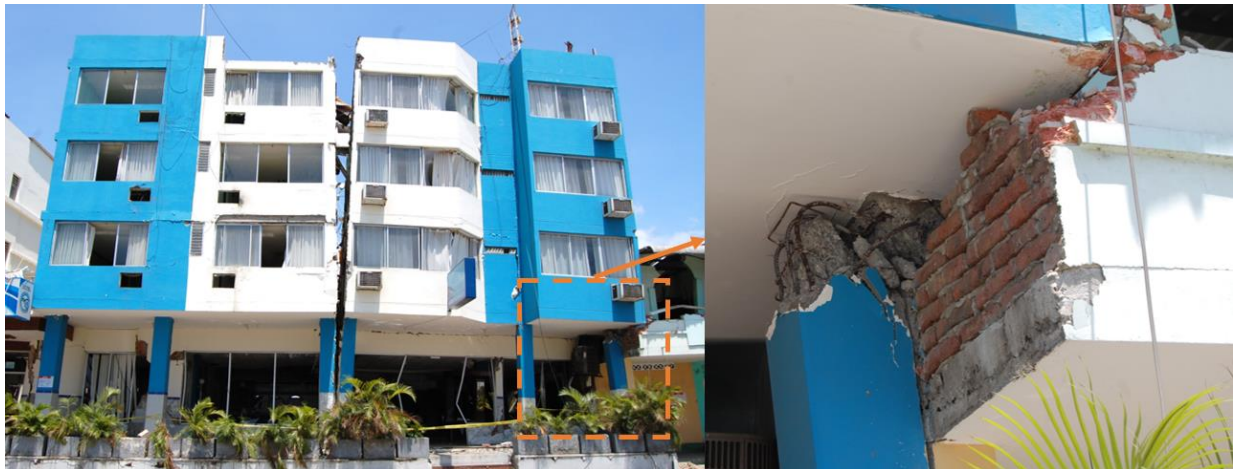
Fig.15: Pounding evidence in Hotel Las Gaviotas in Tarqui, Manta (GPS coordinates: $0^{\circ}57'6.08''S$, $80^{\circ}42'48.85''W$) (Photos by GMSLLP & C. Arteta Torrents)

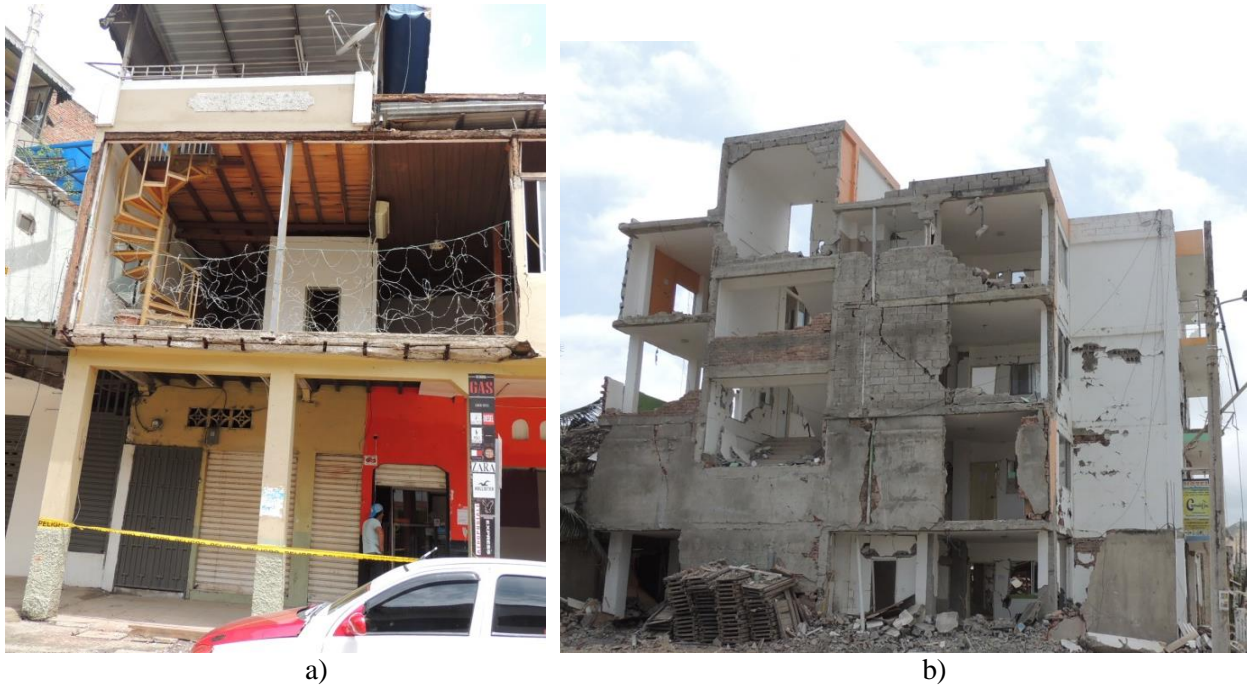
Failure of nonstructural walls: Most interior and exterior walls were composed of masonry, brick, hollow clay or concrete blocks. These walls were most likely conceived and constructed as nonstructural elements. However, during the earthquake these walls were subjected to seismic loads and functioned as part of the lateral load resisting system due to their large in-plane stiffness. The walls were not detailed to resist such loads and failed. These walls have little strength and ductility. Most walls were cracked or, in severe cases, collapsed out-of-plane. There were no concrete shear walls observed. The collapse of these nonstructural walls was the most life-threatening failure, apart from complete structural collapse.

Fig. 16: a) Concrete building with wood and metal deck extension in Portoviejo. Nonstructural wall completely collapsed (GPS coordinates: 0°57'14.6"S, 80°42'38.5"W). b) Concrete building in Canoa where brick and masonry exterior walls collapsed. (GPS coordinates: 0°27'46.59"S, 80°27'23.56"W). (Photos by GMSLLP)

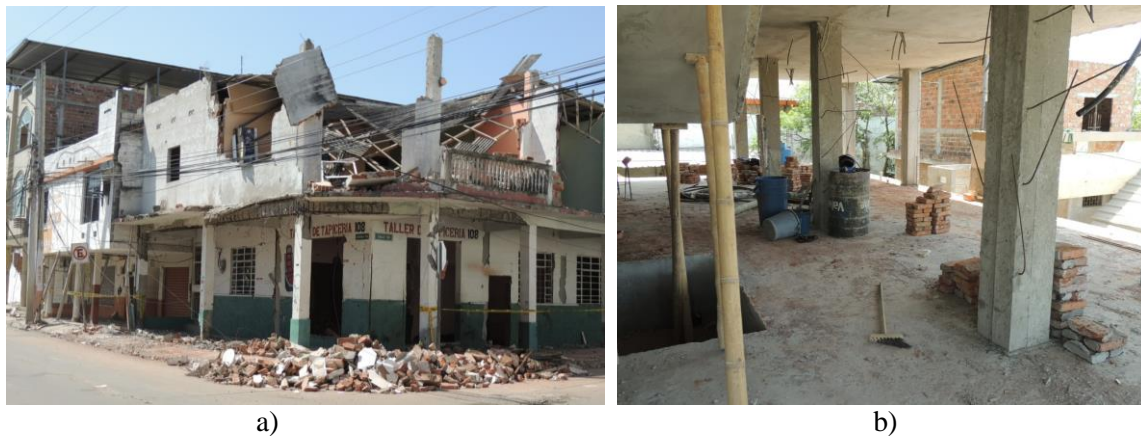
Fig. 17: a. Residential building in Tarqui, Manta, where the exterior walls collapsed. The roof also fell in this property. (GPS coordinates: 0°57'14.6"S, 80°42'38.5"W). (Photos by GMSLLP). b. This is a site of new construction. These are dowels at the concrete columns to be attached to the nonstructural walls (GPS coordinates: 0°57'7.31"S, 80°42'26.44"W). (Photo by GMSLLP)

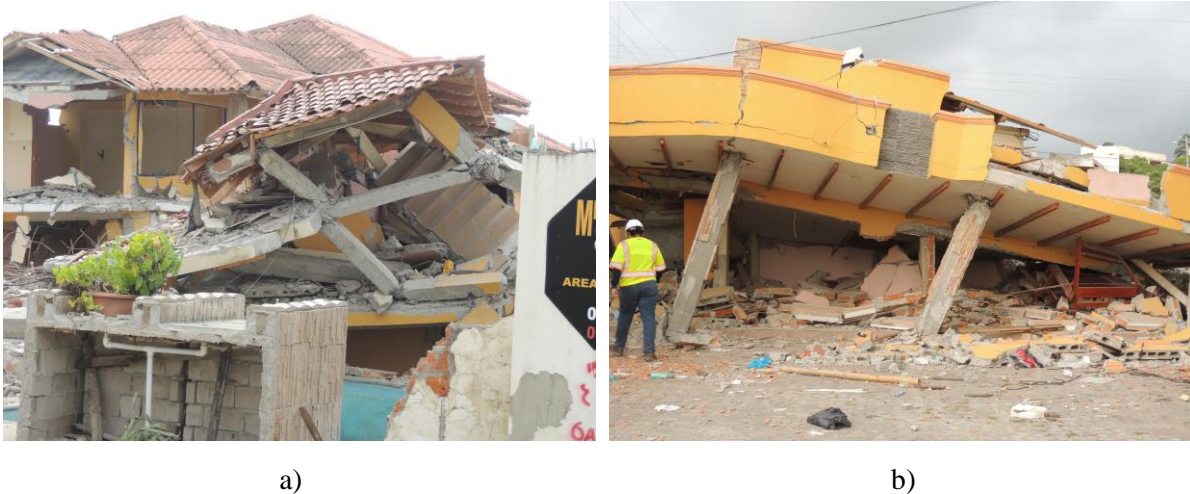
Fig. 18: a) Sideway collapse of residential structure in Pedernales (GPS coordinates: 0°4'4.8"N, 80°3'23.5"W). (Photo by GMSLLP) b) Building collapse in Pedernales. The columns shown have hinges at both ends (GPS coordinates: 0°4'3.94"N, 80°3'24.6"W) (Photo by Photos by GMSLLP)

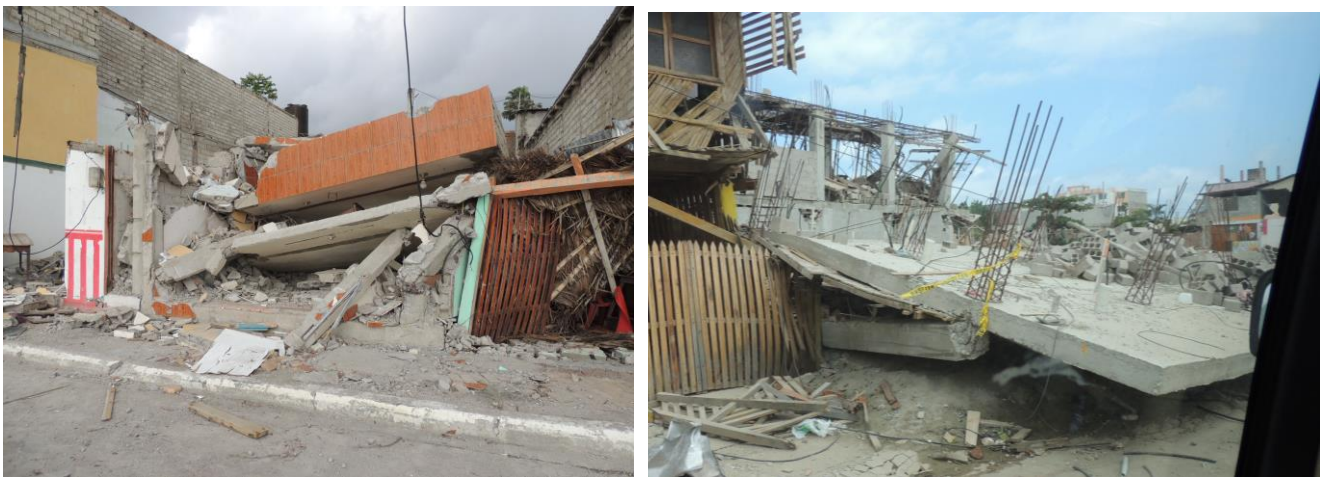
Fig. 19: a) Collapse of building with flat slab construction in Pedernales (GPS coordinates: 0°4'2.5"N, 80°3'33.9"W) (Photo by GMSLLP). b. Collapsed building that was under construction. The construction type was reinforced concrete two-way flat slabs supported on columns (GPS coordinates: 0°27'43.8"S, 80°27'21.0"W). (Photos by GMSLLP)

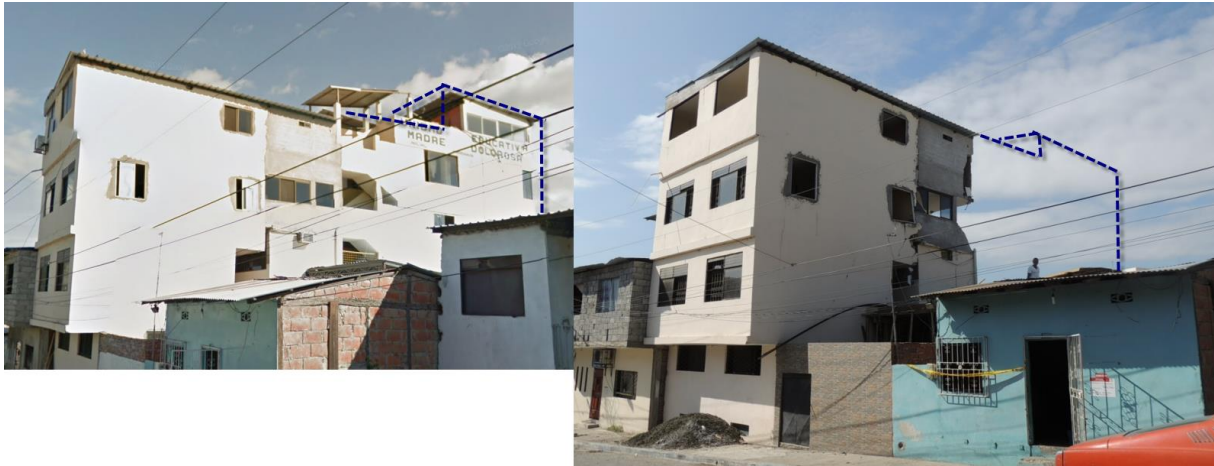
The Unidad Educativa “Linus Pauling,” a school located at 108 Street and 111 Avenue in Tarqui, Manta was comprised of the original five-story reinforced concrete building attached to a newer building of the same height. The older portion of the building completely collapsed; the newer portion did not have significant visible structural damage except for the area where it attached to the older building. The reconnaissance team was informed by neighbors that the school grew “a couple of stories” in the last years.

Fig. 20: a) Unidad Educativa “Linus Pauling” in February 2015 (Google Maps ©2015 Google Inc.). b) Image taken during reconnaissance observation. The older portion of this structure collapsed (GPS coordinates: 0°57'23.3”S, 80°42'41.0”W). (Photos by GMSLLP)

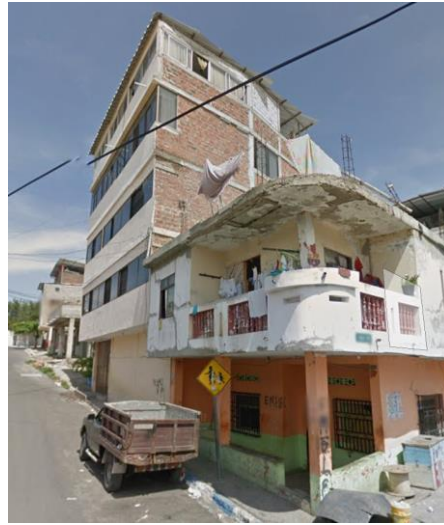
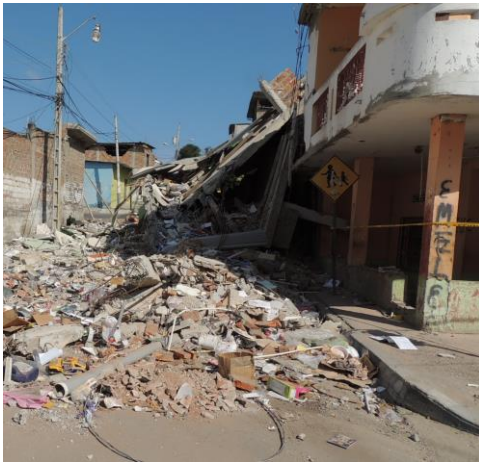
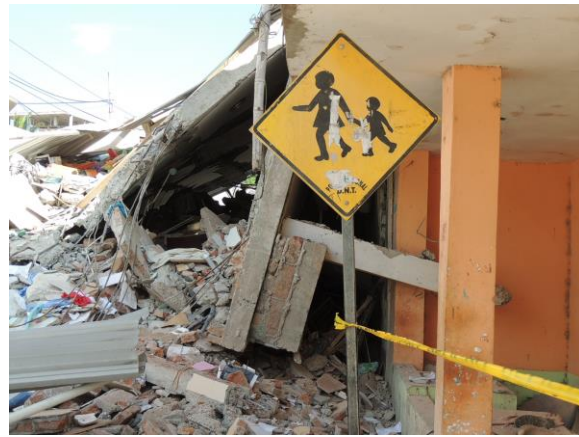
Fig. 21: a) Side view of Unidad Educativa “Linus Pauling” in February 2015 (Google Maps ©2015 Google Inc.). b) Reconnaissance photos of collapsed building after the earthquake (GPS coordinates: 0°57'23.3”S, 80°42'41.0”W). (Photos by GMSLLP)

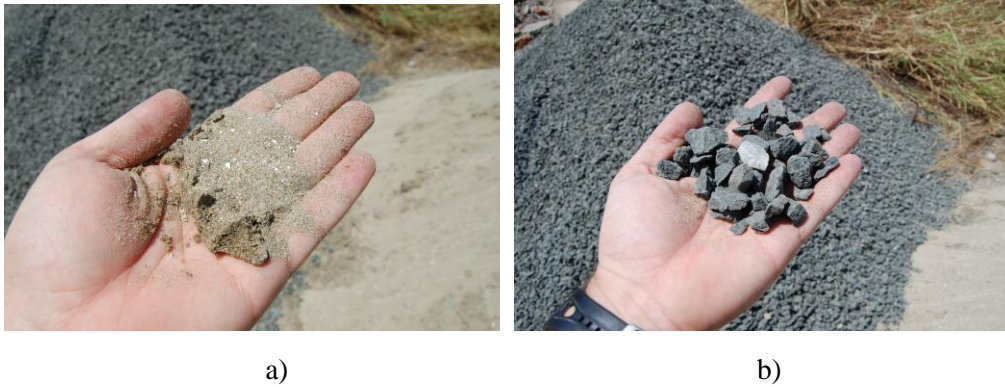
Several existing reinforced concrete structures were built using aggregates containing salty sand or salt water. This causes significant corrosion in the rebar which alters the strength of rebar and the bond to the concrete. For example, in Manta which is adjacent to the Pacific Ocean, observations in the field indicate that exposed rebar in structurally damaged buildings was previously corroded in some cases, with an effective reduction in diameter of the longitudinal, as well as the transverse steel.

Fig. 22: Building materials near Los Esteros Market in Tarqui, Manta. a) Fine aggregate with sea shells. b) Good quality coarse aggregate (GPS coordinates: 0°57'8.94"S, 80°42'29.38"W). (Photos by C. Arteta Torrents)

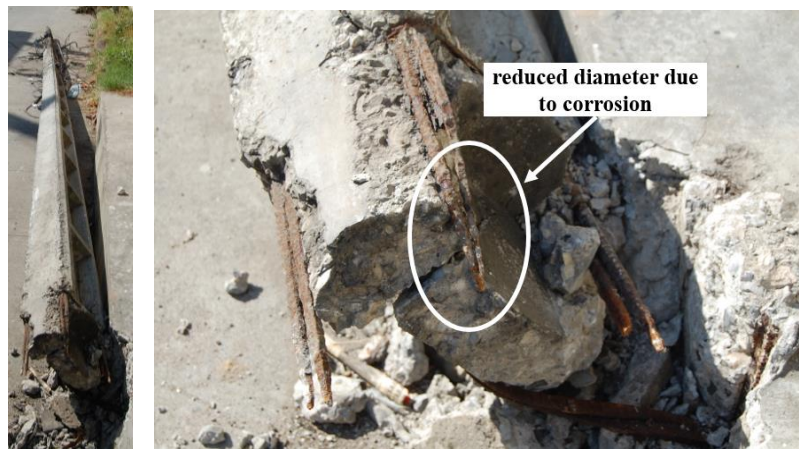
Fig. 23: Signs of severe corrosion on reinforcing steel prior to the earthquake. a) Collapsed electric pole with signs of reinforcement corrosion and reduction of effective area of longitudinal steel in Tarqui, Manta (GPS coordinates: 0°57'29.92"S, 80°42'36.45"W). b) Signs of severe corrosion in the steel at the base of a 1st story column of a three-story building tagged for demolition in Tarqui, Manta (GPS coordinates: 0°57'9.04"S, 80°42'41.54"W). (Photos by GMSLLP & C. Arteta Torrents)

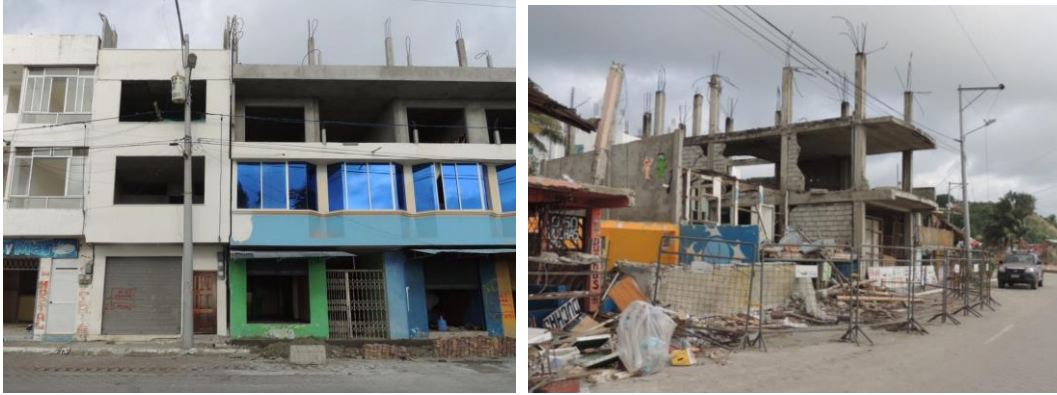
In some existing buildings, there were some rebar sticking out from the top of columns, presumably so a floor could be added to the building in the future. However, leaving the rebar exposed for extended periods of time in a marine environment causes it to corrode.

Fig. 24: Dowels sticking out from the top of the columns, presumably so a floor could be added to the building in the future
a) Buildings in the coastal strip of Pedernales (GPS coordinates: 0°4'4.8"N, 80°3'23.5"W) b) Pedernales (GPS coordinates: 0°4'4.8"N, 80°3'23.5"W) and Tarqui, Manta (GPS coordinates: 0°57'9.04"S, 80°42'41.54"W). (Photos by GMSLLP)
