## **Strong Ground Motions and Damage Investigation of Buildings near the Surface Faulting of the 2016 Kumamoto Earthquake in Japan**

### **Abstract**

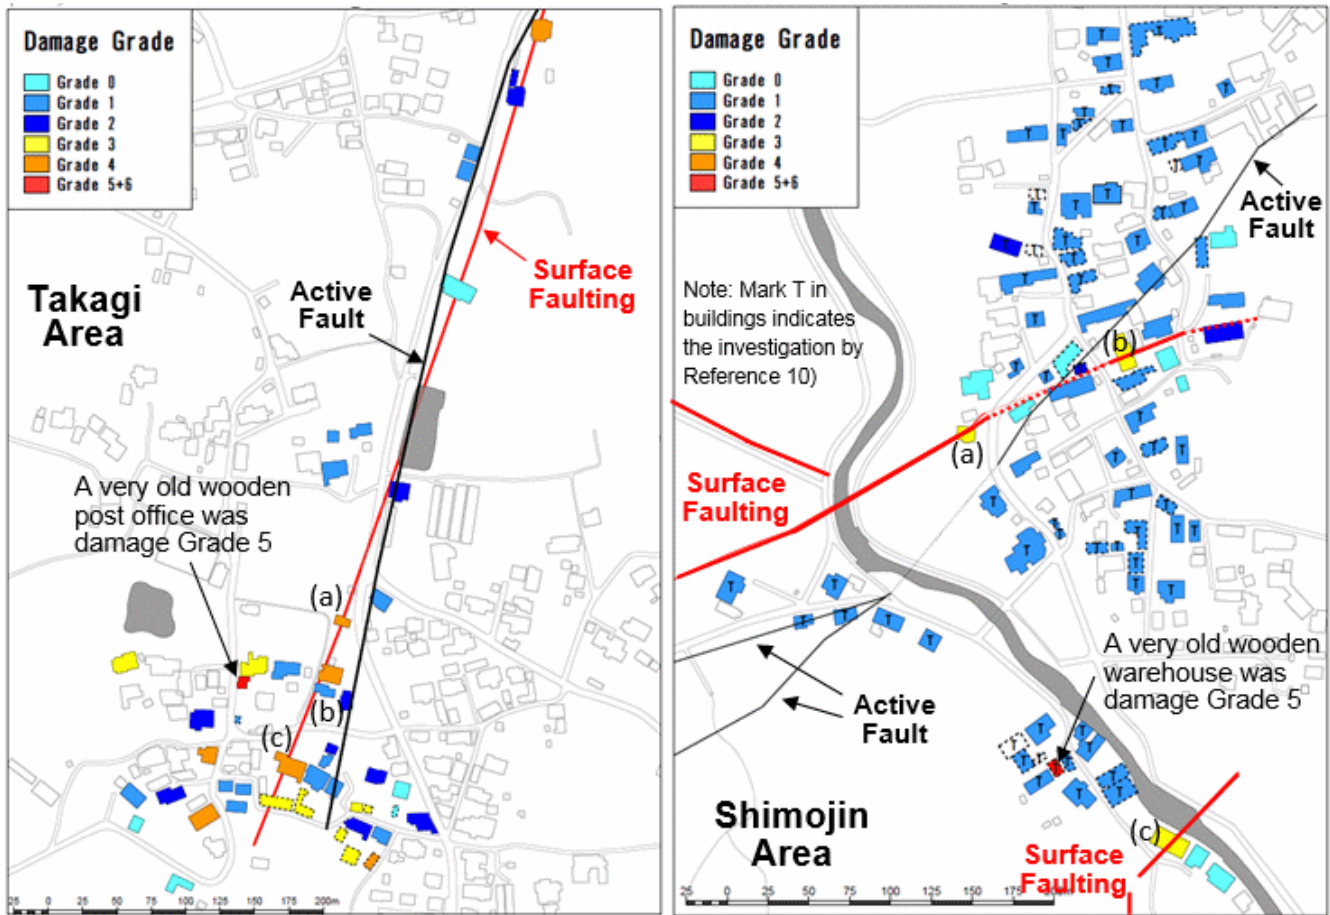
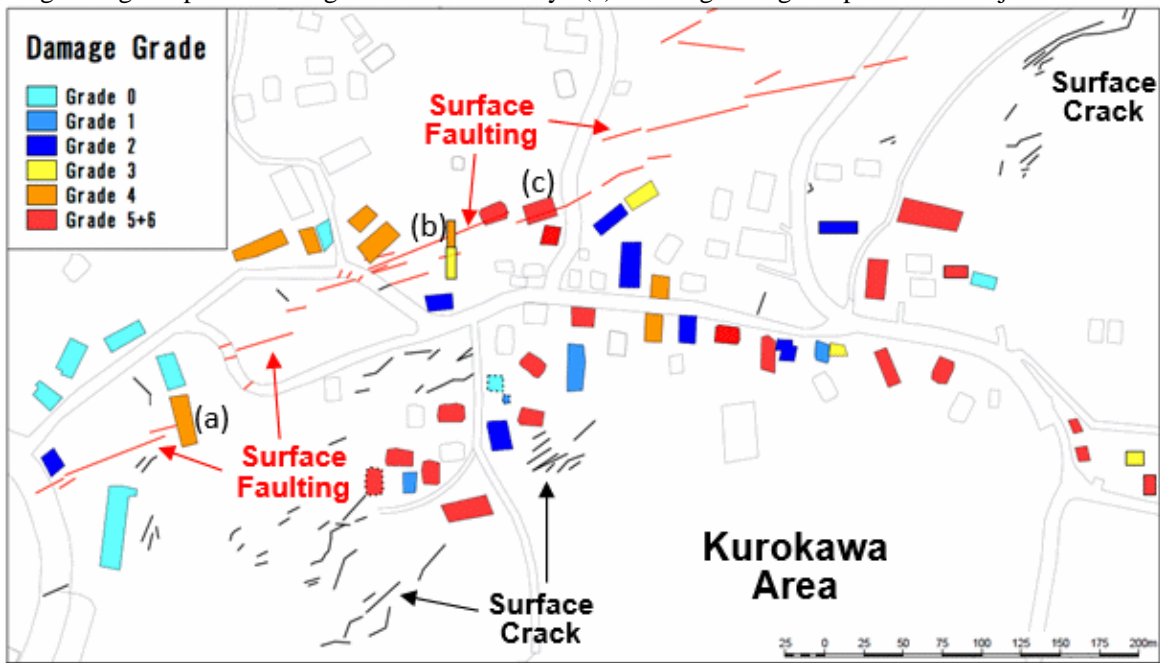
Fig. 4 – The three maps of the building damage and the surface faults (see the locations of the maps in Fig.3, and the pictures of the buildings (a) – (c) in Figs 5 - 7)

(a) Building damage map in the Takagi area in Mifune City (b) Building damage map in the Shimojin area in Mashiki City

(c) Building damage map in the Kurokawa area in Aso City

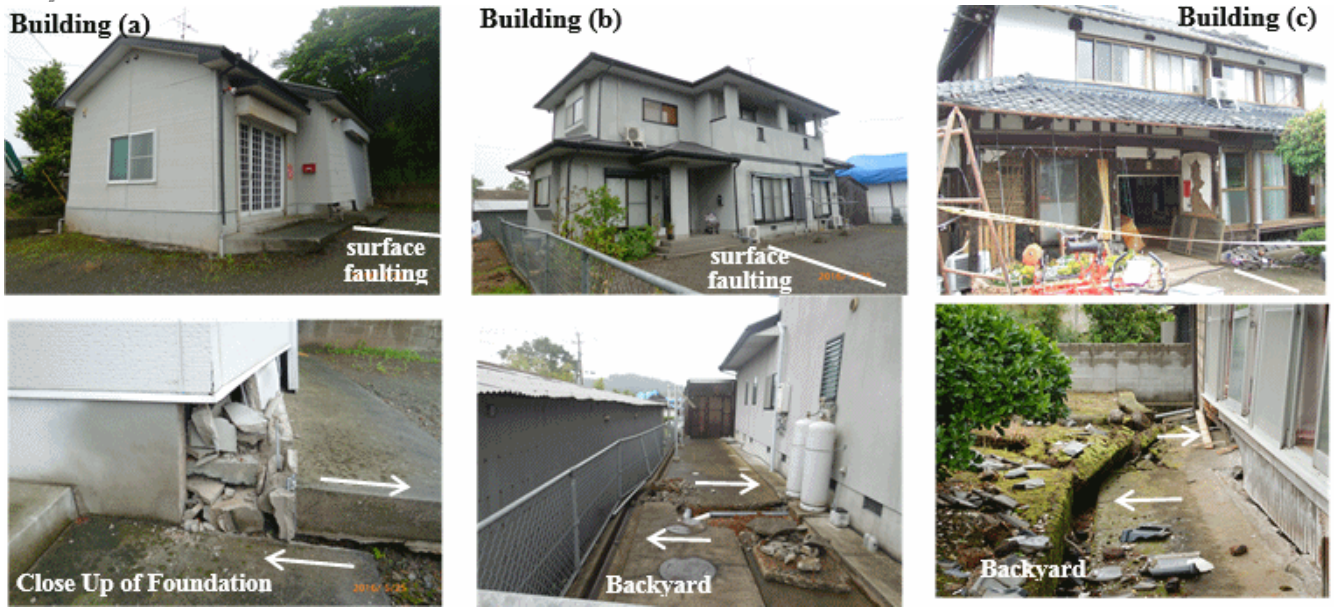
Fig. 5 – Building damage on the surface faults in the Takagi area (see the locations of buildings in Fig.2(a))

Fig.5(a) is an old wooden building on the surface faulting, and close up of the foundation damage. Due to the lateral fault slip of about 50 cm, the foundation of unreinforced concrete blocks are destroyed. This deformation directly transfers into the building, and causes severe structural damage (Damage Grade 4).

Fig.5(b) shows the front and back of a new light-steel house on the surface faulting. Even though the fault slip of about 50 cm was observed next to the building, the damage was very minor (Grade 1); a few cracks were found on the foundation. This is probably because that the mat foundation of reinforce concrete combined with the rigid shear walls and light root was robust enough to prevent the ground slip from entering into the building.

Fig.5(c) shows the front and back of a very old traditional wooden house on the surface faulting. Contrary to Fig.5(b), the individual footings moved by following the fault slip of about 50 cm, and the building was heavily deformed (Damage Grade 4).

(a) An old wooden house on the surface fault (Damage grade 4)      (b) A new house on the surface fault (Damage grade 1)      (c) A very old wooden house on the surface fault (Damage grade 4)

faulting. For example, the new wooden houses with the mat foundation of RC could prevent the slip deformation from reaching the building, and the combinations of the shear wall and light roofs prevented severe damage (see Fig.5(b)). On the other hand, the old Japanese traditional houses generally suffered severe damage, but their structural flexibilities could prevent collapsing by following the slip deformation (see Fig.5(a),(c), and Fig.6(b),(c)). The collapsed buildings were generally old and lacked both the sufficient earthquake-resisting structural members and the effective connections among them (see Fig.7(c)).

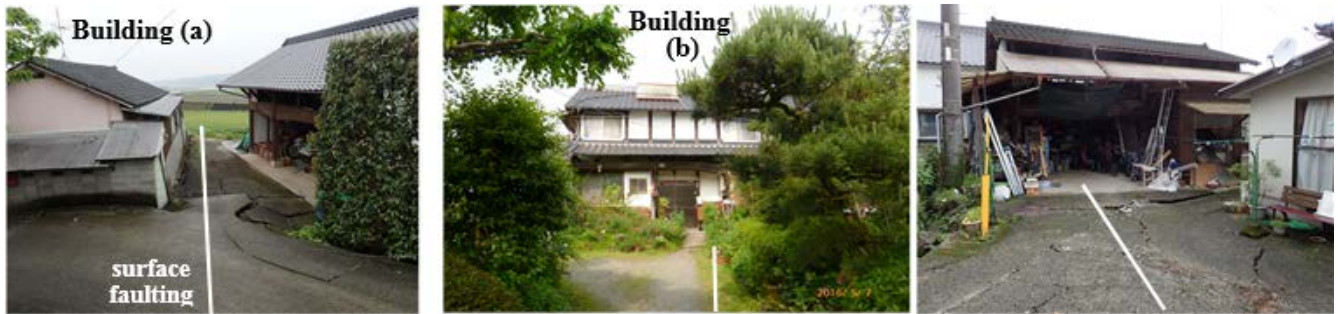
Fig.6 – Building damage on the surface faults in the Shimojin area (see the locations of buildings in Fig.2(b))<sup>10)</sup>

Fig.6(a) is a very old wooden building (the left in the picture) on the surface faulting of 20 – 30 cm slip, which shows substantial damage in the foundation due to the ground deformation (Damage Grade 3)<sup>10)</sup>. On the contrary, the new warehouse, which is the right of the picture and out of the ground slip shows little damage.

In Fig.6(b), the left picture shows the frontal view of a very old wooden house (about 100 years old<sup>10)</sup>), and the right picture is the very old warehouse in the backyard. Even though they are directly above the surface faulting, they seemed little damage from these visual inspections. However, the detail investigation reported that a main column was out of the footing and the structure was severely deformed<sup>10)</sup>. We judged the damage of the house to be Grade 3 on the basis of our visual inspection and the report<sup>10)</sup>.

(a) An old wooden house (left) on the surface fault (Damage grade 3)      (b) A very old wooden house on the surface fault of the front (left: Damage grade 3), and the back (right: a very old warehouse of damage grade 1)

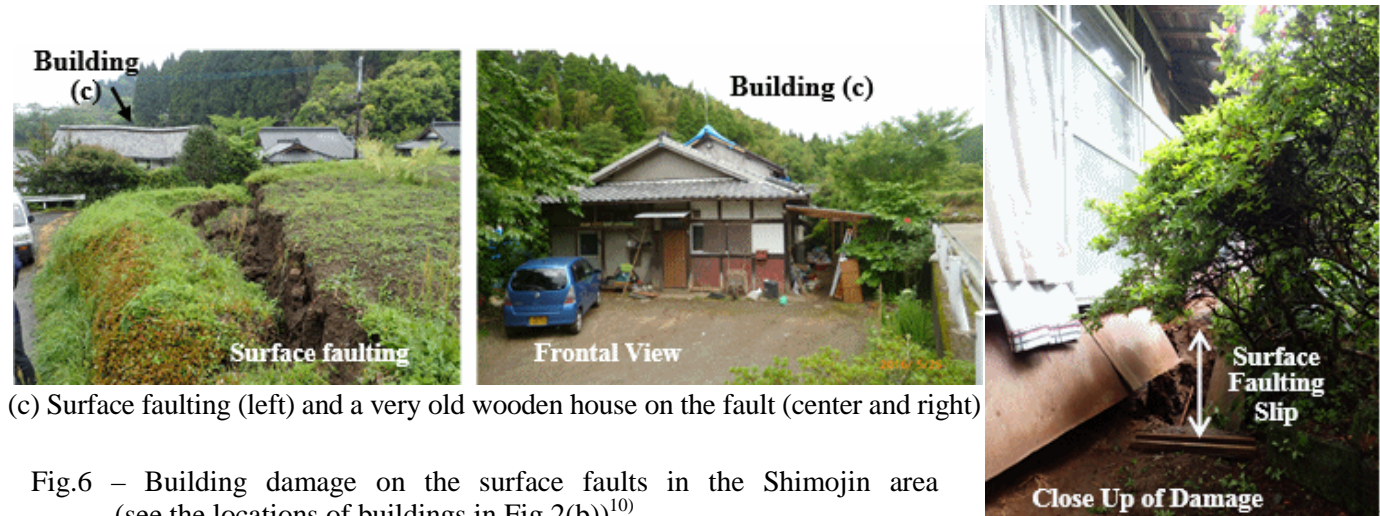
Fig.6(c) shows pictures of a very old house (about 80 to 100 years old<sup>10)</sup>) and the surface faulting of 50 – 60 cm slip, which is about 300 m away and parallel to the faulting of Figs.6(a) and (b). The left, center, and right pictures show the surface faulting (front) and the house (back), the frontal view of the house, and the close up of the surface faulting and the building damage, respectively. The detail investigation of the house reported that the fault slip deforms its main structures (foundation, columns, and beams)<sup>10)</sup>. Again, we judged the damage of the house to be Grade 3 on the basis of our visual inspection and the report<sup>10)</sup>.

(c) Surface faulting (left) and a very old wooden house on the fault (center and right)

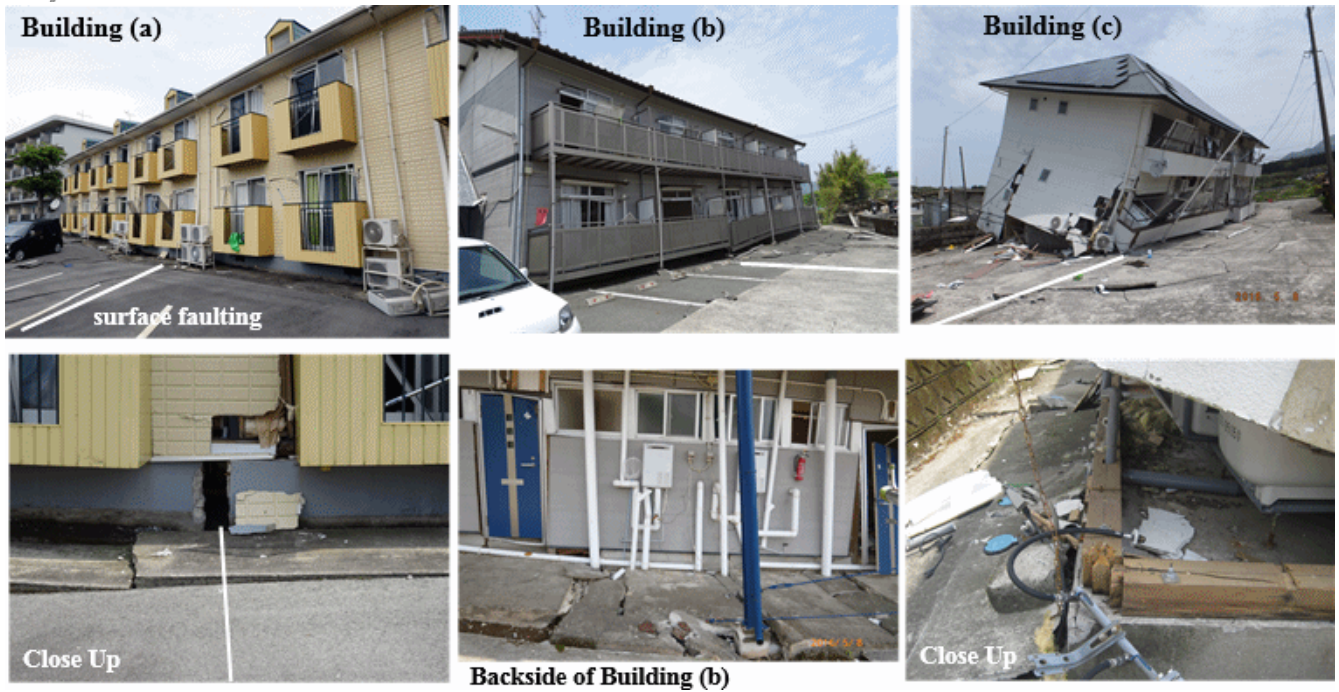
Fig.7 – Building damage on the surface faults in the Kurokawa area (see the locations of buildings in Fig.2(c))

Fig.7(a) shows an old steel apartment, which is located directly above the surface faulting, and the close up of the foundation damage. The ground deformation destroyed the foundation of unreinforced concrete, and thus, the building structures are tilted and heavily damaged (Damage Grade 4). On the contrary, the RC apartment of 4 stories, which is next to this building (the left in the picture) and out of the fault slip, shows no damage (Damage Grade 0).

Fig.7(b) shows the front and back of an old wooden apartment directly above the surface faulting. Similar to Fig.7(a), the foundation and the building are deformed and heavily damaged due to the ground deformation (Damage Grade 4).

Fig.7(c) shows the collapse of an old wooden apartment above the surface faulting and the close up of the damage (pulling out of a column). This apartment was 3 stories, but the soft first story of the garage in the front completely collapsed by the strong shaking. As shown in the close-up picture, there were no hall-down hardware to fix the columns to the foundation, that caused the overturning of the building (Damage Grade 5).

(a) An old steel apartment on the surface fault (Damage grade 4)      (b) An old wooden apartment on the surface fault (Damage grade 4)      (c) An old wooden apartment on the surface Fault (Damage grade 5)
