PRELIMINAR DAMAGE ASSESMENT OF MASONRY BUILT HERITAGE AFTER THE AMATRICE 2016 EARTHQUAKE

F. Brandi ⁽¹⁾, N. Palazzi⁽²⁾, L. Rovero⁽³⁾, U. Tonietti⁽⁴⁾

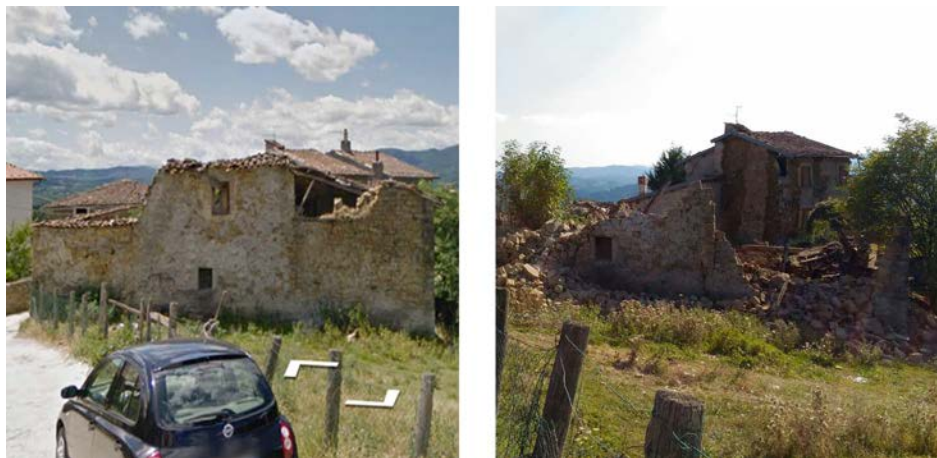
Fig.2a - An abandoned building collapsed by disaggregation. The total absence of maintenance has exposed the interiors to atmospheric agents, causing an important deterioration of the masonry made of pebbles and mud mortar, Casale village

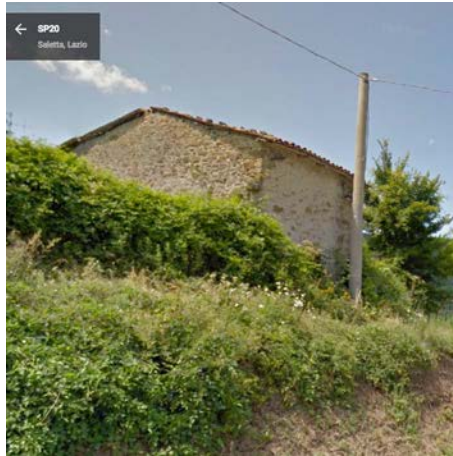
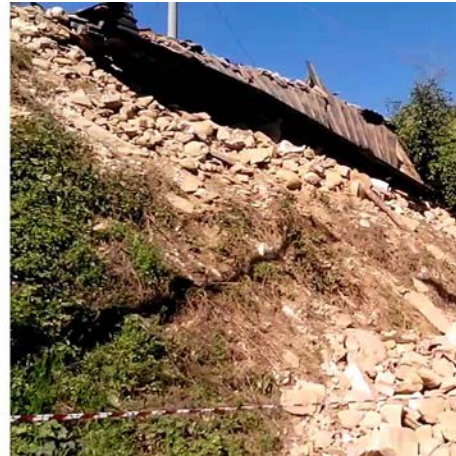
Fig. 2b- An isolated rural building subjected to a global collapse due to the disaggregation of masonry walls constituted by mud mortar and pebbles elements, Saletta village

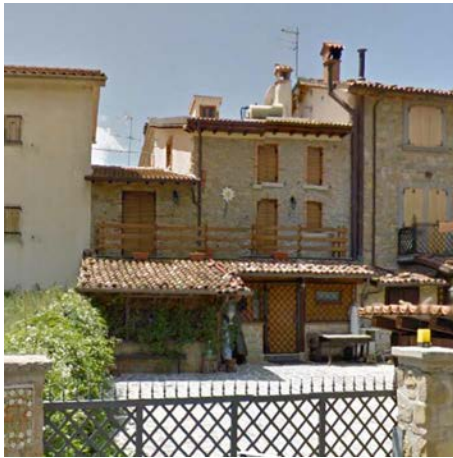
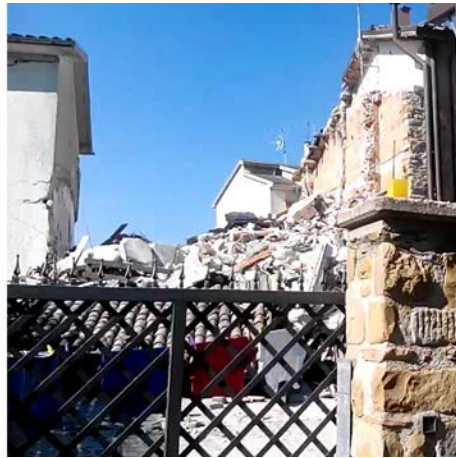
Fig.2c - Two terraced dwellings interlocked between higher buildings with stagger floors, collapsed by disaggregation, Saletta village

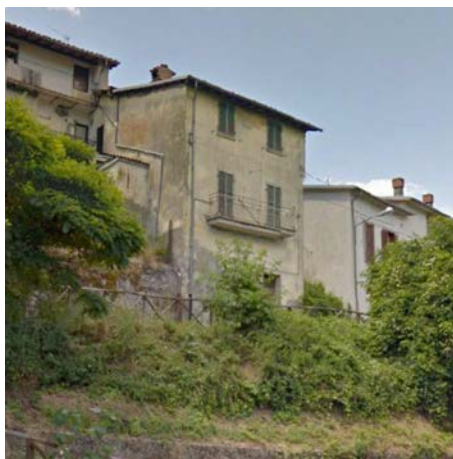
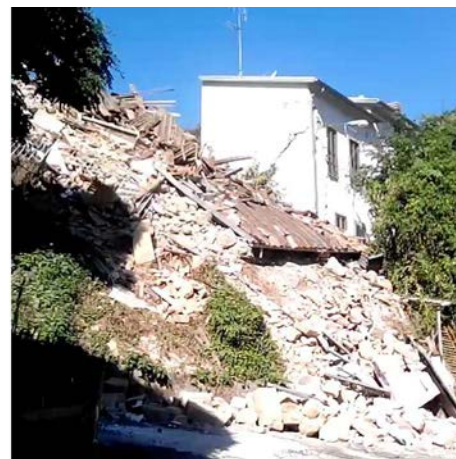
Fig.2d – A three floors slender building located on an elevated slope characterized by *zero mechanism* due to poor and disaggregated masonry, Saletta village

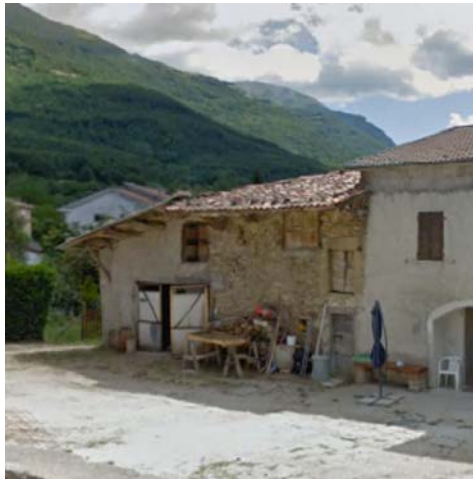
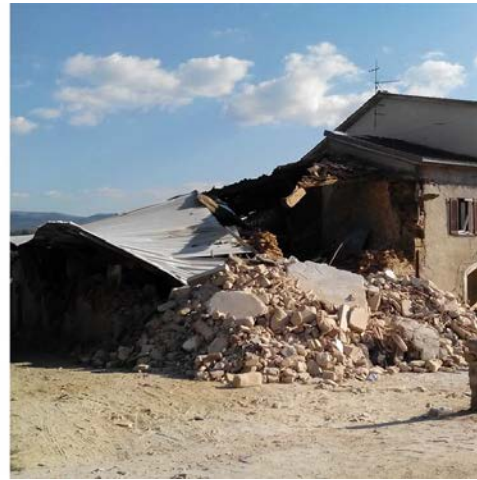
Fig.2e - Rural warehouse has collapsed by disaggregation. The less of maintenance get worse the originally main weakness: the poor quality of the masonry made of pebbles and mud mortar, San Lorenzo a Flaviano village

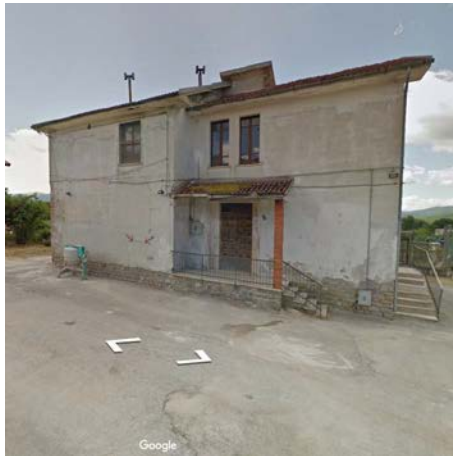
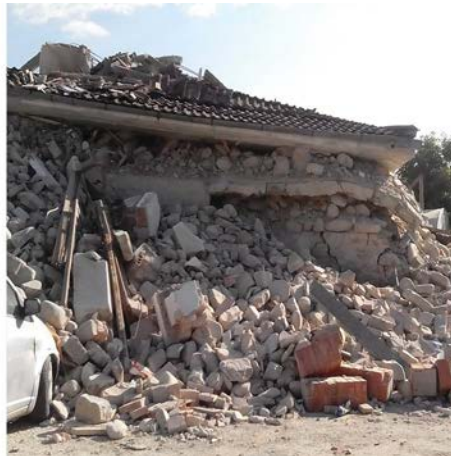
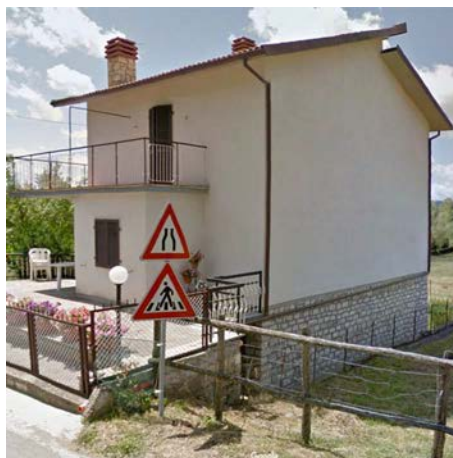
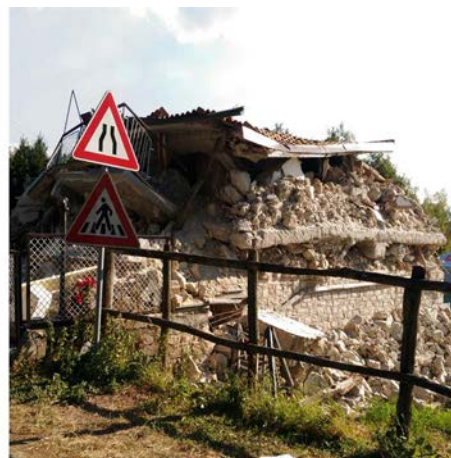
Fig. 3a/b – Two isolated dwelling due to stiff and heavy RC gable roof and floor sliding, have determined a global collapse of masonry structure, San Lorenzo a Flaviano village

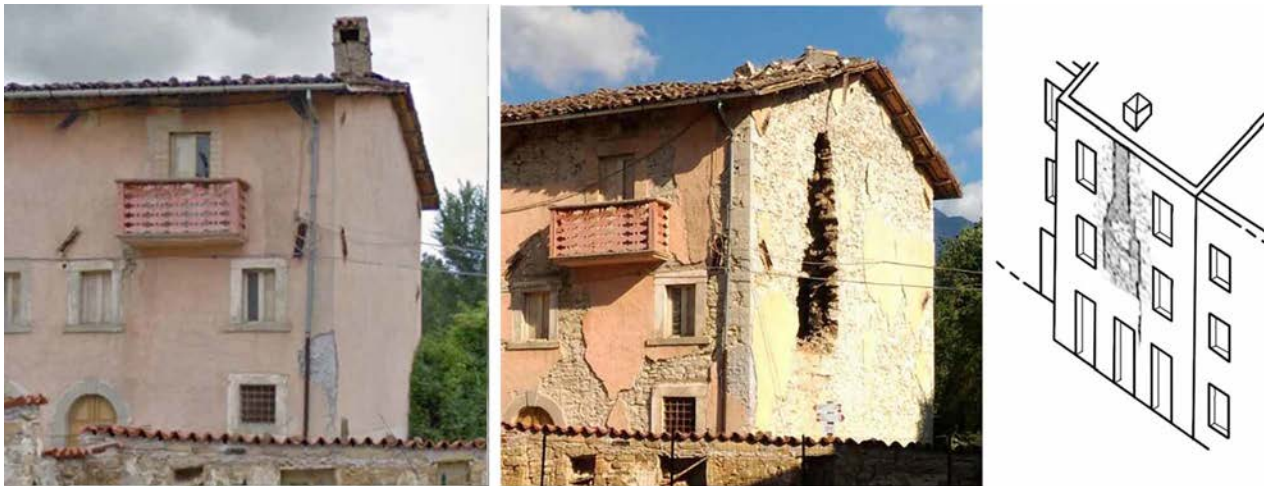
Fig. 4a- Out-of-plane mechanism due to material irregularity and local weakness of masonry wall determinate by the presence of a flue, Cascello village

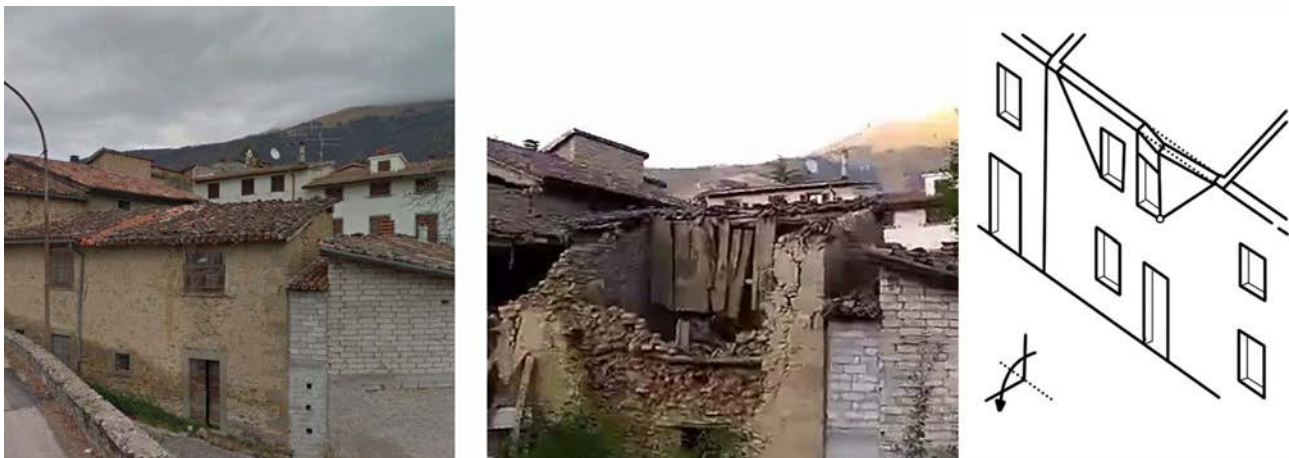
Fig. 4b- A rural interlocked building shows horizontal arch mechanism inducing the overturn of the façade and the separation of external leave of remaining wall, Sommati village

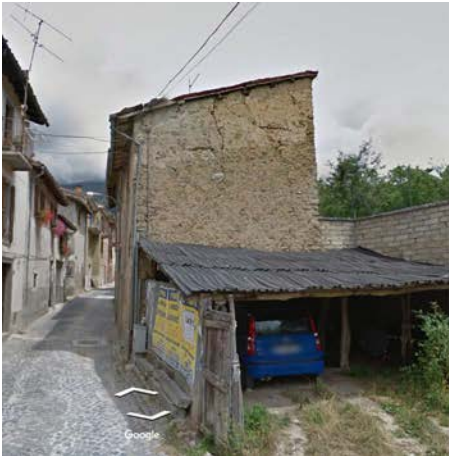
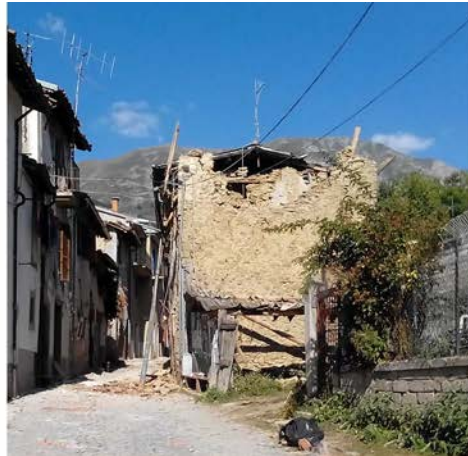
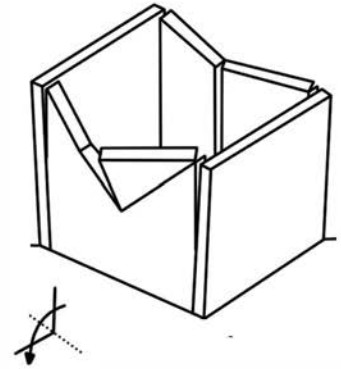
Fig. 4c – Horizontal arch mechanism involved upper part of a three floors rural building, Sommati village

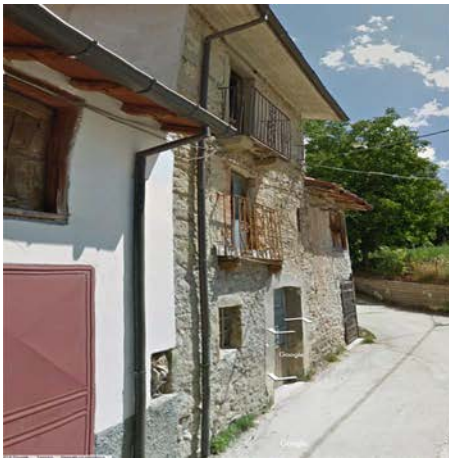
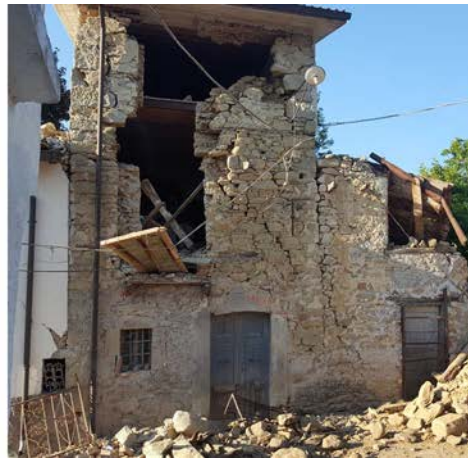
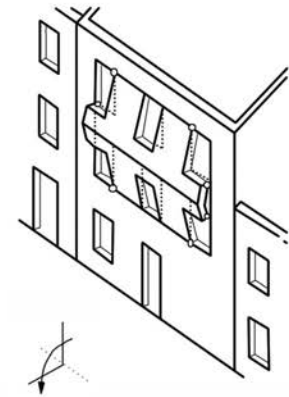
Fig. 4d- The building presents the activation of vertical arch mechanism due to lack of good connections between floor and masonry wall and to hammering of floor on rubble masonry, Faizzone village

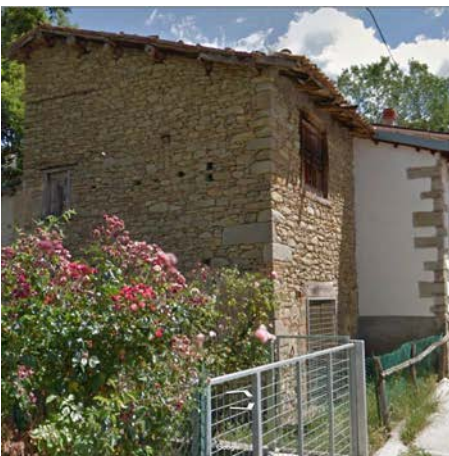
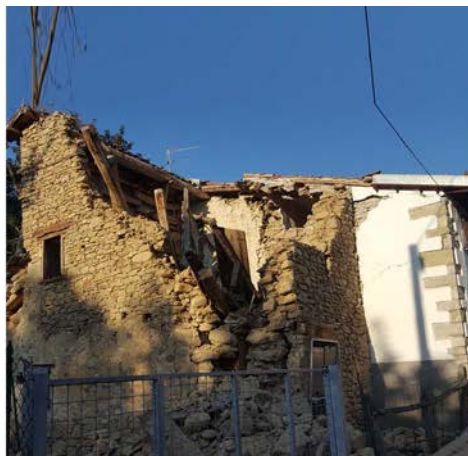
Fig. 4e – The rural building shows the corner collapse depends on the presence of quoins, on the layout of the opening and spanning direction of the roof, Faizzone village

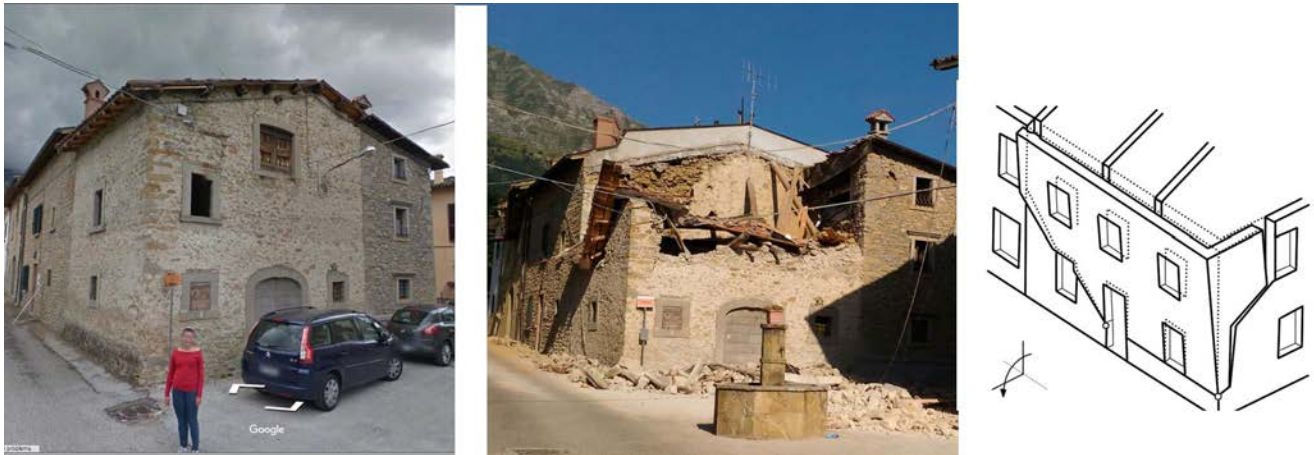
Fig. 4f – Composite overturning mechanism of façade due to the absence adequate quoins between the additions, to the presence of a big opening and of other opening in proximity of wall extremity, Cascello village

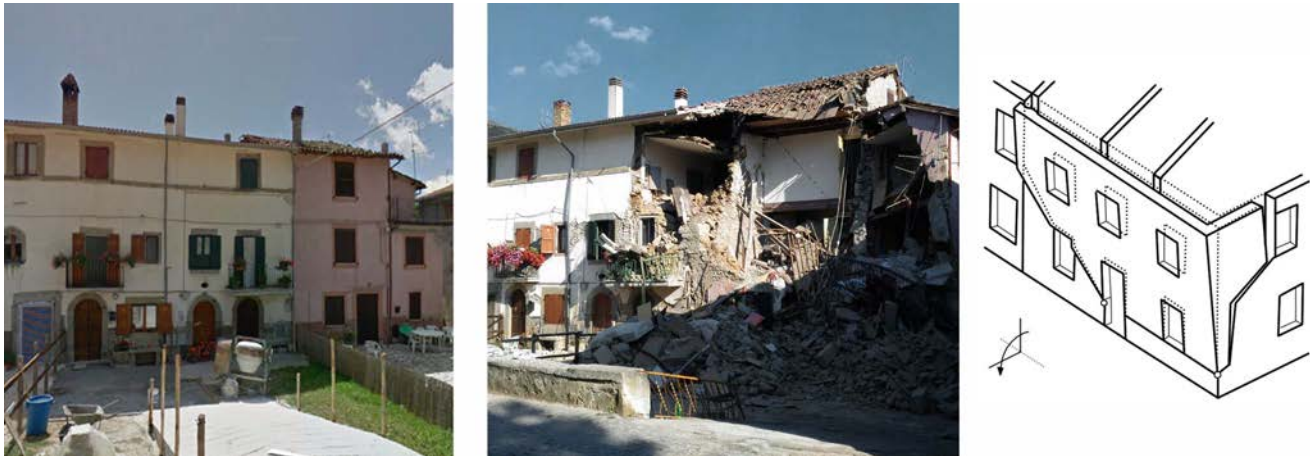
Fig. 4g - Composite overturning of the façade in the terraced aggregate, San Lorenzo a Flaviano

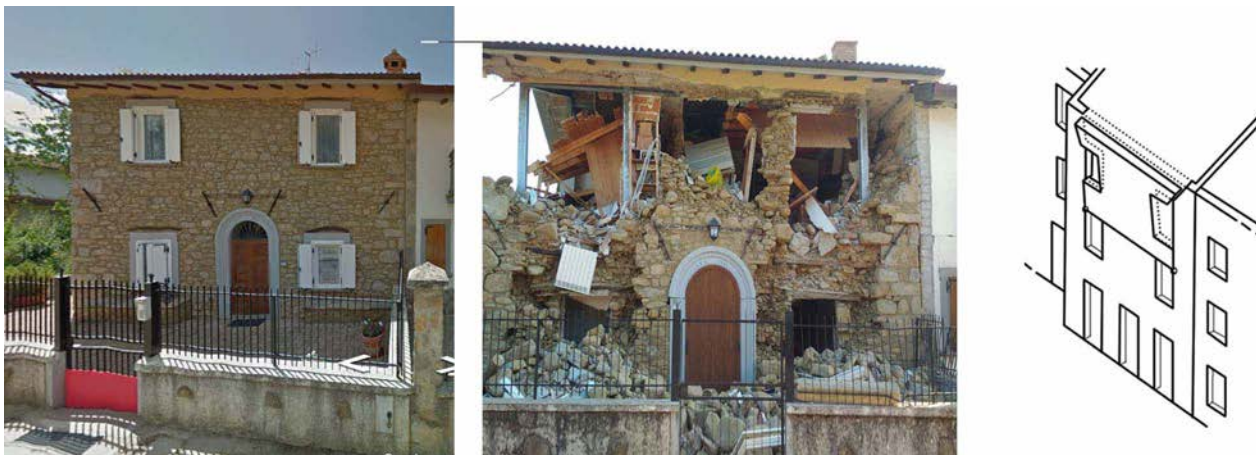
Fig. 4h- Example of masonry building with inadequate interventions of consolidation. Steel elements, at the second floor, hammered the rubble masonry wall determining the overturning of the all upper part of façade. The presence of ties has limited the collapse at the lower part of the façade, Rocchetta village

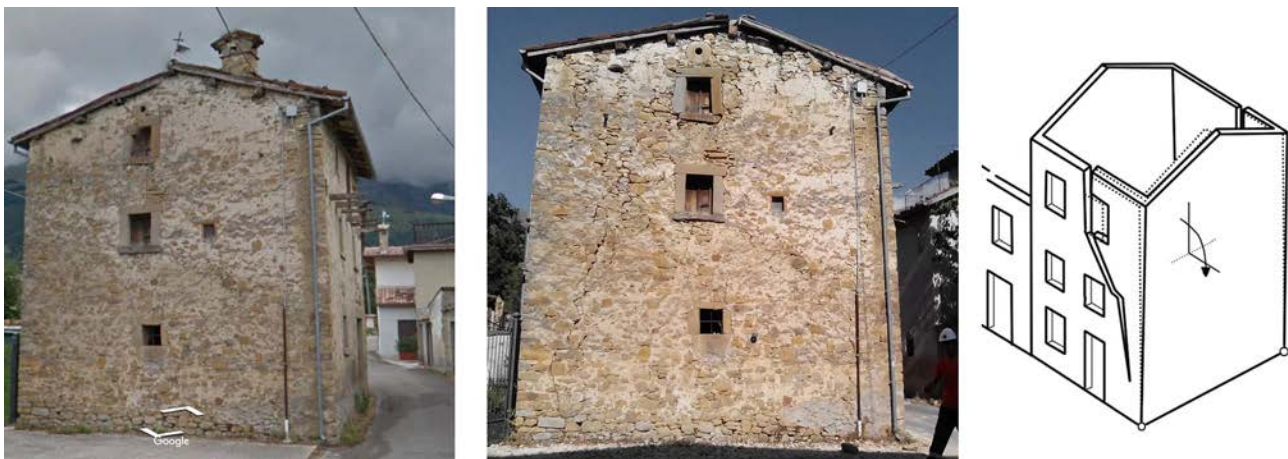
A significant number of structures in Tronto Valley showed a better *box behaviour*. These buildings are characterized by prevalently in-plane mechanisms due to shear and bending (Fig.5a, b, c). Such behaviour, the *second damage mode*, is achieved through devices that prevent the wall overturning so transferring the strengthening capacity to the transversal walls (that work in-plane). Sometimes an inadequate insertion of chains (Fig. 5a) shows a partial activation of overturning mechanism that doesn't reach the collapse.

Fig. 5a - The isolated building shows the partial activation of façade overturning which doesn't collapse because of the presence of a tie-rod, located at the second floor. Prato village

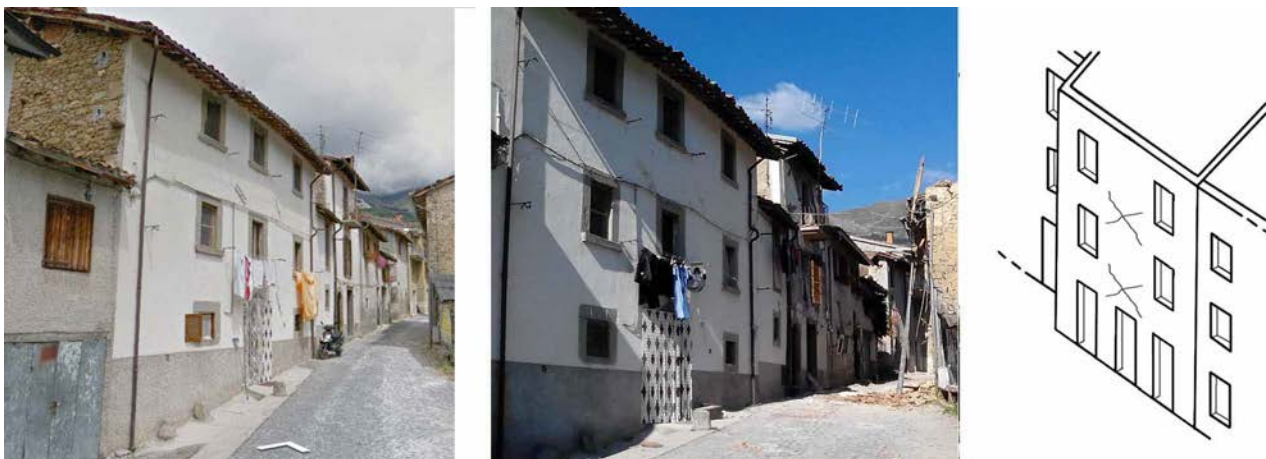
Fig. 5b - The terraced buildings show a good *box-behavior* characterized by diagonal shear cracks in upper level storey, mainly due to the ties at two levels (second and third floor), Sommati village

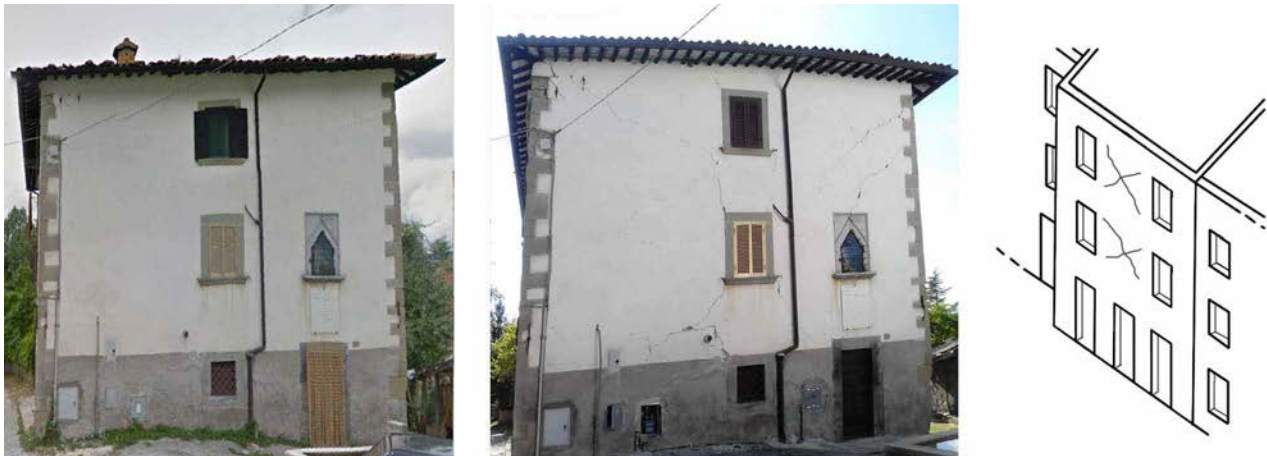
Fig. 5c – The isolated building shows both diagonal and vertical cracks; it exhibits tie-rods just at the second floor and corners bonds with regular and squared medium size blocks, Sommati village

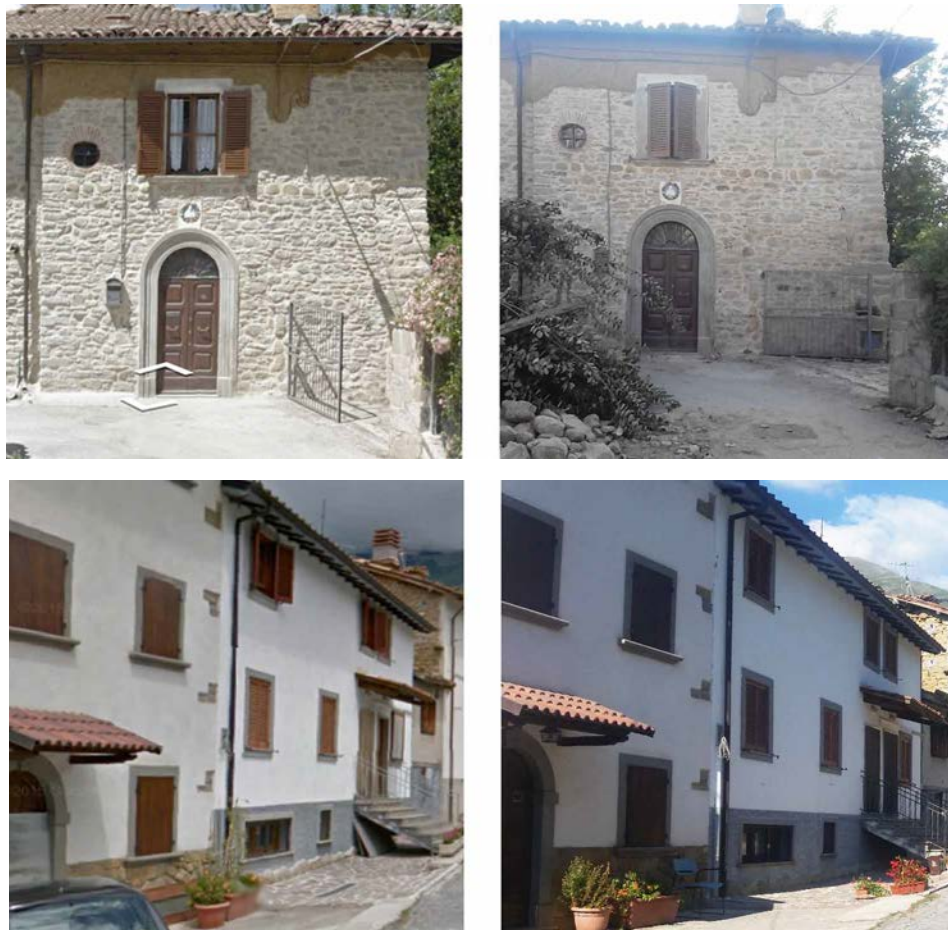
Fortunately, during the mission, some examples of buildings with non-structural damages were detected (Fig.6a and b) bring to light the use of efficient building techniques which respect the fundamental requirements of the "rule of the art".

Fig.6a, b - Terraced houses and isolated house with non-structural damage, Sommati and Faizzone villages
