IMPORTANT LESSONS FROM FIELD RECONNAISSANCE FOLLOWING THE 2016 MEINONG EARTHQUAKE IN SOUTHERN TAIWAN

T.C. Hutchinson⁽¹⁾, K. Clahan⁽²⁾, J. Sun⁽³⁾, F. Menq⁽⁴⁾, E. Lo⁽¹⁾, W.-J. Chang⁽⁵⁾, C.-C. Tsai⁽⁶⁾

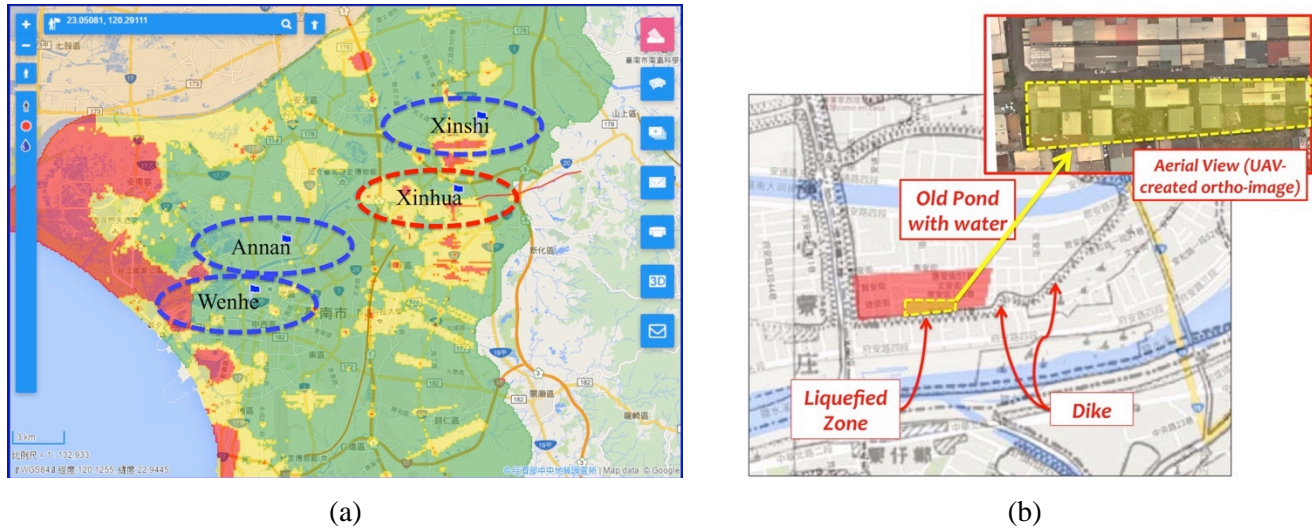
settlement, the zone of liquefaction of the Annan site is outlined in Figure 5b. Overlapping the current and the 1898 maps, clearly indicates that the liquefaction occurred in the area mapped as an old fish pond, with the two sides of the liquefied boundaries located along the mapped old dike. Field reconnaissance identified differential settlement along the dike as high as 50 cm in some locations. Typical failure patterns included ground settlements, cracks of pavements, settlement/tilting of reinforced concrete structures on shallow foundations, and rupture of underground utilities.

Fig. 5 – (a) Survey sites near Tainan City where extensive liquefaction was observed (note that Annan, Wenhe, and Xinshi are residential areas, while Xinhua is an open area and region of repeated liquefaction, see [1]). A recent liquefaction hazard map is offered in the background (background map courtesy of [7]), where green, yellow, and red = low, medium, and high liquefaction potential, respectively. (b) Overlap of 1898 map [8] and present-day Google map at the Annan site (inset denotes location of region presented in damage mapping in Figure 7) (1898 map source [8])

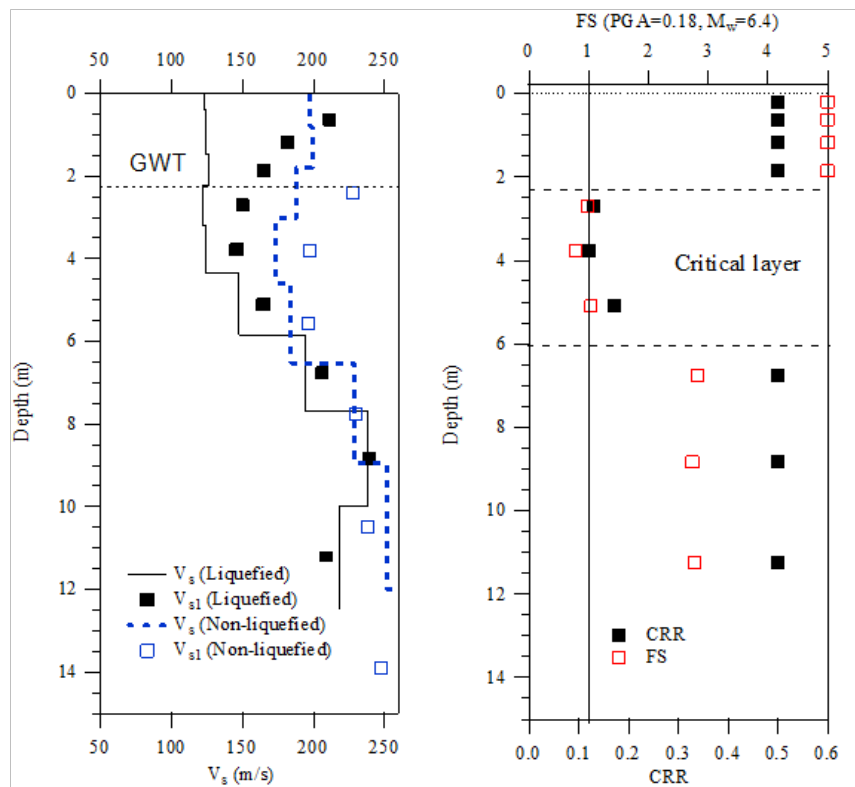
An emerging issue recognized during this reconnaissance is the need to identify potential local liquefiable zones in residential areas. While available geologic and historical planning maps are both good references to help identify potential liquefaction areas, they are not accurate enough to describe the liquefaction potential at a small enough scale for an individual property owner (Figure 5 clearly demonstrates this). Based on observations from this earthquake reconnaissance, Vs profiling techniques (multi-channel analysis of surface waves; MASW) provides good data for estimating liquefaction potential. Herein, the simplified procedure using Vs data generated through MASW [6] is used to identify the liquefied layer. These results show that the liquefied layers are located at depths of 2 to 6 m below grade, which is the general depth of commercial fish ponds in this area and corresponds to the depth ranges of the loose backfill (Figure 6). This is also in agreement with observations in the field that new buildings constructed with a deeper basement performed well in areas where adjacent older structures without a basement suffered liquefaction induced settlement and associated structural distress. An example is shown for the Annan area, where MASW surveys conducted on February 24, 2016 (2.5 weeks after the event), provide the Vs profiles measured near a severely damaged building (Figure 10). Note that the ground water table is estimated at the depth of 2.3 m below the surface; as inferred from the Vs profile and confirmed by local residents. Results of the liquefaction analysis indicate that the liquefied layer is located at depths from 2.3 to 6 m (Figure 6). Moreover, the non-liquefied zones have an ample factor of safety over 2.5 at all depths. These results agree with the performance of subsoils during this event and the history of the site.

Fig. 6 – Annan district Vs profiles and liquefaction triggering estimates.

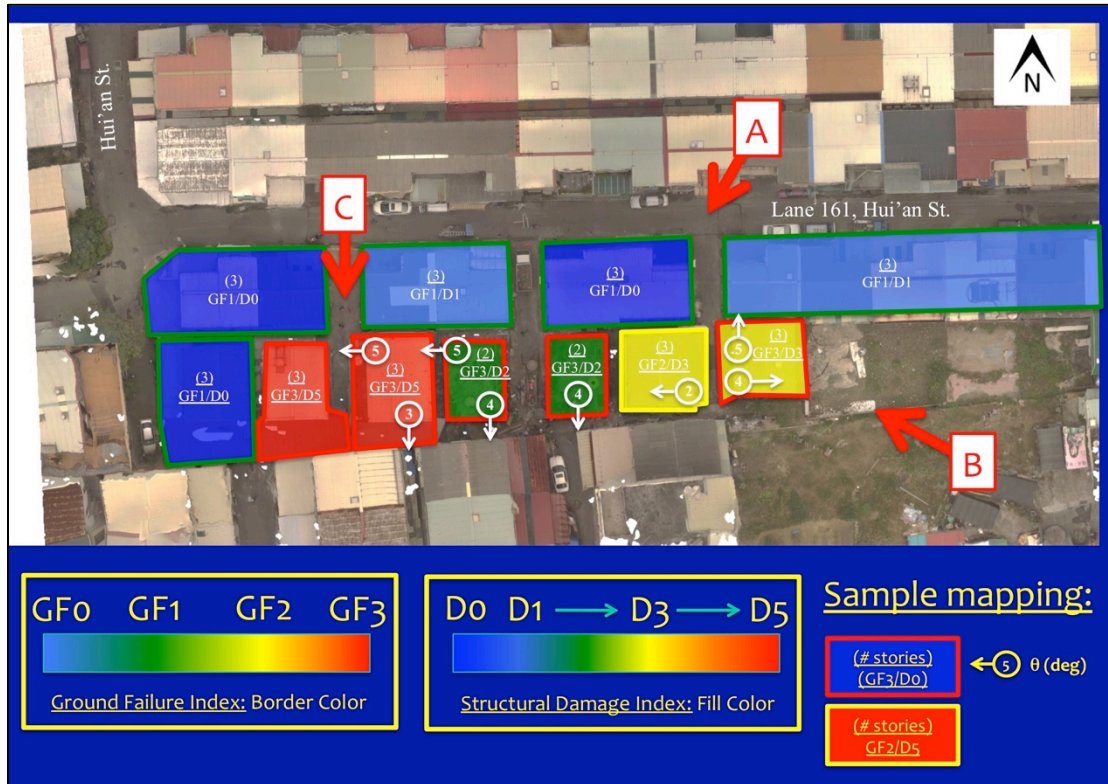
Several important aspects can be investigated in the context of Figure 7. Beginning with the highly dominant blue shading at the exterior buildings, these long buildings consistently observe little to no structural damage as graded with a structural damage index between D0 and D1; despite the presence of ground failure features, though graded as minor GF1. The pair of photos shown in Figure 8 articulates an example of a nominal ground failure graded as GF1, where settlement of the structure is observed; yet at most damage to the structure is only cosmetic in nature (graded as D1); despite the manifestation of settlement, the lack of significant structural damage is likely due to the well connected and continuous foundation of this building. Moreover, no building extensions were noted in these buildings. In contrast, Figure 9 provides a perspective view from the south east (viewpoint B in Figure 7) looking onto several buildings where clear evidence of liquefaction in the field is noted as visible in the bulging of exterior slabs (center of image) and rotation of light-weight screen fences (left of image), surface sand boils (in field and elsewhere). The pair of buildings on the left of this image observed ground failure features at their exterior classified as moderate to severe (GF2-GF3; while their resulting structural damage was graded as heavy (D3; significant damage to load bearing elements); as is evident

from views on the opposing side (not shown here); in stark contrast, the long building on the right likely of similar weight and with surrounding ground failure characterized as minor, observed only very minor cosmetic damage. Its foundation and structural system were continuous and no additions were observed along the exterior of this building, which may be why this building suffered no damage despite the visible surrounding ground failure. The most severe ground failure-structural damage locations mapped in Figure 7 are those structures observed from viewpoint C of Figure 7. Graded as yellow through red or D3->D5, these excessive structural damage regions of the district were mostly associated buildings with structural discontinuities primarily at the foundation, and often associated with light-weight single story addition regions (Figure 10).

Fig. 7 – Assessment of ground failure – structural damage index (A, B, C denote images shown in Figures 8, 9, and 10 respectively). (center of region at: 23.0254°, 120.2074°)

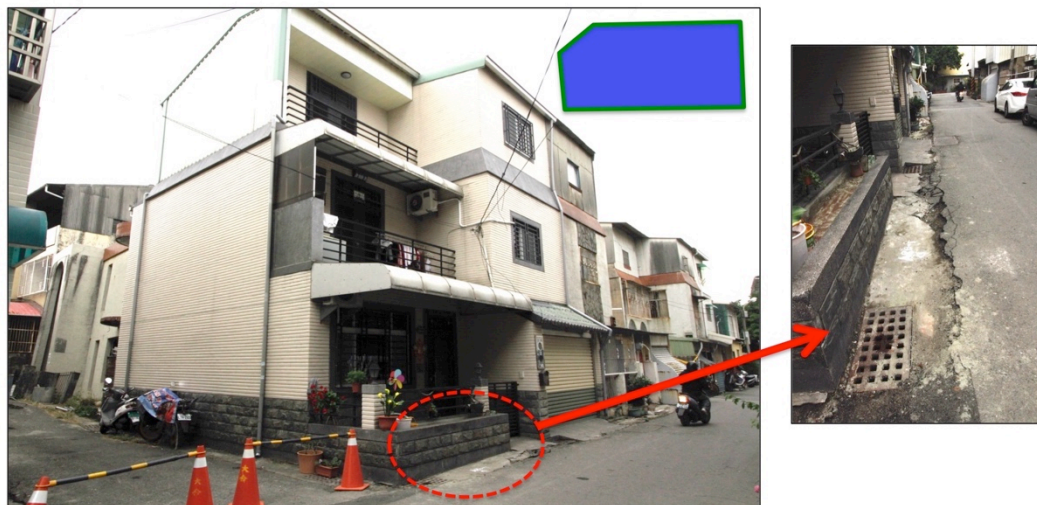
Fig. 8 – Example of mapping GF1-D0 (or GF1-D1). (23.0255°, 120.2078°)

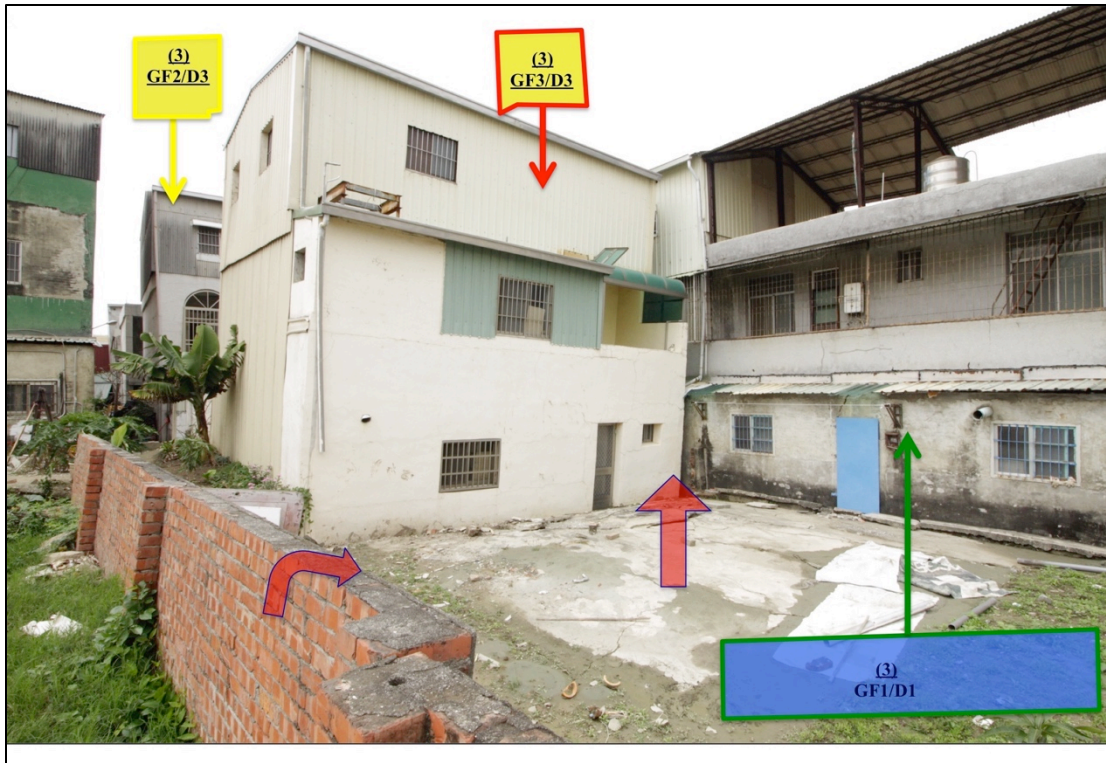
Fig. 9 – Example of mapping GF1 through GF3; demonstrating various structural damage states. (23.0254°, 120.2075°)

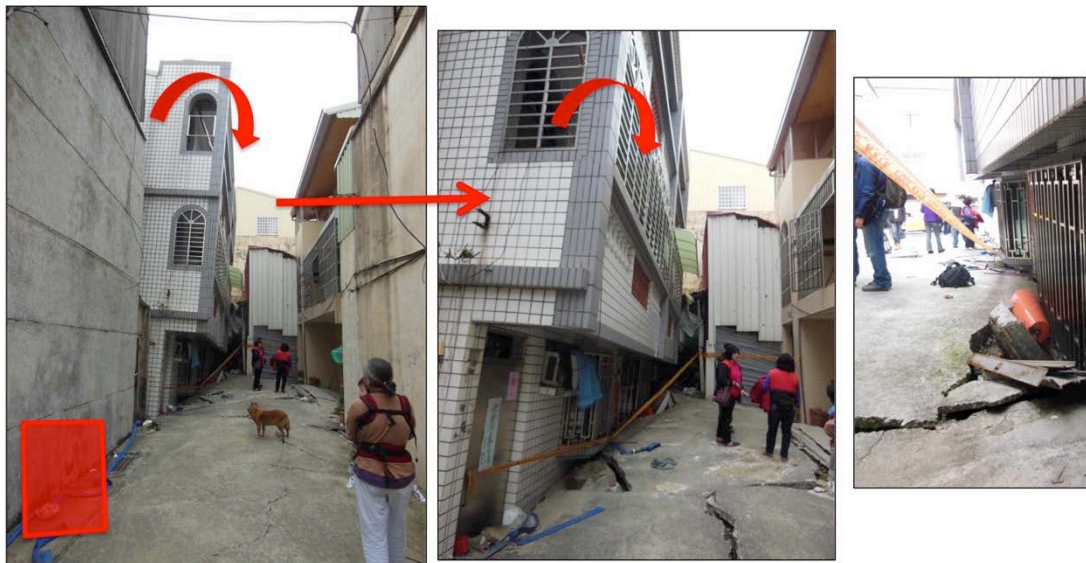
Fig. 10 – Example of mapping worse case ground and structural damage combination (GF3-DF5). (23.0254°, 120.2074°; Lane 161, Hui'an St)

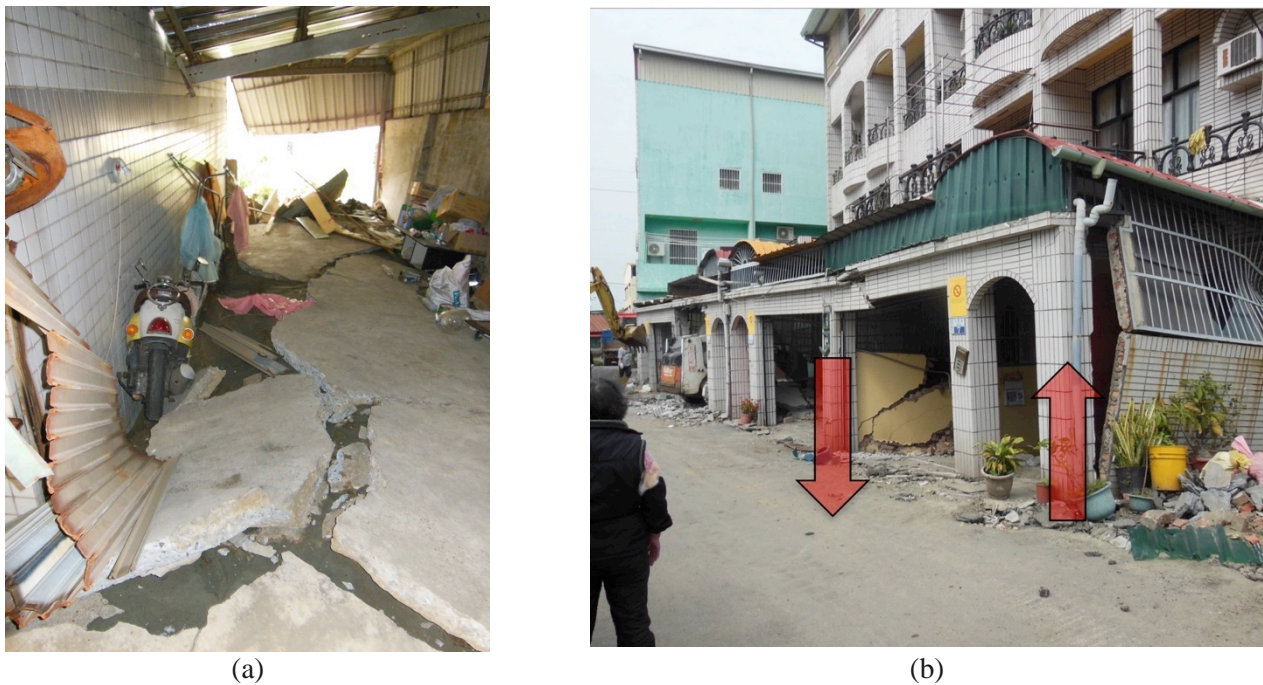
A common theme in this and others regions impacted by liquefaction during this event is that perimeter footings, if continually connected, performed well even though the building experienced significant differential movement as manifest in observations of the surrounding soils and hardscape features. In contrast, unreinforced slabs not

connected to the foundation heaved and suffered complete disconnection in most cases in response to surrounding liquefaction (e.g. Figure 11a). Perimeter footings connected with adequately reinforced grade beams generally performed well, even with structures that experienced significant displacement. In some cases, although the ground heaved excessively, no structural cracks were observed within the interior walls of buildings, if sufficient foundation continuity was offered. In these situations, settlement of the building was fairly uniform, rendering very little to no differential displacement onto the structure. Meanwhile ejected sand was observed along slab edges. In fact, light-weight single story extensions to residential buildings almost exclusively suffered severe damage or complete collapse if surrounding liquefaction occurred and their foundations were not well integrated (tied to) the primary buildings foundation. In this case, ground heave overcomes the isolated footings limited resistance (e.g. Figure 11b). It was also noted that, while just using the strip footing with sufficient continuity may protect the structural integrity, special attention should be given to the location of the mass center relative to the footing center to prevent tilting should liquefaction (especially uneven liquefaction) occur below the foundation.

Fig. 11 – Examples of single story additions, lacking interconnected footings with the primary structure: (a) Annan site and (b) Xinshi site (not the structural hinge mechanism that develops within the single story carport beams due to excessive differential settlement of the isolated column footings; the main multi-story structure in the background remained undamaged, whereas the single-story carport was demolished).

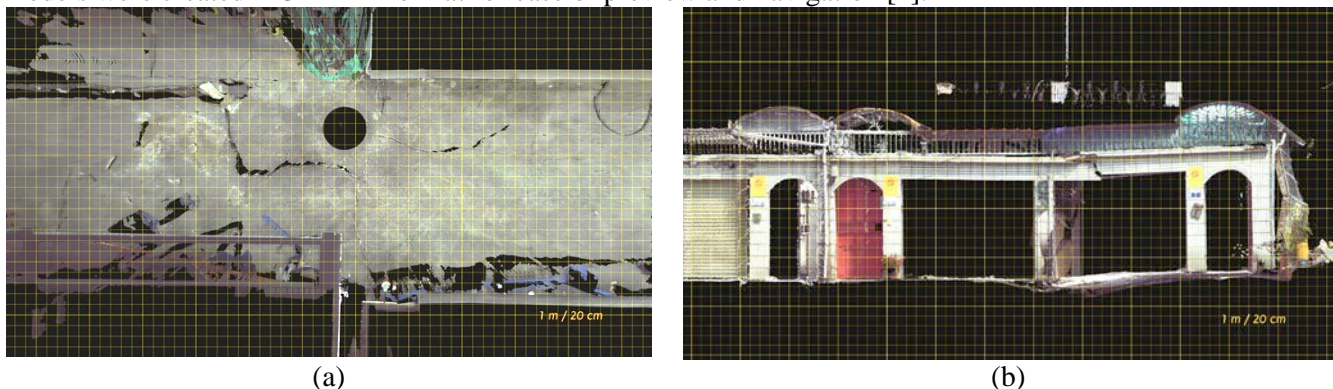
Figure 12. LiDAR orthographic views overlaid with a 20cm grid: (a) top down view articulating the ground surface cracks in between buildings in Annan (view C in Figure 7), and (b) front view of the residential complex at Xinshi (single story region of Figure 11d).
