PERFORMANCE OF COLLAPSE PREVENTION DESIGNED BUILDINGS DURING THE SEPTEMBER 19, 2017 EARTHQUAKE IN MEXICO CITY

A. Tena-Colunga ⁽¹⁾, H. Hernández-Ramírez ⁽²⁾, E. A. Godínez-Domínguez ⁽³⁾, L. E. Pérez-Rocha ⁽⁴⁾,
A. Grande-Vega ⁽⁵⁾, L. A. Urbina-Californias ⁽⁶⁾, O. Villegas-Jiménez ⁽⁷⁾

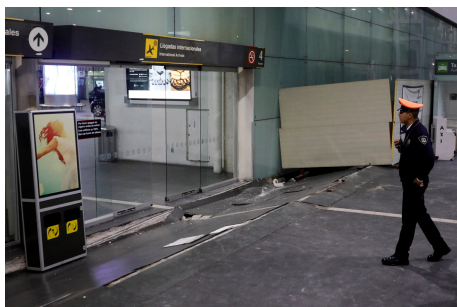
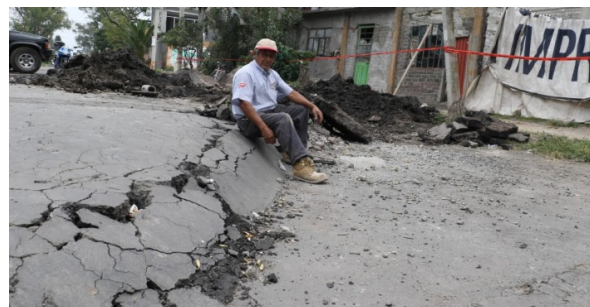
Fig. 4 – Sudden soil settlements and soil tensile cracks occurred at soft soils, in: a) Terminal 2 of Mexico's City International Airport and, b) Colonia del Mar, Tláhuac District

Xochimilco and Chalco. Strong damage was more concentrated and extended in the west part of former Texcoco lake, despite the fact that ground motions were not very intense there (Fig. 3), as a natural consequence that the hearth of the city is there, and there are many buildings, some of them very old. However, very strong damage also occurred in buildings located in soft soils of former Xochimilco lake nearby the connection with the Texcoco lake (Fig. 5a), where the highest strong motions occurred (Fig. 3). The extent was not as large as these buildings are more recent and the building density in that region is considerably smaller than at the traditional central part of the city. Something that was very surprising to Mexican engineers in this event was the important number of damaged and collapse buildings in transition soils, as in previous strong earthquakes this did not happen in such extent. Other hot spots were Tláhuac District (specially Colonia del Mar) and Xochimilco District (primarily the town of San Gregorio Atlapulco), both in the south-east part of Ciudad de México (Fig. 5a), located near former boundary between Xochimilco and Chalco lakes (Fig. 2) where ground motions were also strong (Fig. 3). In these sites, many houses collapsed or were severely damaged and demolished, particularly for the impressive sudden soil settlements and soil tensile cracks that occurred there (Fig. 4b), in part because these soft soils are not consolidated.

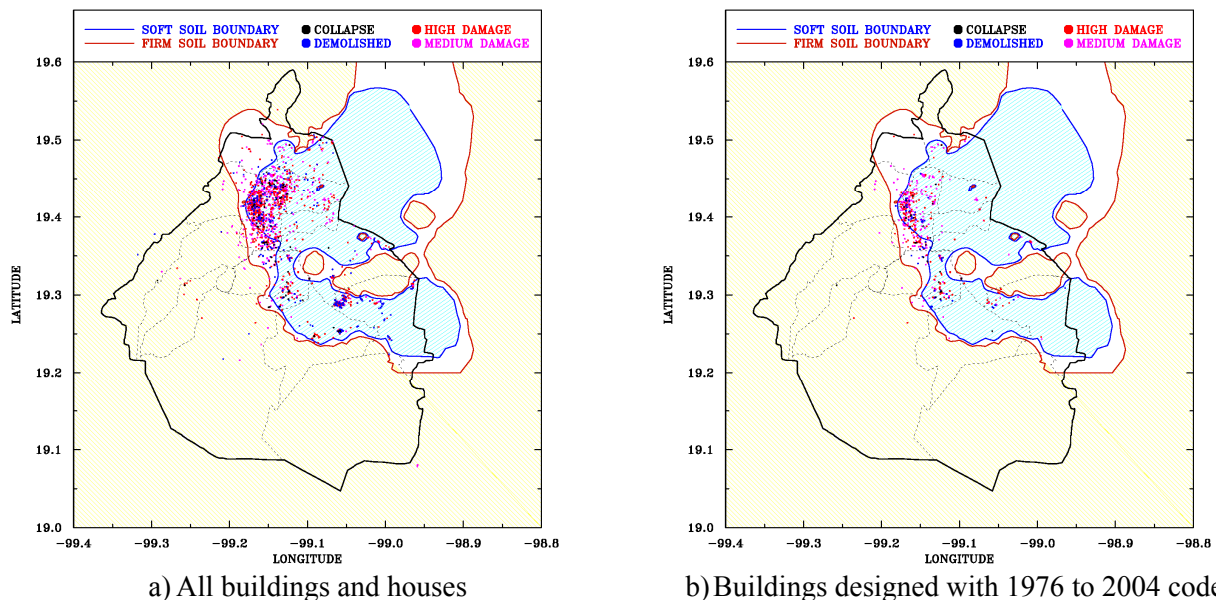
The geographical distribution of the 2,414 buildings and houses are depicted in Fig. 5a, where to improve visibility, a magenta color is used for the medium damage category. As it can be observed in Fig. 5a, most of the experienced strong damage occurred in the soft soils of the former lakes of Texcoco,

Fig. 5 – Geographical distribution of buildings, houses and structures in Mexico City Metropolitan area which experienced moderate to strong damage, partial or total collapse during the September 19, 2017 earthquake, of have been already demolished.

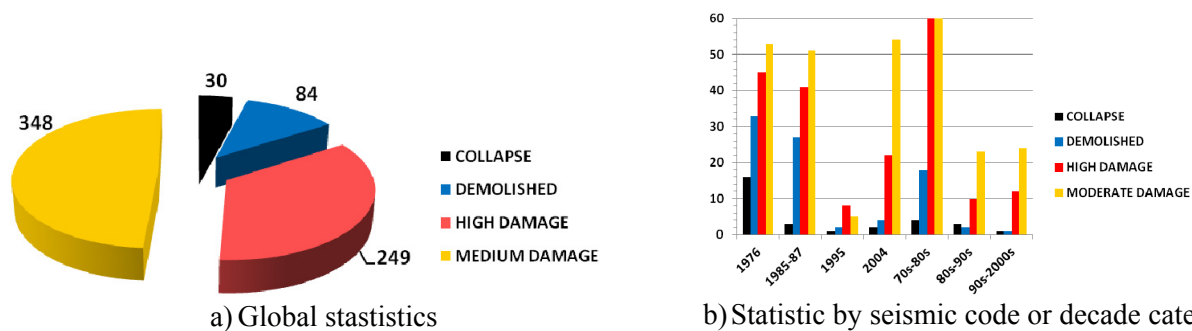
The specific statistics for each collapse-prevention seismic code for the considered damage categories are depicted in Fig. 6b. It is worth noting that in Fig. 6b, the 70s-80s category groups buildings which approximate date of construction was not available yet, but the best estimate from the first author is that they may belong to the 1976 code, with a smaller probability that some of them may belong to other code (1985 or even 1966). A similar explanation can be done for the 80s-90s category (suspected to belong to the 1985-87 code) and 90s-2000s category (suspected to belong to the 1995 code). It can be observed from Fig. 6b that most of the damage was concentrated for the 1976 code category (Figs. 7a-b) and the 70s-80s category, and this should be expected, as spectral ordinates for this building code were not very high and their corresponding the seismic detailing for RC buildings corresponded to intermediate moment frames. Nevertheless, there were an important number of damage buildings for the 1985-87 (Figs. 7c-d) and 80s-90s categories. Finally, it was also very surprising -and frankly disappointing- the large number of damaged buildings which were recently constructed according to the 2004 seismic code (Figs. 7e-f).

Fig. 6 – Damage statistic for buildings in Mexico City designed according to collapse-prevention seismic codes (1976 to date) during the September 19, 2017 earthquake

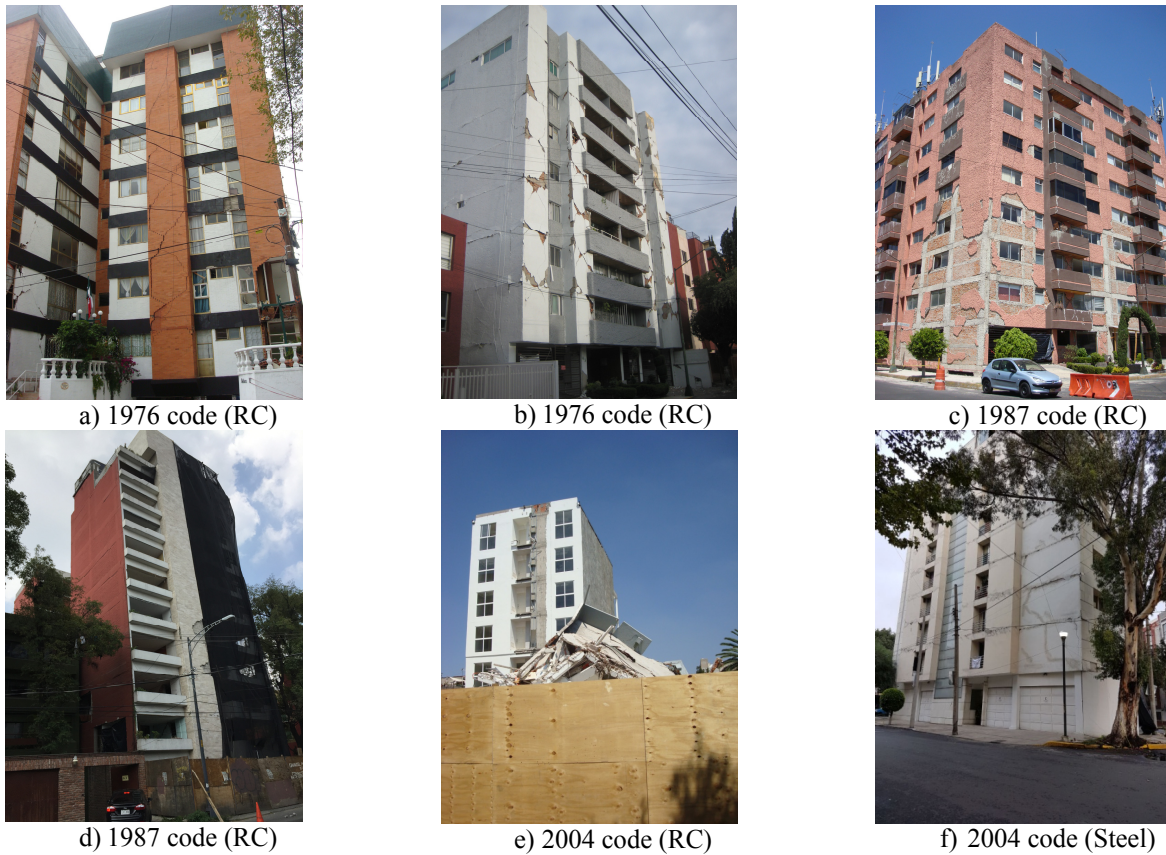
Fig. 7 – Some of the heavily damaged buildings design according to collapse prevention codes. Buildings shown in figures a) to d) have already been demolished. Front building in e) collapsed and the rear one was demolished. Building shown in f) was already retrofitted with concentric steel braces

spectra obtained from stations located there, one can understand right away that severe damage should be expected for buildings built according to the 1987 and 2004 codes (building in Fig. 7c, a 1987 code design, is around that region).

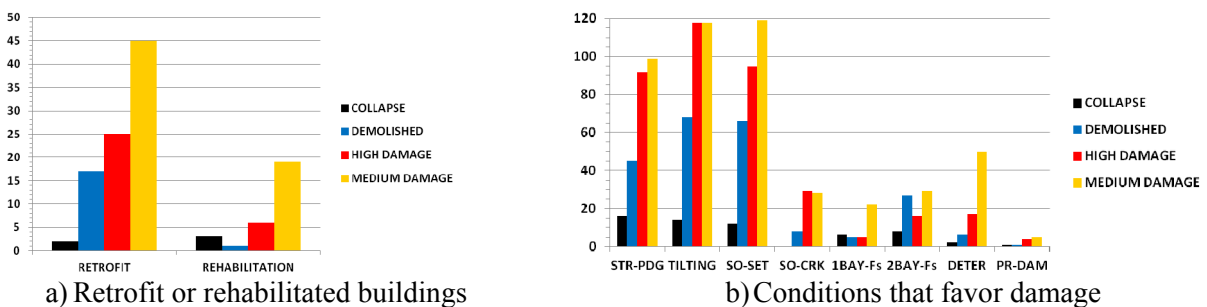
The statistics of some undesirable conditions that favor the damage of buildings during strong earthquakes are shown in Fig. 8b for the 711 building inventory. Of course, in many buildings some of these conditions simultaneously affected their seismic response. As most buildings are founded in soft soils, differential or sudden soil settlements (SO-SET) were observed in 292 buildings (41%) and different levels of tilting were present in 318 buildings (44.7%). A large amount of structural pounding (STR-PDG) of different intensities was observed, affecting 255 of these buildings (35.9%). This problem is directly related

to the fact that in Mexico City building separations according to building codes [6] are not really enforced, and they usually range between 5 cm to 10 cm. In addition, structural pounding is also favored by soil-structure interaction effects in soft soils, particularly due to rocking, as well as previous tilting. Tensile cracks in soft soils (SO-CRK) affected primarily Tláhuac (Fig. 4b), Iztapalapa and Xochimilco Districts, and since there were no many buildings belonging to this category in those zones, they affected 65 of these 711 buildings (9.1%). Aging or deterioration (DETER) because of the lack of an adequate maintenance was observed in 75 buildings (10.6%). Also, 11 buildings (1.6%) had previous damage before the earthquake stroke (shear or soil settlement cracks, corrosion of steel reinforcement, etc.). Finally, 118 buildings (16.6%) had one-bay (1BAY-Fs) or two-bay (2BAY-Fs) frames in one of the resisting orthogonal directions, usually the most damaged one, confirming that weakly redundant buildings in one orthogonal direction are prone to experience important damage.

Fig. 8 – Damage statistic for buildings in Mexico City designed according to collapse-prevention seismic codes (1976 to date) during the September 19, 2017 earthquake

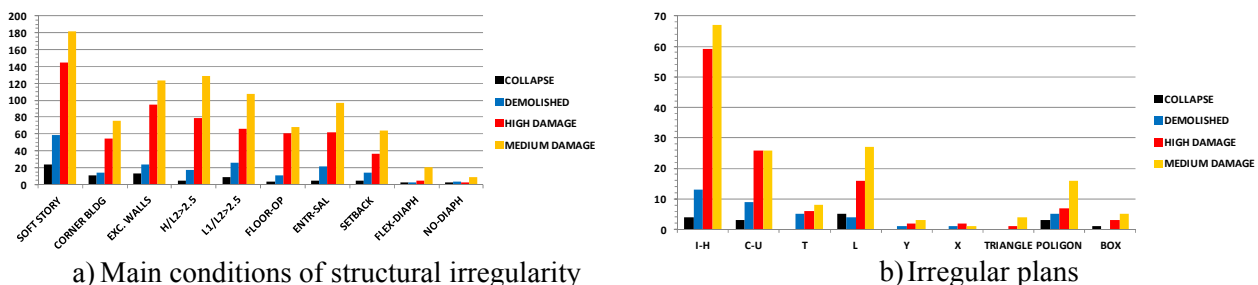
As it can be observed from Fig. 9a, most building had a soft-story configuration (usually the first story), as there were 410 of them (57.7%), although fortunately, not many of them developed a weak-soft story failure, taking aside some of the collapsed and demolished buildings, primarily corresponding to designs according to the 1976 code or 70s-80s category. About 155 corner buildings (21.8%) were found, and most of them indeed favored torsional responses. Additional torsional sources were found in 255 buildings (35.9%) which had eccentric shear or infill walls, primarily because of the location of stairs or elevator cube shafts. There were 230 slender buildings ($H/L_2 > 2.5$), which corresponds to the 32.3%, and 208 buildings (29.3%) with slender rectangular plans ($L_1/L_2 > 2.5$) or a portion of the plan (a web or flange) in case of irregular plans (Fig. 9b). Large openings or multiple openings higher than 20% the plan area were found in 143 buildings (20.1%). Re-entrants and “outback” plans (ENTR-SAL) higher than 20% were found in 184 buildings (25.9%). Setbacks were found in 118 buildings (16.6%), and they were mostly one-story, last story setbacks, where the last story area was at least 50% of the previous one. Flexible diaphragms (FLEX-DIAPH) were mostly counted for buildings that had “modern” RC floors systems with very large Styrofoam blocks; 29 recent buildings (4.1%) had this floor system. Buildings with no diaphragms (NO-DIAPH) were counted when a truss-based roof system was simply supported on walls and, in some instances, in columns; 16 buildings (2.3%) had that roof system, usually factories or retail stores.

Fig. 9 – Damage statistic for buildings in Mexico City designed according to collapse-prevention seismic codes during the September 19, 2017 earthquake with conditions of structural irregularity

It is worth noting that 333 buildings (46.8%) had irregular plans (Fig. 9b). The most common irregular plans in this building category were the I-H shape (143 buildings, 20.1%) and the C-U (64 buildings, 9%), which were typically used in apartment buildings in the middle portion of a street. The L shape was found in 52 buildings (7.3%), mostly corner buildings. T shapes were less common (19 buildings, 2.7%), but many irregular polygonal plans were observed (31 buildings, 4.1%). Finally, triangular, box, Y-shaped and X-shaped plans were less common, but there are buildings with such configurations.

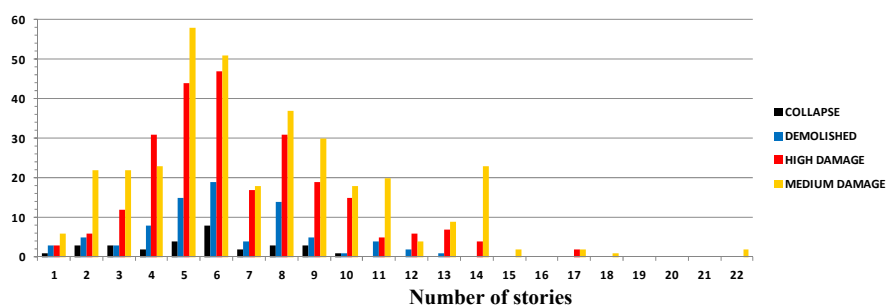
The correlation of damaged buildings with respect to the number of stories is presented in Fig. 10. It is worth noting here that stories were counted since the ground level. Also, when in the last story additional rooms that covered more than 50% the floor area were built by owners, it was counted as a floor and a last-story setbacks (Fig. 9a). As it can be observed, most of the severe damaged buildings ranged from 1 to 14 story buildings, but most of the strong damage was concentrated in buildings between 4 to 9 stories. The most affected buildings had 5, 6 and 8 stories, particularly if one count collapsed and demolished buildings only.

Fig. 10 – Damage statistic for buildings in Mexico City designed according to collapse-prevention seismic codes during the September 19, 2017 earthquake. Correlation with the number of stories.

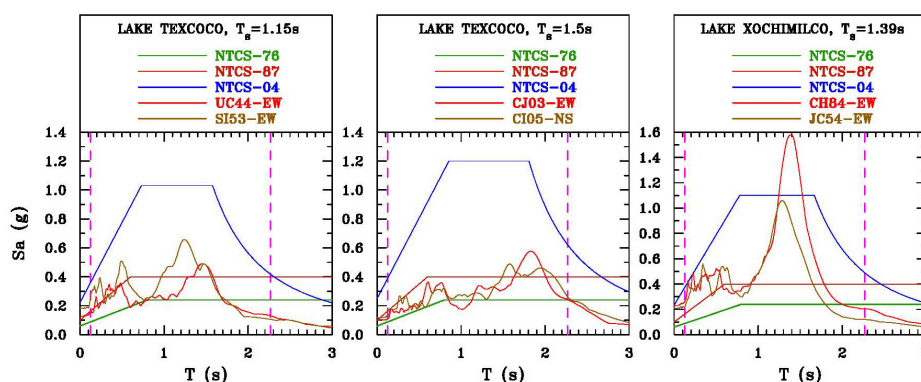
Fig. 11 – Comparison of elastic design spectra for the 1976 to 2004 seismic codes of Mexico City vs elastic response spectra of strong ground motions recorded during the September 19, 2017 earthquake

It can be observed from Fig. 11 that: a) the elastic design spectra for the 1976 code (NTCS-76) was importantly surpassed in most of the period range of interest for all considered sites, and this fact allows one to explain the extent of observed severe damage and collapses associated to this building code (Fig. 6b), b) for the 1987 code, one has to bear in mind that the design spectra (NTCS-87) is a sort of an “equivalent elastic design spectra” already reduced by dividing the real elastic design spectra by a constant overstrength factor $\Omega=2.5$ in the plateau, as explained in detail elsewhere [5]. In fact, if one multiplies the depicted spectra by this 2.5 factor, the plateau reaches $S_a=1g$. Therefore, with this fact in mind, it is clear that the real elastic design spectra for the 1987 code covers by a large margin the elastic design spectra of the strongest ground motions recorded at the sites of interest in Lake Texcoco, and it may be only surpassed at Lake Xochimilco by the strongest record recorded in Culhuacán (CH84-EW) and, c) the elastic design spectra for NTCS-04 code covers by a large margin all the strongest ground motions recorded at Lake Texcoco, but they were highly demanded at Lake Xochimilco, where the CH84-EW record surpassed the plateau in the period range $1.25s \leq T_s \leq 1.52s$. Attending to this information, the question to try to answer is: why are there so many severely damaged buildings in Lake Texcoco zone designed according to the 1987 and 2004 code? It is worth noting that the demolished building shown in Fig. 7d (1987 code) is in Lake Texcoco zone (near to CJ03-EW, Figure 11) and the collapsed building shown in Fig. 7e (2004 code) is also in Lake Texcoco zone (near to SI53-EW, Figure 11). From the elastic design spectra in Lake Xochimilco and the elastic response

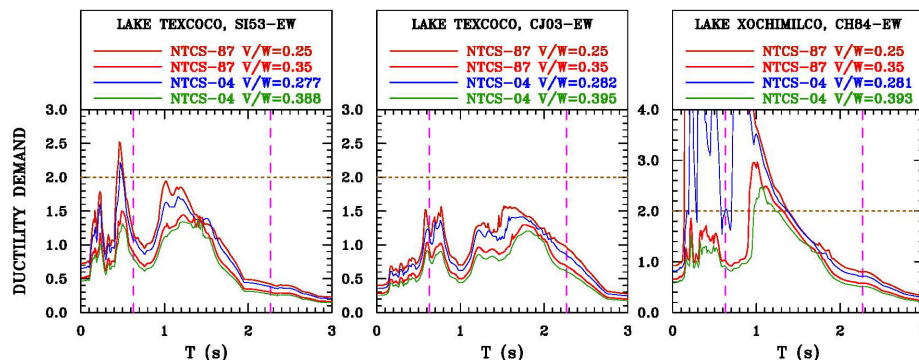
Fig. 12 – Ductility demand spectra for irregular buildings designed according to the 1987 and 2004 seismic codes of Mexico City when considering the strongest ground motions recorded during the September 19, 2017 earthquake in soft soils of former Texcoco and Xochimilco lakes

The resulting ductility demand spectra for the strongest record at each site (SI53-EW, CJ03-EW and CH84-EW for $T_s=1.15s$, $T_s=1.5s$ and $T_s=1.39s$ respectively) when considering these nominal strength and overstrength are depicted in Fig. 12, where the vertical broken lines define the region for 5-story to 18-story buildings and the horizontal broken line depicts the global ductility factor assumed. Attending to nominal strength curves only, it is observed that near SI53 station (San Simón), RC-IMRFs buildings with fundamental periods $1s \leq T \leq 1.4s$ (8 to 11 stories) should experience some moderate to severe damage and RC-IMRFs with periods shorter than $0.6s$ (less than 5-stories) should experience also severe damage. However, when a more realistic, but still conservative assessment of their expected lateral yielding strength is done using an overstrength factor $\Omega=1.4$, peak ductility demands are considerably reduced and only low to moderate damage should be expected. For the zone near CJ03 station (Roma Sur), only moderate damage should be expected for RC-IMRFs for $0.6s \leq T \leq 0.8s$ (5 to 7 stories) and $1.2s \leq T \leq 2.0s$ (9 to 16 stories) when considering nominal strength, and basically no damage or very light damage when considering even a small overstrength $\Omega=1.4$. Therefore, attending to the fact that all structures that are designed according to the code and are well supervised in the construction process develop higher overstrengths, it is somewhat clear using this approximate strategy that the extent of severe damage, collapses and demolitions observed in Lake Texcoco for 1987 code and 2004 code are excessive, given the intensity of the ground motions there. Also, it

is also clear using the ductility demand spectra concept that when a collapse prevention methodology is favored in codes by allowing ductility reductions (some very large) and overstrength reductions for design, one should expect at least moderate damage even if the ground motions yield elastic response spectra less than half of those considered in their design (Fig. 11). The results obtained for the displacement ductility demand spectra for station CH84 (Culhuacán) in particular (Fig. 12), and Lake Xochimilco region in general, just confirms that, in that site, since the elastic demands are close or even surpass the elastic design spectra (Fig. 11), the collapse prevention scenario could be reached by a large inventory of structures, even considering overstrength sources (Fig. 12). Then, the amount of severely damaged, collapsed and demolished buildings in that region (Fig. 4b) is completely justified.
