FIELD OBSERVATIONS IN MEXICO CITY AFTER THE SEPTEMBER 2017 PUEBLA-MORELOS EARTHQUAKE

A. Urich⁽¹⁾

This paper shows the main reconnaissance observations from Mexico City after the September 19th, 2017 Puebla-Morelos Earthquake (7.1 M_w). It presents opinions and photographic illustrations of the seismic culture, the response of society and institutions, and the main factors that affected the structural performance of buildings.

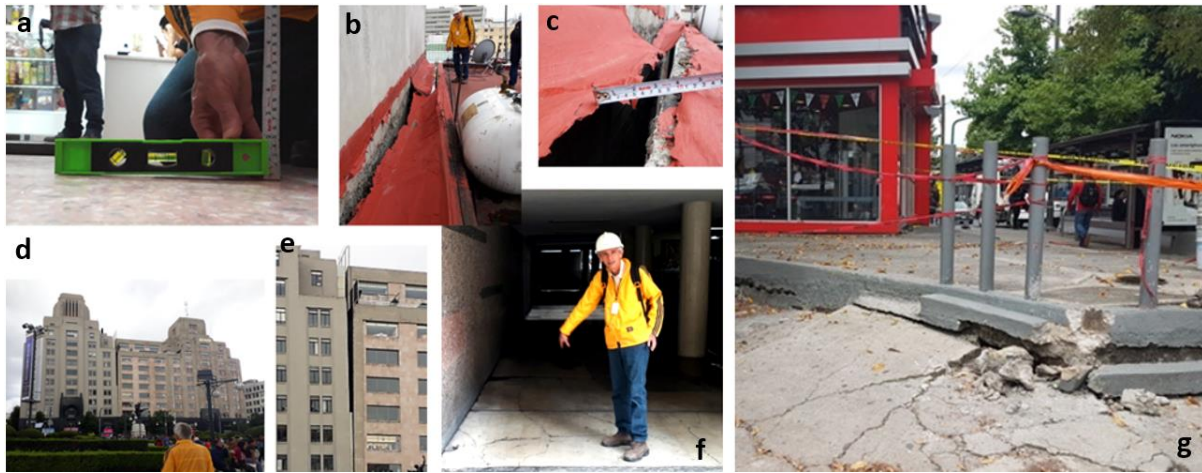
Fig. 4 – Geotechnical and foundation-related damages

Another common concern in Mexico is the failure of foundations. The first building visited caused us alarm because of its leaning (Figs. 4a-c); later on, it was perceived how the Mexican culture coexists with the settlements of foundations and how *Pisa Towers* are spread throughout the city.

Other examples are buildings with recessed doors, where people must go down-stairs to get in; emblematic buildings such as the Sears Tower (Figs. 4d,e), which was already inclined and apparently leaned more during this earthquake. In this last building of two independent structures, the joint cover was observed following the shape of the original inclination. In some of the inspected buildings, cracks on ground reflected the settlement of the structure (Fig. 4f). Sidewalks and pavements were also seen highly damaged (Fig. 4g).

As said before, it is obvious that Mexican engineers and population have a tolerance towards the settlement of foundations much greater than that from people of any other part of the world.

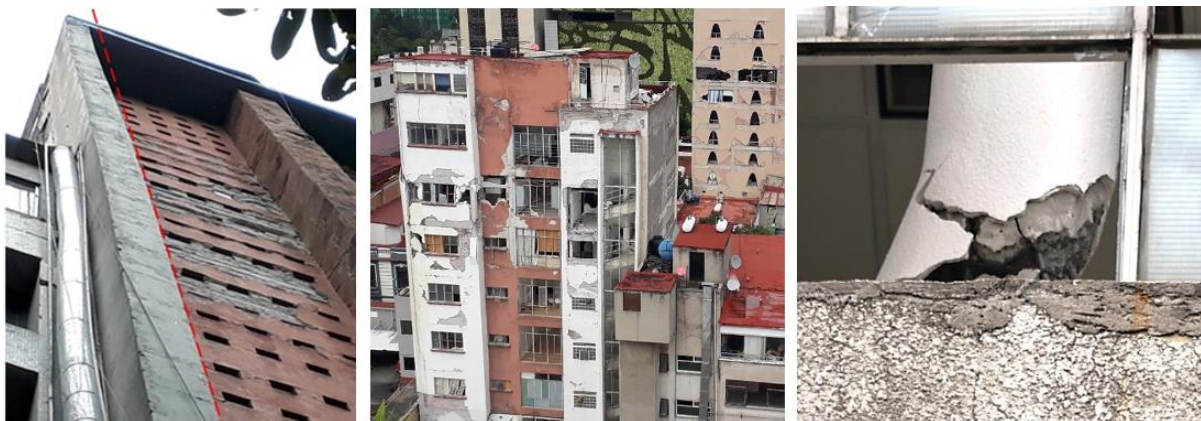
Fig. 5 – Damages due to pounding of adjacent buildings

Another important issue was the pounding between buildings. Fig. 5 shows a med-rise building adjacent to a lower one; this is a critical condition because when they collide, they tend to concentrate a huge deformation demand over this point. The left picture of the figure exposes the residual leaning of the top stories of the building. The middle picture shows the building's extremely damaged rear face. Additionally, a two-story mechanism is observed, evidencing a soft/weak story after the infills and the structural members failed. Finally, the right picture exhibits the failure of one of the columns. Months after, this building was demolished.

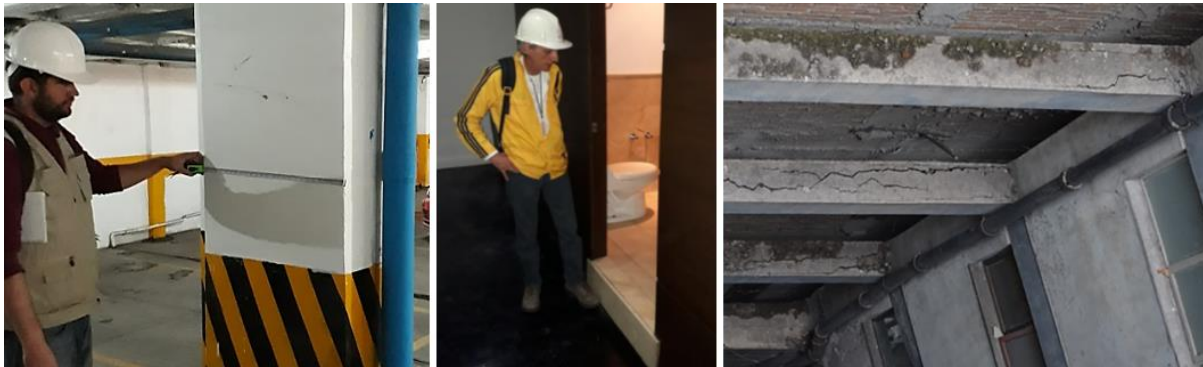
Fig. 6 – Deviations in dimensions; added overweight; corrosion damages

Differences between the on-site dimensions and specified dimensions in drawings; additional stories not considered in the project; thick, heavy flooring added in refurbished apartments; and other deviations from the original project, are examples of irregularities found in the inspected buildings.

There was also noticed corrosion damages in the main structural members of some buildings, caused by constructive deficiencies and lack of maintenance.

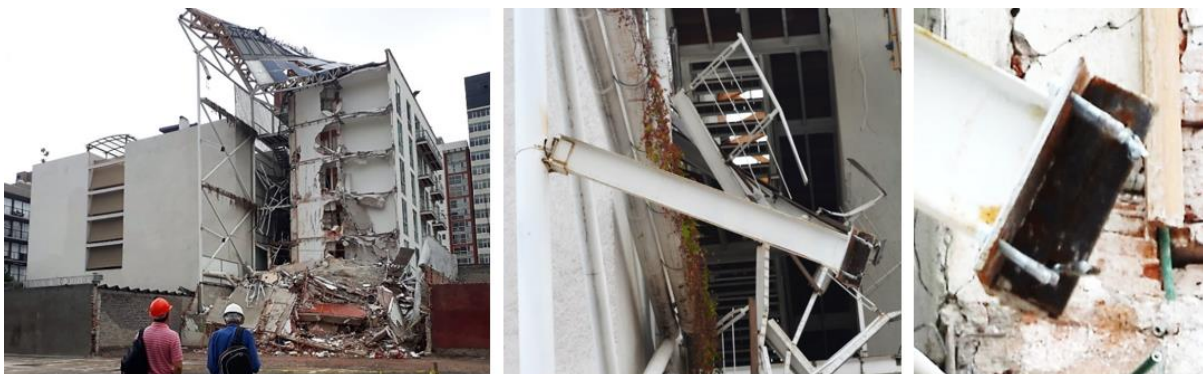
Fig. 7 – Detail of connections in one of the collapsed buildings

The building in Fig. 7 may have had cumulative deficiencies conditioning its collapse. The sections of the structural members of the lateral resisting system look weak, but for the purpose of this paper, it is opportune to emphasize the failure of connections of the steel brace to the rest of the structure. Sometimes, the type of bolts for static or dynamic loads are misunderstood, and even bolts suitable for low stress-high cycle fatigue of machinery are wrongly used for the extreme loads - low cycle fatigue as in earthquakes.

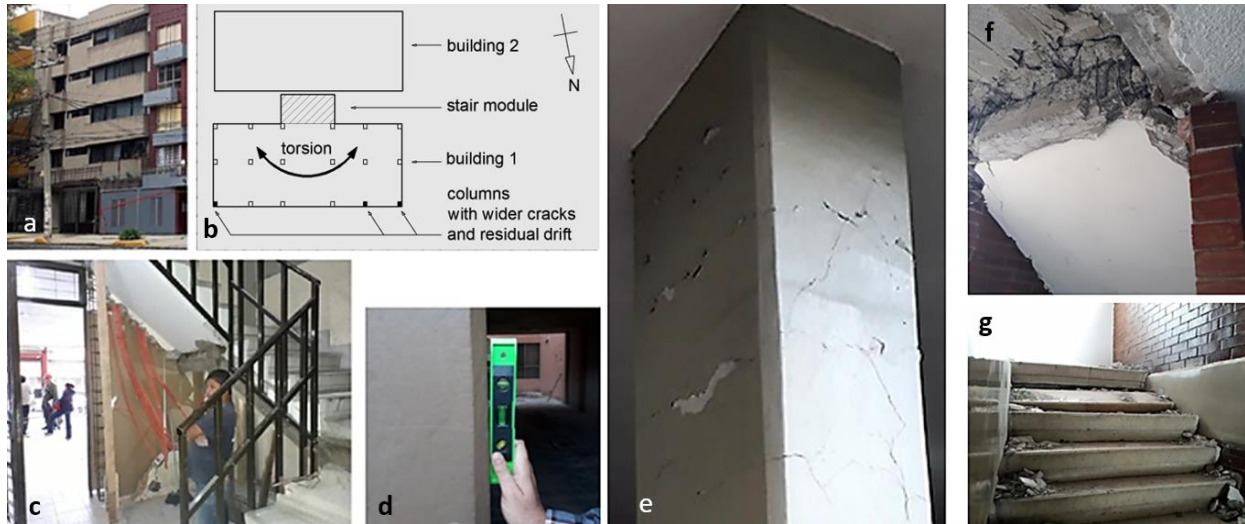
Fig. 8 – Torsion induced by stairs (a to e); extreme damages and obstruction of emergency exit (f, g)

Figs. 8a-e show a building having a very significant torsion due to the presence of an eccentric stair at the south, which induced severe damage to the columns located toward north, away from the center of stiffness

(stairs); it can be noticed the residual drift and the cracks in columns (8d,e). Then, Figs. 8f,g display extreme damage to stairs, which compromised the scape routes of another mid-rise building.

Another concern during the inspections of the affected buildings was the presence of some contractors already making repairs, concentrating on stairs and partitions, but underestimating some structural damages in columns and beams that were detected by our team. One of the locations where this happened was the building shown in Figs. 8a-e above. Our appreciations were reported to the engineers in charge.

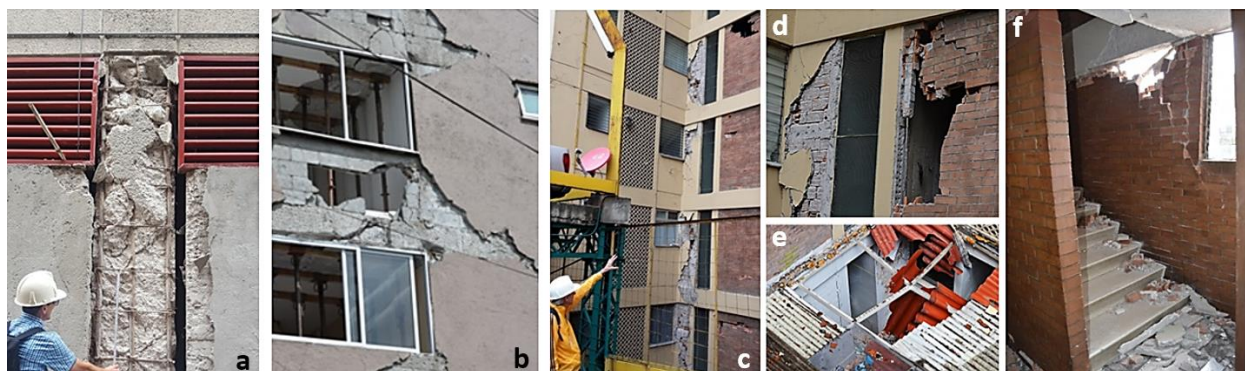
Fig. 9 – Damages related to masonry infills

A repeated cause of collapses was the soft-story due to ground open story, but that was not only seen when evident in the original configuration of the building, but also in upper stories after the masonry walls started to fail, losing their contribution to the stiffness of those stories, which was more likely to occur in cases of pounding between adjacent buildings (Fig. 5 above and Fig. 13 below). The captive column was also determinant in some failures, and also a concentrated damage on beams and slabs as a sort of “captive beams” or “captive slabs” (Figs. 9a,b). Another issue was the widespread damage to masonry walls themselves, even in buildings with no structural damage, showing how the deformation capacity of those stiff – brittle elements is not compatible to the expected drift of a typical moment resisting frame. Figs. 9c-f show an example where the walls fall toward the outer and inner side of the building, compromising the way out and the life-safety performance objective. Finally, adding to section 4.2 above, it is probable that some of the failures of foundations that ended in leaned buildings, were related to the stiffening effect imposed by the infills, which undoubtedly increases the base reactions foreseen in the project.

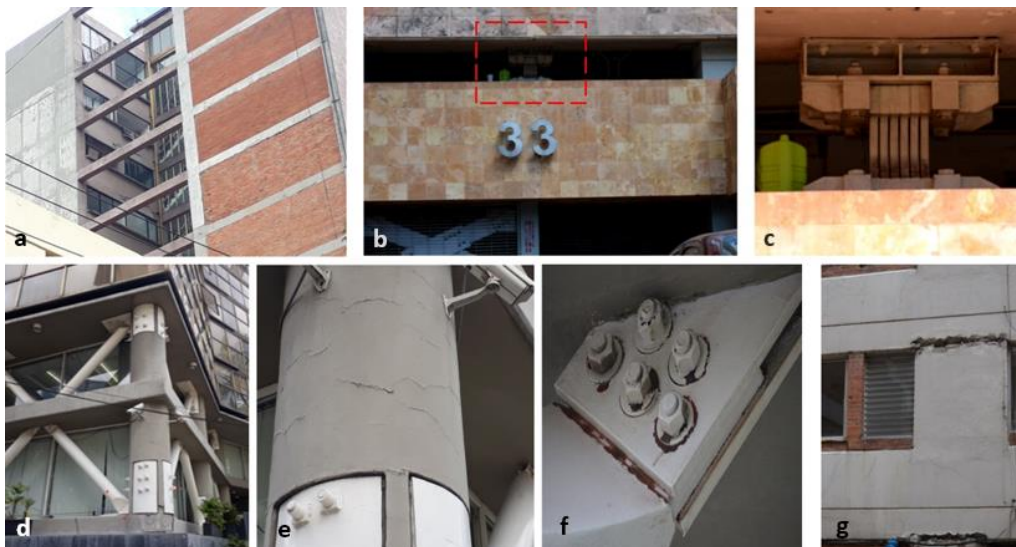
Fig. 11 – Examples of retrofitting techniques and their performance

As Mexico City has suffered various destructive earthquakes, many buildings have been repaired and retrofitted. Fig. 11 exhibits some examples: a) additional beams added to reduce the “H” shape irregularity of the building in plant; b,c) additional damping and stiffness device (ADAS) for energy dissipation; d,e,f) “X” steel braces added to the RC moment resisting frame; g) shear RC walls added to a RC moment resisting frame.

Many of these solutions performed well during the 2017 earthquake, but some inappropriate behaviors were noticed. Figs. 11d-f reveal cracks due to tensile stresses in columns, and the sliding of the connection instead of the nonlinear deformation of the steel braces. Then, Fig. 11g illustrates the failure at joints due to lack of continuity of the longitudinal rebars in the added RC wall.

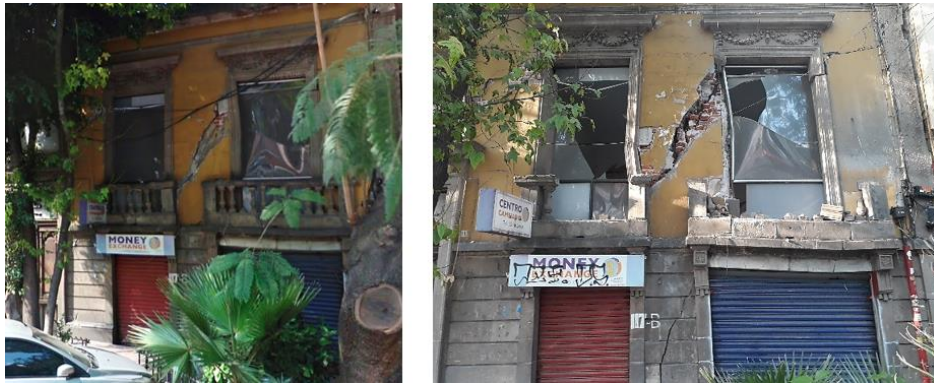
Fig. 12 – Pre-existing damage: Ago. 2014 (left) [4]; after 2017 earthquake (right)

The pre-existing damages made very difficult to obtain a clear diagnosis in many buildings, since many of the visible symptoms were due to the accumulated damage and not lesions originated in this event. This is something to keep in mind, since a damaged structure will always be closer to reaching its collapse limit state. Fig. 12 shows a before and after picture of a building where pre-existing damages might have been underestimated, resulting in insufficient repair or strengthening.

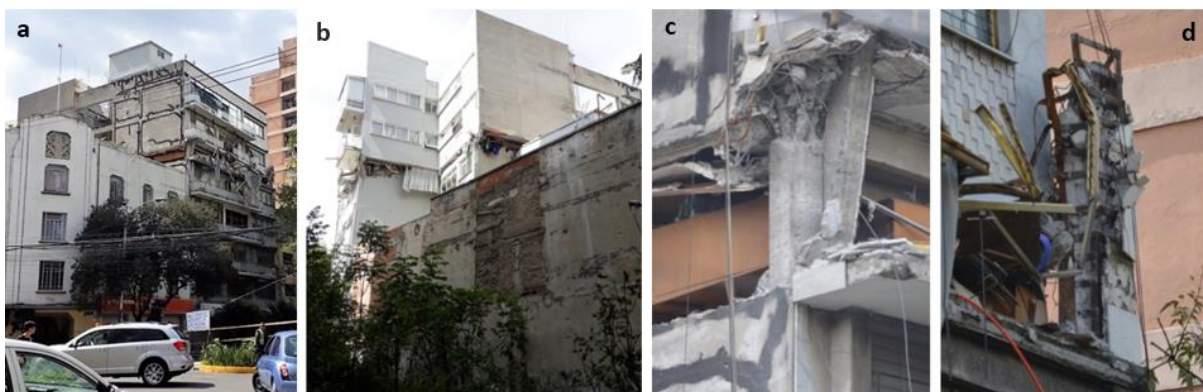
Fig. 13 – Collapse of a building due to the overlap of multiple factors

Fig. 13 displays a collapsed building in Roma district, where soil profile is the same as that of most collapses, showing the relevance of the site effects. The main cause of this collapse might have been the pounding to the adjacent building. It was also noticed a strong torsional trend induced by the "H" shape with wide open areas in plan, a central stiff stair module, and the irregular distribution of the “nonstructural” masonry walls, which were complete height at rear facades and partial height (windows) on facades towards the street (Figs. 13a,b). The collapse mechanism was in a soft and weak upper story, once the structure and the masonry walls failed after hitting the adjacent building.

The furthest column from the stiffness center (Fig. 13d) had a confining strengthening of steel shapes (probably a repair of damages by previous earthquakes). This reinforcement stiffened the body of the column and concentrated tensions at the ends (joints), where the collapse sequence probably begun (column coincides with the corner of maximum displacements due to torsion in plan). If it is confirmed that the reinforcement of this column was in response to damages from previous earthquakes, it alerts about the importance of retrofitting the whole building, balancing the stiffness, strength and ductility, and solving the core causes of damages, instead of being limited to the repair of only the damaged elements.

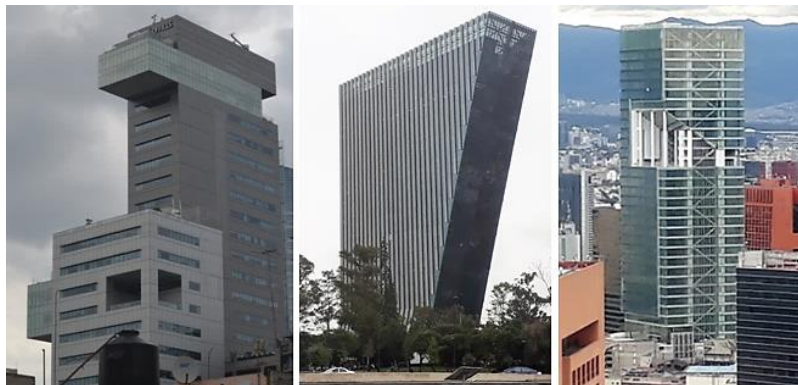
Fig. 14 – Typical high-rise buildings in Mexico City

It is worth mentioning that Mexico has various high-rise buildings with pretty interesting architecture which might be controversial. Fig. 14 shows some of them having irregularities that would be in any “not to do” list in earthquake prone areas. It must be noted that no news about some of these buildings having damages was heard. These emblematic structures are always in hands of highly qualified firms and it is expected an up-to-date – well-detailed project, regardless the evident irregularities that for sure were taken into account. For some low to middle-rise buildings it might be seen the other side of the coin, as some promoters pressure for a cheap-fast project, which might mean accepting less qualified professionals.

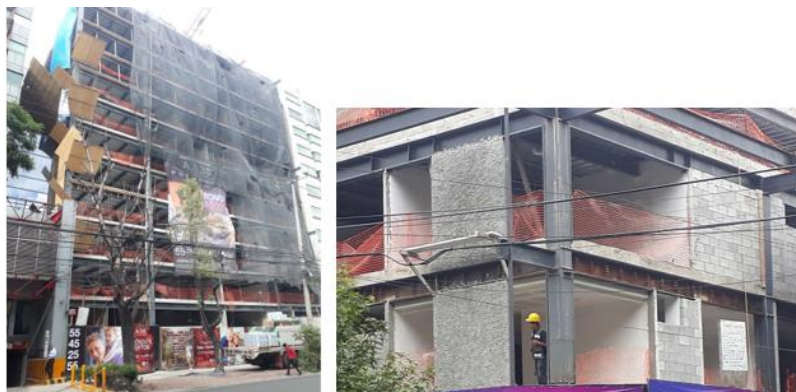
Fig. 15 – Buildings under construction – Left: too close to the adjacent buildings
Right: with infills neither properly insulated nor connected to the structure

Two middle-rise buildings under construction are shown in Fig. 15. The one at the left looks too close to the adjacent buildings, which might conduce to pounding. The one at the right exhibits the masonry infills without the properly insulation from the main structure, and without evidence of having been considered as part of the structural system. These configurations are widely referred as vulnerable, and may induce damages as those described in sections 4.3 and 4.7 above.

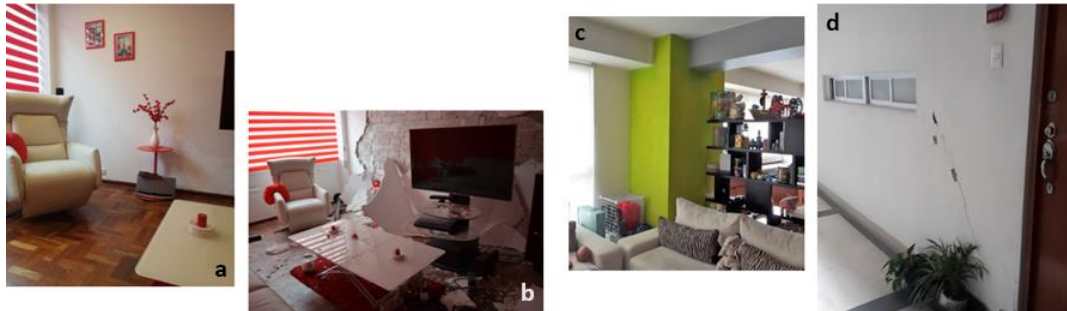
Fig. 16 – Damage to “non-structural” masonry walls. What should be acceptable

before the earthquake, which can be compared to the condition after (Figs. 16a,b). In another building, some people were moving out after seeing minor cracks in “non-structural” masonry walls; even though the building had been inspected by different engineers agreeing in the opinion that cracks didn’t represent any issue for its safety. Figs. 16c,d show the sound condition of a robust columns and beams in this building; then, the minor cracks in walls, which caused panic to residents to the point of making them to move out.

The precedent paragraph leads to think about the current criteria in many codes, which still focus on life safety and collapse prevention limit states, but pay less attention to the acceptable damages, especially those related to non-structural components and content. Both examples presented in Fig. 16 might have, by far, exceeded the performance objectives for the intensity of this earthquake, but still that is something too difficult to understand and accept by the owners and residents of those buildings. It would be appropriate to review the levels of damage that codes accept today, both for new constructions and for repairs or retrofits.
