## CHIMNEY AND MOBILE HOME PERFORMANCE IN RECENT U.S. EARTHQUAKES

### Abstract

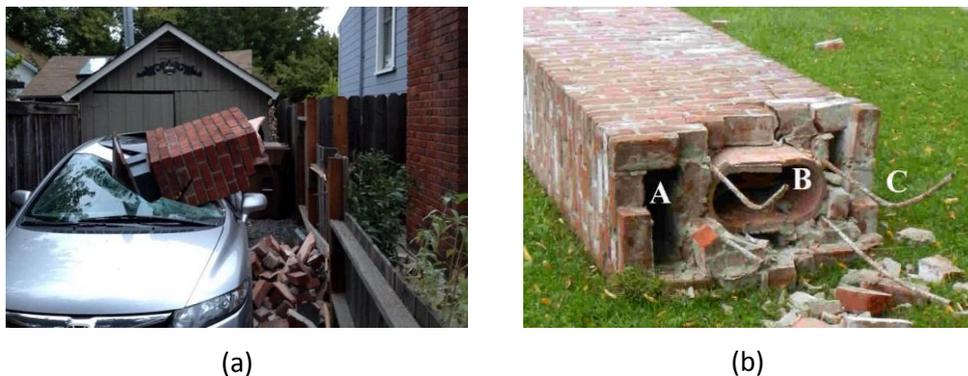
Fig. 1 – Example of collapsed chimneys from the 2014 South Napa California earthquake [3]. (a) Collapse of upper portion of chimney. (b) Features of failed reinforced masonry chimney. Hollow cavity at A and clay tile flue at B. Bent rebar at C that pulled out apparently due to insufficient bond strength.

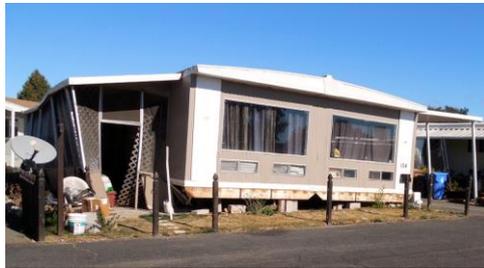
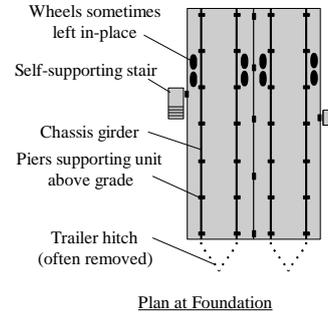
2 shows a double-wide mobile home consisting of two units that fell off the supports. In this case, the mobile home was situated on piers consisting of stacked concrete masonry units, and lacked tie-downs.

Fig. 2 – Example of double-wide mobile home after the 2014 South Napa California earthquake [4]. (a) Mobile home toppled off its supports and fell to the left. (b) Support system underneath home having piers consisting of stacked concrete masonry units and lacking tie-downs.

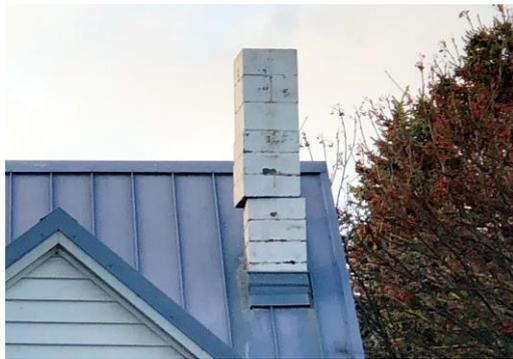
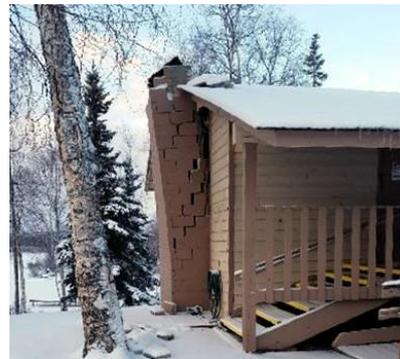
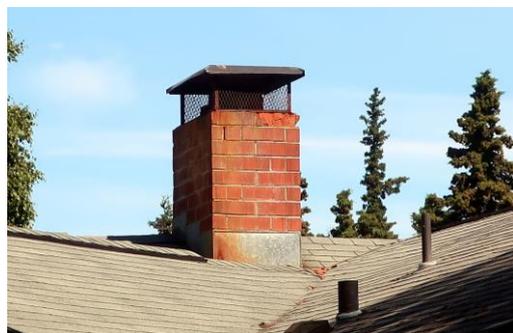
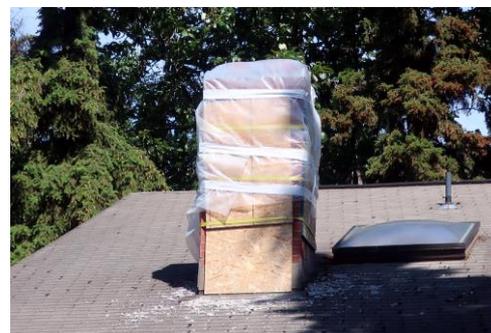
The authors performed on-site reconnaissance in June 2019 including discussions with Anchorage officials and contractors familiar with Anchorage earthquake damage and recovery efforts. Damage to very few masonry chimneys was apparent (Figure 5). This was confirmed by review of the Anchorage building department damage survey database.

Fig. 5 – Examples of masonry chimney damage by the 2018 Anchorage earthquake. (a) Incipient collapse of the portion above CMU mortar joint (Jessica Feenstra). (b) collapse of upper portion of CMU chimney (Janise Rodgers). (c) Short chimney having minor brick spalling from earthquake. Brick flakes visible in roof valley. (d) Chimney damaged by earthquake and covered by particle boards and plastic wrap. Owner indicated masonry was reinforced with rebar. Chimney apparently not considered a falling hazard since repairs yet to be enacted. Photos (a) and (b) taken shortly after quake; and (c) and (d) taken in June 2019.

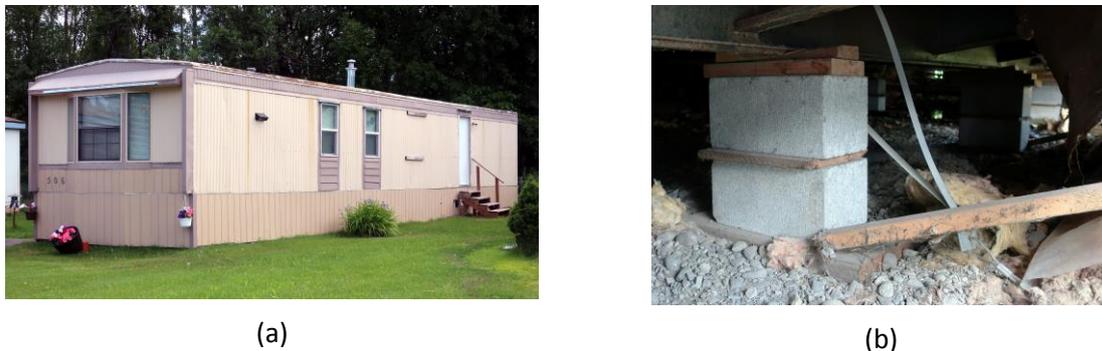
Fig. 7 – Typical Anchorage mobile home. (a) Exterior view. (b) View of support systems consisting of Stacked concrete masonry units (at left) and tie-down system consisting of a steel strap placed around chassis girder and connected to soil anchor by steel cable (at center). Inclined wood 2x4 struts brace the lower portion of home perimeter skirt (at right).

It should be noted that tie-down systems in the 1970s dealt with wind forces that are greatest in the home transverse direction because of the large longitudinal vertical area. Accordingly, tie-downs were required only in the transverse direction. Lateral support in the longitudinal direction was provided by friction between the mobile home, piers and foundation. Moreover, slack provided in the tie-down system to accommodate seasonal freeze-thaw movements could inhibit the effectiveness of the tie-downs to mitigate damaging lateral movements of the home. Hence, it is an open question how effective the observed tie-downs (Figure 7b) might be in mitigating toppling under higher intensity shaking.

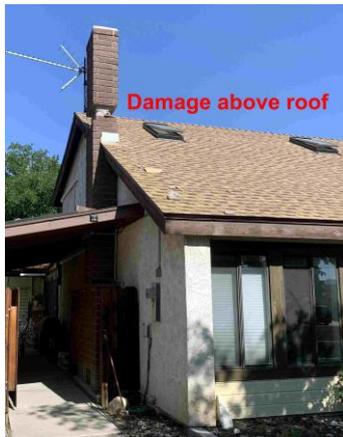
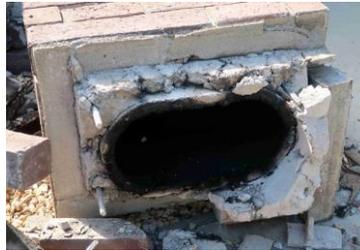
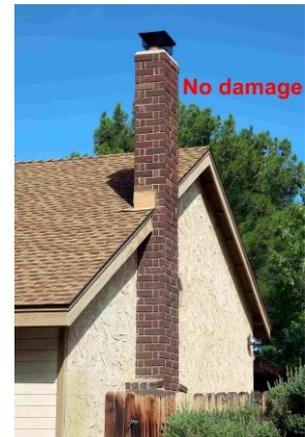
No damage was observed to metal chimneys like the type in Figure 10a, and relatively few masonry chimneys were found to be damaged. A key factor contributing to damage appears to be deficient construction as illustrated by the following examples. Figure 11a shows a damaged chimney in a neighborhood having numerous tract homes built circa 1982. The chimney had the building code-required four vertical rebar, but the grout had voids thereby poor bonding to the bricks allowing them to fall away (Figure 11b). The neighboring homes were ostensibly the same (Figure 11c), yet suffered no damage suggesting that faulty construction played a role in the damaged chimney. Figure 12 shows more Ridgecrest damaged masonry chimneys exhibiting deficient construction. The grout had voids and no rebar was observed at places where the bricks fell away. Figure 13 shows a different type of damage where a masonry chimney pulled away from the home likely from deficient anchoring (strapping) of the chimney to the house floors and roof.

Fig. 11 – Damage to reinforced masonry chimney on Ridgecrest tract home. (a) Chimney damage at roof elevation. (b) Photo taken after chimney demolition showing poor grouting at location where bricks fell away. (c) Similar neighboring home having no chimney damage.

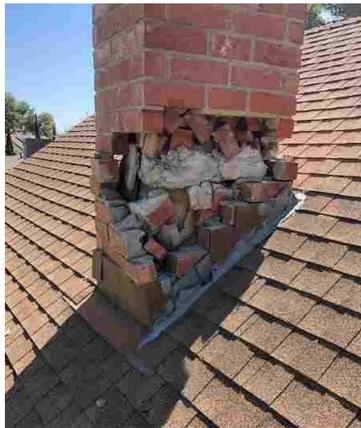
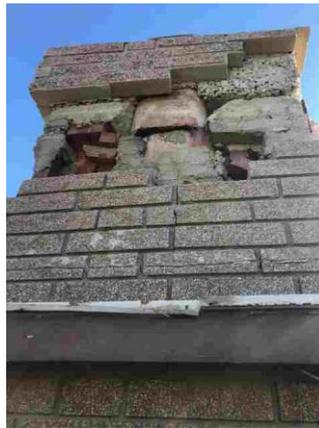
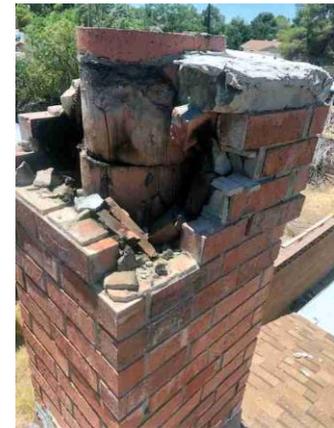
Fig. 12 – Examples of deficient masonry construction observed in damaged Ridgecrest chimneys.

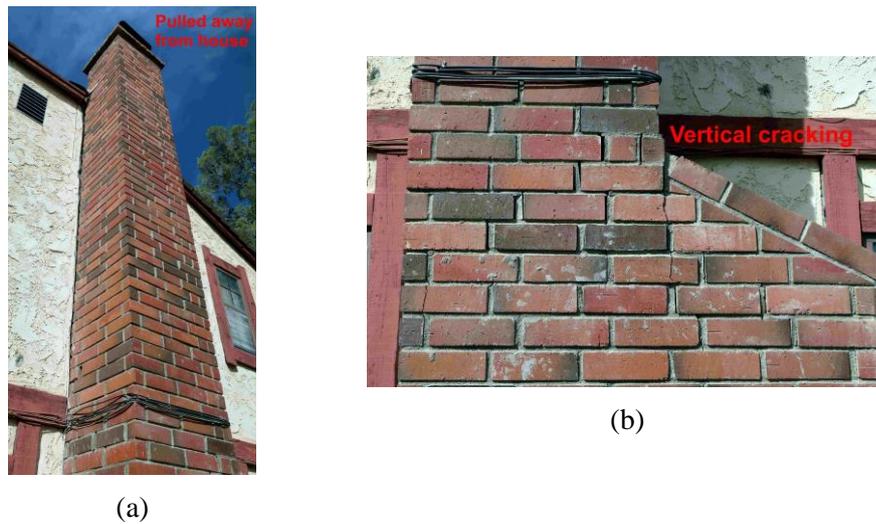
Fig. 13 – Example of Ridgecrest masonry chimney that pulled away from home likely from deficient anchoring to home at floor and roof levels.

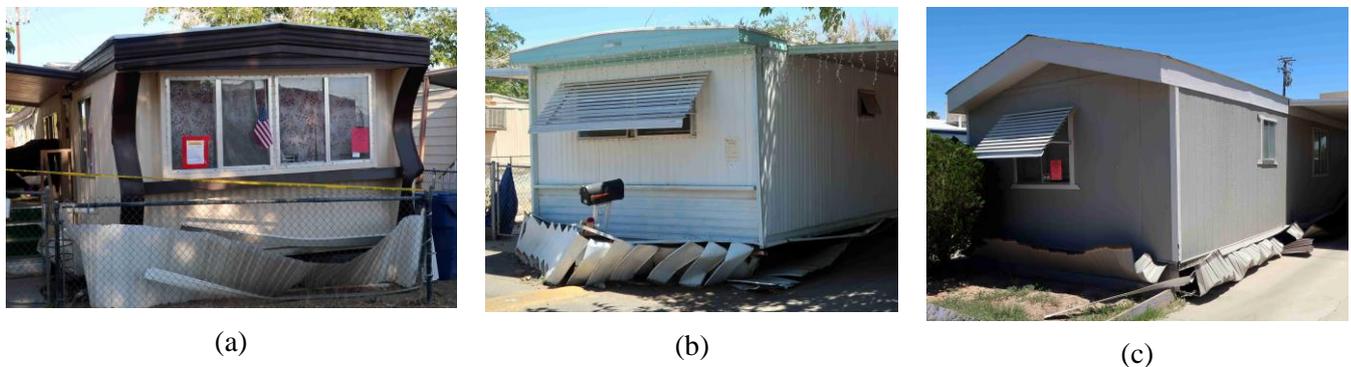
About 50 mobile homes were observed to have significantly shifted on their supports or fell to the ground representing about 8% of the mobile homes surveyed. One mobile home park notably had about 30% of its mobile homes damage while the other parks had less than 15% damaged. There was a trend of damage in the older parks with the most heavily damaged one dating to 1964. Examples of damaged mobile homes are shown in Figure 12. Notice how the mobile homes shifted off their supports and fell like rigid blocks. The mobile home unit itself had relatively modest damage and could be re-installed and occupied in each of these cases.

Fig. 14 – Examples of damaged mobile homes in Ridgecrest.

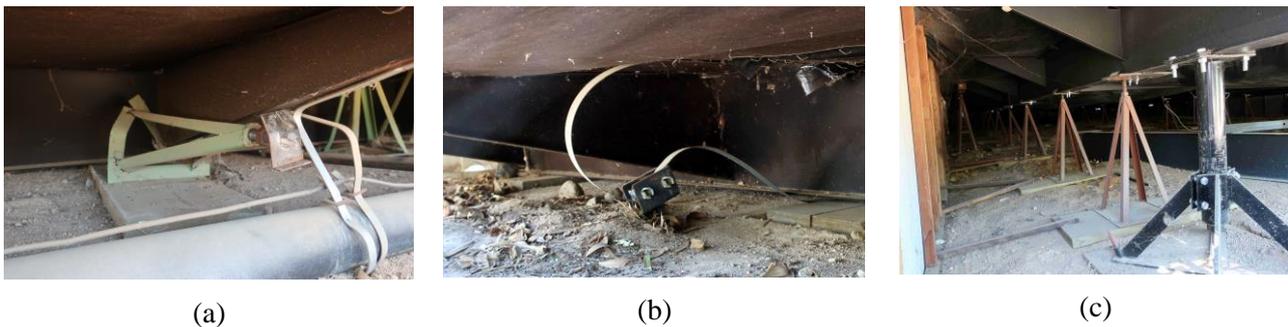
Figure 15 shows support types observed underneath mobile homes. Steel piers were very common, and in this case, the mobile home had fallen and crushed the pier (Figure 15a). The mobile home chassis

girder initially sat on the L-shaped bracket shown at the top of the pier. It lacked a positive (bolted or welded) connection to the chassis girder so the mobile home slid off the pier at relatively small displacements. Most of the observed damaged mobile homes used this type of steel pier and also lacked tie-downs. However, several mobile homes having tie-downs were also damaged, and Figure 15b shows a tie-down after collapse of a mobile home. The mobile home slipped off the steel piers at small displacements before the straps became taut thereby making them ineffective in providing lateral restraint. Figure 15c shows the support system under a mobile home installed circa 1987 that suffered no damage. Lateral restraint was provided by a steel stanchion system bolted to the chassis girder and connected to the ground with embedded steel rods. The steel piers were also bolted to the chassis girder thereby preventing its sliding off. These systems are very rugged and no damage was observed to homes having them.

Fig. 15 – Mobile home support systems. (a) Steel pier crushed by falling of mobile home. The chassis girder lies on the ground (at rear). (b) Tie-down system under a collapsed home. Steel strap connected to a ground anchor (at center) and wraps around the mobile home chassis girder now lying on ground (to the right). The girder slipped off the steel piers like those shown in (a). (c) Modern support system under a mobile home installed circa 1987. A steel stanchions system is shown at right and steel piers in background. Notice the bolted connections at the chassis girder.
