## SEISMIC DAMAGE AT THE STATE OF MORELOS (MEXICO) DUE TO SEPTEMBER 19/2017 EARTHQUAKE

H. I. Archundia-Aranda<sup>(1)</sup>

### **Abstract**

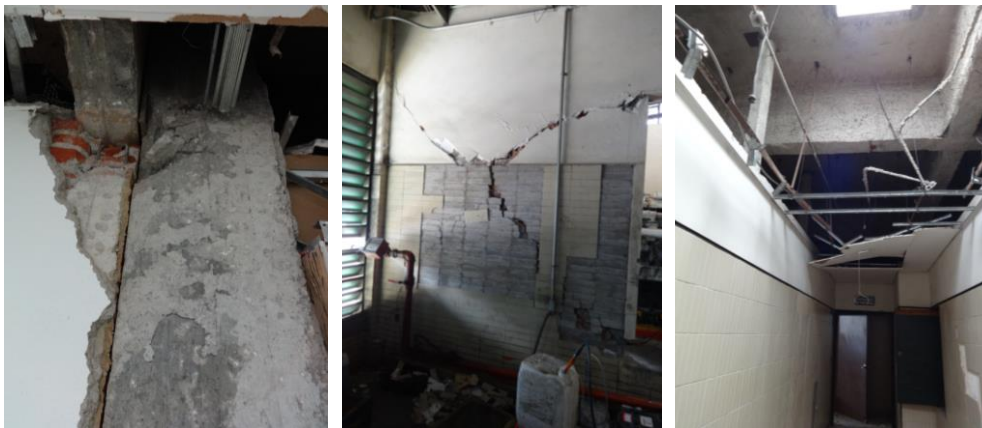
The observed damage in Morelos due to S/19/2017/E was very important in practically the whole Morelos (epicentral zone, Fig. 4). According to official sources [7] the deaths counted were 74, houses with total damage were around 7,400 and other 16,500 presented some kind of structural damage. Around of 1,300 schools (84% from the total) were damaged (36 collapsed), and 7,000 economic units were affected (factories, markets, stores, particular service offices, etc.). Some hospitals, ordinary electrical substations, hydraulic infrastructure and bridges also presented seismic damages that left them totally or partially inoperative. For example, the major public regional hospital in Cuautla, the second city in importance in Morelos (own population of 200,000 inhabitants but 400,000 inhabitants as metropolitan area), was closed two years because of slight to moderate structural damage and moderate to severe nonstructural damage in components and equipment (Fig. 5). In the same way, Cuautla was left without electric energy around 12 hours after of S/19/2017/E because of the shutdown of the electrical substation located at the downtown [8]. Finally, a bridge located on the shortcut between Tlaltizapan and Tlaquiltenango (at the southwest) was closed three weeks due to slight structural and nonstructural damage in the road pavement and abutments (Fig. 6).

Fig. 5 – Typical structural and nonstructural damage due to S/19/2017/E in the IMSS Zonal General Hospital No. 7 at Cuautla, Morelos

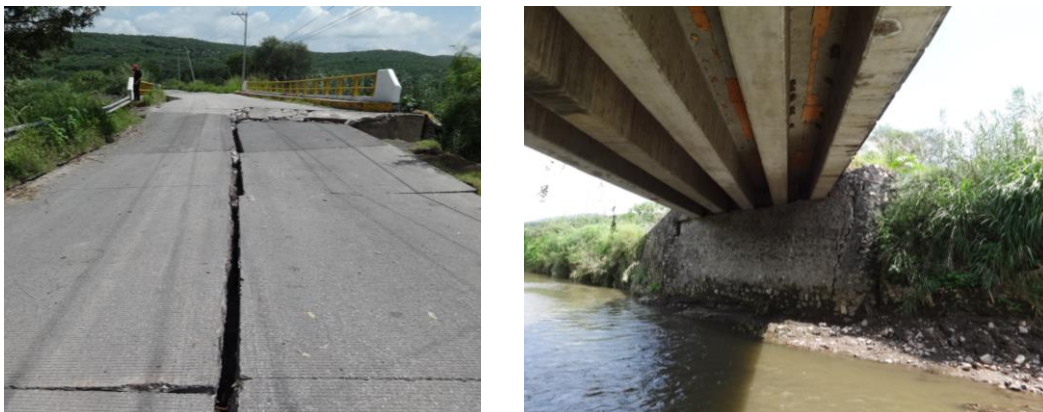
Fig. 6 – Typical structural and nonstructural damage due to S/19/2017/E in a bridge on the shortcut between Tlaltizapan and Tlaquiltenango, Morelos

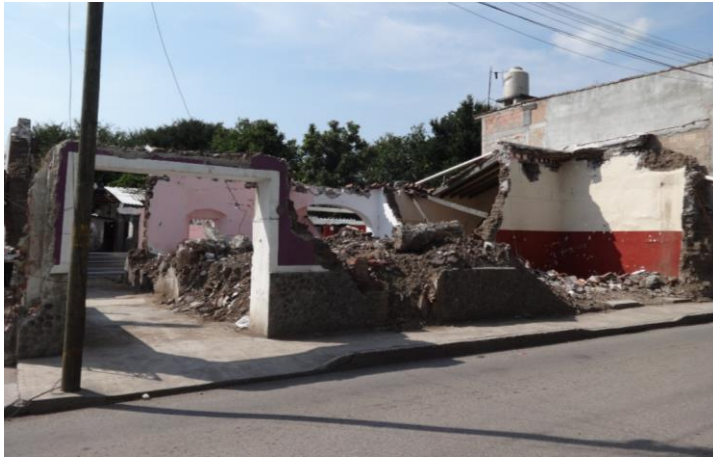
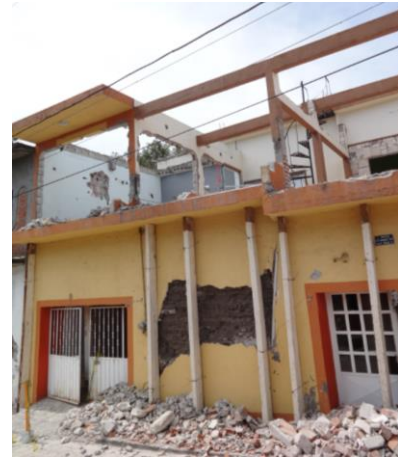
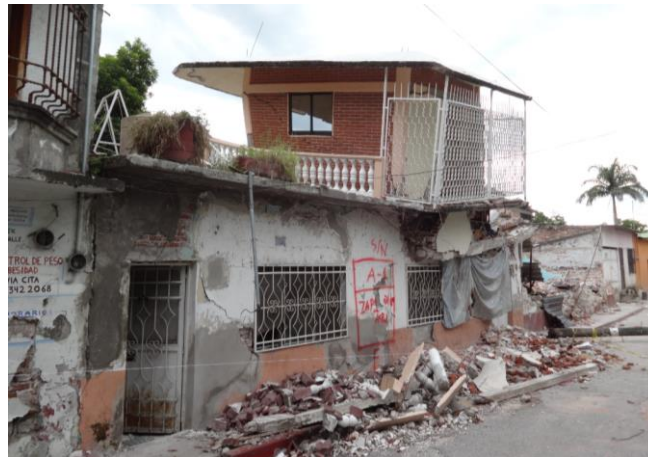
Fig. 9 – Typical failures in housing with poor quality: a) adobe (Jonacatepec, east region), b) adobe in first level and concrete/masonry in second level (Jantetelco, east region) and, c) unreinforced masonry (Jojutla, south region)

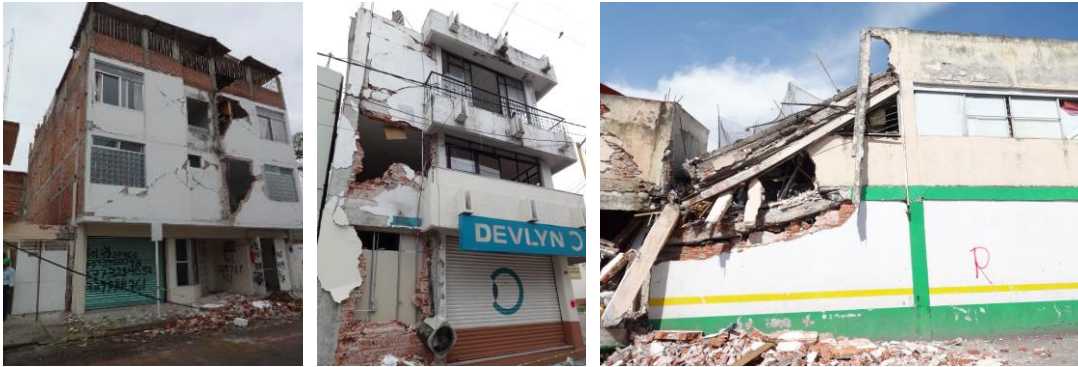
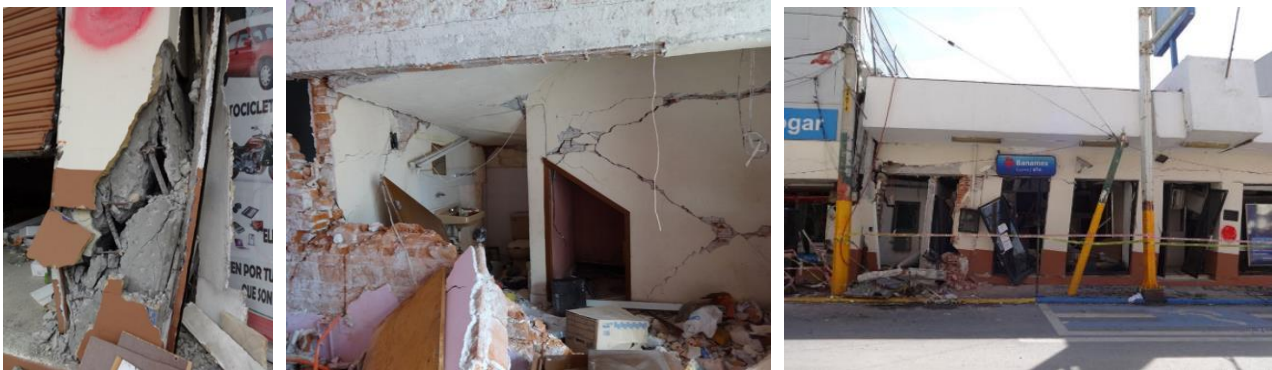
a) commercial buildings

In Fig. 14 is presented the typical seismic damage in Jojutla due to S/19/2017/E. Massive damage was observed at downtown in commercial buildings of one to four levels. It is worth noting that, as a rule, in this failures an absent or deficient seismic detailed was observed in columns, beams and structural walls. In the same way very deficient building materials was detected (concrete and masonry). Some blocks of downtown in the commercial zone was demolded due to the extensive damage. In the other hand, it was observed that some houses with architectural project collapsed (in the majority of the registered cases an architect was on charge of the structural project). Finally, self-construction housing of unconfined/unreinforced masonry was massively damaged, so much that a big block was complete demolded (to 400 meter of downtown).

Fig. 14 – Typical seismic damage in Jojutla, Morelos, due to S/19/2017/E

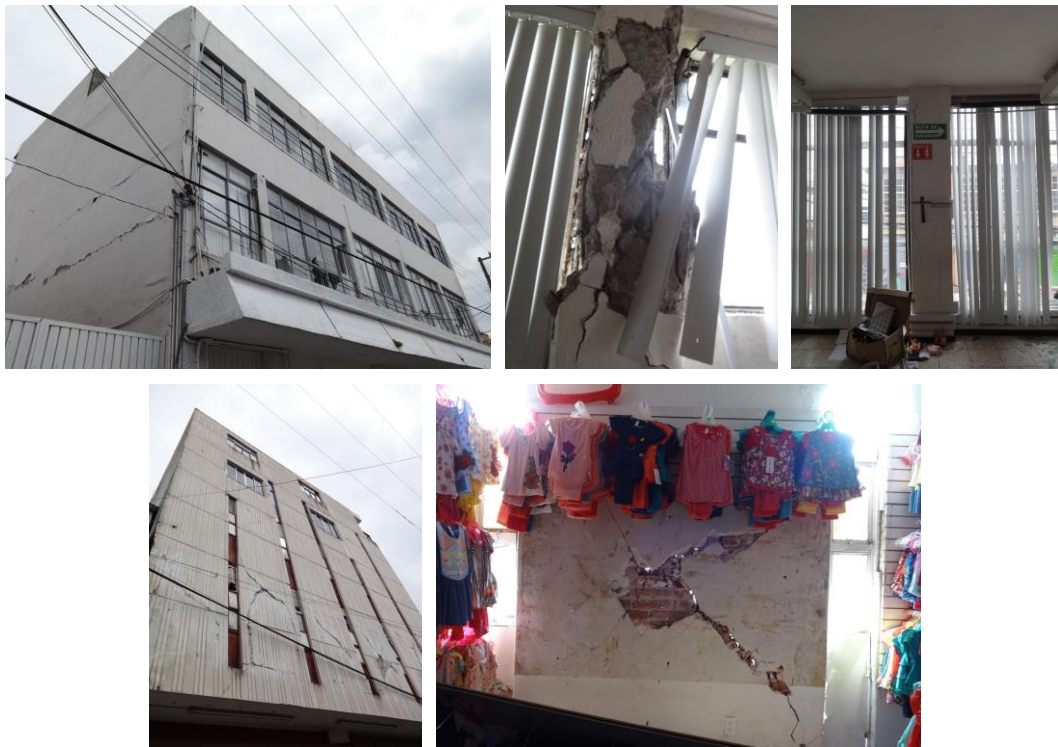
a) commercial buildings

In Fig. 15 is presented the typical seismic damaged observed in Cuautla. In general, the damage has the same typology observed in Jojutla, but not so concentrated, neither so strong. As particular case, in Cuautla was observed a big unit housing (80 buildings of three or four levels) with moderate damaged (but six buildings already demolded due to severe damaged). This unit housing had to be designed to resist strong seismic motions; nevertheless, preliminary analyses suggest that the area of walls in one direction was insufficient to resist the S/19/2017/E and the seismic forces recommended in the year of its design/construction (about 1995) [13].

Fig. 15 – Typical seismic damage in Cuautla, Morelos, due to S/19/2017/E
