Response of school buildings after the September 2017 earthquakes in Mexico

S.M. Alcocer⁽¹⁾, D. Murià⁽²⁾, L. Fernández⁽³⁾, M. Ordaz⁽⁴⁾ J. Arce⁽⁵⁾

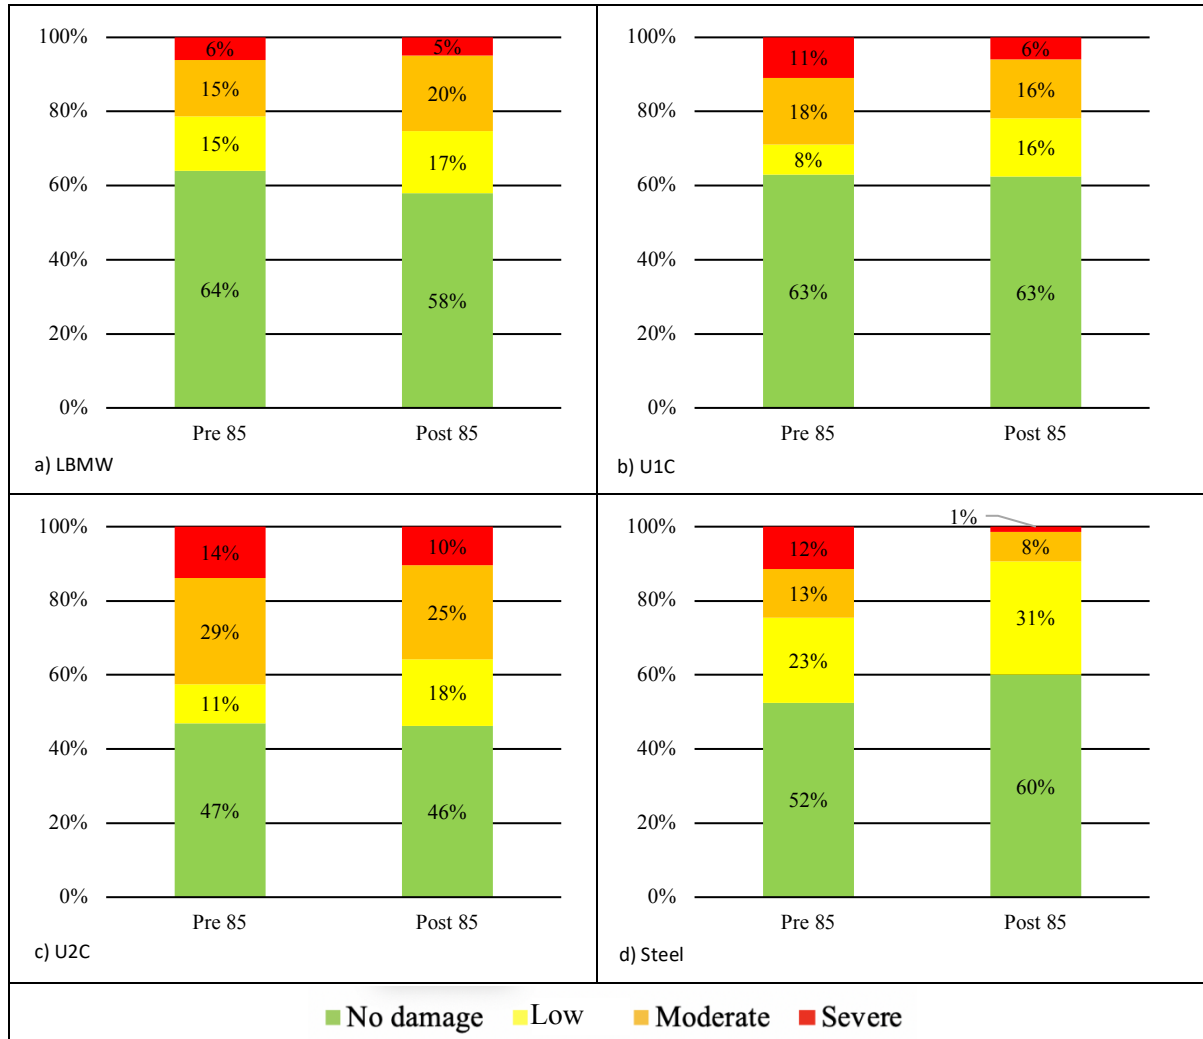
Age of construction is a key parameter for assessing a school structural vulnerability. A comparison of damage level in pre-1985 and post-1985 buildings is presented in Fig. 2. In the case of Mexico, the 1985 Mexico City earthquake represents a point of inflection in earthquake resistant design of structures. In the aftermath of this event, seismic design coefficients were augmented; also, detailing aimed at achieving ductile

behavior was implemented [6]. For concrete structures, detailing requirements after 1985 followed the ACI 318-83 [7]. In the case of the 2017 earthquakes, two-thirds of structures in the database were built before 1985. For masonry structures (all with one story), little difference was found in damaged schools built before or after 1985. Conversely, damage frequency and intensity in reinforced concrete (RC) and steel structures was consistently less in buildings built after 1985.

Fig. 2 - Comparison of damage level in pre-1985 and post-1985 prototypes [4]: a) LBMW, b) U1C, c) U2C and d) Steel

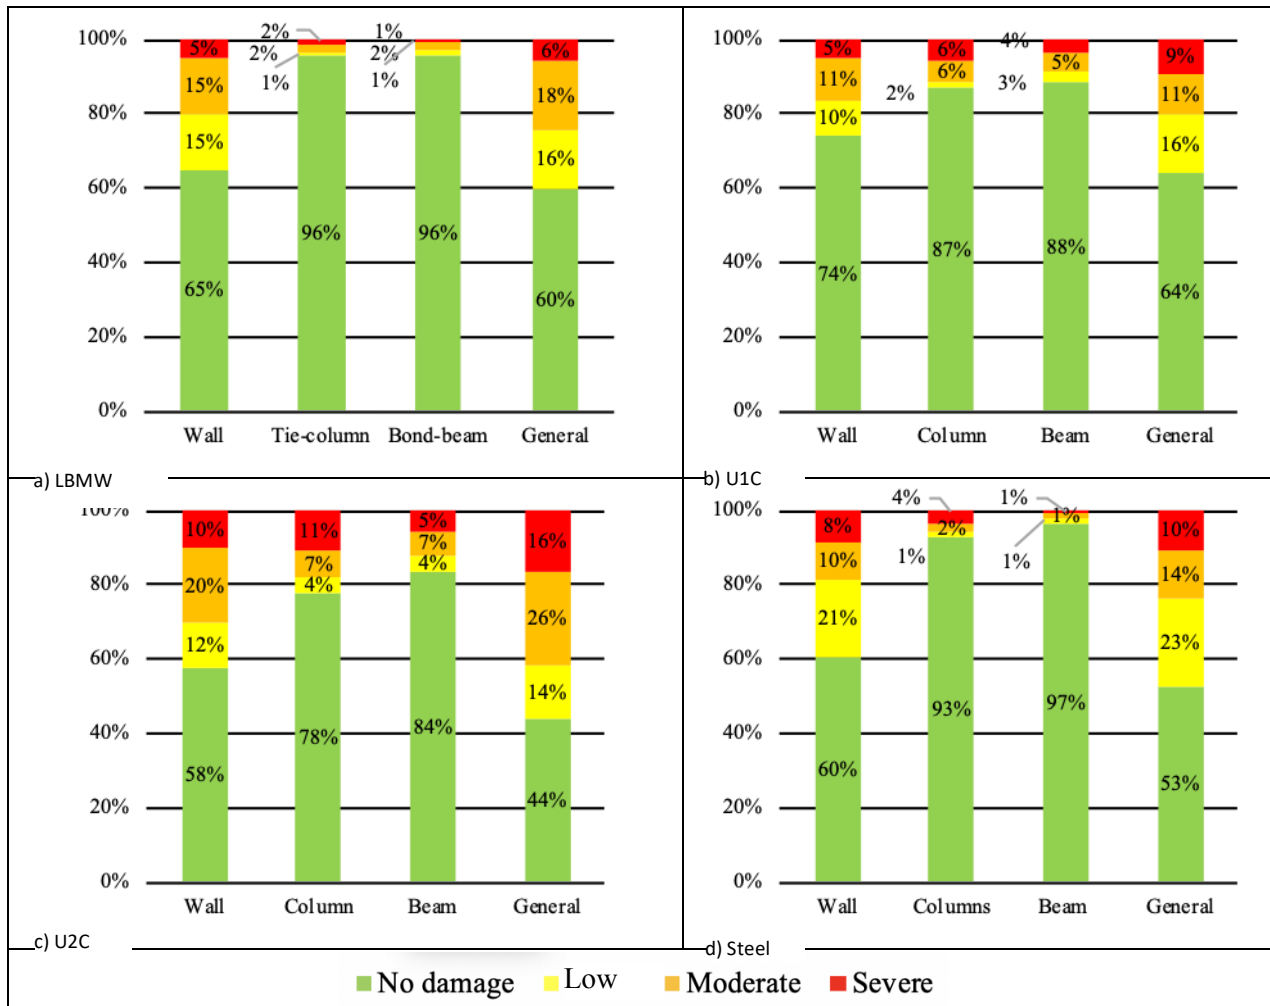
Damage distribution of prototype buildings is shown in Fig. 3. Minor damage was exhibited in 75% of buildings in the database. Damage was concentrated in load-bearing walls in masonry structures, and infill walls in RC and steel frame structures. Only 13% and 4% of damaged masonry structures experienced light and severe distress in walls, respectively. Typical damage in masonry walls were inclined cracking and, in few cases, flexural cracking in buttress walls. Post-1985 LBMW prototypes included external buttress walls aimed at increasing lateral shear strength, thus without reducing the available space in classrooms.

Fig. 3 - Damage level distribution in each prototype [4]: a) LBMW, b) U1C, c) U2C and d) Steel

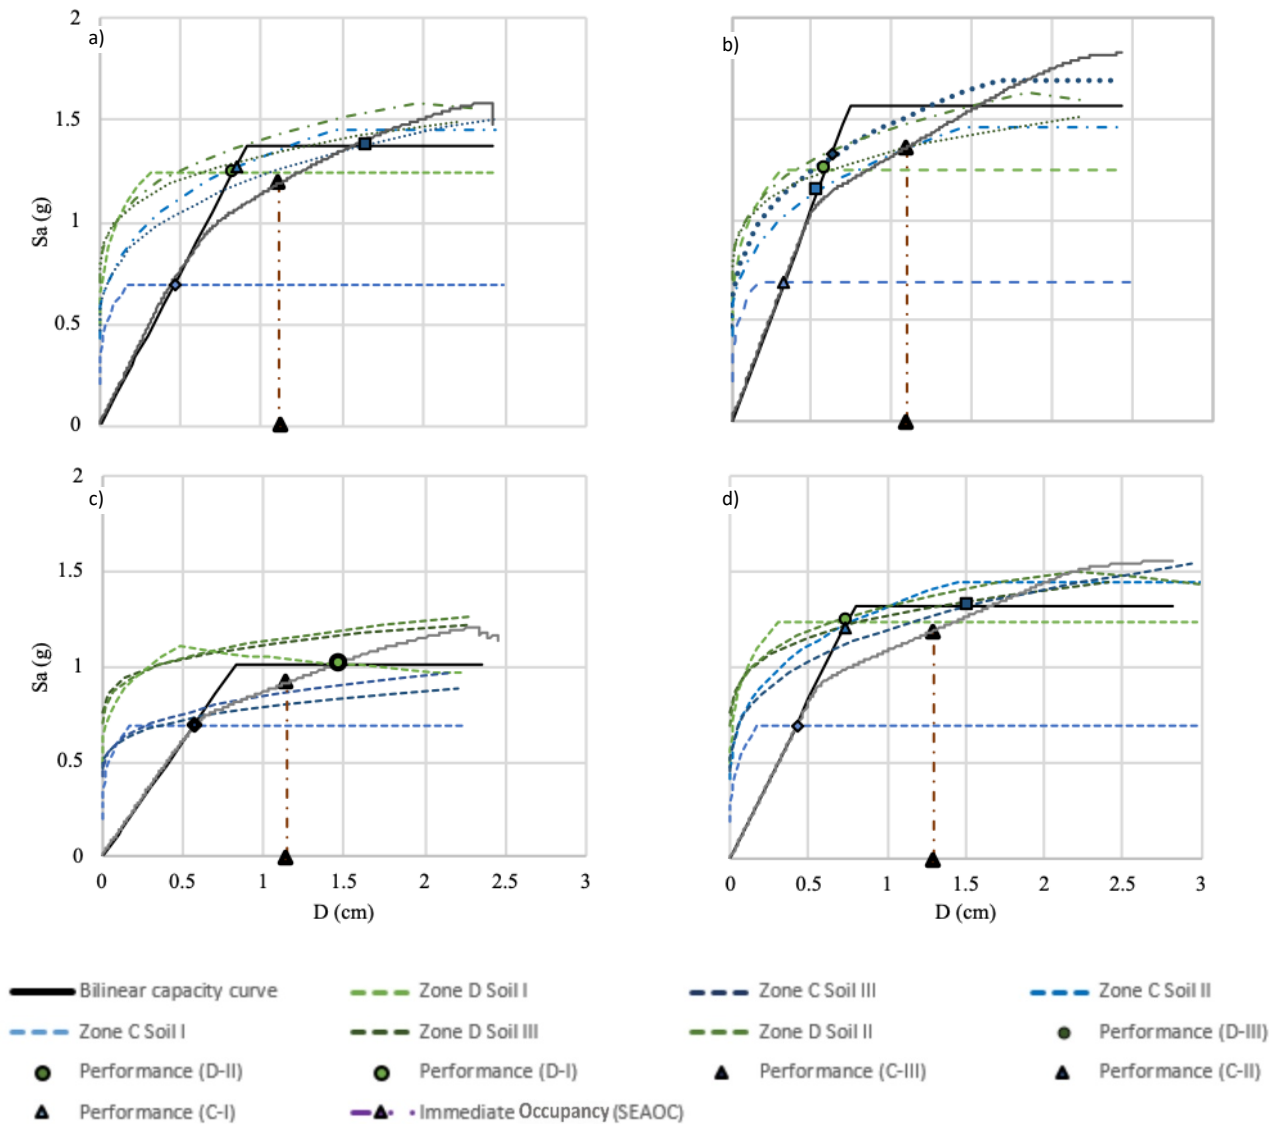
Comparison of calculated capacity curves and capacity design spectra for one-story masonry index buildings EI1 and EI4 is shown in Fig. 6. Index buildings EI1 and EI4 correspond to one-story LBMW structures with one and four classrooms, respectively. Performance points were defined where the capacity design spectrum intersected the capacity curve. If performance point was located in the elastic branch of the capacity curve, the elastic design spectrum was used. If performance point was located in the plastic branch of the capacity curve, then the design spectra modified to account for inelastic behavior was used. In some cases, the performance point could not be defined as no intersection of the capacity and design spectrum curves was noted in the range studied. These cases indicate a high probability of severe damage and loss of structure's stability.

Nonlinear static analyses indicate that, for masonry index structures, buildings located in type I soils are likely to attain IO (see Fig. 6). In all other cases, more damage is to be expected. Schools in Zone C in soft soil (type III) and in Zone D, in firm (type II) and soft soils (type III) are likely to exhibit damage that would compromise the structure stability. Such cases should be revised using more refined models. The prototype could be required to be modified accordingly.

Fig. 6 - Calculated capacity curves, capacity design spectra and performance points for one-story masonry index buildings [14]: EI1 - a) longitudinal and b) transverse direction; and EI4 - c) longitudinal and d) transverse direction) in Zones C and D and soil types I, II and III

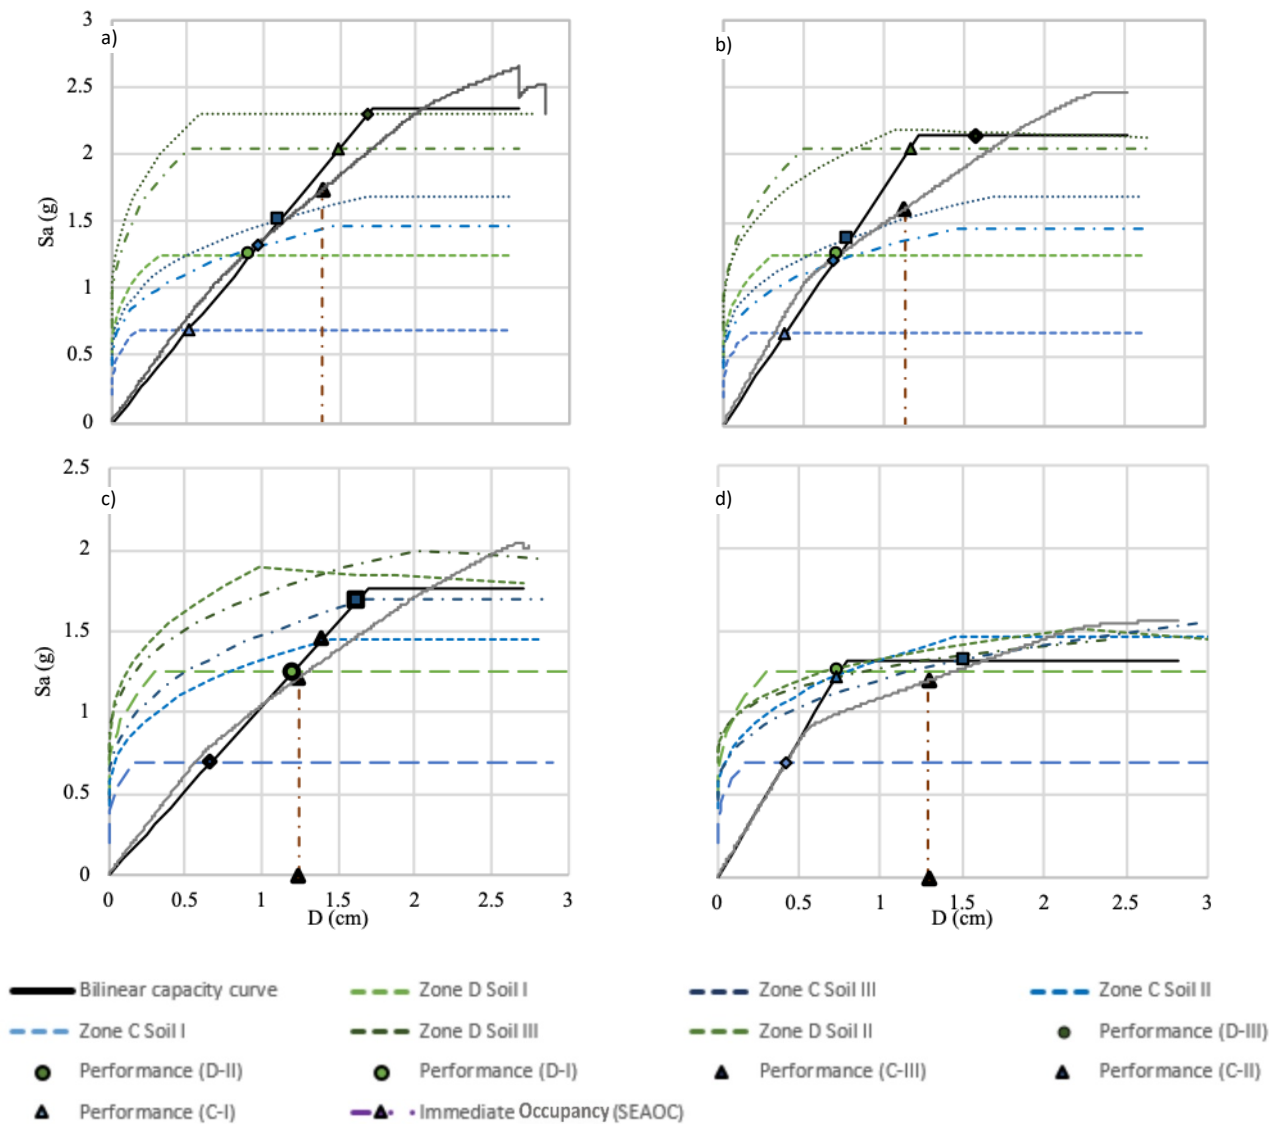
Static analyses indicated that under design demands, both masonry and concrete index structures are likely to exhibit larger damage than anticipated for IO. For prototype EI1R, with one classroom, IO is failed to be attained in Zone D, soil types II and III. For EI4R, the critical case was Zone C, soil type III.

Fig. 7 - Calculated capacity curves, capacity design spectra and performance points for rehabilitated masonry index buildings [14]: EI1R - a) longitudinal and b) transverse direction; and EI4R - c) longitudinal and d) transverse direction) in Zones C and D and soil types I, II and III

Although calculated response does not suggest a significant probability of collapse or severe damage, it is therefore recommended that such cases be revised using more refined models and that, if necessary, structural drawings be modified accordingly.
