DAMAGE TO REINFORCED CONCRETE SCHOOL BUILDINGS BY 2016 KUMAMOTO EARTHQUAKE

S. Tajiri⁽¹⁾, Toshimi Kabeyasawa⁽²⁾, Toshikazu Kabeyasawa⁽³⁾

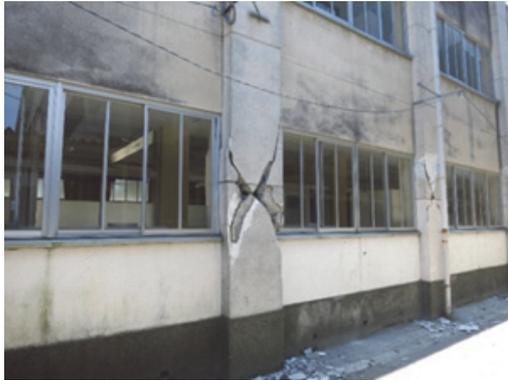
Some buildings were judged to need demolished and rebuilt due to major damages or collapse, and some of moderate or minor damaged buildings required limited entry. Many of them were the buildings constructed before 1981, and particularly severe damage was observed in buildings which was constructed before 1971 and had not been retrofitted. Such damage was limited in public schools and somewhat noticeable in private schools. Most of the structural damage is shear failure of columns (Photos 1 (a) and (b)) and flexural failure (Photo 1 (c)), or damage to foundations or ground (Photo 1 (d)).

These damages are mainly due to insufficient amount of shear reinforcement of columns in old buildings. It is also presumed that the ground deformation directly affected the response of the superstructure. Furthermore, since the ground motion near the hypocenter greatly exceeded the expected ground motion, even some buildings with enough ductility and strength caused severe damage close to collapse. (Photo 1 (c)).

(a) Shear failure of columns

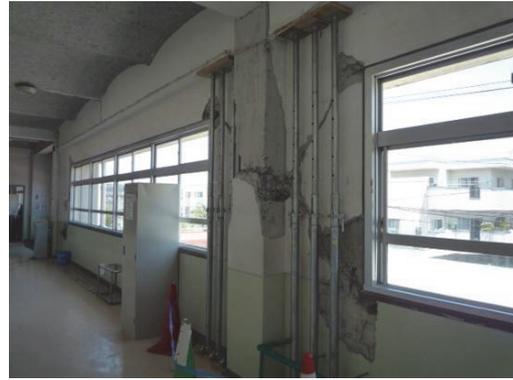
(b) Shear failure of a column with wing-walls

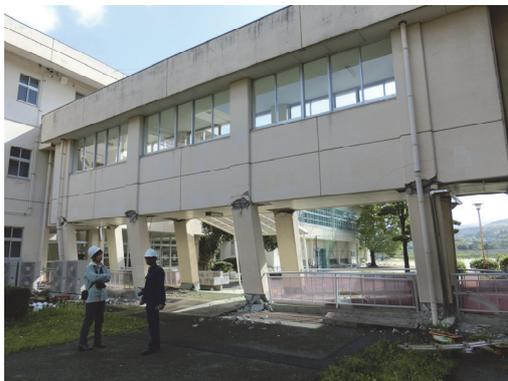
(c) Flexural failure of columns

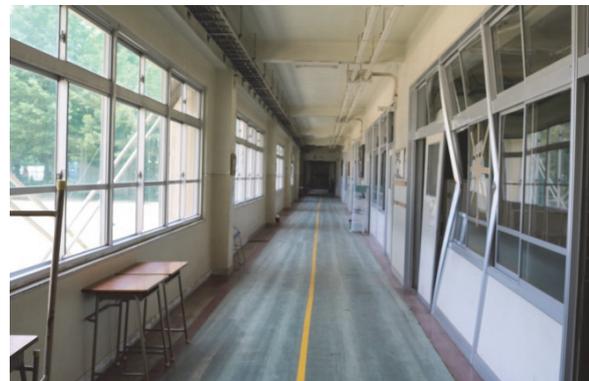
(d) Damage due to settlement

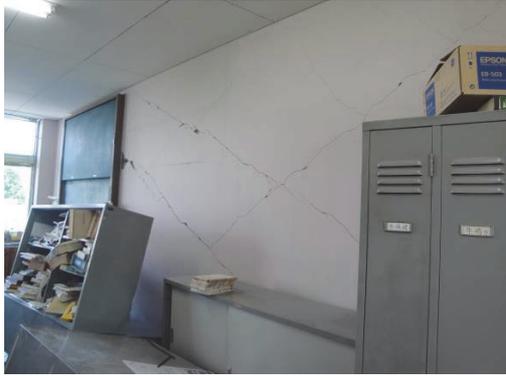
Some buildings constructed after 1982 (designed with 1981 seismic code) or some buildings that did not require retrofit as a result of seismic evaluation showed moderate damage or minor damage that hinder continuous use of the buildings. The main structural damages shown were shear cracks in shear walls (Photo 2 (a)), shear cracks and shear failure of RC non-structural walls (Photo 2 (b)), and shear cracks in columns (with side walls) (Photo 2 (c)) and cracks in the beam-column joint (Photo 2 (d)).

In the current Japanese Building Standard Law and the Japanese standard of seismic evaluation and retrofit, the goal of structural performance of buildings against extremely rare earthquakes is to ensure safety, and prevention of damage is not considered. Therefore, in general, buildings designed with the current seismic code can be damaged to the extent that they need to be repaired even in the case of the expected earthquake in the seismic design. Further, even in a retrofitted building, some brittle members may cause shear failure or shear cracking.

(a) Shear cracks in shear walls

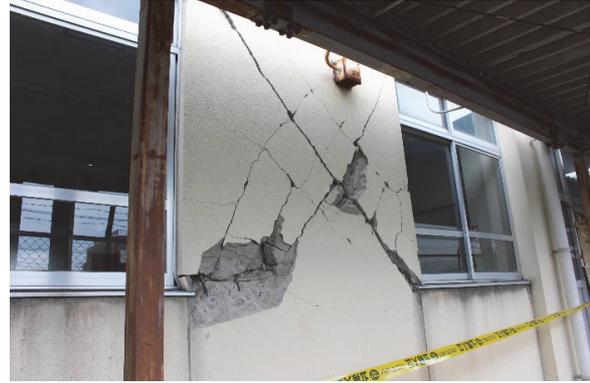
(b) Shear failure of non-structural walls

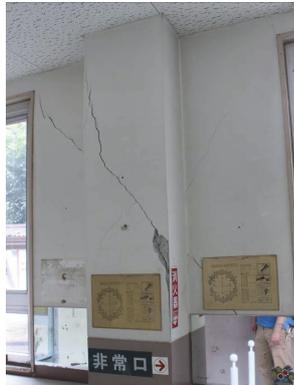
(c) Shear cracks in columns with side walls

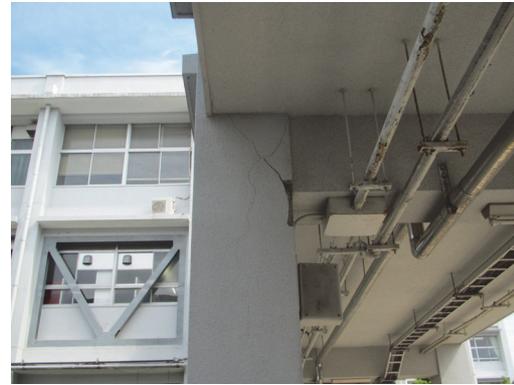
(d) Cracks in beam-column joints

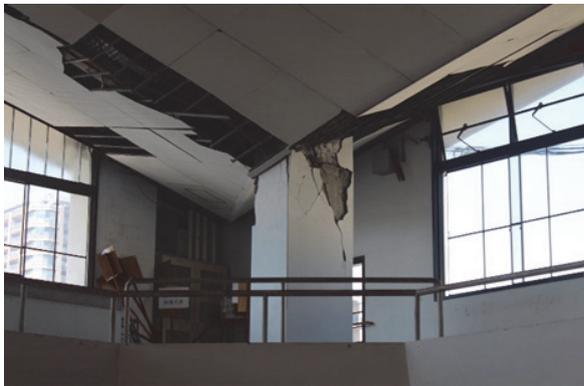
In composite structures of RC columns and steel beams, such as large-span structures (gymnasiums or public halls), spalling, collapse and cracking of cover concrete were found at the joints of RC columns and steel beams due to insufficient beam end anchoring (Photos 3 (a) and (b)).

Even buildings designed with the current seismic code have suffered such damage, and there is a possibility that the current seismic design method of the RC column-steel beam joint may have problems.

(a) Damage to RC column at joint with steel beam

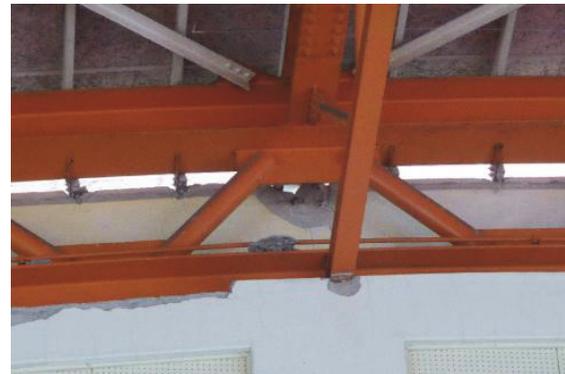
(b) Damage to RC wall at joint with steel beam

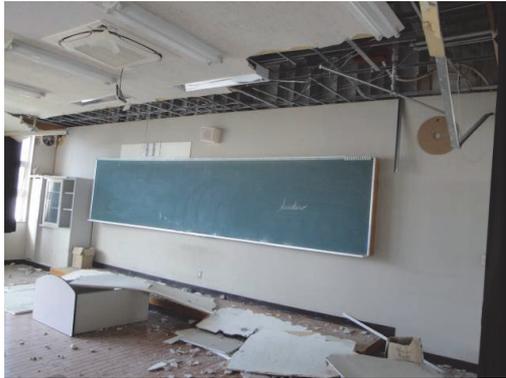
Some buildings could not be used continuously due to the falling of ceiling materials and destruction of non-structural members such as partition walls. These were also found in relatively new buildings designed with the current seismic code.

Since damage control of non-structural walls and finishing materials and prevention of collapse of non-structural members such as ceiling materials are not guaranteed by the current seismic design, it is probable that such damage was observed a lot. However, in the gymnasium of a public school in Kumamoto City, the ceiling had been removed in principle as a measure against earthquakes, so no damage was seen from the ceiling falling.

(a) Falling of ceiling material

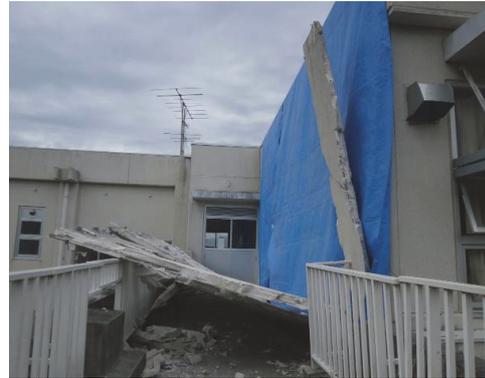
(b) ALC board collapse

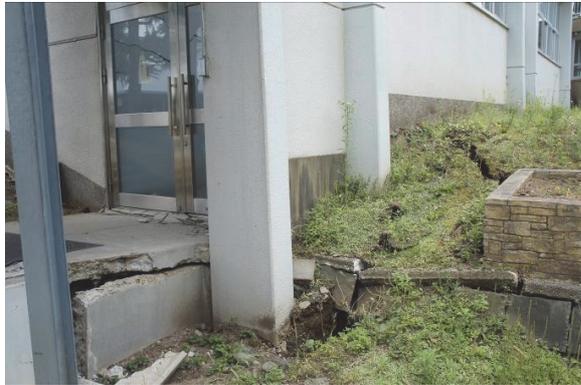
Settlement or inclination of the foundation of the building, which is presumed to be caused by pile and ground deformation, liquefaction, and a fault (ground crack) that appeared on the ground surface, was observed. These were also seen in relatively new buildings designed with the current seismic code and buildings with superstructures retrofitted.

In most buildings, piles and ground are not designed to be safe against extremely rare earthquake, so brittle fractures can occur at the pile head. Furthermore, since the effect of the fault appeared as a ground deformation on the ground surface directly at the Kumamoto earthquake, it is estimated that the direct influence of the ground deformation caused differential settlement and inclination of the superstructure.

(a) Building damage due to ground deformation

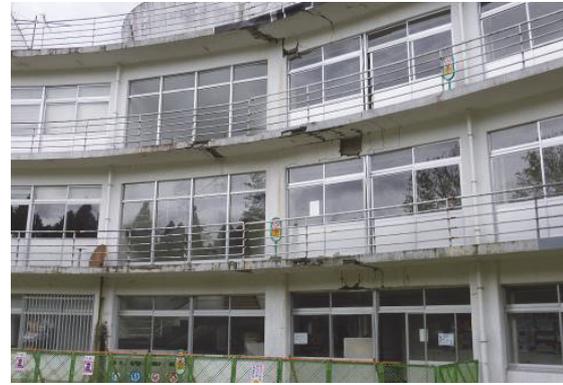
(b) Vertical cracks in beams due to fault displacement
