ANALYTICAL STUDY OF RC BUILDING WITH SOFT FIRST STORY DESIGNED AFTER 1981 AND DAMAGED IN THE 2016 KUMAMOTO EARTHQUAKE

R. Wakamatsu⁽¹⁾, T. Mukai⁽²⁾, H. Kinugasa⁽³⁾, Y. Matsuda⁽⁴⁾

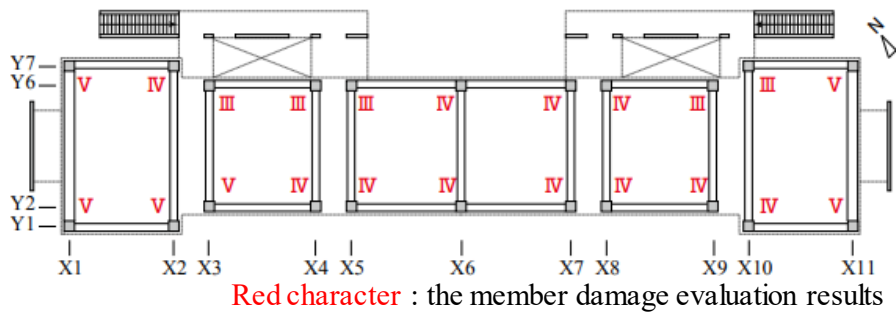
Fig. 1 – The first story plane shape including damage status

The survey results of the damaged subject building, according to the Quick Report of the Field Survey on the Building Damage by the 2016 Kumamoto Earthquake [1] by the Building Research Institute, are given below. The damage situation of the first story is shown using the definitions in Fig. 1.

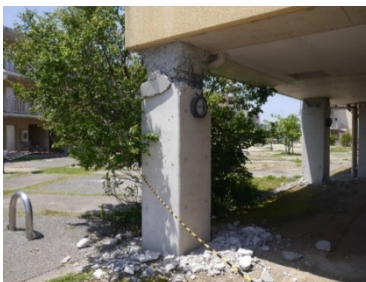
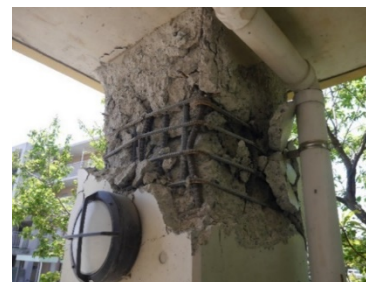
Picture 1 – X11-Y1 pillar (Damage degree V)

Many main rebars buckled on the first story pillars and some fractured, with most damage at the pillar tops (Photos 1 and 2); however, there was similar damage in several of the pillar bottoms. There was cracking in the walls along the periphery; however, the damage was less severe than in the pillars. Thus, the walls along the periphery were not considered in the present study because these would not have acted as earthquake resisting elements in conjunction with the pillars.

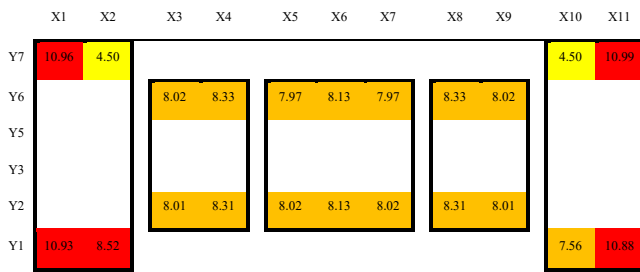
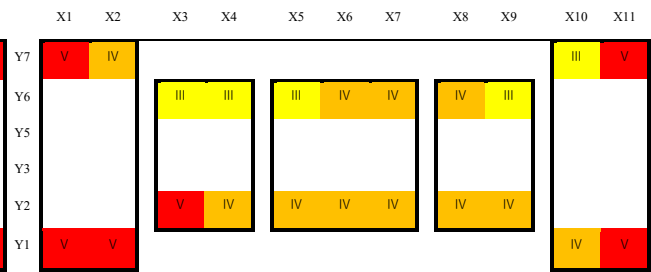
The adopted plasticity rate of each pillar was the smaller of the pillar top and bottom values for each input seismic wave. Fig. 9 shows a list of plasticity rates for the first story pillars of model 2. Here, the three categories above are denoted in yellow, orange, and red. The member damage evaluation results [1] are shown in Fig. 10, where damage categories III, IV, and V are colored in yellow, orange, and red, respectively. The fracture results from model 2 and the damage evaluation results roughly matched. Therefore, the

structural slits should have been along the two sides, if there were any, and the model was verified to be reasonable.

According to Figs. 9 and 10, the damage in the long direction was relatively accurate. In contrast, in the short direction, the actual damage was more severe in the Y1-2 passage than that in the Y6-7 passage; however, the damage was basically symmetrical from the analysis. One possible reason is that the stairs located at the northeast of the Y6-7 passage, which were not included in the analysis, had the ability to bear structural proof stress. Therefore, the model was reasonable in general; however, stairs must be modeled to reproduce damage more accurately.
