## STRUCTURAL DAMAGE IN HOUSING AND APARTMENT BUILDINGS DURING THE SEPTEMBER 7, 2017 TEHUANTEPEC EARTHQUAKE

E. Godínez-Domínguez<sup>(1)</sup>, A. Tena-Colunga<sup>(2)</sup>, H. Archundia-Aranda<sup>(2)</sup>, A. Gómez-Bernal<sup>(2)</sup>, R. Ruíz-Torres<sup>(1)</sup>, J. Escamilla-Cruz<sup>(3)</sup>

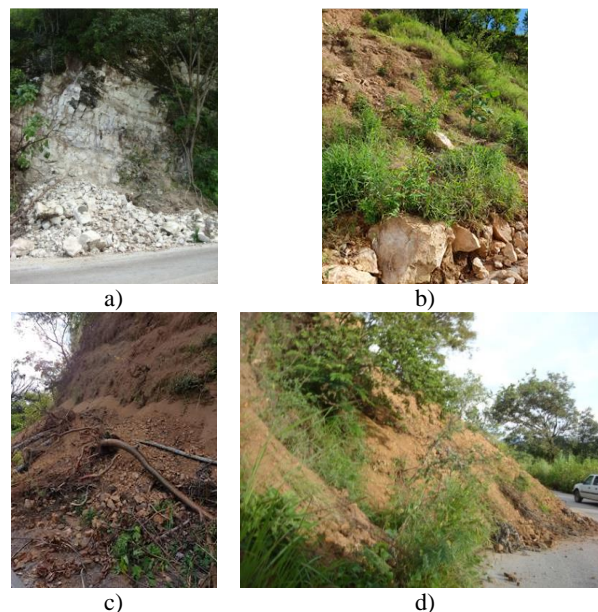
As a consequence of the earthquake, landslides were observed in several places, particularly on roads which communicate the visited cities (Fig. 5).

Fig. 5 – Some landslides observed on roads connecting Tuxtla Gutiérrez and Guadalupe Victoria (a) and Villaflores and Tonalá (b, c, d), Chiapas

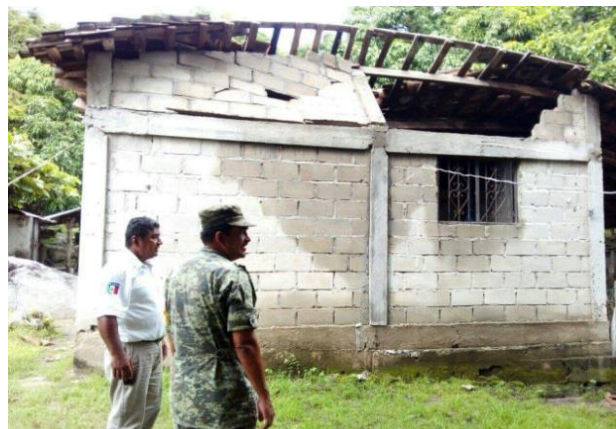
Confined masonry is widely used in Mexico [6, 7]. However, it is common in non-engineered construction that provided confinement elements are deficiently disposed or they are insufficient. In non-engineered constructions, the following components are often not well confined: a) door and/or window openings, b) slender walls (wallets), frequently used in kitchens and bedrooms and, c) parapets. Sometimes, the separation between tie-columns is greater than the maximum recommended in design codes. In some instances, bond-beams are simply not used. Unfortunately, some of this confinement construction deficiencies are sometimes also observed in housing projects assisted by architects or engineers, as it is discussed later. A particularly interesting case was observed in Pijjiapan, Chiapas, where the out-of-plane failure of confined masonry walls was registered as a consequence of the lack of lateral support, given that the house had a light wooden roof simply supported on the walls (Fig. 7). There was also a lack of confinement in the window opening, which it is unfortunately typical in self-construction.

Fig. 7 – Out-of-plane overturning because of inadequate confinement of walls and as a consequence of the lack of lateral support, Pijjiapan, Chiapas

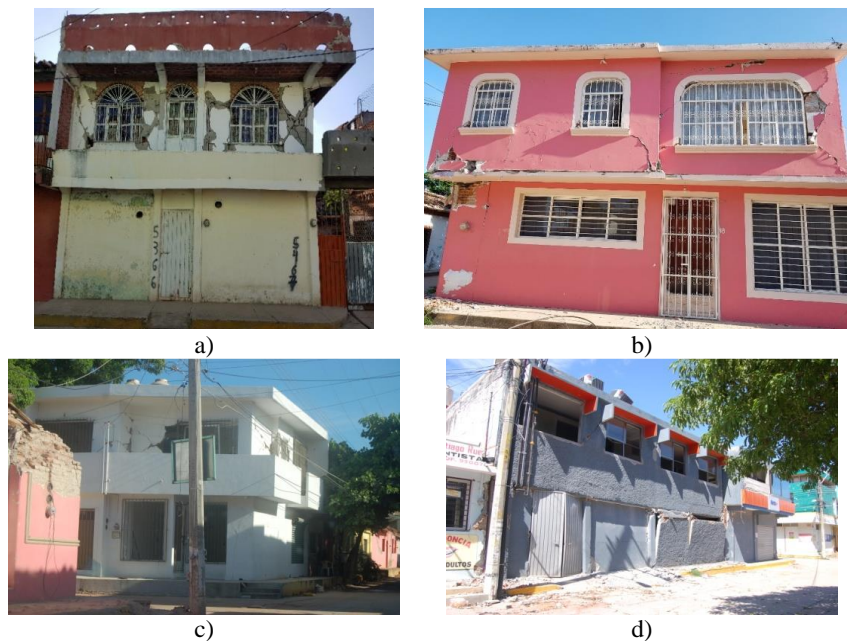
The observed typical damage on several poorly-confined masonry houses located in Juchitán de Zaragoza, Oaxaca is depicted in Fig. 8. It is shown the common diagonal tension failures in walls (Figs. 8a-d), whose cross shape is due to the reversible nature of the earthquake. Despite of having confining tie-columns, their placement is deficient, as confining tie-columns are absent within window openings. In addition, their detailing, construction materials and/or construction process was deficient. Commonly

observed errors were: a) inadequate spacing of transverse steel reinforcement (stirrups) and, b) 90 degree hooks in stirrups (reducing the effectiveness of confining the concrete core and supporting the longitudinal bars). In the house shown in Fig. 8b, there was also an evident lack of bond between the concrete slab at the ground floor and the low bond-beam for the walls on the second floor, as well as an inadequate connection between the tie-columns and the concrete slabs (which it is direct, as bond-beams do not exist). A particularly interesting case is shown in Fig. 8d, where in addition to the diagonal tension failure of the wall between windows on the second floor, two walls on the ground floor almost completely overturned out of their plane. This was a consequence of having been built as a RC frame with masonry infills, and not having effectively restricted their potential out-of-plane overturning, connecting them by means of steel angles to the floor system, as recommended, for example, in Mexican masonry guidelines [8].

Fig. 8 – Observed damage in poorly confined masonry houses, caused by different design/construction errors in Juchitán, Oaxaca

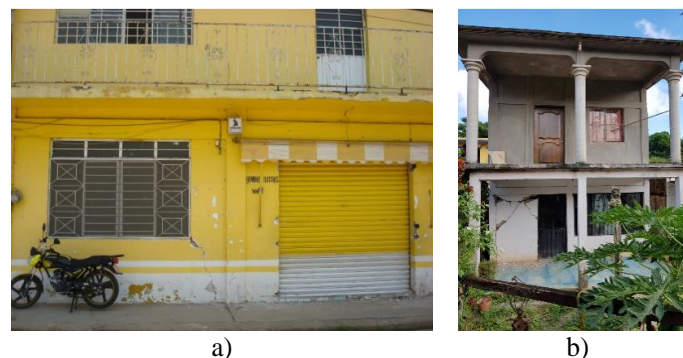
Diagonal tension damages in walls due to deficient confinements also occurred in other cities where the seismic accelerations were notably lower than in Juchitán, for example, in Matías Romero, Oaxaca (Fig. 9). A diagonal tension cracking near a large, unconfined window opening is shown in Fig. 9a. The most interesting case is shown in Fig. 9b, where it can be observed that the diagonal tension cracking on the ground floor is a consequence of the absence of a tie-column that confines the door opening, because paradoxically, in that region, a tie-column exists in the door of the upper level, where there was no damage.

Fig. 9 – Observed damage in poorly confined masonry houses, in Matías Romero, Oaxaca

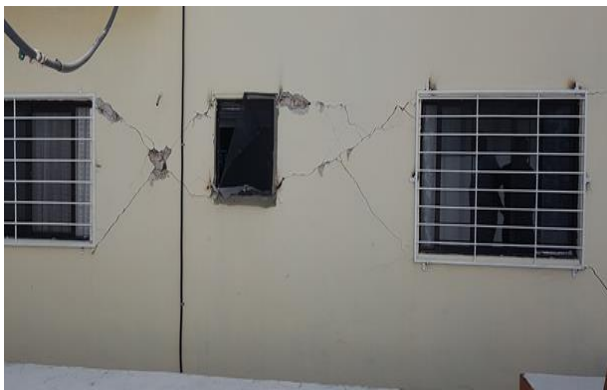
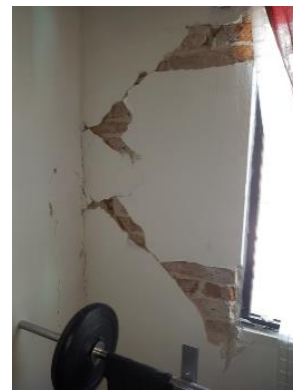
The observed damage in different houses located in the cities of Tuxtla Gutiérrez and Berriozábal, both in the state of Chiapas, are shown in Figs. 10 and 11. In this case, according to the owner, the house shown in Fig. 10 had an architectural design, but not an engineering design. The three-story house developed significant damage in practically all walls on the second story, associated with an inadequate confinement of the masonry, since the door and window openings were not delimited by tie-columns and bond-beams (Fig. 10b). A lack of confinement elements was observed, not only in door and window openings, but also in long walls, exceeding the recommendations of Mexican masonry guidelines for these cases. This defect is common in self-construction housing, even in middle and upper-middle class housing (even in cases where architects are involved), as it has been observed in other earthquakes in Mexico [9-11].

a) Rear facade

b) Unconfined window opening

Fig. 10 – Damage due to inadequate confinement in a house located in the Terán neighborhood of Tuxtla Gutiérrez, Chiapas

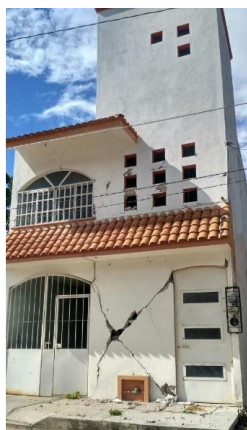
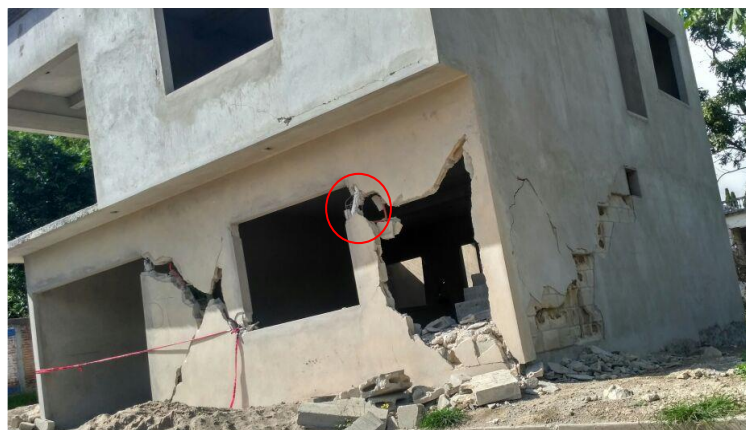
Serious structural diagonal tension damages to the facade walls of the ground floor were observed in the house shown in Fig. 11. This was again due to the inadequate/lack of confinement of the openings, as well as the inadequate detailing of the short elements located on the second floor (which forms the openings for illumination of the stairwell, Fig. 11a). As observed in Fig. 11b, it is clear that due to the practice of placing sanitary piping inside structural confinement elements (tie-columns), their resisting area is significantly reduced, leading to a poor masonry performance. It should also be noted that, in addition, masonry is usually built using non-industrial hollow concrete blocks, with no quality control [12].

Fig. 11 – Damage to houses located in the city of Berriozábal, Chiapas

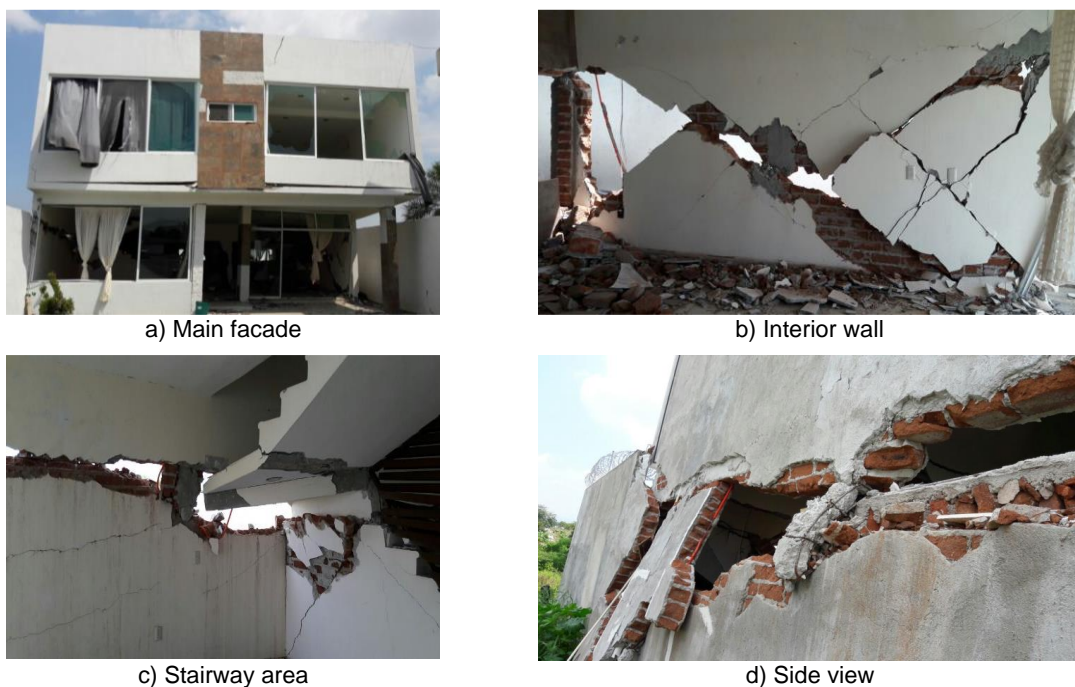
A clear example of the latter is shown in Fig. 12, which corresponds to the observed damage in a residential house located in Tuxtla Gutiérrez, Chiapas (Fig. 6). In this case, in theory, both a “formal” structural design and specialized technical supervision was carried out. The severe structural damage observed (total loss) was a clear indicator of the poor quality of the construction materials used (concrete, mortars, non-industrial clay bricks, etc), the poor quality of the workmanship and an inadequate architectural and structural design. The following shortcomings can be observed, among others: a) low wall density area to carry shear forces in the direction parallel to the facade, b) diagonal tension failures in walls, c) shear failures in confining RC tie-columns, (d) shear failures due to sliding along bed joints (Fig. 12d), e) buckling and fracture of the steel reinforcement of the confining elements (Fig. 12b), f) inadequate connection (lack of bond) between the ground-floor slab and the second-floor masonry walls (Fig. 12a). Clearly, in this case, in addition to what it was previously mentioned, there was negligence on the part of those in charge of the execution, supervision and revision of the construction.

Fig. 12 – Severe structural damage to a residential house located in Tuxtla Gutiérrez, Chiapas (photographs courtesy of BSc. Christian Burguete D'Artote)

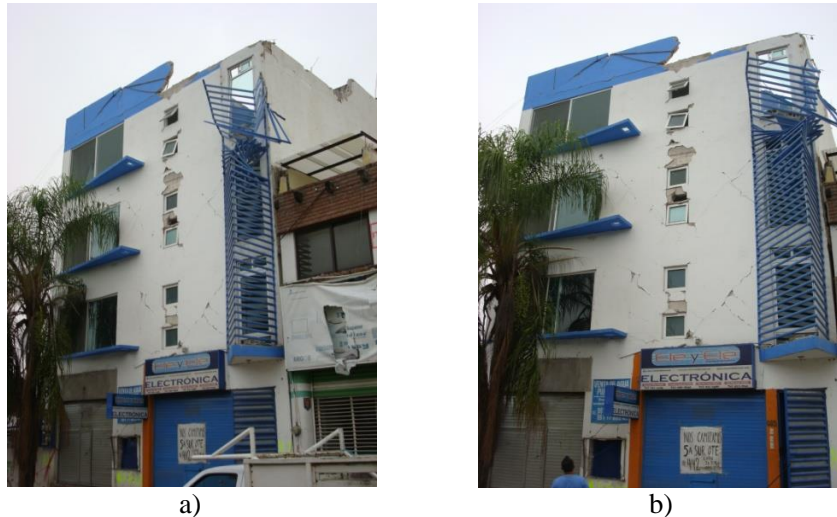
A four-story apartment building in which all the windows of the facade wall are not adequately confined is shown in Fig. 13. As it can be observed, the parapet collapsed as a consequence to the inadequate

design and/or construction process, affecting the neighboring low-rise building to the left. The building also had a structural system prone to develop a soft-story mechanism, which fortunately it did not develop.

Fig. 13 – Observed damage in an apartment building due to inadequate confinement, located in the Terán neighborhood of Tuxtla Gutiérrez, Chiapas

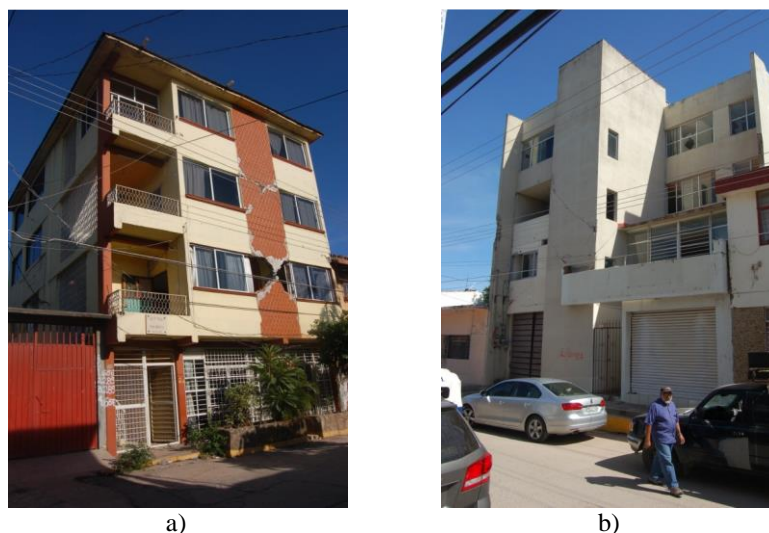
Two four-story apartment buildings located in Juchitán, Oaxaca are shown in Fig. 14. The masonry walls failure due to the lack of adequate confinement is evident in the building shown in Fig. 14a, and it may have triggered by the following reasons. It can be seen that, as usually done for commercial purposes, large open spaces without walls are frequently used on the ground floor, so the building configuration has the potential to develop a soft and weak story. However, this soft-story did not develop because the building previously experienced structural pounding with the house on its right at the second level, and this impact, which fortunately occurred directly between the floor systems of both buildings, led to unconfined wall shear failure on the second story and the severe cracking on the third story.

The building shown in Fig. 14b developed lighter diagonal tension damage in the facade wall on the second and third levels and in the wall between third level windows. Both damages were caused by the structural pounding with the two-story self-construction house to its right, which it seems to be part of the same property.

Fig. 14 – Damage to masonry walls of apartment buildings located in Juchitán, Oaxaca

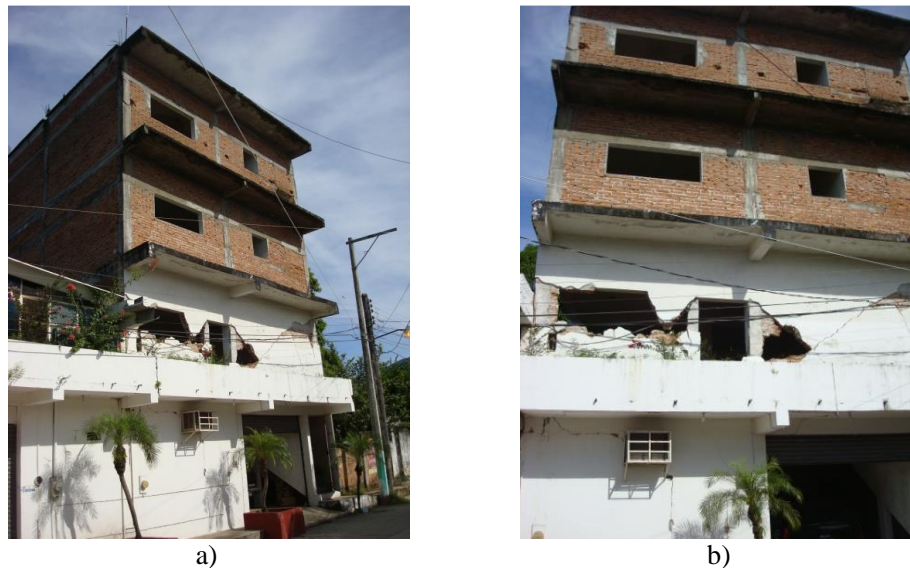
The damage observed in a four-story confined masonry building located in Tonalá, Chiapas is shown in Fig. 15. It is clear that the building has been built in different stages, where the first two stories are the original ones, and the last two stories have been added recently. In addition, the absence of RC tie-columns in window openings is evident. Curiously, there is an intermediate RC bond-beam at the top of window openings. A constructive or modification error was also observed, where the window openings to the right of the photographs were reduced in size using clay bricks in a later construction stage, so that there is a vertical joint in the absence of continuity in the construction process (Fig. 15b).

Fig. 15 – Damage to masonry walls in a four-story apartment building in Tonalá, Chiapas

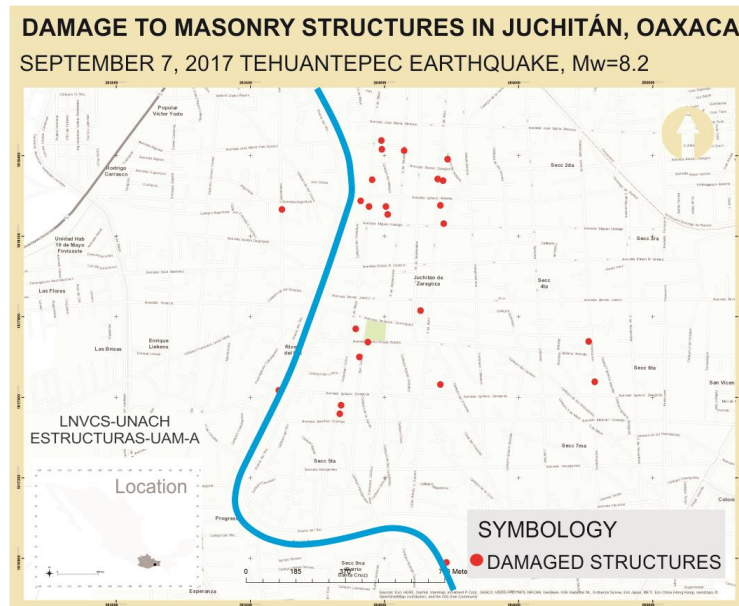
Most of the observed damage in Juchitán, Oaxaca, in addition to the structuring and/or construction problems mentioned above, may have also been related to weak soil conditions in which these structures were located. As shown in Fig. 16, a large region of the inventory of severely damaged structures in Juchitán was found in the areas nearby the banks of Los Perros River. Given that the riverbed may have changed over the years, as well as the fact that the soils on its banks are of poor quality due to water filtrations along the sides of the riverbed, soils of poor quality are obtained in its vicinity, and therefore, unfavorable site effects are observed. The red circles shown in Fig. 16 represent not only a damaged structure, but in some cases, they refer to the location of several damaged constructions, as often several damaged structures were contiguous and numerous.

Fig. 16 – Geographical location of severe damage to housing and apartment buildings in Juchitán, Oaxaca
