## MEXICO EARTHQUAKE OF SEPTEMBER 19, 2017: CORRELATION BETWEEN SITE EFFECTS AND STRUCTURAL DAMAGE

*Keywords: Mexico City, soft soil, collapsed buildings, seismic intensities, September 19*

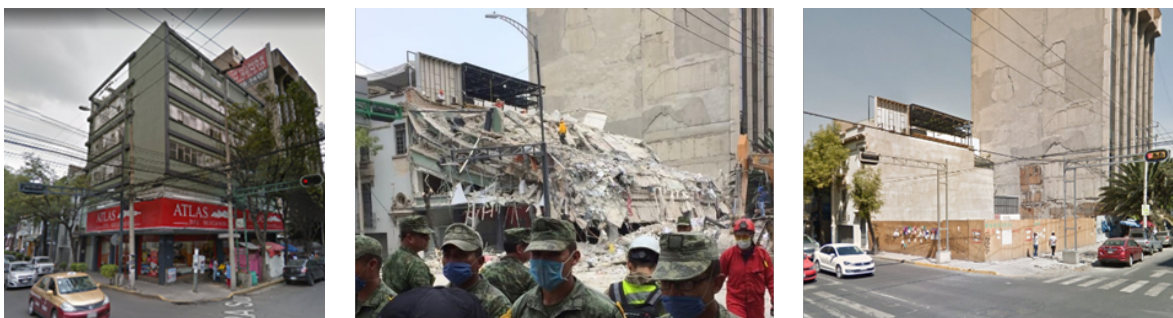
a) Before de 2017 earthquake      b) during the 2017 earthquake      c) After the 2017 earthquake

As shown in Figs. 8 and 9, the condition of FSS is far more critical than corner asymmetry. The cases in which both pathologies were correlated, and affected a given structure were also analyzed. An example of this is the building located in Medellín 176, which had FSS and corner effect. This building collapsed after the 2017 earthquake, and the buildings images, before and after the earthquake, are shown in Fig. 10.

Fig. 10 – Photos of the building located in Medellín 176, before, during and after the earthquake. The building has both pathologies studied: corner asymmetry and ground weak story.
