A STUDY ON DAMAGE INVESTIGATION OF DAMEGED BUILDING DUE TO THE 2016 KUMAMOTO EARTHQUAKE

Abstract

A reinforced concrete building was damaged by the 2016 Kumamoto earthquake. Functional use of the building was not allowed after the earthquake due to tilt and settlement of the building. The building has deep foundation system with precast concrete piles. Several damage investigations were carried out for the foundation system and structural members of superstructure in the building.

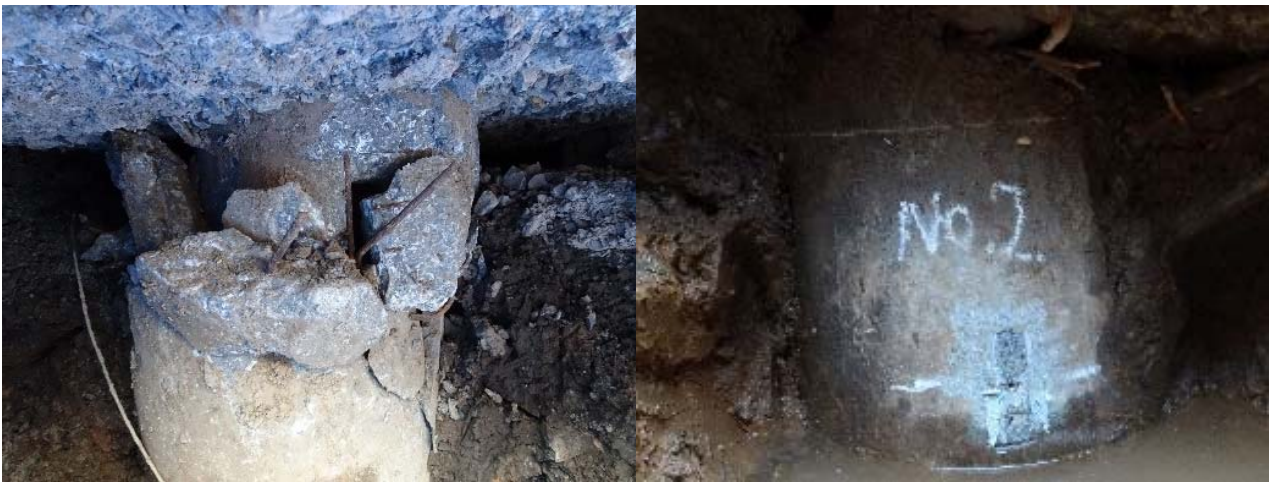
Fig. 2 –Damage of pile head

First investigation was carried out for the three piles on August 2016. Damage of pile head and pile location are shown in Fig.2 and Fig.3, respectively. No.1 pile was broken with diagonal crack and shorten in axial direction with longitudinal reinforcements buckling. Connection face of No.2 pile was broken with longitudinal reinforcements buckling. Damage of No.3 pile was not observed by hearing investigation.

(a) No.1(X2, Y1)

(b) No.2(X1, Y4)

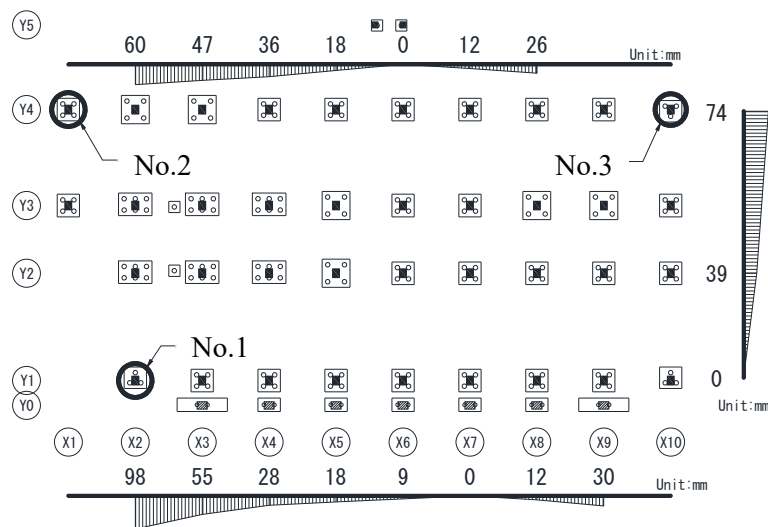
Fig. 3 –Pile location and relative settlement

Building relative settlement of each point is shown in Fig.3. The values were guessed by gap between each point and highest point. The height of points was measured in exterior joint line of each side which was probably horizontal line before earthquake. The maximum settlement value was 98mm at south-west point. The building was tilted to the north side.

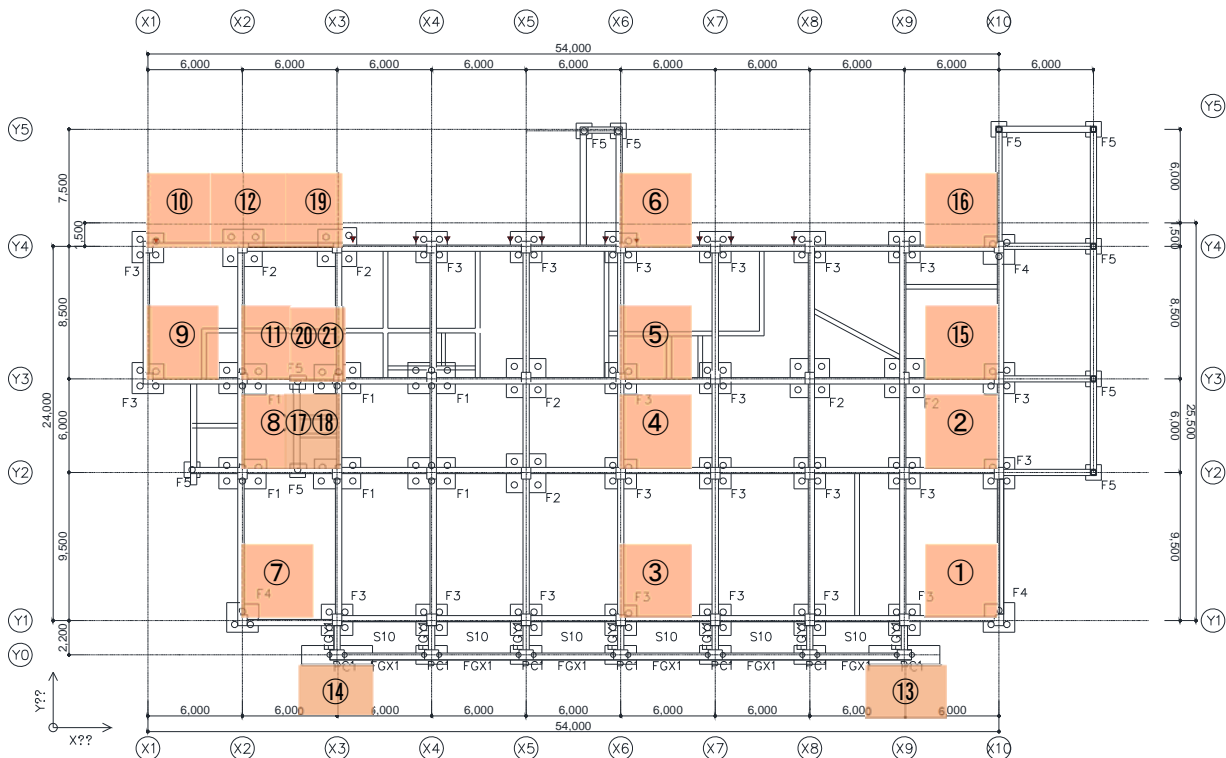
Fig. 5 – Investigation area

The investigated areas are shown in Fig. 5. Typical damage of the piles is shown in Fig. 6. The circled number (1 to 21) in Fig. 5 means ID number of investigated footings. Furthermore, ID number of investigated piles is added branch number to footing ID number. All piles were tilted. All piles except for a pile (pile ID: 11-1) was tilted to east direction. Tilt angle was 2.6% to 13.7% in east-west direction. One of northwest pile (pile ID: 9-1) was not settled, however, it was slipped in horizontal direction as shown in Fig. 6 (a). Fig. 6 (a) was recorded from north side of the pile. One of southwest pile (pile ID: 14-2) which was attached to precast retrofit RC frame foundation was settled due to steel pipe buckling at pile head as shown in Fig. 6 (b). Fig. 6 (b) was recorded from south side of the pile. One of northeast pile (pile ID: 16-1) was damaged only north side part of the pile head concrete as shown in Fig. 6 (c). Fig. 6 (c) was recorded from north side of the pile. This pile was tilted to south direction (3.6%) and east direction (6.7%). Additional digging (0.7m depth more) was conducted only for this pile. As the result, south side of 1.1m to 1.7m area from pile head was clashed concrete as shown in Fig. 6 (d). Fig. 6 (d) was recorded from west side of the pile. The other piles were not observed intermediate part of the piles; however, many piles were tilted more than 2.0 % as well as 16-1 pile. If the other piles were same condition as 16-1 pile, it is guessed that intermediate part of pile was damaged. 16-1 pile was same pile as No.3 pile which was judged to no damage in first investigation. Thus, intermediate part damage of the pile was not founded in first investigation.

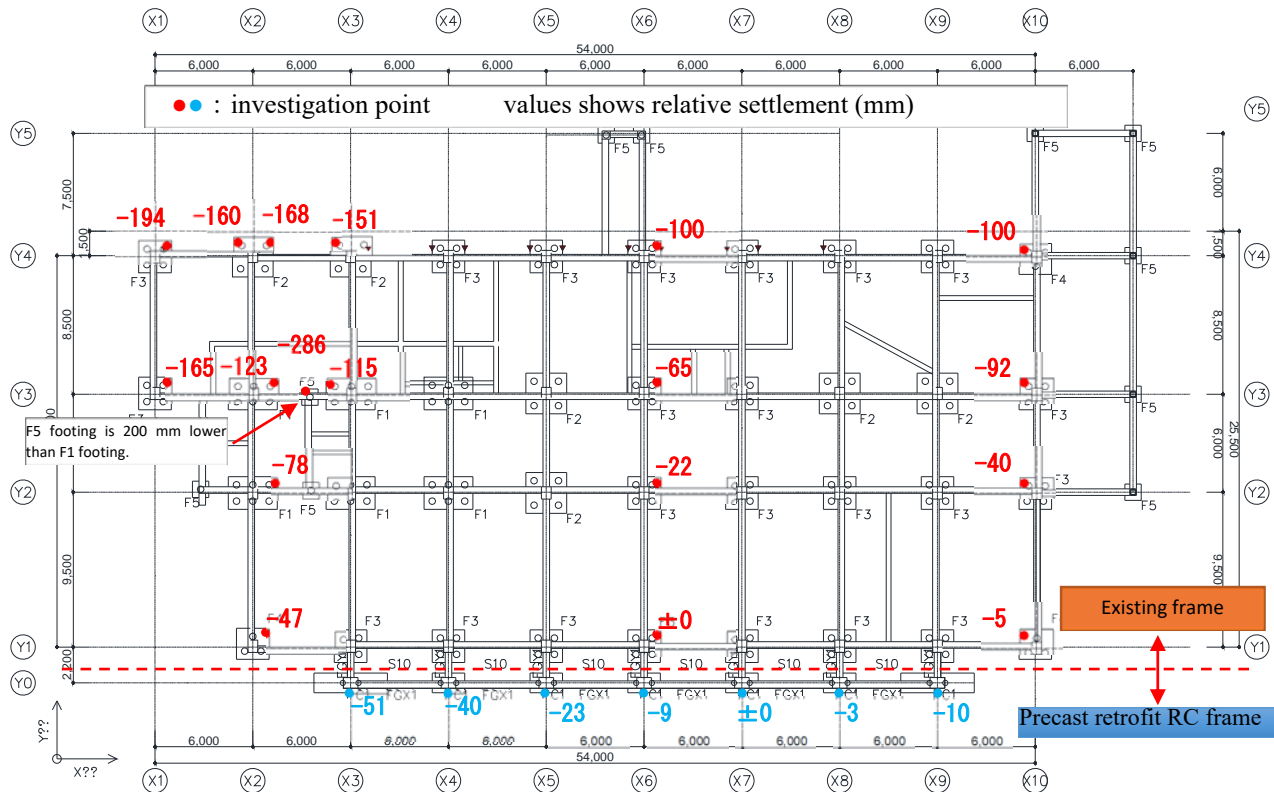
Fig. 7 – Relative settlement (unit: mm)

Building relative settlement of investigation point are shown in Fig.7. The values were guessed by gap between each point and highest point. The measuring was conducted in existing frame area and in precast retrofit RC frame area, respectively. The height of points was measured top surface of each footing in existing frame. On the other hand, the height of points was measured in top surface of exterior mortar in precast retrofit RC frame area. The maximum settlement value was 194mm at north-west point. The building was tilted to the north side. On the other hand, settlement values at center of frame was small in east-west direction. The settlement values

of first and second investigation was different. However, tilted direction and settlement condition were almost same results.

In first investigation, settlement value was measured using exterior joint line. In second investigation, settlement value was measured using top surface of each footing in existing frame. The settlement values of first and second investigation was different. However, tilted direction and settlement condition were almost same results. The maximum settlement value and the maximum tilted angle are calculated for each investigation, using each measured settlement values. The results are shown in Table 2. The maximum settlement value was changed 98mm to 194mm. The maximum tilted angles (X-direction) of each investigation are almost same value. The maximum tilted angles (Y-direction) was changed 0.41% to 0.87%. Damage classification criteria for foundations ^[2] is shown in Table 3. The classified damage was changed moderate damage to severe damage. Thus, guessed settlement value using exterior joint line of superstructure was underestimated actual foundation settlement. However, tilted direction and can be evaluated using exterior joint line of superstructure.

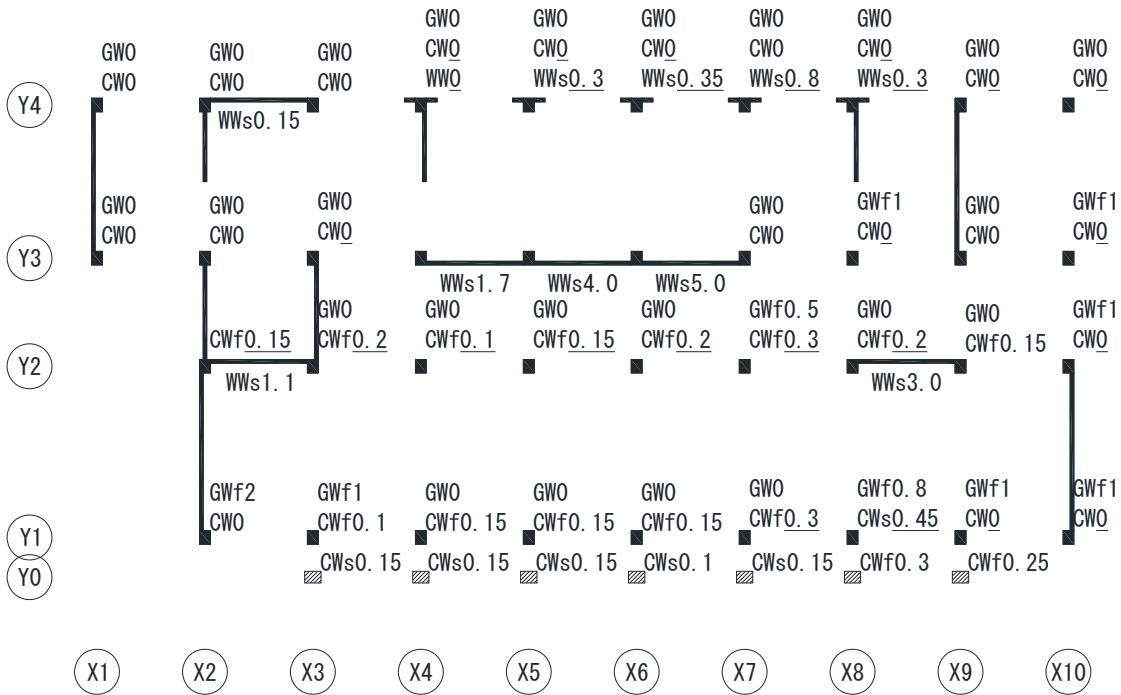
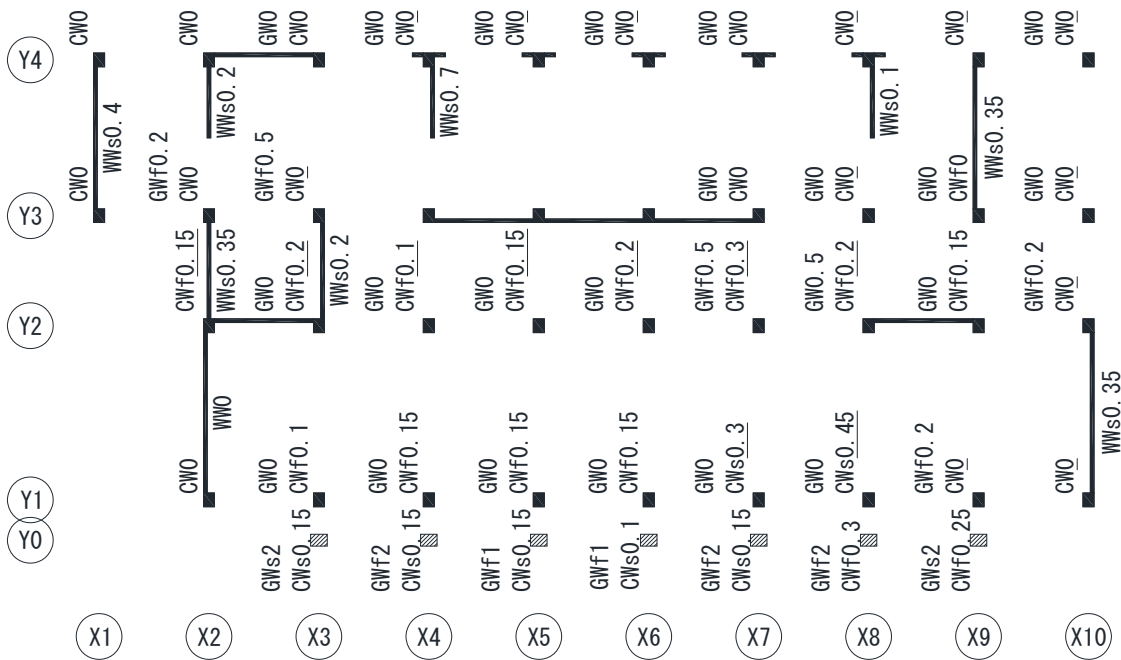
Fig. 10 – Damage of structural members on first floor (Second investigation, expert team)

First damage investigation for structural members of superstructure were carried out by two experts. The investigation was carried out for three hours before removal of interior material, ceiling material and furniture. Damage level of columns and walls were judged only first floor, because of short time of investigation. Furthermore, some structural member was not observed because of furniture or locked room. Damage of inside beam was not investigated because of ceiling material. However, outside beam (connecting existing frame and precast retrofit RC frame) can be observed as shown in Fig. 8. Damage of structural members are shown in Fig. 9. Cracks of columns and walls were measured over interior material. Generally, damage investigation after earthquake is conducted under same condition. Shear crack width 1.7mm was observed at X direction wall (X8-X9, Y2). Visible shear crack was observed at Y direction outside beams as shown in Fig. 8. The crack width was not measured directly, because of high. However, the crack width was judged about 2.0mm by visual inspection of expert team.

In X-direction, damage classification is “Moderate”. The result is lighter than result of second investigation by expert team, because large shear cracks of structural walls were not observed in first investigation behind gypsum plaster board. In Y-direction, damage classification is “Moderate”. The result is heavier than result of second investigation by expert team, because not damage columns were not investigated in first investigation because of short time, furniture or locked room.

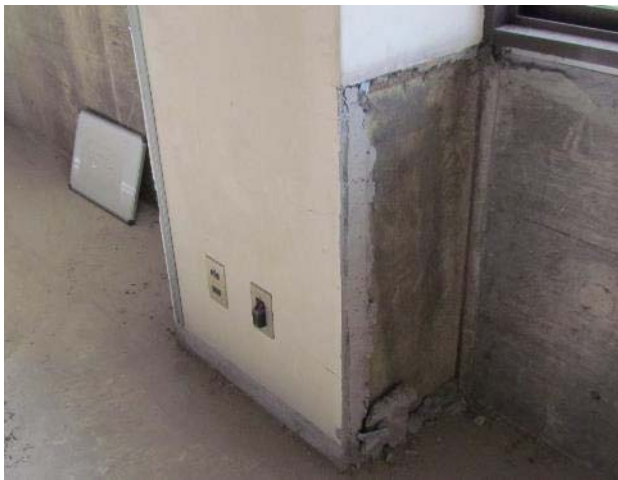
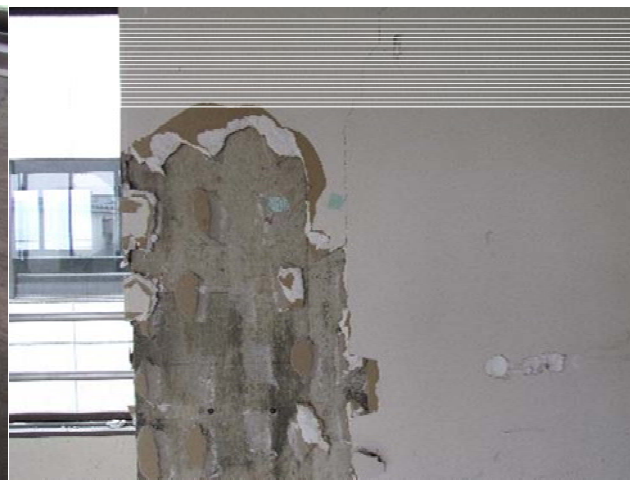
Fig. 11 – structural member with interior material

In many case of structural member, interior material was removed, however, in some case of structural member, interior material was not removed. Some cracks were crossovered between interior material area and interior material removed area as shown in Fig. 11. Relationship between actual crack and measured crack over interior material is shown in Table 1. The actual crack width was measured in interior material removed area. The measured crack over interior material was measured in interior material area. Twenty-two flexural crack were mesured over mortar finishing as sample data. There were not enough data for the other type crack. Relationship between actual crack and measured crack over mortar finishing is shown in Fig. 12. The measured

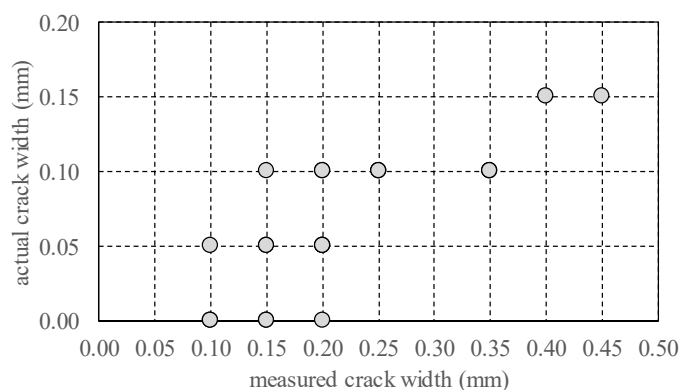
Fig. 12 – Relationship between actual crack and measured crack over mortar finishing

crack width over mortar finishing were 0.1 to 0.45 mm, however, the actual crack width were less than 0.20 mm. Thus, if measured crack width over mortar finishing is less than or equal to 0.45mm, actual crack width is judged to be less than 0.20mm for post-earthquake damage evaluation in chapter 5.

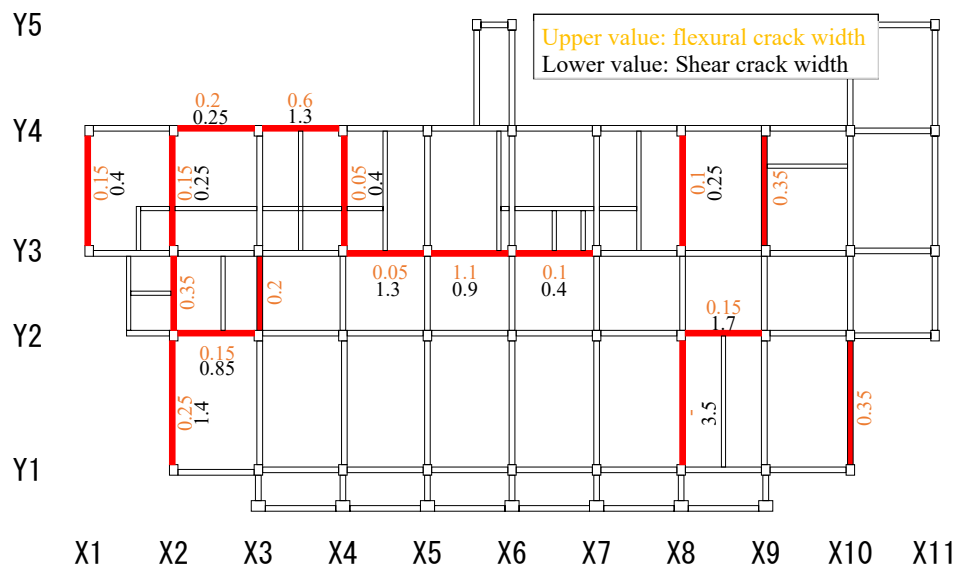
Fig. 14 – Damage of Wall on first floor (Second investigation, student team)

Shear crack width 1.3, 0.9 or 0.4mm was observed at X direction walls (X4-X7, Y3), respectively. On the other hand, 1.7, 4.0 or 5.0 was measured by expert team in the same walls. Because these cracks were measured upper 2.0 m height by expert team. Many columns of north area were not investigated. These columns were not damaged according to second investigation by expert team.

In X-direction on first floor, damage classification is “Severe”. The result is same as result of second investigation by expert team, because large shear cracks of structural walls were not observed in first investigation behind gypsum plaster board. In Y-direction on first floor, damage classification is “Moderate”. The result is heavier than result of second investigation by expert team, because of same reason as first damage investigation. On the other hand, second and third floor, only wall were investigated. In this building, damage of walls is heavier than damage of columns. Thus, the results of damage classification in second and third floor are heavier than result of second investigation by expert team.
