IMPACTS OF THE M7.1 NOVEMBER 30, 2018 ANCHORAGE, ALASKA EARTHQUAKE ON SCHOOLS

J. Rodgers⁽¹⁾, W. Hassan⁽²⁾, C. Motter⁽³⁾, and J. Thornley⁽⁴⁾

Abstract

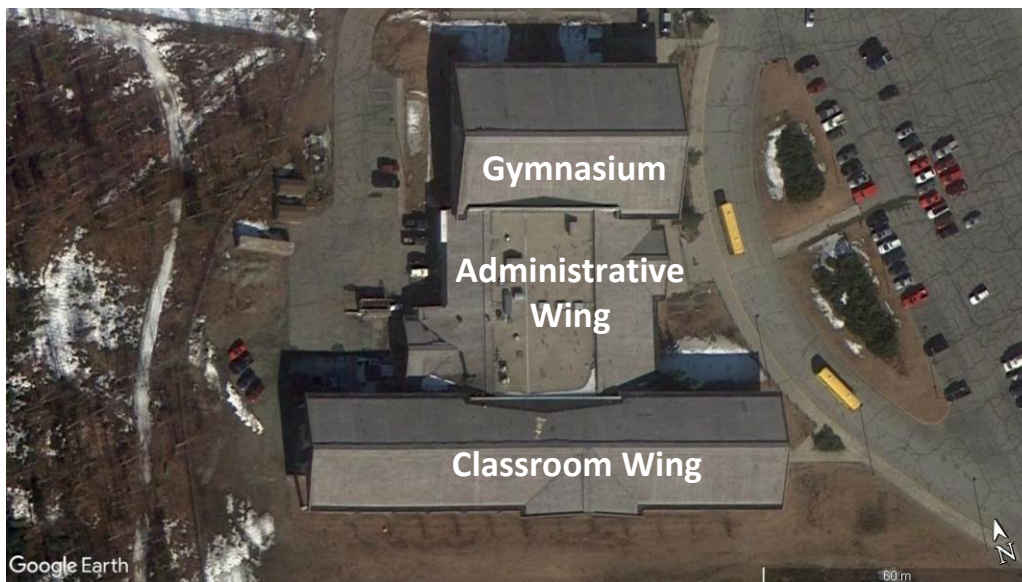
Houston Middle School, shown in Figure 2, is a reinforced CMU and steel frame building constructed in 1986. It has three main portions: a classroom wing, an administrative wing that also contains assembly and vocational education areas, and a gymnasium. It suffered the most significant structural damage of Mat-Su schools and it was declared unsafe for students and closed for the remainder of the school year.

Figure 2 – Houston Middle School, showing the three main parts of the building. Imagery: Google Earth

The classroom wing suffered the most significant damage. At the time of this report, the district had approved the replacement of the most heavily damaged wing and seismic upgrades to other portions. The

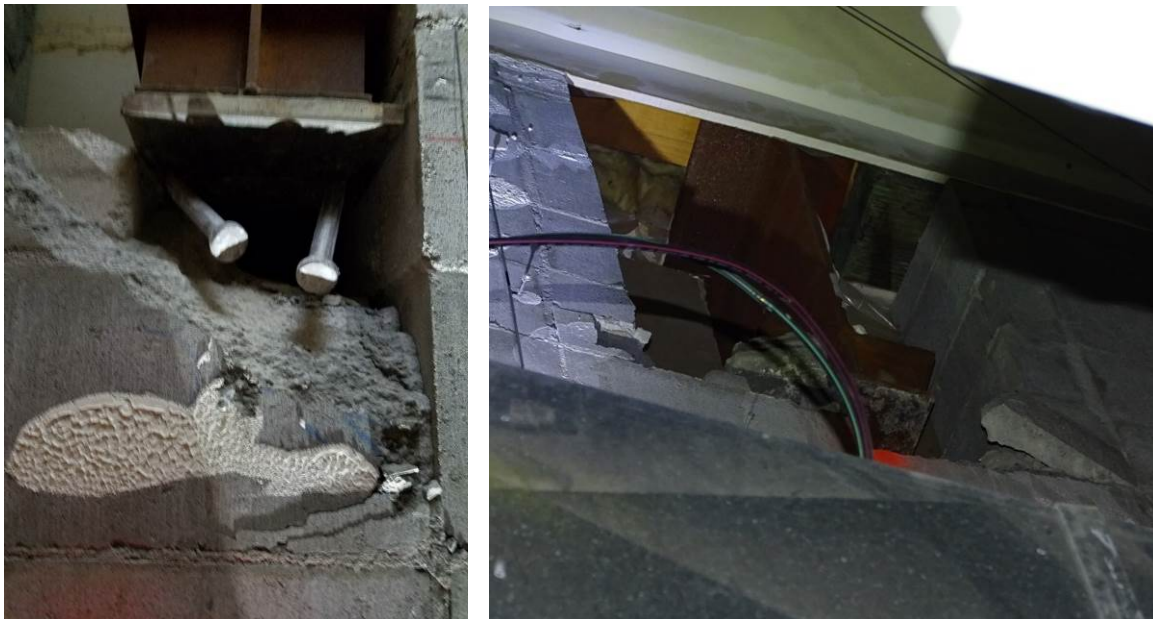
Houston Middle School has several design features and construction defects that contributed to the damage. The lateral load resisting system consists of partially grouted, CMU shear walls with reinforcement spacing twice that required by modern codes [7], laid in stack bond (rather than the stronger and more typical running bond), with a flexible wood diaphragm at the roof and a concrete floor on steel deck at the first floor. The steel frame system in the gymnasium wing was complete, but the gravity frame in the classroom wing was not. The classroom wing had several steel roof girders bearing directly on tall CMU walls, without a supporting column beneath. A number of girder-to-wall connections, which consisted of shear studs embedded in a grouted cell in the top course of a tall CMU block wall, failed during shaking (Figure 3), leaving the girders in danger of unseating in an aftershock, and falling into the classrooms below. The reinforced concrete bond beam at the top of the CMU walls shown on the drawings (see Figure 4), and into which the beam connections were supposed to have been made, was not installed, according to a post-earthquake engineering inspection [7]. Had it been installed, the bond beam would have resulted in a stronger connection that may have reduced observed damage, though the CMU walls and overall structural design had other significant deficiencies as well.

Figure 3 – Failed connection between steel roof girder and CMU wall in second story of classroom wing (left); similar failed connection (right). Photos: Bill Noyes (left), Janise Rodgers (right).

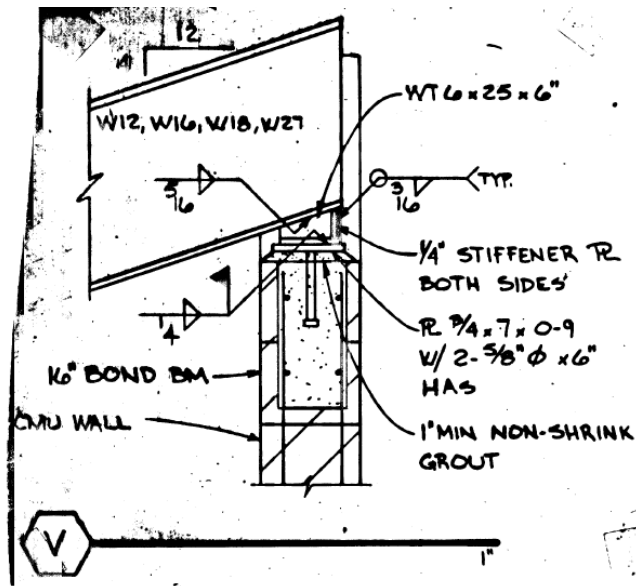
Figure 4 – Structural drawing of roof girder-to-CMU wall detail that failed (courtesy MSBSD). Post-earthquake inspections revealed that the bond beam at the top of the CMU wall had not been installed.

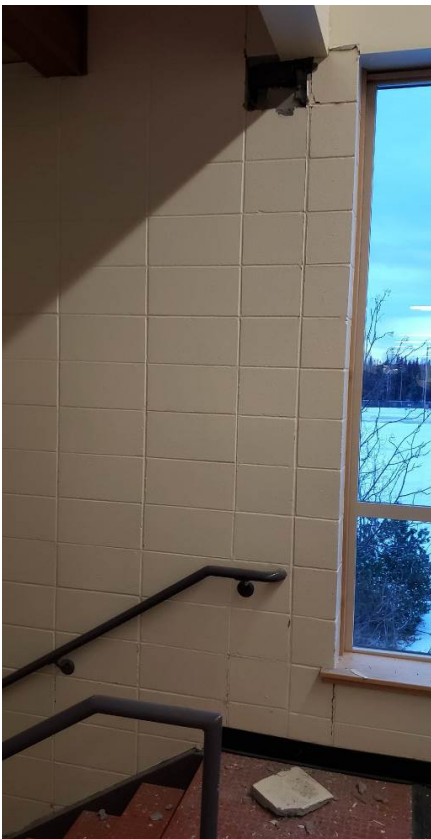
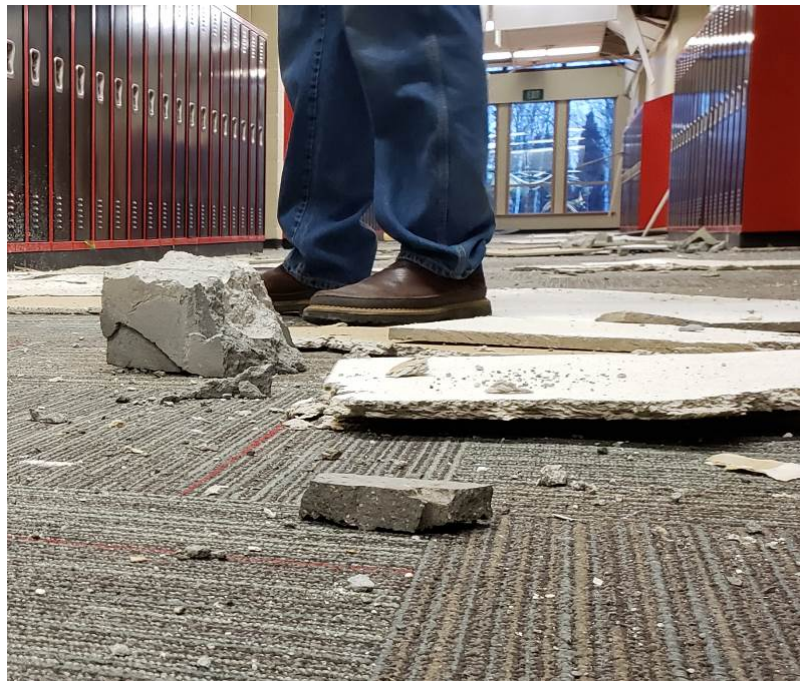
Engineers also determined that CMU was installed unreinforced in some isolated locations at the tops of walls and around structural steel members [7], meaning it was much more easily dislodged. Some blocks broke apart and fell, presenting a significant life safety hazard to anyone in the vicinity. Figure 5 shows fallen block in the Classroom Wing. Other damage included significant cracking of the partially grouted stack-bond CMU walls in the classroom wing, CMU cracking in numerous other locations, and cracking in the gymnasium CMU walls caused by relative motion of the steel roof members, as shown in Figure 6.

Figure 5 – Fallen block at stairs (left) and in hallway (right), Classroom Wing. The latter was dislodged by damage to the steel-girder to CMU wall connections shown in Figure 3. The classroom wing also suffered extensive damage to the suspended ceiling grid and tile, and many tiles fell. Photos: MSBSD

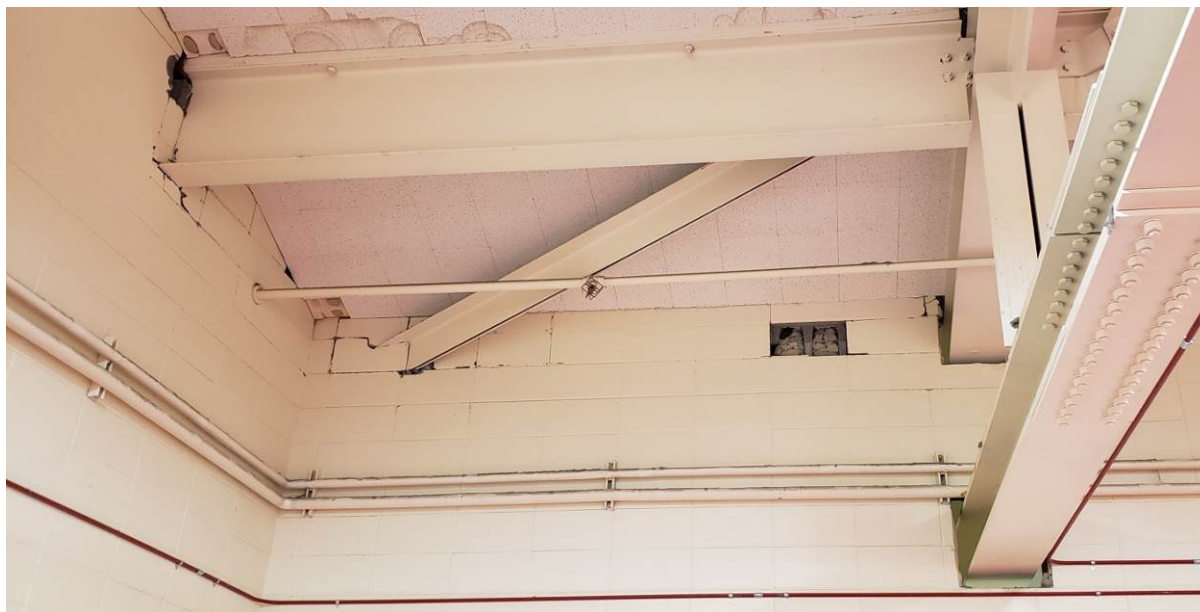
Figure 6 – CMU block at top of wall cracked and loosened due to differential motion of steel roof framing, Houston Middle School. Loose blocks pose a falling hazard to those below. Photo: MSBSD

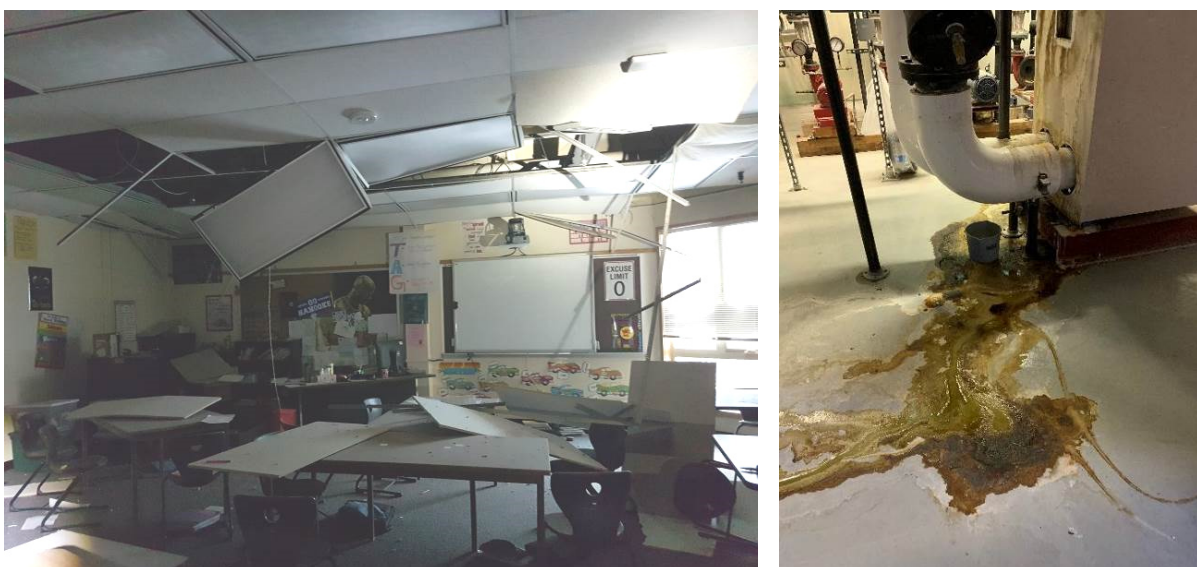
In both districts, far fewer schools suffered structural damage than damage to architectural elements, building systems, other nonstructural components, and contents. Damage to architectural finishes, particularly suspended ceilings and gypsum wallboard, was widespread across both districts. Schools in both districts also reported numerous leaks from pipes carrying water and glycol (a fluid used in heating systems). Unanchored equipment in mechanical rooms also shifted, causing further leaks and damage. Figure 7 shows examples of damage to suspended ceilings and piping.

Figure 7 – Example of major ceiling damage, Houston Middle School (left) and glycol leak due to pipe connection damage, Gruening Middle School (right). Photos: MSBSD (left) and Wael Hassan (right)
