## SEISMIC PERFORMANCE ESTIMATION BY RESPONSE ANALYSIS OF A BUILDING DAMAGED IN THE 2016 KUMAMOTO EARTHQUAKE

*Keywords: Seismic performance estimation; R/C building; Damage evaluation; Observed record; 2016 Kumamoto EQ*

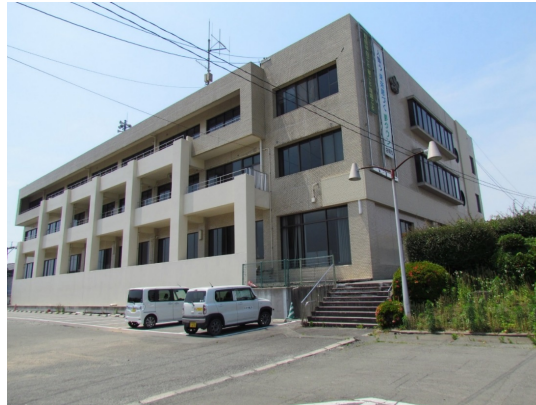
Many buildings were damaged in the 2016 Kumamoto Earthquake. A reinforced concrete government building shown in Photo 1, which was built in 1980 and retrofitted in 2012, was also damaged, making it difficult to continue to use. For this reason, a detailed damage investigation of this building and the foundations <sup>[1],[2],[3]</sup> was conducted. In this paper, we try to estimate these damages by the earthquake response analysis.

Photo 1 –Retrofitted R/C building damaged by the 2016 Kumamoto EQ

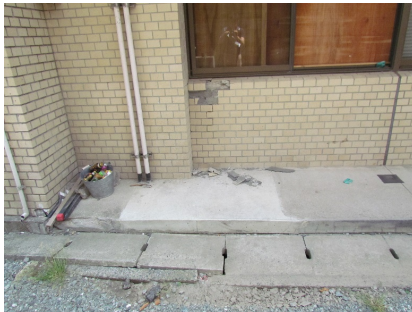
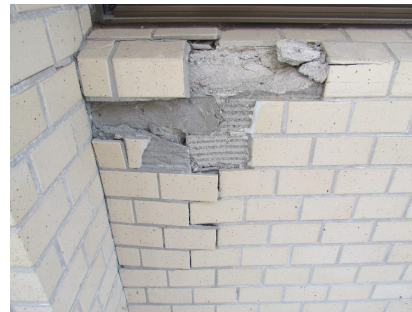
Since the Kumamoto Earthquake occurred on April 16<sup>th</sup>, 2016, damage investigations of this building have been carried out several times. Photo 2 taken on May 2017 shows damage to the spandrel wall of the north Y4 frame, and Photo 3 shows cracks in the seismic retrofit precast R/C outer frame of the south frame. Photo 4 taken in February 2018 shows damage to wall girder above the opening of the wall after removing the finish in the building. Photo 5 taken in two years after the earthquake shows the damage of precast R/C pile and buckled steel pipe pile confirmed when foundation excavated.

Photo 2 – Tile damaged at north Y4 frame spandrel wall

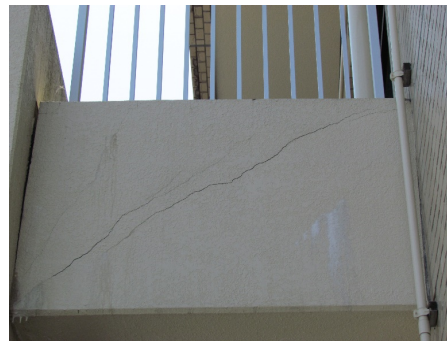
Photo 3 – Crack of connection beam between adding precast frame and existing R/C frame

The maximum response drift angle in y-direction are shown in Fig.9. The same results as x-direction also concluded from the response of y-direction. The maximum drift angle of FX15 responded about 1/400 which damage level showed in y-direction in Photo 3 and Fig. 4.

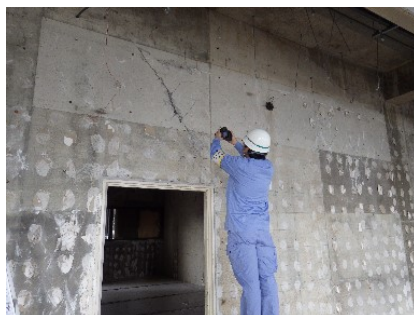
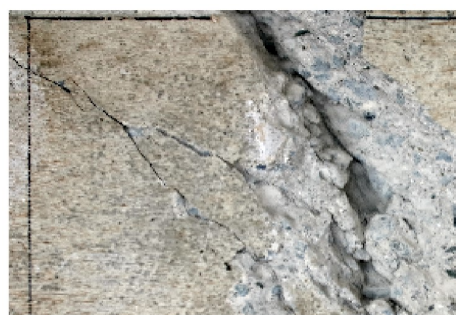
Photo 4 – Shear failure of wall girder above the opening of wall at Y3 frame of x-direction

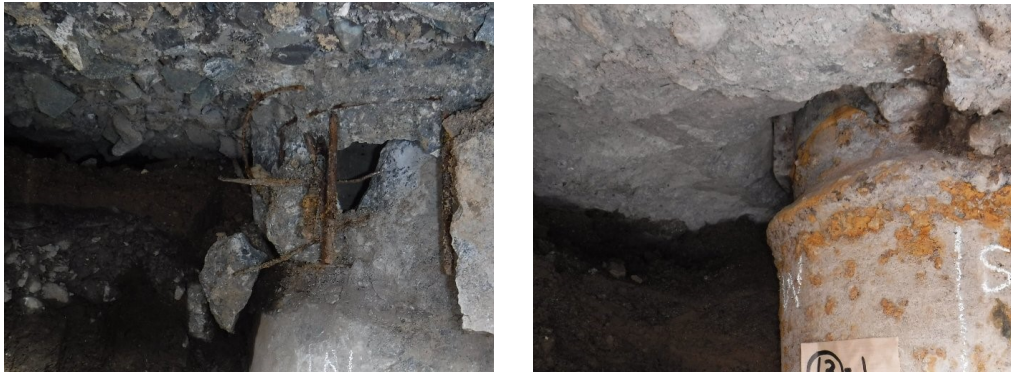
Most of the damage of the foundation concentrated at piles. The foundation tilted greatly toward to the north direction due to the failure of the pile (damaged at the pile head and/or the pile intermediate part).

The maximum relative subsidence of the foundation was 194mm (X1-Y4 footing). The maximum inclination angle in the north-south direction was 0.87% between Y2-Y3 in X10 frame, and the maximum inclination angle in the east-west direction was 0.70% between X1-X2 in Y3 frame. As a result of these, the damage class to the pile foundation classified as a severe damage [6].

Photo 5 – Failure of precast pretensioned concrete pile and buckling of steel pipe pile

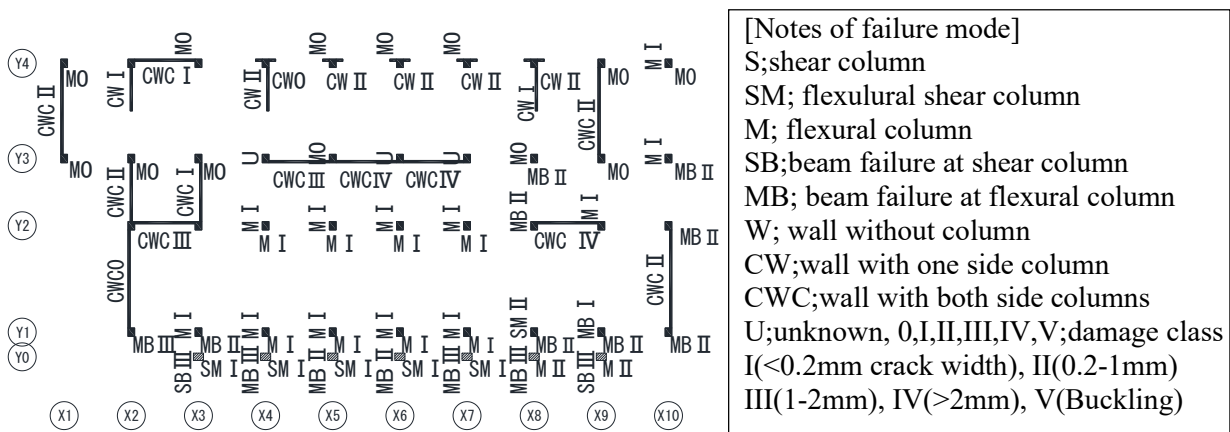
In each floor of the building, the damage class (0 I II III IV V) at the first floor was determined according to the damage classification <sup>[6]</sup> and shown in Fig. 4. Damage class I is defined as some cracks within 0.2mm width observed, and damage class IV is defined as many heavy cracks which is larger than 2mm width observed and reinforcing bars exposed due to spalling of the covering concrete. Here, the damage classified

after removing the finishing. The results of detailed damage assessment in the x-direction of the 1<sup>st</sup> Floor judged as severe damage (seismic residual capacity  $R$  equal to 57.8%), and the result of the y-direction of the 1<sup>st</sup> Floor judged as minor damage (seismic residual capacity  $R$  equal to 82.7%). In addition, the original structure before retrofit damaged more than the seismic retrofitted structure.

Fig. 4–Damage level at the 1<sup>st</sup> story
