## DAMAGE AND IMPACTS FROM THE 2018 M5.9 PORT-DE-PAIX, HAITI EARTHQUAKE

J. Rodgers<sup>(1)</sup>, G. Mentor-William<sup>(2)</sup>, S. Symithe<sup>(3)</sup>, R. Gilles<sup>(4)</sup>, G. Dévilme<sup>(5)</sup>, J.-H. Petit<sup>(6)</sup>, R. Jose<sup>(7)</sup>, A. Morales-Cartagena<sup>(8)</sup>, and S. William<sup>(9)</sup>

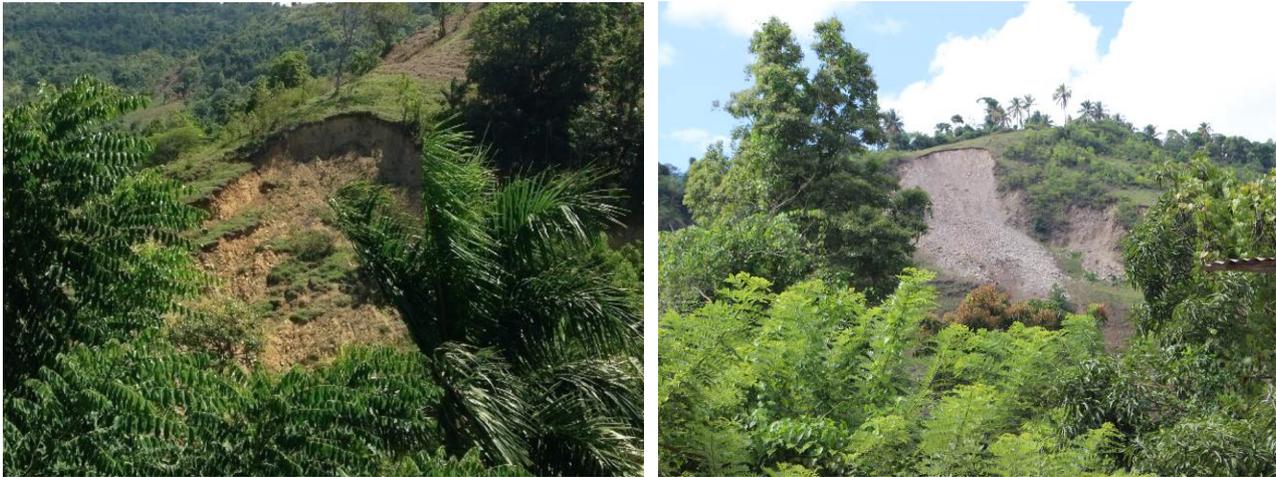
At least one landslide in the La Crête Formation in Port-de-Paix and one in Pilate were reported, shown in Figure 2. It is unknown if these landslides were caused by the earthquake alone; slopes may have been saturated by rain from Tropical Storm Isaac, which hit the northwest coast of Haiti in September 2018, causing floods in the area until the end of the month. This multi-hazard environment may have been responsible for triggering these landslides.

Figure 2 – Landslides in La Crete formation (left); and Pilate (right). Photos: BME (left) and DPC (right).

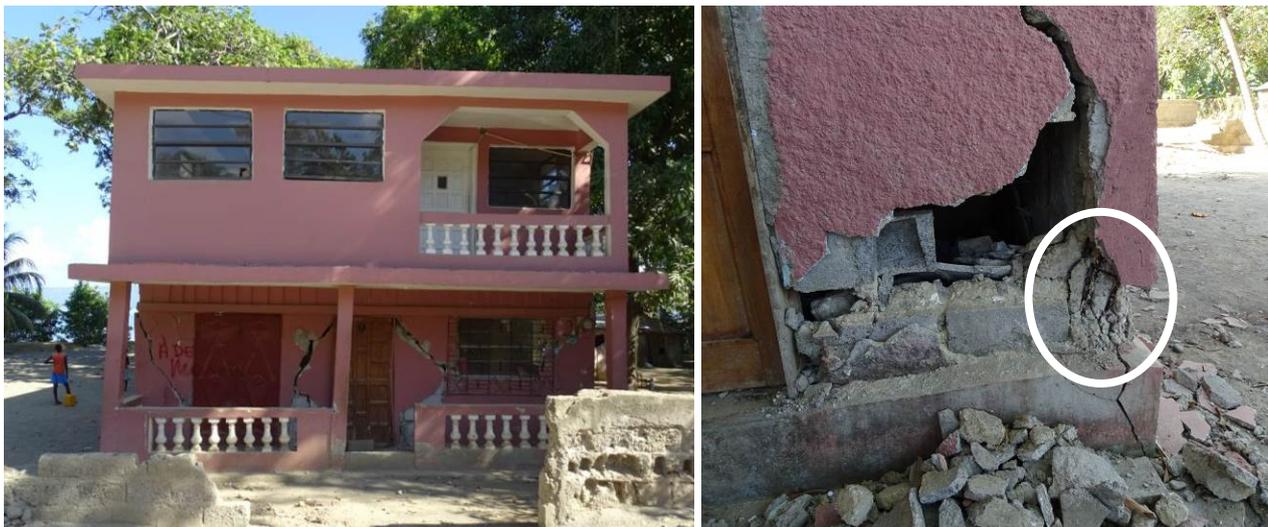
Figure 3 – Damaged concrete block residence in Saint-Louis-du-Nord (left) with some small tie columns (white circle) only in certain locations and not around all openings (right). Photos: Janise Rodgers, GHI.

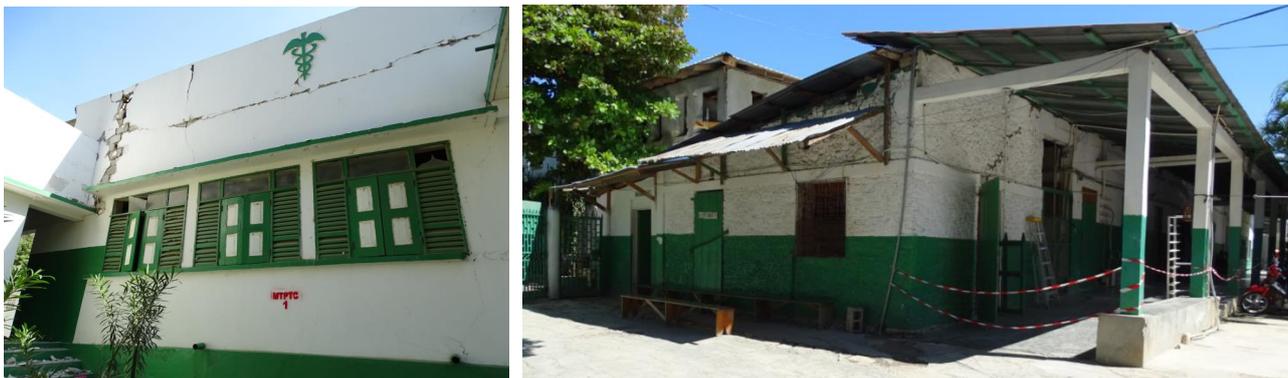
In Port-de-Paix, the main hospital's buildings suffered varying degrees of damage. The surgery building in Figure 4 suffered wall damage at both ends and was red-tagged by MPTPC. Several other buildings had lesser damage and were yellow-tagged. Patients from the surgery building and the internal medicine department were evacuated at the time of the visit, and being treated in a tent in the hospital courtyard. The internal medicine department was in a yellow tagged building, and patients were fearful of remaining inside due to aftershocks.

Figure 4 – Damage to surgery building in Port-de-Paix (left) and pediatrics building in Gros Morne (right).  
Photos: Janise Rodgers, GHI.

The Gros Morne hospital contains a number of buildings of varying ages and construction types. The apparent oldest, a stone masonry building built in perhaps the 1960s, suffered severe damage and was cordoned off with caution tape, as Figure 4 shows. It had not been officially red-tagged, but the building was not in use. The hospital has a range of single story buildings of varying ages and construction types ranging from stone masonry with some concrete members, to concrete block, to confined masonry. Many of these buildings had cracks in their masonry gables, often across the base, but the gables had not fallen. Some

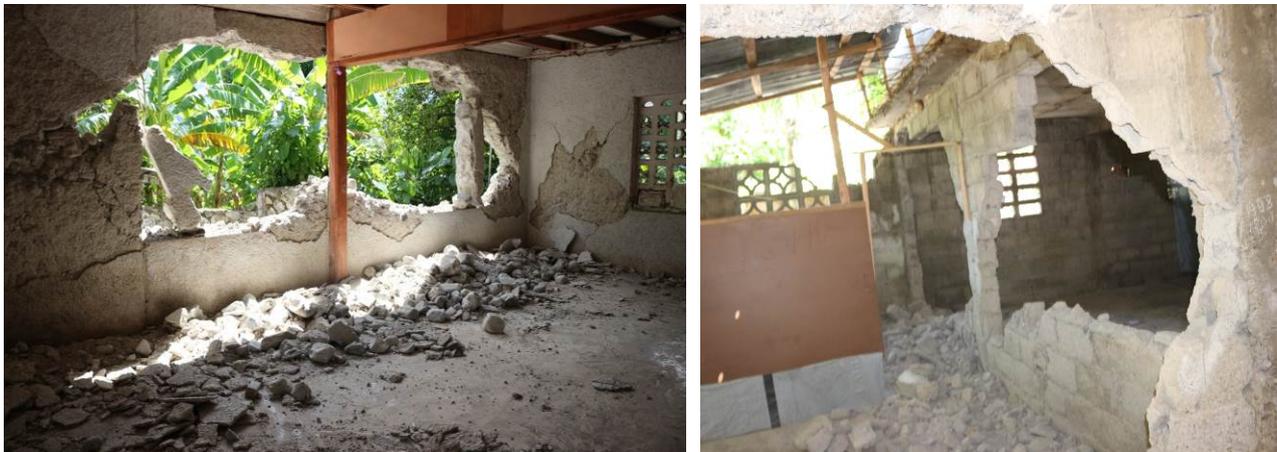
In Port-de-Paix, we observed significant damage at two private schools, and moderate damage to the government high school. In Pilate, the DPC team observed significant damage at schools. Rubble stone masonry piers in both a two story building and a single story building experienced severe cracking, and some walls experienced partial collapse. At the private Ecole Evangel Emmanuel, a concrete block demising wall between classrooms partially collapsed, and other walls were severely cracked. Figure 5 shows typical damage to both schools. In Saint-Louis-du-Nord, the GHI team visited the high school. The older building had suffered some modest cracking in few walls, in a newer part of the building. Other buildings appeared undamaged.

Figure 5 – Collapsed exterior stone masonry school wall in Pilate (left); damaged interior walls at Ecole Evangel Emmanuel in Pilate (right). Photos: Jean-Henri Petit, DPC.

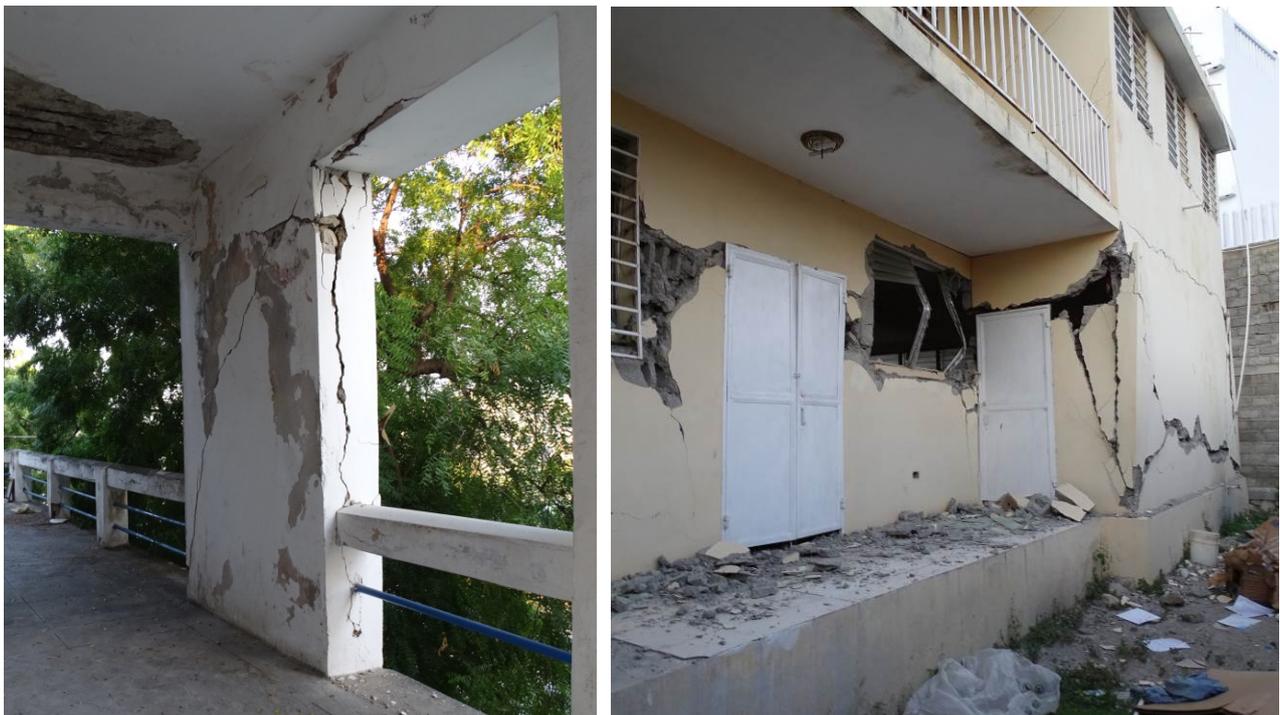
The GHI team visited the police stations in Port-de-Paix and Gros Morne, both of which had buildings that suffered significant damage and were red-tagged by MPTPC. The Port-de-Paix Police Commissariat is a two-story stone masonry building built in 1976, with reinforced concrete floors and *galeries* (exterior corridors). Walls throughout the building suffered shear cracking. The second story was especially badly damaged, with piers severely cracked and in some cases having the two stone wythes partially delaminated. One corner of a second-story room partially collapsed. An adjoining two-story concrete frame and block prison building constructed in 2004 experienced wall cracking in the ground story, and was yellow-tagged by MPTPC. A nearby courthouse and municipal administration building appeared undamaged. A fairly recently built semi-confined masonry education office also nearby was badly damaged and red-tagged. In Gros Morne, the single story stone masonry police station suffered significant shear cracking, and was red-tagged by MPTPC. A new building constructed in the 2000s was undamaged, as was the recently built court building several blocks away.

Figure 6 – Second-story stone masonry pier with shear cracking and partial delamination of the inner and outer wythes, Police Commissariat, Port-de-Paix (left); Severely damaged semi-confined masonry education office, Port-de-Paix (right). Photos: Janise Rodgers, GHI.
