## DAMAGE TO TELECOMMUNICATION FACILITIES IN THE 2016 KUMAMOTO EARTHQUAKE

M. Okutsu<sup>(1)</sup>, A. Ito<sup>(2)</sup>, K. Itasaka<sup>(3)</sup>, M. Tanaka<sup>(4)</sup>, G. Shoji<sup>(5)</sup>, T. Suzuki<sup>(6)</sup>

### **Abstract**

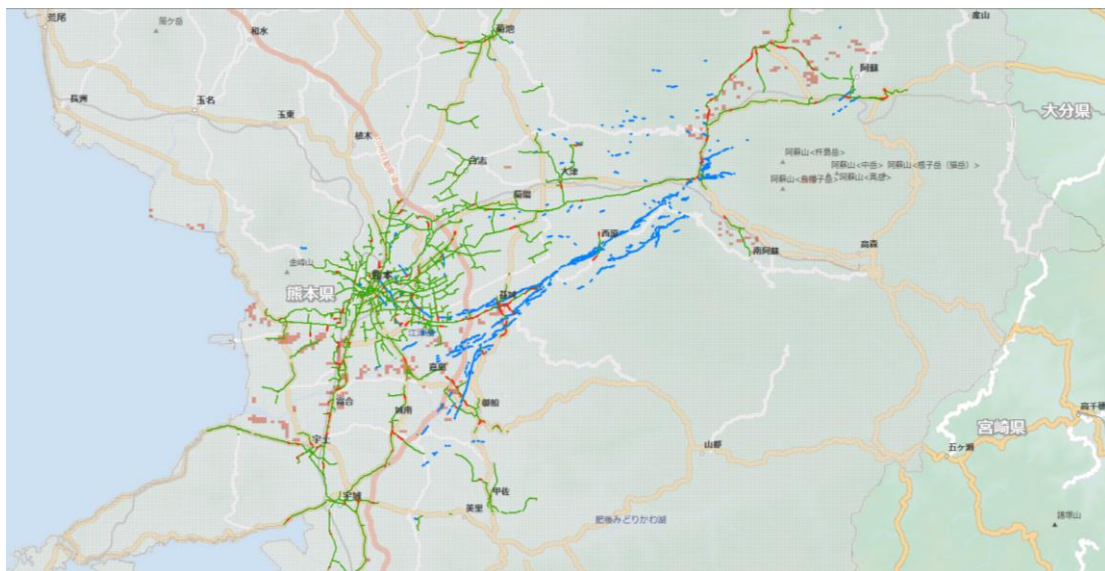
Fig. 1 Distribution of inspected conduits

Fig. 1 shows the distribution of the communication conduits. The red lines represent damaged spans, the green lines represent undamaged spans, the blue lines represent surface earthquake faults, and the pink rectangle represents the 250-m mesh values for liquefaction. Fig. 2 shows some examples of conduit damages.

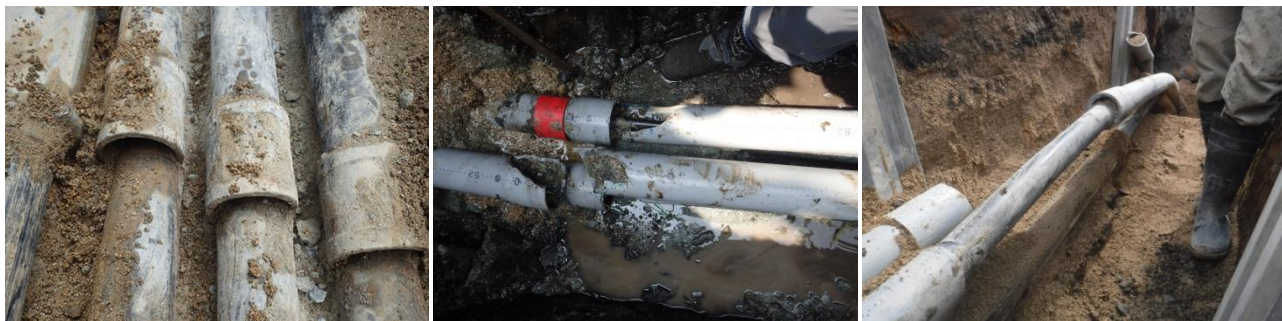
Fig. 2 Examples of conduit damage

(a) Threaded-joint

(b) Adhesive-joint

(c) Large deformation

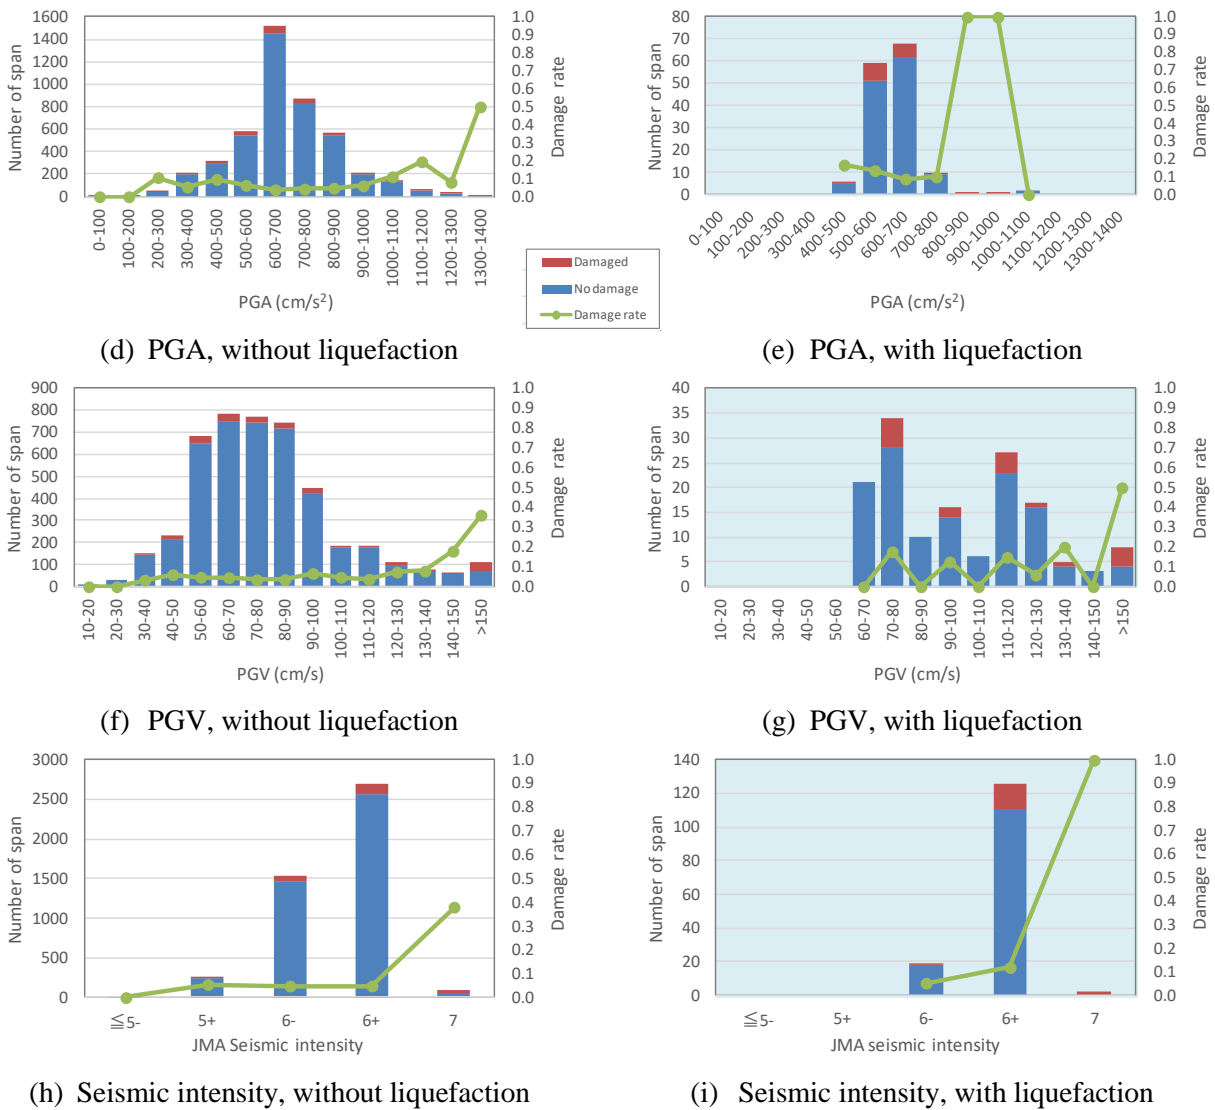
Fig. 3 Conduit damage regarding seismic motion

First, the characteristics of the ground-motion intensity and the damage to communication conduits were analyzed. Fig. 3 shows relationship between conduit damage and seismic motion index. In the following figures, instances of damage are classified as "with liquefaction" and "without liquefaction." Because there were many data instance without liquefaction, the overall tendency was similar to that case.

The damage rate was almost the same until the intensity of the seismic motion reached a certain value, and then it tended to increase from that value. In cases with liquefaction, the damage rate was higher in areas where the PGA was more than 800 cm/s<sup>2</sup> and areas where the PGV was more than 150 cm/s. We must carefully consider this result, however, because the number of data instances was small. In cases without liquefaction, the damage rate tended to increase when the PGA exceeded 900 cm/s<sup>2</sup> and the PGV exceeded 120 cm/s. As for the JMA seismic intensity, damage started to appear from just over 5+, remained almost the same up to 6+, and rapidly increased at 7. This tendency is similar to the findings of Yamazaki et al[2].

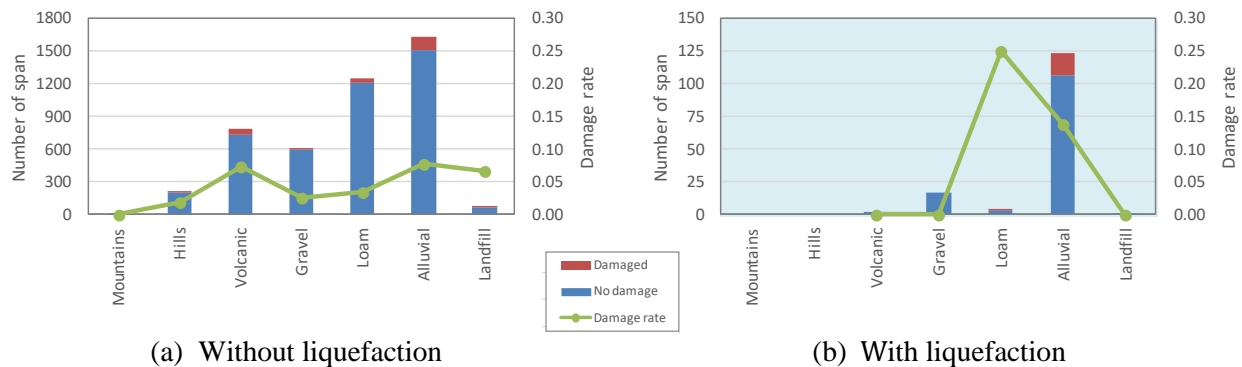
Fig. 4 Conduit damage regarding topography

Using the method of Shoji et al.[3], we classified the micro-topography into the 10 types listed in Table 5. Fig. 4 shows the relationship between conduit damage and topography. In terms of micro-topography, the damage rate was highest in alluvial plains, which are considered soft ground, followed by volcanic areas and volcanic foothills. Looking at the alluvial plains in detail, the damage rate was dominant in back marshes and relatively high in fans and natural embankments. One characteristic of the Kumamoto Earthquake was that the damage rate was high in volcanic foothills, which are considered better topography than back marshes. These micro-topographic categories are concentrated in Mashiki and Aso. Many surface earthquake faults have been confirmed in Mashiki, and strong earthquakes equivalent to the Great Hanshin Earthquake have been observed. On the other hand, ground deformation in Aso has been confirmed over a wide area.

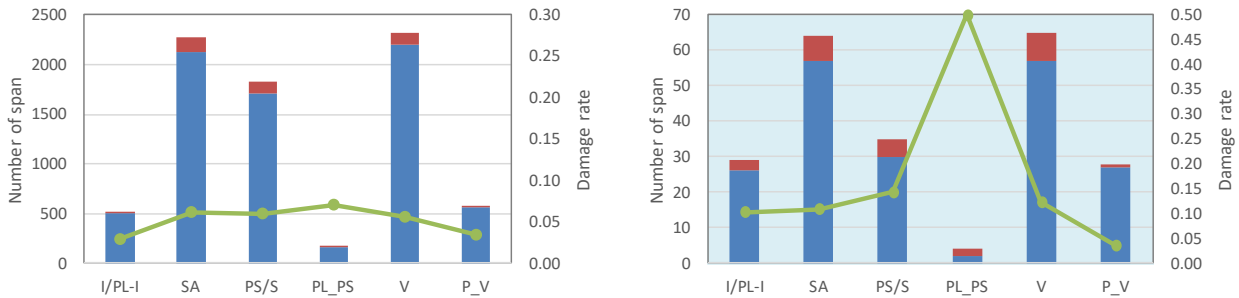
(a) Without liquefaction (b) With liquefaction  
Fig. 5 Conduit damage regarding pipe type

As mentioned above, various pipe types are used in communication conduits. As listed in Table 3, we classify pipes into six types from the viewpoint of the material and joint structure: cast-iron pipe (I/PL-I), threaded-joint jute-wound steel pipe (SA), threaded-joint polyethylene-coated steel pipe (PS/S), push-on lock-joint steel pipe (PL-PS), adhesive-joint hard vinyl pipe (V), and push-on lock hard vinyl pipe (P-V). Fig. 5 shows the inspection results. The types SA, PS/S, and V, which have no expansion or contraction under the old standard, had relatively high damage rates. PL-PS also had a high damage rate. The mode of all damage was bending at joints. Although joints were bent so that the inspection equipment could not pass, no detachment was found with the pipe camera, and there was no effect on the cable.

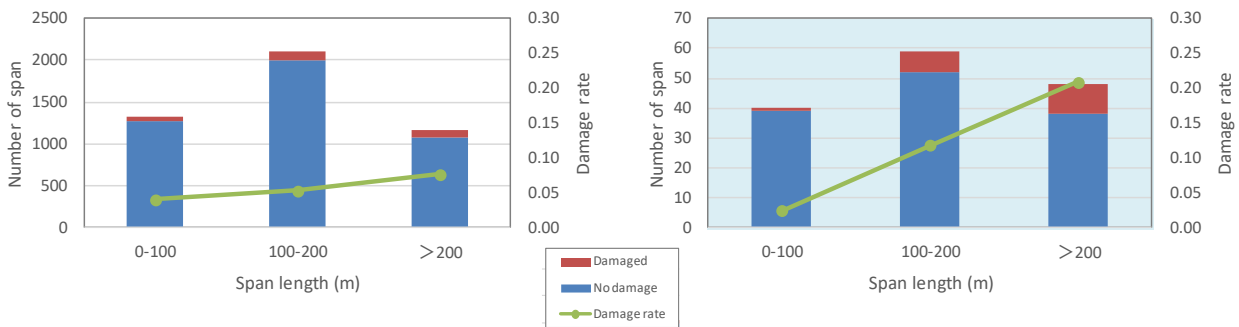
(a) Without liquefaction (b) With liquefaction  
Fig. 6 Conduit damage regarding span length

Fig. 6 shows the inspection results by span lengths, grouped into 100-m ranges. It can be seen that the damage rate increased with the span length. This is similar to the tendency observed during the 2011 Great East Japan Earthquake. It is thought that as a span becomes longer, a greater length is affected by the seismic ground motion, making the pipe more likely to be damaged.

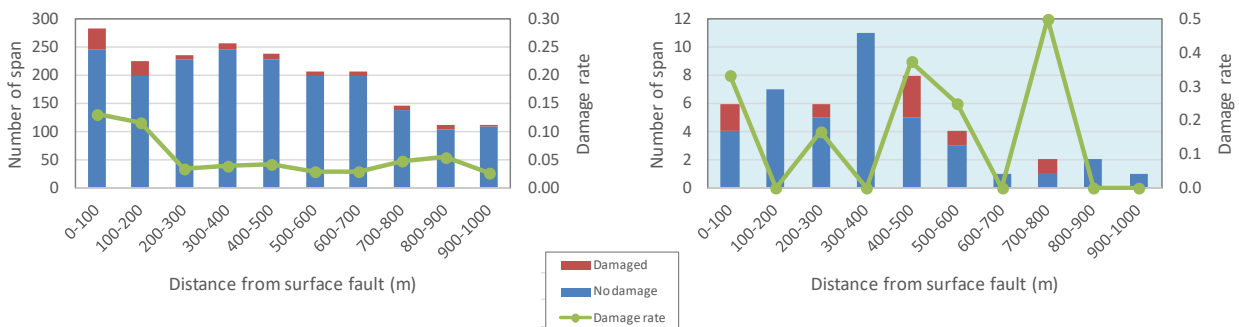
(a) Without liquefaction (b) With liquefaction  
Fig. 7 Conduit damage regarding distance from surface fault

One feature of the Kumamoto Earthquake is that many surface earthquake faults have been identified. The distance from the manholes at both ends of a conduit span to a surface earthquake fault was calculated using a geographic information system (GIS), and the shorter distance was taken as the distance from the fault to that span. Fig. 7 shows the inspection results grouped into 100-m ranges, up to 1000 m from a fault.

In cases without liquefaction, the damage rate was relatively high up to a distance of 200 m from a surface earthquake fault, and then it was almost flat. In cases with liquefaction, there was no clear relationship with distance, but note that the number of samples was small.

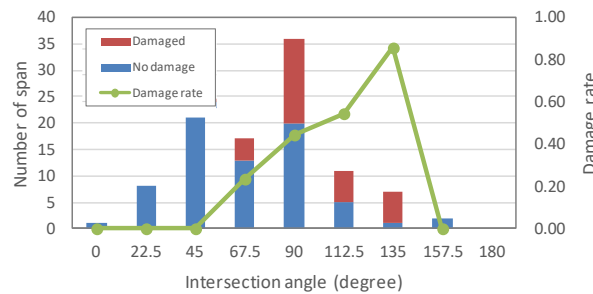
Fig. 8 Conduit damage regarding intersection angle

Of 103 conduit spans crossing surface earthquake faults, 32 had damage, giving a damage rate of 0.31. This damage rate is five times higher than that of the Kumamoto Earthquake overall. Fig. 8 shows the inspection results for various angles of intersection between the surface earthquake fault and the conduit span. Note that the number of samples was small. Nevertheless, the damage rate was small when the intersection angle was small, but it was high in the range of 45° to 135°, with a peak at 135°. Note that, while actual conduits may be laid in a curve to follow a road, only the coordinates of the manholes at both ends are captured in the equipment data used for the analysis. Therefore, in calculating the intersection angle, a conduit was treated as a straight line connecting two points.

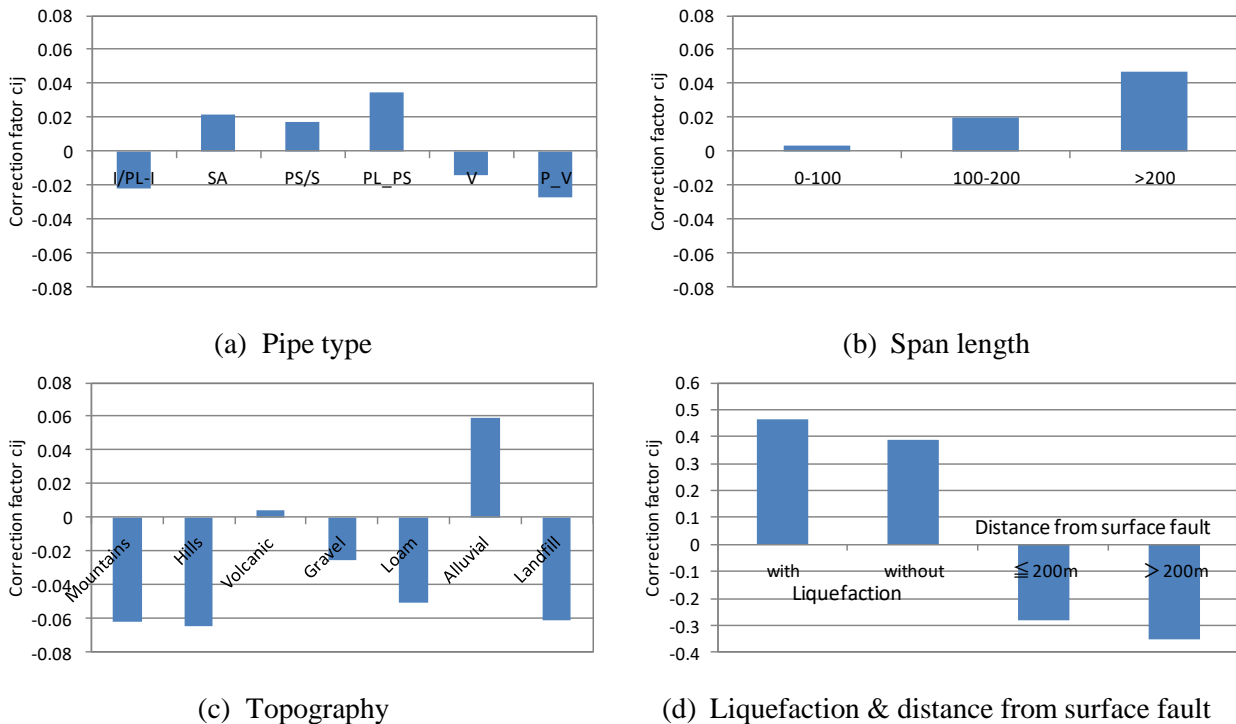
Fig. 9 Correction coefficients

Fig. 9 shows the calculation results for the correction coefficient  $c_{ij}$ . From the figure, the correction coefficient was large for steel pipe and maximal for PL-PS. For SA and PS/S with threaded joints, the damage rate was high even in past earthquakes, which is consistent with this result. Regarding PL-PS, the damage rate was low in past earthquakes, so the cause was separately examined. In the study of Shoji et al.[3], the coefficient of V was the largest, but in this study it was small. As for the span length, the coefficient tended to increase as the length increased, which is the same tendency as for the damage rate and in the research by Shoji et al.[3]. The micro-topographic classification was positive for alluvial plains and volcanic terrain and had the same tendency as the damage rate. For liquefaction, the coefficient was larger with it than without it, reflecting the general tendency. The coefficient of the distance from a surface earthquake fault was negative, but it was larger within a distance of 200 m, which was also the same tendency as for the damage rate.
