## ANALYSIS OF BUILDING DAMAGE IN ABIRA TOWN DUE TO THE 2018 HOKKAIDO EASTERN IBURI EARTHQUAKE, JAPAN

K. Horie<sup>(1)</sup>, K. Kawabe<sup>(2)</sup>, M. Inoguchi<sup>(3)</sup>, M. Matsuoka<sup>(4)</sup>, K. Torisawa<sup>(5)</sup>, W. Liu<sup>(6)</sup>, F. Yamazaki<sup>(7)</sup>

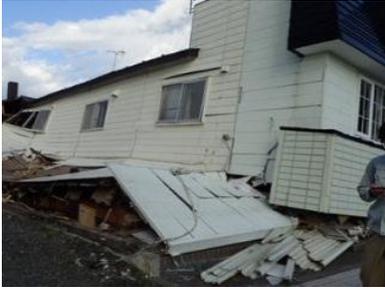
We conducted a field survey in the affected area after the earthquake and found severely damaged buildings by various causes such as damaged by strong shaking in Abira Town and Mukawa Town where strong motion was observed, buildings crushed by large-scale landslides in Atsuma Town, and buildings damaged by liquefaction over a wide area in/around Sapporo City as shown in Fig. 2 (a), (b), and (c).

(a) Completely collapsed building by strong motion in Mukawa Town

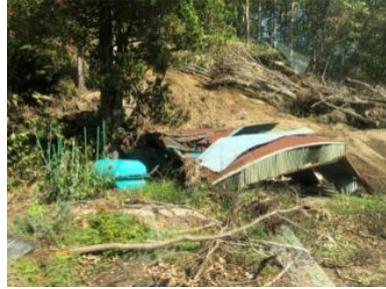
(b) Crushed building by landslides in Atsuma Town

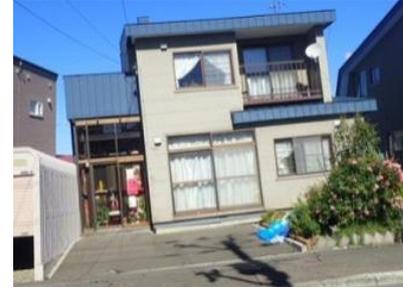
(c) Tilted building by liquefaction in Sapporo City

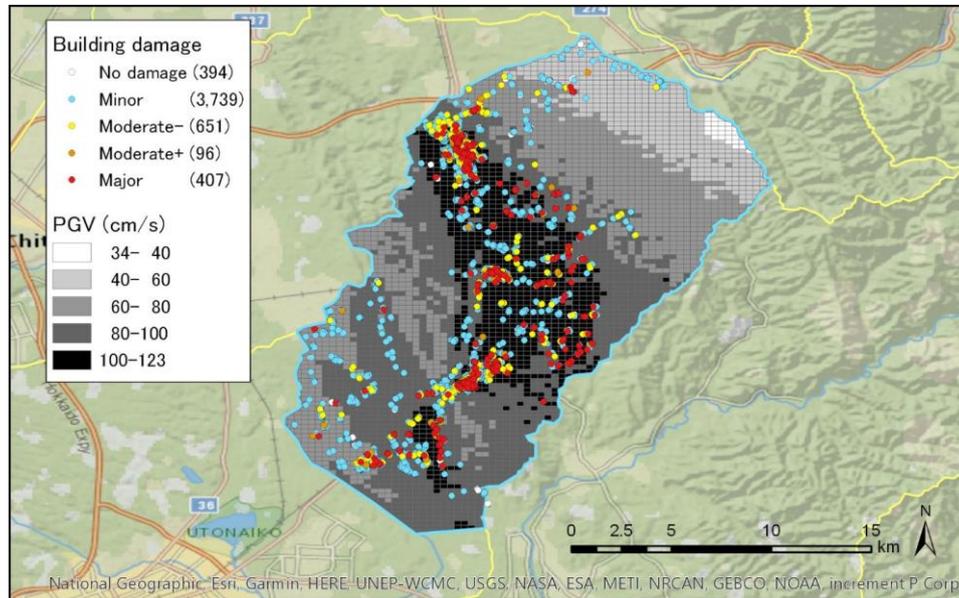
Fig. 7 – Building damage assessment using DATS in Abira Town

The building data are plotted on a layer of the estimated PGV distribution using GIS as shown in Fig. 7. It is confirmed that the major damaged buildings were distributed in the area where the seismic motion was relatively large.

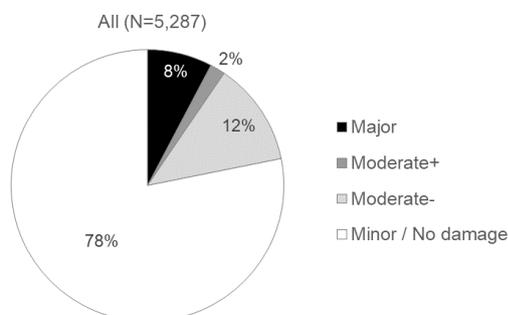
(a) Damage classification

Figure 8 (a) shows the damage classification for the all buildings in Abira Town; 8% of them were major damaged and 22% were moderate- or more damaged. Figure 8 (b) shows the breakdown of damage by the occupancy type. A comparison of the major damage ratio shows that 3.7% of residential and 12.6% of non-residential buildings, indicating that the damage ratio of non-residential buildings was higher than that of residential ones.

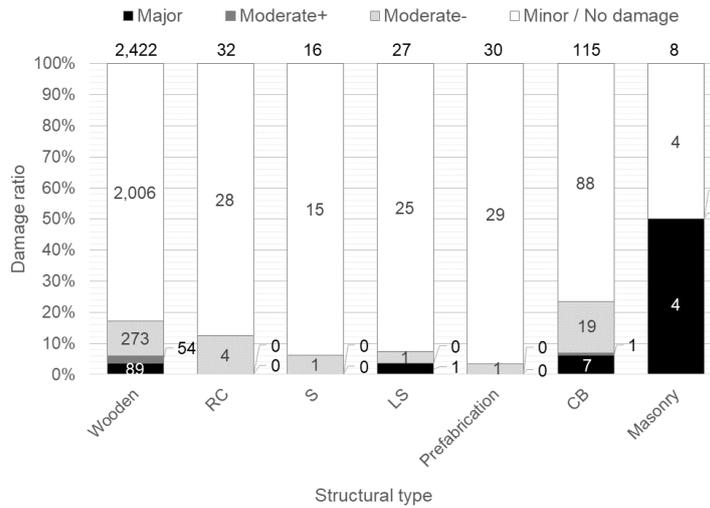
Fig. 9 – Damage classification for the residential buildings with respect to the structural type

A detailed damage analysis was carried out for the residential buildings because various supports for rebuilding the livelihood of disaster victims are provided based on the damage level of their houses. Figure 9 shows the damage classification for the residential buildings with respect to the structural type. The ratio of major damage for each structural type is in the order of Masonry, CB, Wooden, and LS. There were no major damaged houses in the structural type of RC, S and Prefabrication.

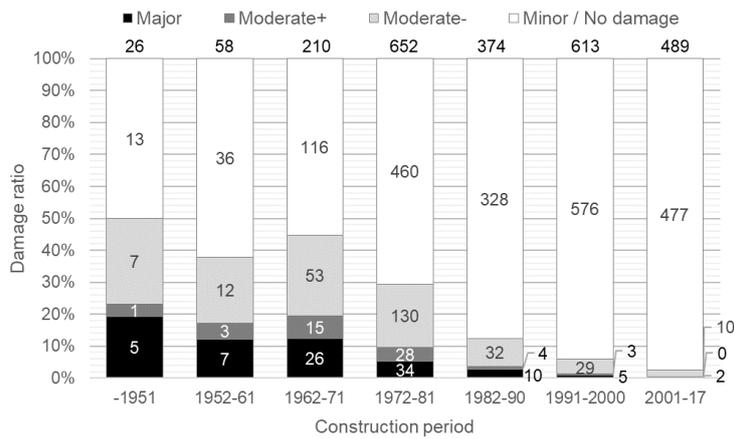
Fig. 10 – Damage classification for wooden houses with respect to the construction period

Figure 10 shows the damage ratio of wooden houses in Abira Town with respect to the construction period and damage grade. The damage ratio tends to get smaller as the construction period becomes newer. The major damage ratio is greatly declined after 1982 as the effect of the revision of seismic provision. Note that the seismic provision for wooden buildings was further upgraded in 2000.

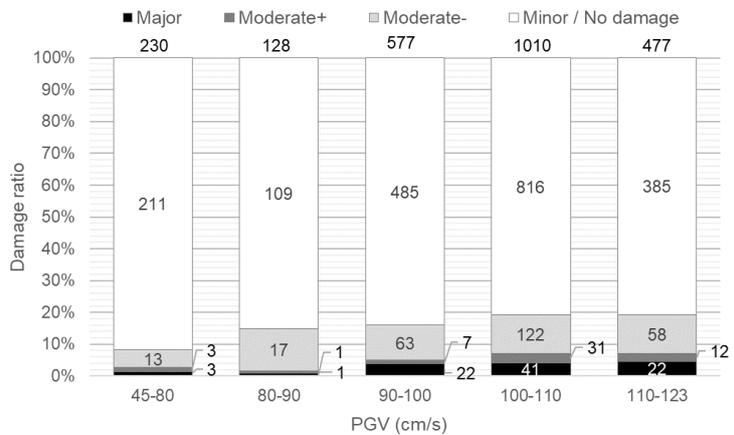
Fig. 11 – Relationship between the estimated PGV and damage class of wooden houses

Figure 11 shows the relationship between the estimated PGV and the damage classification of wooden houses. It was found that the major damage ratio tends to increase as the seismic motion increases.

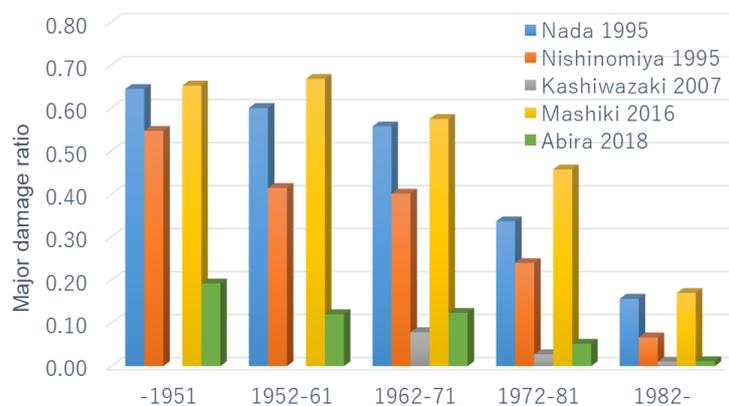
Fig. 12 – Compares the major damage ratio class for wooden buildings with respect to the construction period for five different datasets in Japan.

In the damage category, "Major" representing a monetary loss over 50% is most important since the demolition of the building is a normal situation for this class. Figure 12 compares the ratio of major damage class for wooden buildings with respect to the construction period for Nada Ward in Kobe City [1] and

Nishinomiya City [16] due to the 1995 Kobe earthquake, Kashiwazaki City [17] due to the 2007 Niigata-Chuetsu-Oki earthquake, and the Mashiki Town [3] due to the 2016 Kumamoto earthquake, and Abira Town data in this study. For the same construction period, the major damage ratio of Abira Town is almost the same level as that of Kashiwazaki City and is much lower than those in Nada Ward, Nishinomiya City, and Mashiki Town.

The major damage ratio of Abira Town and Kashiwazaki City was much lower than the other three locations although the strong motion records are in the comparable level. One of reason is considered to explain this discrepancy. In the western Japan, like Kobe and Kumamoto, wooden houses are more vulnerable than those in the eastern (northern) Japan since typhoons are more frequent natural hazards than earthquakes, and thus heavy roofs were dominant for older wooden houses in the western Japan.
