FACTORS AFFECTING BUILDING DAMAGE INDUCED BY THE SEPTEMBER 2017 MEXICO EARTHQUAKES

E. Lekkas⁽¹⁾, S. Mavroulis⁽²⁾, P. Carydis⁽³⁾

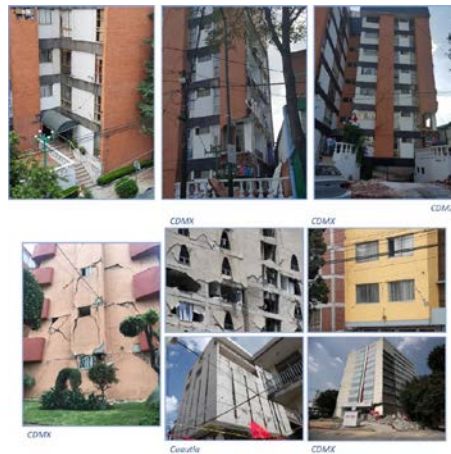
Several R/C buildings with exterior non-structural damage were observed in the Oaxaca and Chiapas states induced by the first earthquake and in the Greater Mexico City area and Puebla and Morelos states induced by the second earthquake (Fig. 7, 8). This damage comprised horizontal and subhorizontal cracks in the infill walls mainly in Oaxaca and Chiapas states induced by the first earthquake and diagonal cracks in the Greater Mexico City area caused by the second earthquake (Fig. 7, 8). Moreover, detachments of plaster pieces from the infill walls, detachment of the infill walls from the surrounding R/C frame, and partial or total collapse of infill walls as well as damage to window, parapets on balconies and ornamental molding along the roof line of older buildings induced by both earthquakes (Fig. 7, 8). The generation of horizontal and subhorizontal cracks is attributed to the prevalence of the vertical component of the earthquake ground motion, while diagonal cracks are due to the prevalence of the horizontal one.

Fig. 7 – Non-structural damage in RC buildings in Mexico City (Ciudad de México: CDMX) and Cuautla (Morelos State).

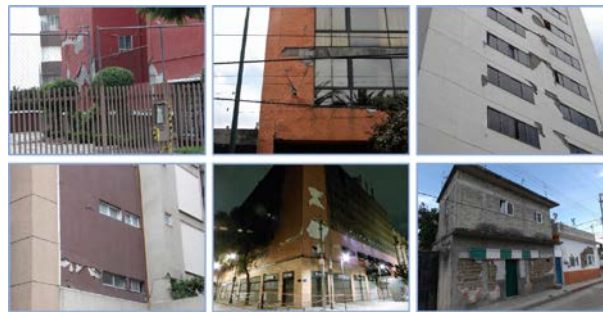
Fig. 8 – Non-structural damage to R/C and mixed type buildings in the affected area due to the September 19, 2017 M 7.1 Puebla-Morelos earthquake. Cracks in the infill walls and detachment of pieces of plaster from the infill walls.

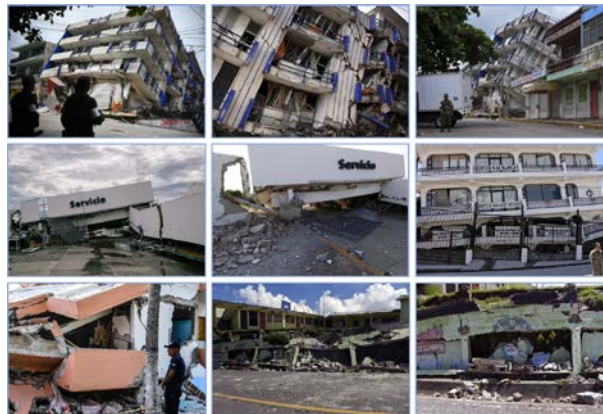
R/C buildings in Oaxaca and Chiapas states suffered very heavy structural damage from the first earthquake (Fig. 9). The common characteristic of the inspected buildings was the decomposition of the concrete in the columns of the ground floor due to crushing resulting in failure of columns and the subsequent tilting or the vertical collapse within the plan of the ground floor, while the upper floors of the structures were left practically intact. This damage is typical of an earthquake with prevalence of the vertical component of the earthquake ground motion over the limited horizontal component [12; 13]. As regards the impact on the building stock of Mexico City, there was no damage reported by the first earthquake. Only some buildings were trembled forcing residents to evacuate.

Fig. 9 – R/C buildings in Oaxaca State with damage induced by the September 7, 2017 earthquake.

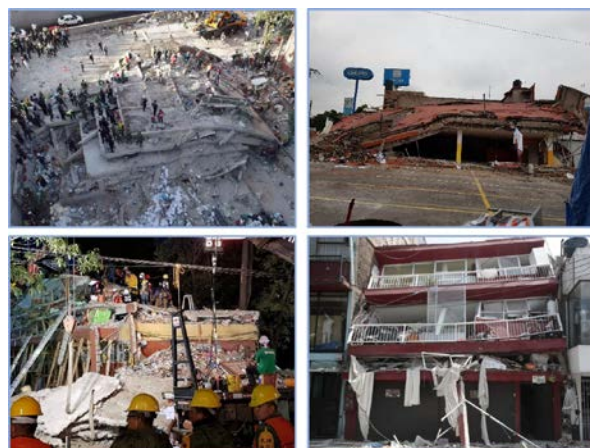
Moreover, the total collapses induced by the second September 2018 earthquake were observed in buildings that appeared to have structural deficiencies including soft stories, structural irregularities, and discontinuous or incomplete lateral load paths (Fig. 11).

Fig. 11 – Very heavy structural damage (total collapse) of buildings in the Greater Mexico City area induced by the second earthquake in September 2018.

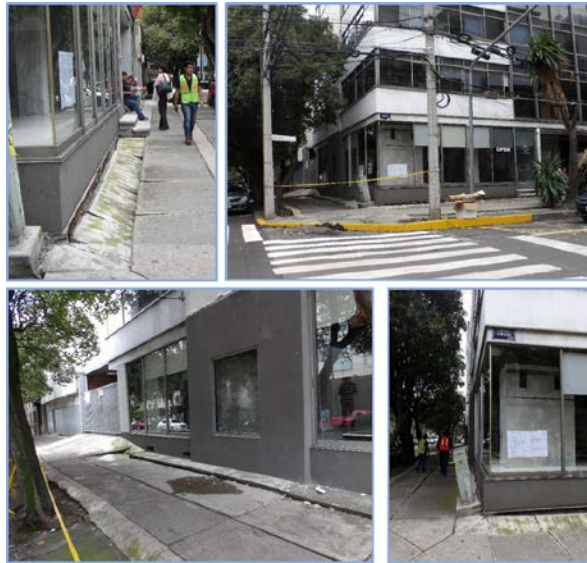
The most common structural damage to the R/C buildings in the Greater Mexico City area was mainly attributed to differential settlement (Fig. 12) and the subsequent foundation movement and to building

pounding (Fig. 13). Buildings affected from these phenomena were still standing after the earthquake. They either tilted due to differential settlement (Fig. 12) or suffered heavy damage due to pounding (Fig. 13).

Fig. 12 – Tilting of buildings in Mexico City due to the September 19, 2017 earthquake and the related differential displacement affecting the building foundation. The structural components of the building were generally undamaged.

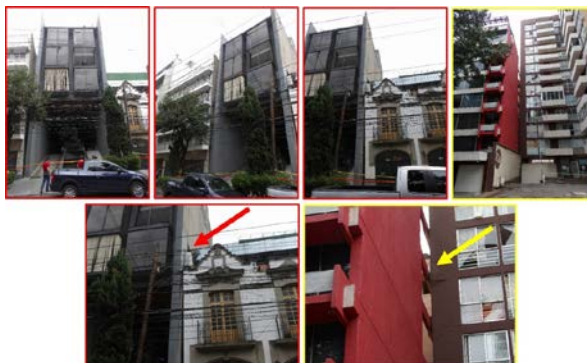
Fig. 13 – Damage induced by pounding between closely spaced buildings due to the September 19, 2017 earthquake.

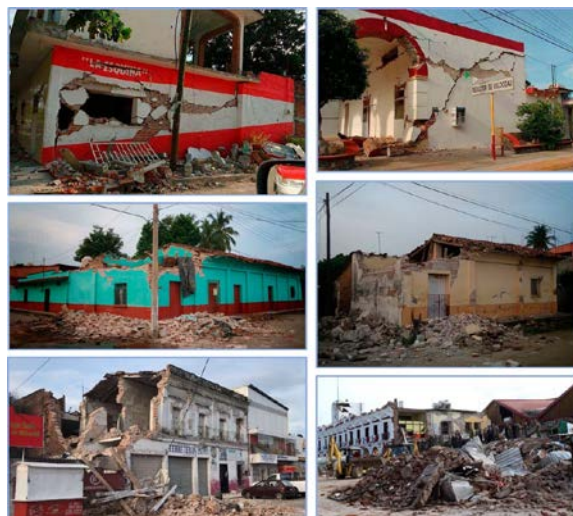
The adobe buildings suffered non-structural and structural damage by both September 2017 earthquakes. The non-structural damage generally comprised detachment of plaster from and light cracking of the walls (Fig. 14). In Oaxaca and Chiapas states affected by the first earthquake, the structural damage to the adobe and masonry buildings comprised extended cracks in the load-bearing walls and partial or total collapse of the walls. The presence of horizontal or subhorizontal cracks in the majority of the observed structures, damage in the upper part of the structures, the symmetrical distribution of damage in the upper corners of the structures as well as the partial collapse with the still standing part left intact by the earthquake (Fig. 14) are damage indicative of the prevalence of the vertical component of the earthquake ground motion over the horizontal one [12, 13]. In Puebla and Morelos states affected by the second earthquake, similar structural damage were also observed (Fig. 15).

Fig. 14 – Non-structural and structural damage induced by the first earthquake on September 7, 2017 to the adobe and masonry buildings in Oaxaca and Chiapas states.

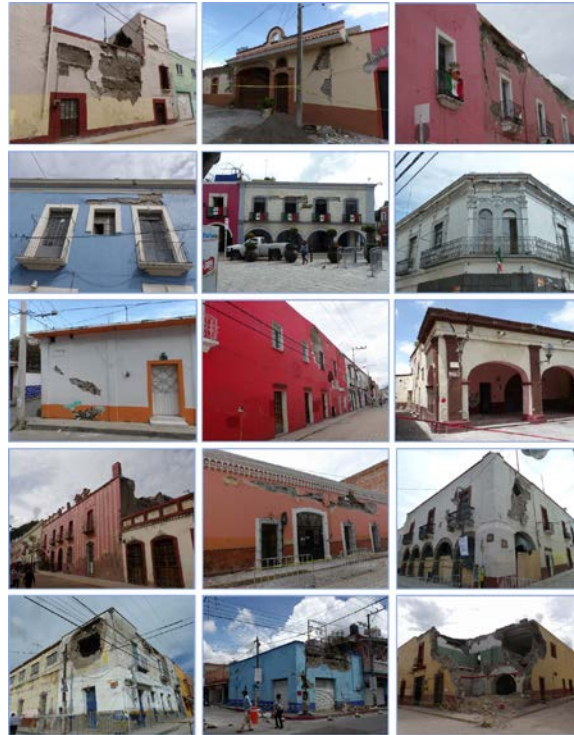
Fig. 15 – Non-structural and structural damage induced by the second earthquake on September 19, 2017 to the adobe and masonry buildings in Puebla and Morelos states.
