DAMAGES IN NON-STRUCTURAL ELEMENTS OF R.C. RESIDENTIAL BUILDINGS CAUSED BY THE 2011 LORCA EARTHQUAKE

Abstract

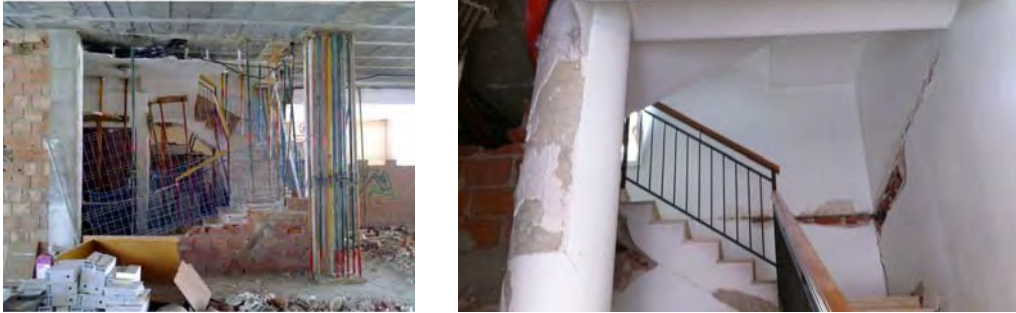
-Damages to unreinforced masonry infill walls located on vertical communication cores: a significant number of buildings presented damages to these elements. The main consequence associated with the damage to these elements is that they prevent the users of the building from being evacuated safely.

Fig. 3 – Damages to unreinforced masonry infill walls located on vertical communication cores

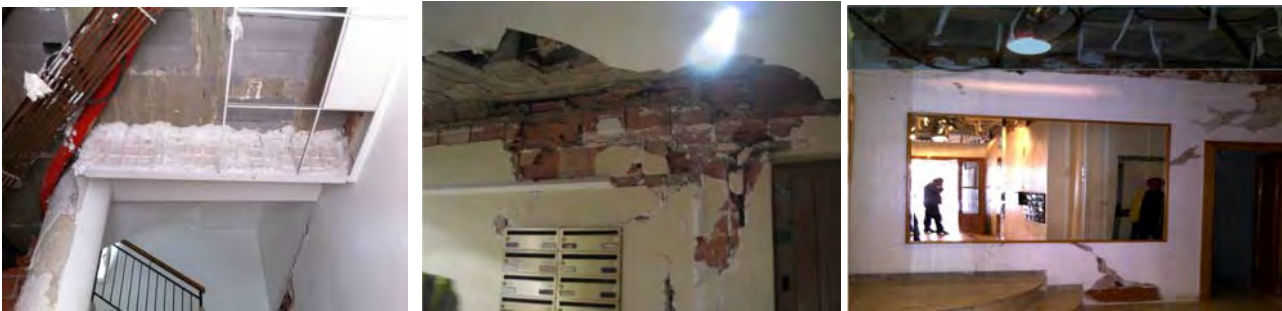
-Damages to non-structural elements located in the common areas of the ground floor: in the same vein as the damages to elements pertaining to the vertical communication cores, damages to these elements compromise the safety of the evacuations and in the cases of infill walls where cables and pipes run, their failure can prevent the proper functioning of the electricity and water installations. Suspended ceilings have also proved to be extremely vulnerable and hazardous elements. The majority of them show fissures and cracks after the seism, and a considerable number of them present detachments and local or global collapses.

Fig. 4 – Damages to non-structural elements located in the common areas of the ground floor

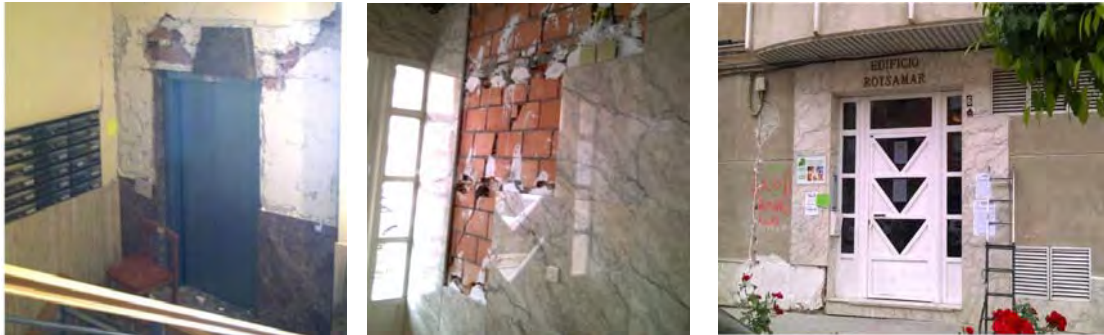
-Damages to interior and exterior claddings panels: the majority of the connections of the cladding panels to the exterior and interior walls were executed without any type of mechanical fixation (neither screws nor nails), trusting their adherence to the binding material, for example, cement. A type of connection that has demonstrated to be insufficient in the case of the Lorca earthquake. In some cases, the reparation projects prescribed the complete removal of the cladding panels and their substitution with a different type of panel, and in other cases, they prescribed an additional mechanical fixation for them.

Fig. 5 – Damages to interior and exterior claddings panels

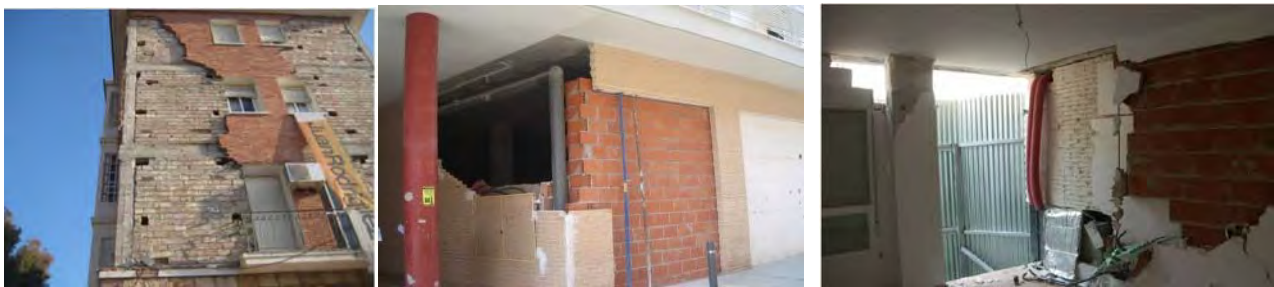
-Damages to exterior infill walls (interior and exterior façades): on the one hand, an important number of façades has shown a lack of firm connection between the infill masonry walls and the structural elements. In these cases, not only the detached parts represented a risk to life, but also the remaining parts. Hence, the whole element has to be removed or fixed in a better way. On the other hand, these exterior IMWs are composed by two single-leaf brick masonry walls. However, just a tiny part of them includes elements of connection between both leaves, such as steel ties; which constitute a widespread and economical improvement to their resistance against lateral forces.

Fig. 6 – Damages to exterior infill walls (interior and exterior façades)

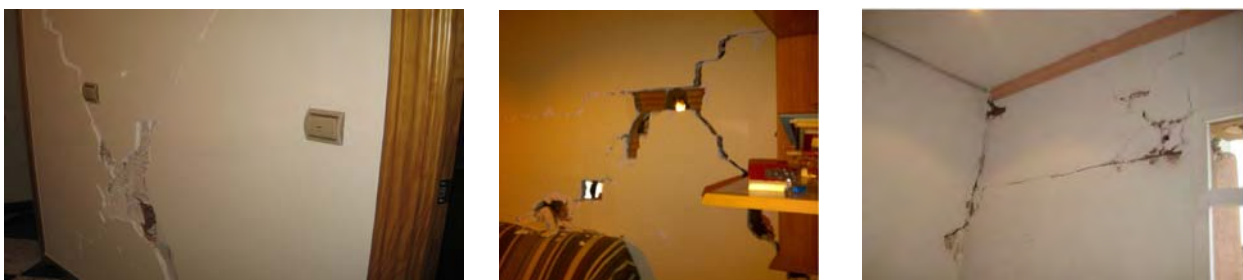
-Damages to interior infill walls: the most hazardous damages to interior infill walls have been found on the ground floor, where habitually commercial units can be found. Nevertheless, the reparation of fissures and cracks provoked by exceeding internal shear forces on interior walls and the restitution of the detached ceramic tiles in bathrooms constituted a significant part of the total budget of the reparation.

Fig. 7 – Damages to interior infill walls

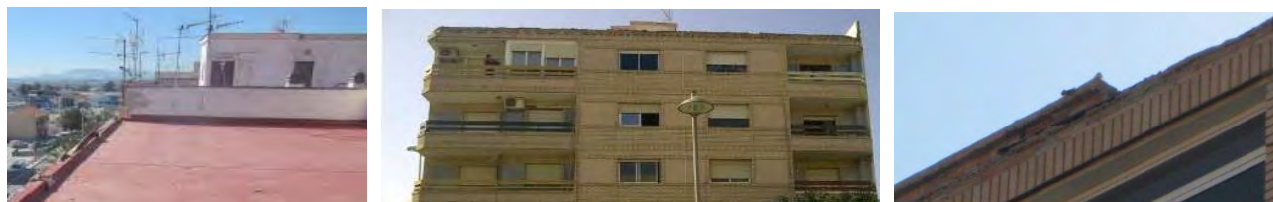
-Damages to unreinforced masonry roof parapets: these elements have proved to be the most hazardous components of the buildings due to being the cause of the majority of the fatalities. Among the buildings studied, authors have found several complete collapses. Moreover, they present clay or stone coping pieces that, in the majority of the cases, are not firmly fixed to the parapet; resulting in an added risk. Additionally, some ledges have proved to be unable to withstand the Lorca earthquake.

Fig. 8 – Damages to unreinforced masonry roof parapets

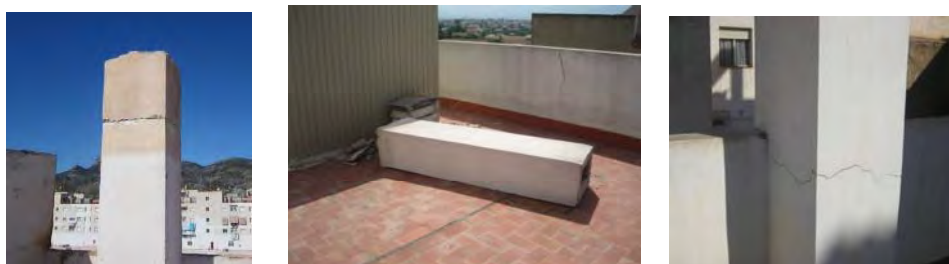
-Damages to unreinforced masonry roof chimneys: a great deal of these elements, which are made of unreinforced masonry, have resulted in collapse or in such a state of degradation that had to be demolished.

Fig. 9 – Damages to unreinforced masonry roof chimneys
