## MARCH 22, 2020 ZAGREB, CROATIA EARTHQUAKE

J. Atalic<sup>(1)</sup>, M. Uros<sup>(2)</sup>, M. Savor Novak<sup>(3)</sup>, M. Demsic<sup>(4)</sup>, M. Banicek<sup>(5)</sup>

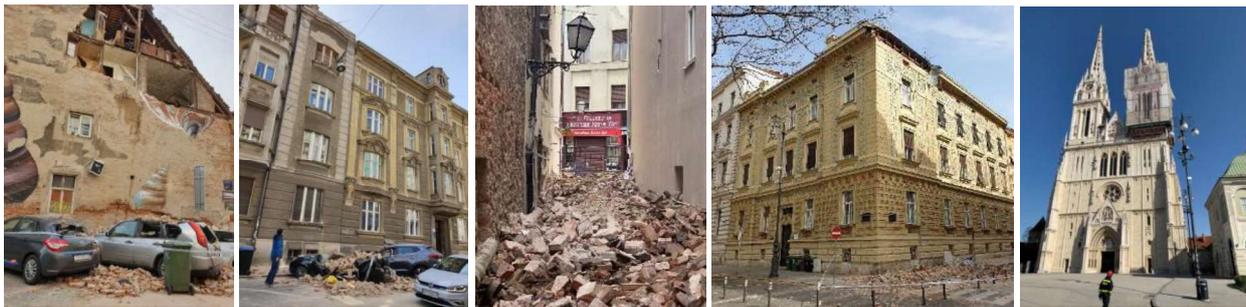
Although the earthquakes were of moderate magnitude from the seismological aspect, they nevertheless caused a loss of one human life and huge material damage (which is currently estimated at approximately € 10 billion), especially in the protected historic center of the city, and in the epicentral area. It is assumed that approximately one fifth of the housing stock (up to 25.000 buildings) was affected by the earthquake. In the most vulnerable central part of the city, damage was inflicted on many buildings belonging to critical infrastructure, schools, hospitals and buildings crucial for proper functioning of the city and the country, as Zagreb is the administrative center of Croatia. In addition, many protected cultural monuments, sacral buildings such as the Zagreb Cathedral and numerous museums were also damaged in this seismic event (Fig. 1).

Fig. 1 – Historic center after the earthquake [3]

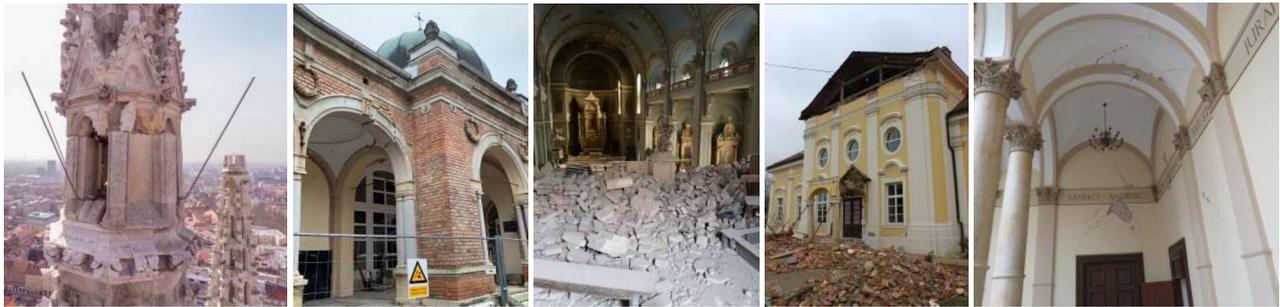
As already mentioned in the Introduction, the earthquake also affected invaluable cultural heritage (Fig. 8), such as the largest Croatian sacral building, the Zagreb Cathedral. The stone spire of its southern bell tower collapsed and caused damage to the roof of the cathedral. During the inspection, significant damage was observed to the spire of northern bell tower as well, which had to be urgently removed. In addition, the balustrade above the apse was destroyed, and the façade walls and vaults were significantly damaged. The Basilica of the Sacred Heart of Jesus had almost a third of its ceiling collapsed. Numerous other churches, museums and other buildings, individually protected as cultural heritage buildings, were also damaged (almost 500 such buildings). In addition to structural damage, the earthquake also affected numerous decorative elements on the buildings that give the city its identity, so that restoration will be demanding also from the point of view of the conservators.

Fig. 8 – Damage to cultural heritage: the Zagreb Cathedral, Mirogoj cemetery, Basilica of the Sacred Heart of Jesus, Croatian restoration institute and Croatian Academy of Sciences and Arts

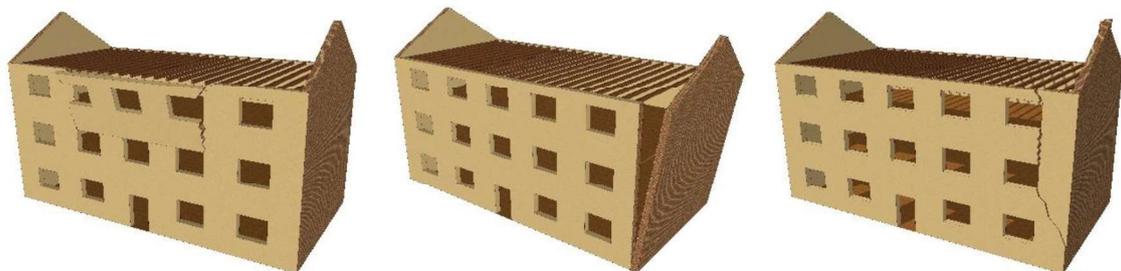
Nevertheless, the most affected by the earthquake was the housing sector, which accounted for almost two-thirds of the total damage, according to [11]. Unreinforced masonry buildings with timber floor systems were damaged the most (very often out-of-plane mechanisms occurred– Fig. 9), but other structural types were also affected (for example, reinforced concrete frames with infills or in general, buildings that do not comply with the modern seismic standards). Older masonry buildings were not designed for horizontal loads, and unfortunately often poorly maintained, so that material deterioration is pronounced (especially in buildings that do not have a façade).

Fig. 9 – Out-of-plane mechanisms frequently observed in the buildings damaged by the Zagreb earthquake [12]

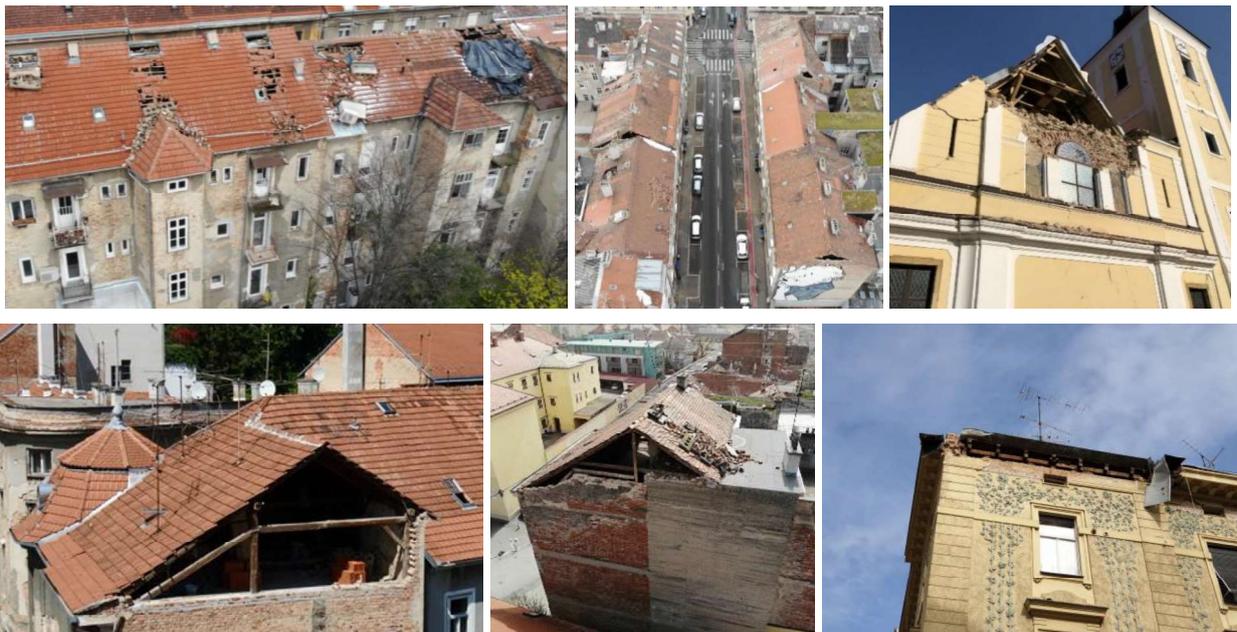
Fig. 10 – Collapse of chimneys and top part of the gable walls, damage to roof structures and to parapet walls [3, 13]

In brief, typical observed damage includes collapse and damage of chimneys, attic gable walls and various other unsupported elements (attics, domes, etc.) (Fig. 10), separation of gable walls along the height (Fig. 11), roof damage, in-plane damage of masonry walls with characteristic diagonal cracks, often along mortar bed joints (Fig. 12), damage to lintels (Fig. 13) and vaults, staircases and partition walls. They are described in detail in [8], but few examples are shown in the following Figures.

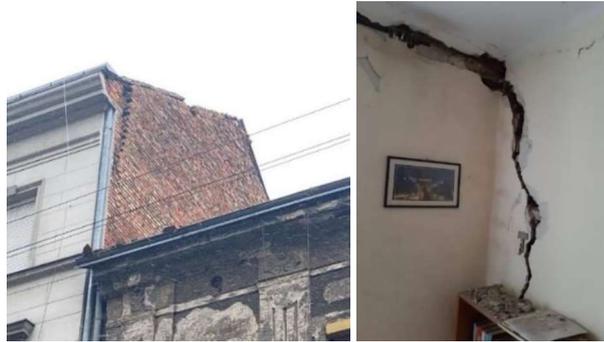
Fig. 11 – Separation of walls along the height due to out-of-plane mechanisms [3, 14]

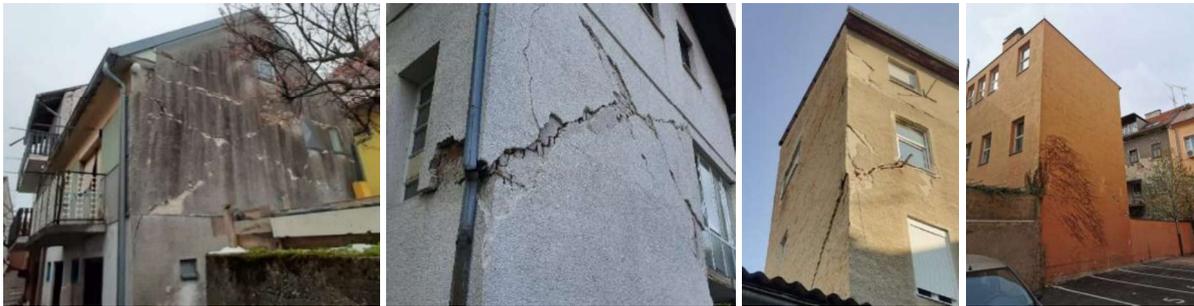
Fig. 12 – Diagonal cracks in walls [3, 14]

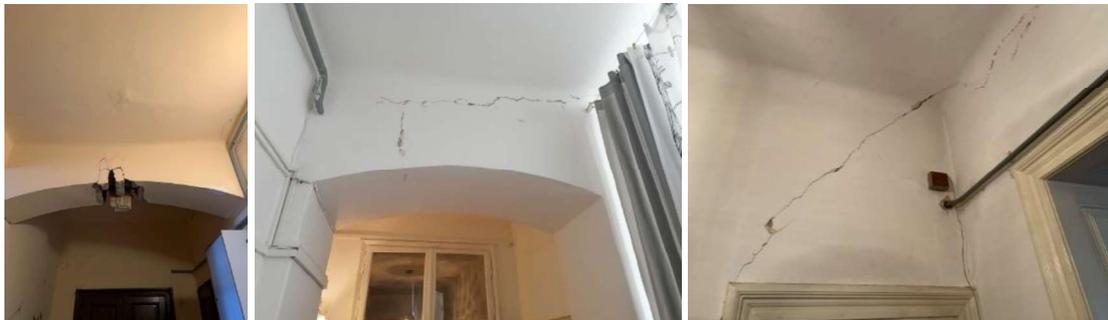
Fig. 13 – Damage to lintels [3]

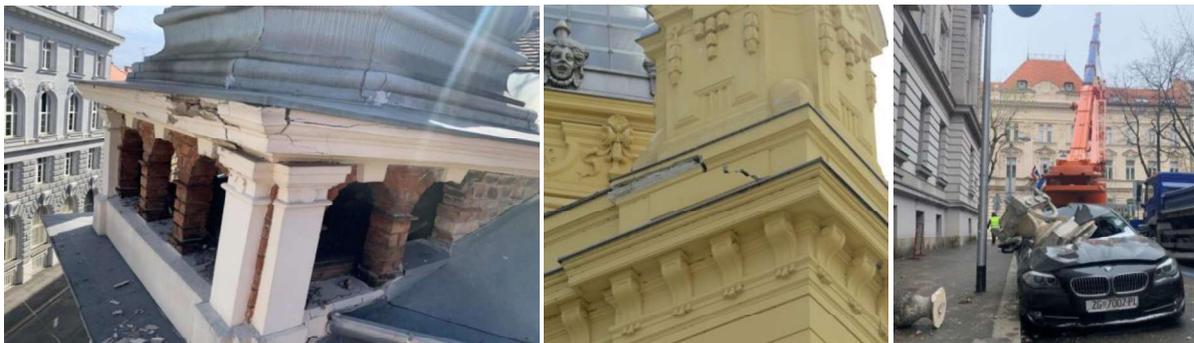
Furthermore, decorative elements such as roof domes, portals, cornices on facades, and decorative sculptures, have also suffered considerable damage (Fig. 14). Usually, these elements were not properly restrained. There are still many elements that have not been removed or properly retrofitted, so that despite their cultural value, they represent considerable hazard in the case of a new earthquake.

Fig. 14 – Damage to decorative elements

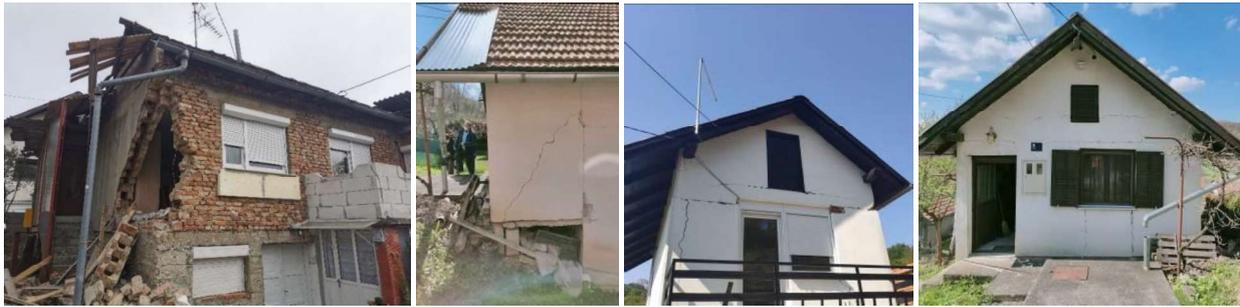
As for the epicentral area, it should be noted that damage was very frequently observed in masonry houses with poor quality of construction and where structural systems were further weakened by additions and renovations. Very often, addition of one or more floors was subsequently made without strengthening the ground floor, although in new floors one may find walls with tie beams (not extended to the ground floor). On top of that, board-based floor with rubble was often removed during renovation and replaced with concrete slab without reinforcement, and without adequate anchoring into walls. Fig. 15 highlights several characteristic examples from the epicentral area.

Fig. 15 – Damage to houses in the epicentral area [3, 8]
