Analysis of seismic damage characteristics of Shuanghe Town in the meizoseismal area of Changning M6.0 Earthquake, Sichuan Province.

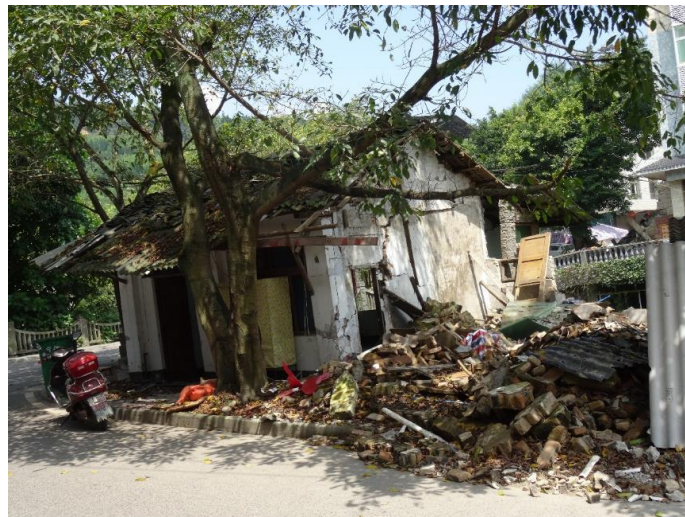
Simple houses include civil structure building, brick and wood structure building and stone concrete structure building. The simple houses in Shuanghe town are mainly of brick and wood structure. Brick and wood structure buildings are mainly self-built houses of local residents. These houses are load-bearing with brick walls and wooden roof. There is no connection between the vertical and horizontal walls of the brick and wood structure buildings in the disaster area, and the masonry quality is poor. (Fig. 5-Fig.7).

Fig. 5 – Collapse of brick wall and roof of brick wood structure buildings in disaster area

(1) Simple houses: This type of building is limited by the material characteristics that the strength of the wall is low and the rigidity is large, it is very easy to damage under the earthquake action. [3]

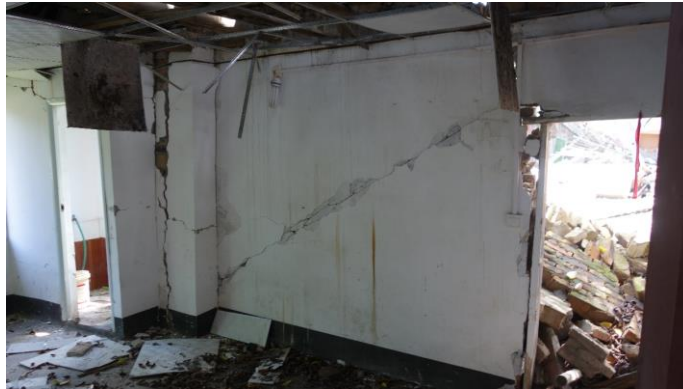
Fig. 6 – The brick and wood buildings with obvious cracks in the wall

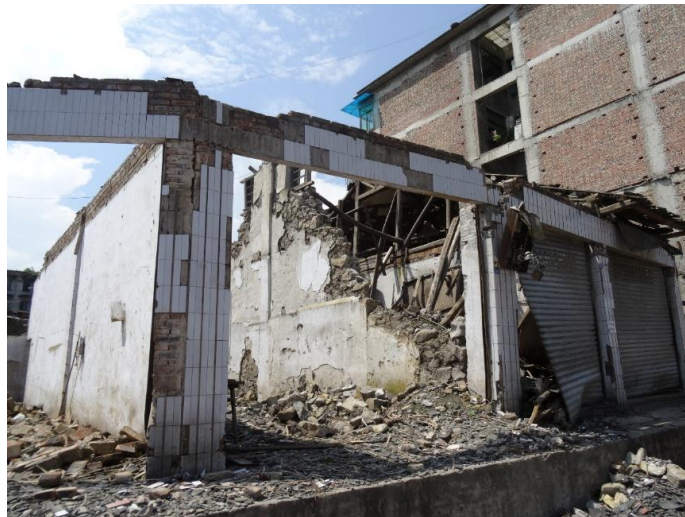
Fig. 7 – Destruction of brick and wood structure buildings in disaster area

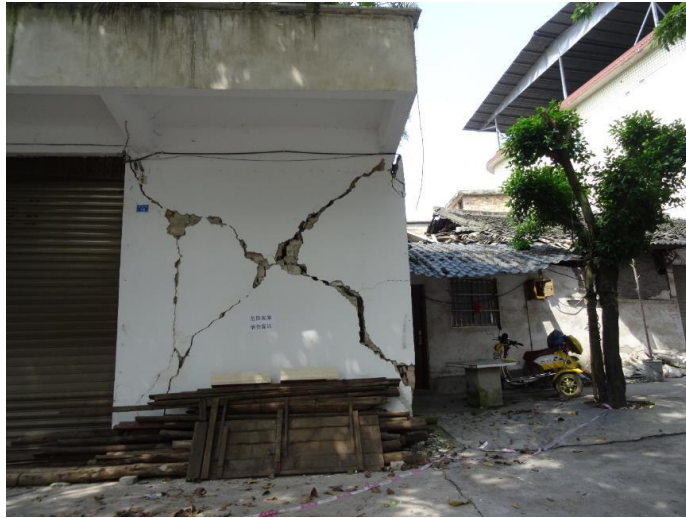
In this paper, about 90% of the buildings in the study area are brick concrete structures. Compared with simple buildings, brick concrete structures have certain seismic performance. However, because Shuanghe town is located in the epicenter of the earthquake, it is the most affected by the earthquake, so the brick concrete structures in the study area have suffered a certain damage, and the damage situation also has a great correlation with the building age. The newly built buildings' performance in this earthquake the house were better, through analysis, it is found that the brick and concrete structure buildings built in recent years show a trend of "half frame type", that is, the non-standard frame structure with brick wall and column beam bearing together. In this earthquake, the damage characteristics of brick concrete structure buildings are as follows: individual collapse, incline or partial collapse of brick concrete structure buildings, horizontal or "X" shaped cracks on a few bearing walls, dislocation of a few walls, obvious cracks on the walls between most doors, windows or window corners, wide cracks on the walls of some houses and completely through the walls (Fig. 8 – Fig.10).

Fig. 8 – "X" cracks of brick concrete structure building in disaster area

(2) Brick concrete structure buildings: This is the main type of local buildings. This type of buildings are easy to crack and fall off under the action of earthquake, it's mainly because the building material of brick concrete structure is brittle and its overall performance is poor, and its longitudinal wall bearing capacity is insufficient.

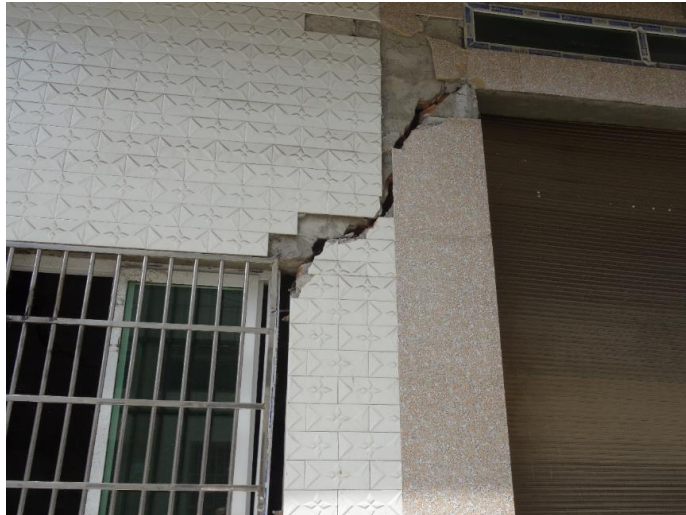
Fig. 9 –Cracks in the corners of brick concrete buildings in the disaster area

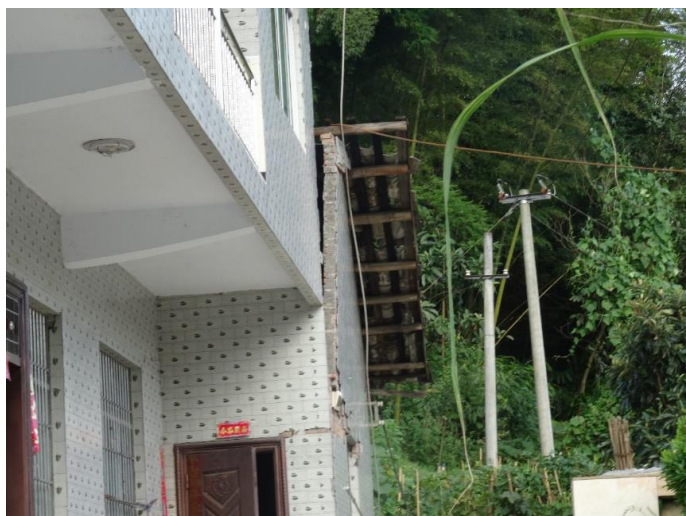
Fig. 10 –Displacement of brick concrete structure building wall in disaster area

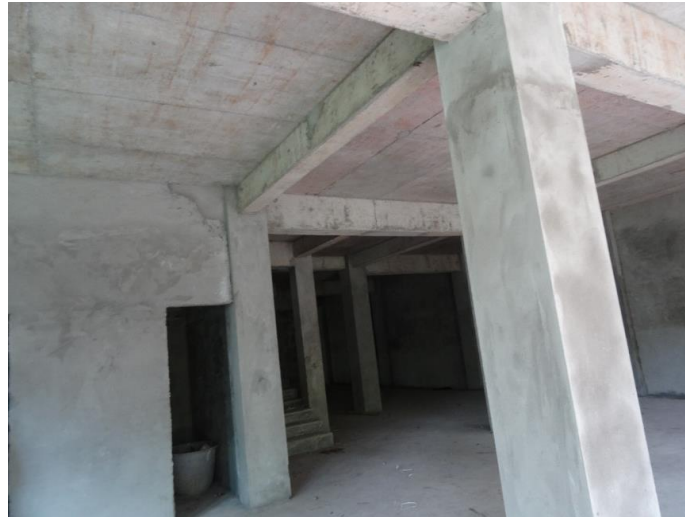
Reinforced concrete frame structure buildings in Shuanghe town were mainly public buildings such as township government office buildings, hospitals and schools, and a few were self-built house by local residents. In this earthquake, the seismic performance of the frame structure was good, and there was basically no obvious damage. The damage phenomenon was that the wall skin of the non-bearing wall felt off. (Fig.11-Fig.12).

Fig. 11 –No damage in the earthquake of self-built frame structure buildings

(3) Frame structure buildings: The frame structure buildings went by reasonable design have good aseismic performance and no obvious damage in this earthquake.

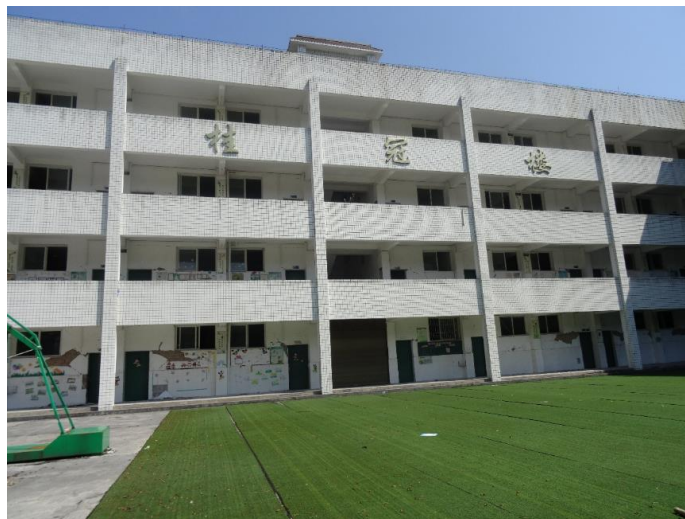
Fig. 12 –The frame structure school buildings without obvious damage during earthquake

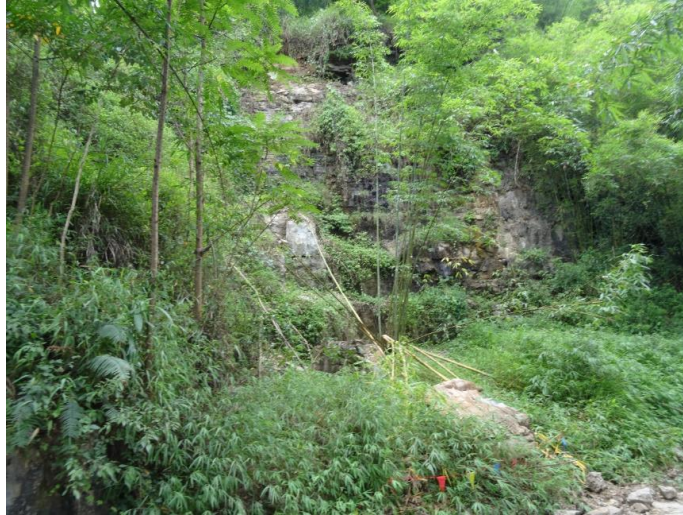
The M6.0 earthquake of Changning City in Sichuan Province was large and the disaster area was also wide, however the earthquake didn't cause large-scale surface deformation or rupture. The main geological disasters in the study area were collapses, and landslides caused by heavy rainfall after the earthquake etc. (Fig.13-Fig.14).

Fig. 13 –Landslide caused by earthquake in disaster area

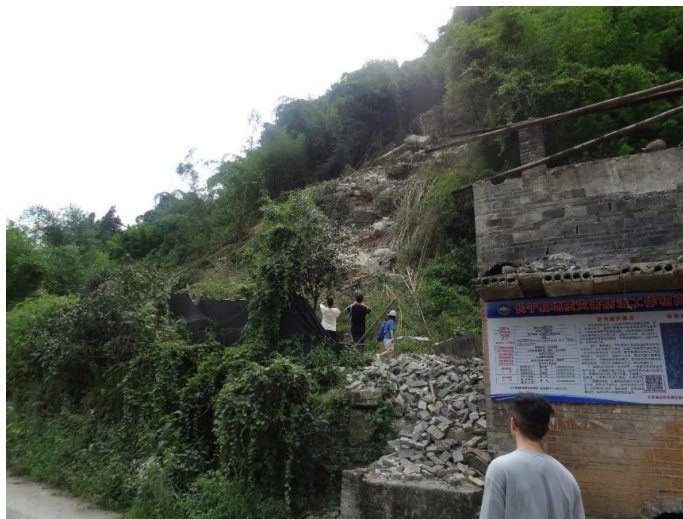
Fig. 14 –Collapses caused by earthquake in disaster area
