## Status of wooden houses in Mashiki town two years after the 2016 Kumamoto earthquakes

### Abstract

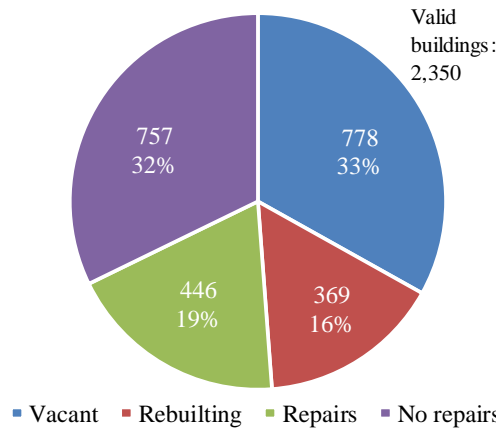
Fig. 1 shows the situation of all buildings in Mashiki town two years after the earthquake, with the proportion of vacant lots, rebuilding, repairs, and no repairs. The repaired building was counted as one whose roof, exterior wall, or foundation has been repaired. However, those which have been repaired outside the building, such as retaining walls, were excluded. The repairing of outside the building itself will be described in the subsequent section. The 33% of the buildings have been vacant and 16% have been rebuilt. That is indicating that nearly half of the buildings do not exist. Half of the buildings remained, but a comparison of the ratio of repairs and no repairs revealed that the ratio of buildings without repairs was higher.

Fig.1 Status of total buildings in Mashiki town two years after the earthquake

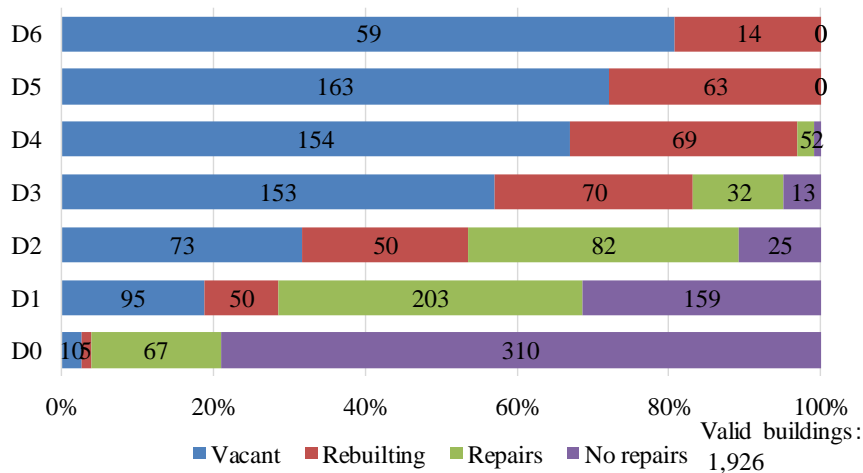
Fig. 2 shows the building status of wooden houses by damage level. The values in the figure indicate the number of buildings. When defining the damage level, the appearance survey proposed by Okada and Takai was used in this research [2]. The damage level from D6 to D0 indicate collapsed, destroyed, partially destroyed, partially damaged, and non-damaged, respectively (Table 1). As the damage level increases from D0 to D6, the ratio of demolition of buildings shown as vacant lots and rebuilding tends to increase. In addition, at all damage levels, the proportion of vacant lots was higher than that of rebuilding, indicating that the reconstruction of buildings was not progressing so much. As for the remaining buildings, it was found that about 17% of buildings in the D0 were repaired. In D1, 56% of the remaining buildings were repaired, and in D2, 77% were repaired. It was confirmed that the higher the damage level, the lower the percentage of continuous use without repairs. It was also found that more than 80% of D3 houses classified as partially destroyed and about half of D2 houses classified as partially damaged were demolished after the disaster. Although the relationship with the actual damage certificate is not cleared, regarding continuous use, there is rough judgment criteria between partial destroy and partial damage. If the building damage was over D2, it was indicated a tendency to be a problematic for continually use.

Fig.2 Status of wooden houses by damage level

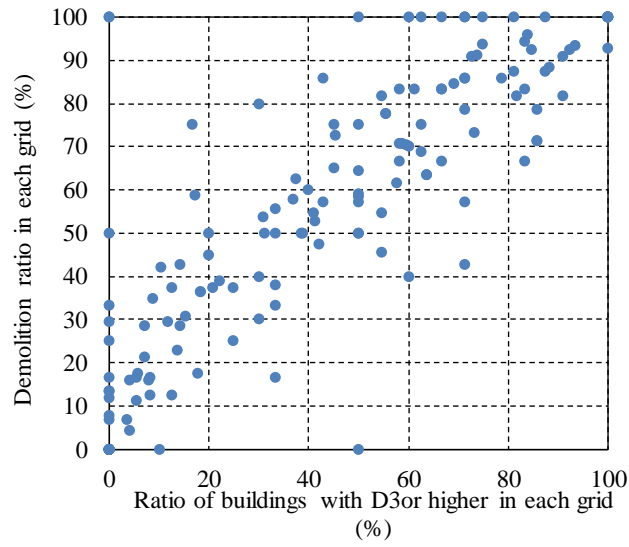
The target area is divided into 100 m grids, and the relationship between the ratio of buildings with a damage level of D3 or higher in each grid and the demolition (vacant land + rebuilding) ratio in the grid is shown in Fig. 3. About the grid division of the survey area, refer to Reference [3]. The trend of the higher ratio of D3 building in the grid, the higher the demolition building ratio of belonging to that grid was showed. On the other hand, it was found that even if the ratio of D3 buildings was the more less (damage was relatively small), there were areas where the building demolition ratio was high. In buildings D0-D3, in addition to the actual damage level of the building, it was thought that there were decision-making factors to demolish the damaged building. Therefore, the effects of the demolition of surrounding buildings was investigated. Fig. 4 shows the relationship between the demolition ratio of all buildings in each grid and the demolition rate of buildings by damage level belonging to the grid. Many of the data show that the demolition ratio by damage level on the vertical axis is 0% or 100%, it was difficult to understand the trend. Therefore, in Fig. 5, the horizontal axis represents the building demolition ratio of each grid sectioned at every 20%, and the vertical axis represents the average value of the demolition ratio for each damage level in the grid within that range.

Fig.3 Relationship between the ratio of buildings with a damage level of D3 or higher in each grid and the demolition ratio in the grid

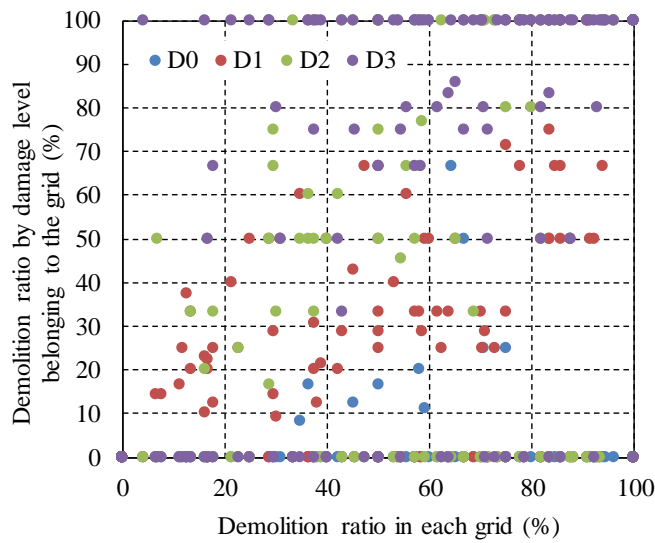
It was found that the higher the demolition ratio in the grid, the higher the ratio of demolition of buildings with the same damage level. The same tendency was observed in the case of buildings that were judged to be partially damaged. It is indicating that the demolition status of surrounding buildings has affected the decision to demolish the damaged buildings even in buildings with low damage levels. In other words, it was found that as the damage scale of the earthquake increases, the demolition ratio of low-damage houses might increase.

Fig.4 Relationship between the demolition ratio of all buildings in each grid and the demolition ratio of buildings by damage level belonging to the grid

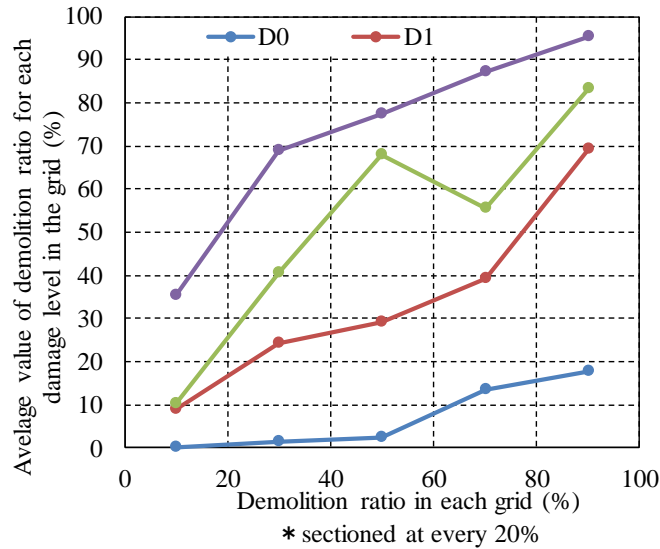
If the surrounding buildings are not demolished, the demolition ratio of D3 building shows 35% or more, while the D2 building demolition ratio shows relatively close value of the D1 building's one. However, as the demolition ratio of the surrounding area increases, the demolition ratio sharply increases. Therefore, the demolition ratio of the D2 building suggests the possibility of increasing due to the influence of the demolition ratio of the surrounding buildings. This suggests that it is necessary to keep the damage level within D2 in order to aim for continued use after the disaster.

Fig.5 Relationship between the demolition ratio of all buildings in each grid and the demolition ratio of buildings by damage level (sectioned at every 20%)

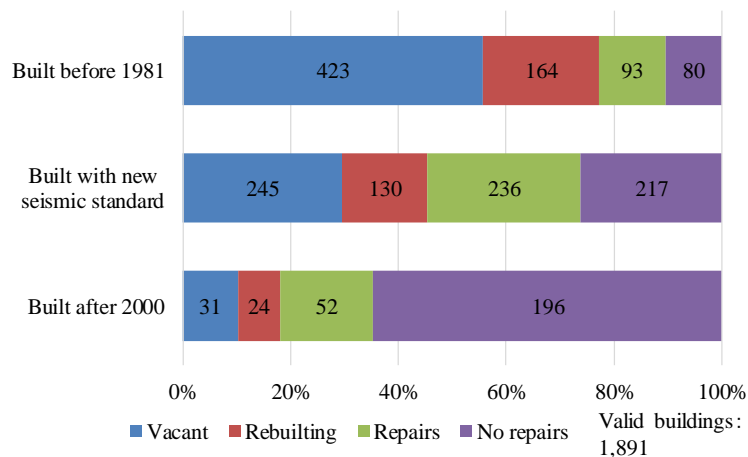
Fig. 6 shows the status of wooden houses by building age. It was shown that the survival ratio was larger as the construction year was newer. The ratio of repaired buildings constructed before 2000 was higher than that in non-repaired buildings, but the proportion of buildings without repairs was higher in after 2000 buildings. One of reasons is considered that the buildings based on new standards have higher seismic performance, and less damage. However, it was found that 18 % of the buildings built since 2000 have been demolished after the disaster.

Fig.6 Status of wooden houses by building age

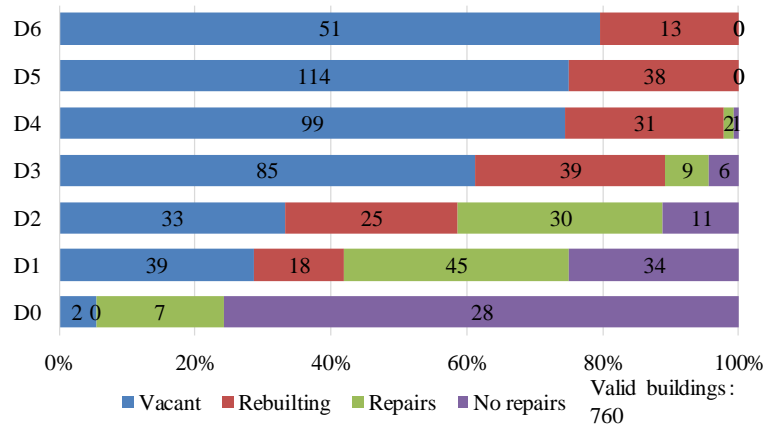
Fig. 7-9 show a comparison building status by building age and damage level. At damage levels less than D0 and more than D4, the ratio of the building's survive did not change, hence the age of the building was not significantly related to the judgment on continued use of the building at the excluding D1-D3. However, in D1, about 40% of the buildings built before 1981 were demolished, while about 25% of buildings built with new seismic standard and buildings built after 2000 were demolished. In D2, about 60% of the buildings

built before 1981 were demolished, while about 50% of buildings built with new seismic standard and 40% of buildings built after 2000 were demolished. In D3, about 90% of the buildings built before 1981 and about 80% of the buildings built with new seismic standard were demolished, while about 50% of buildings after 2000 were demolished. The buildings built before 1981 have a higher ratio of demolishing buildings than others, even if the damage level is same. In addition, comparing the building between built after 1981 and built after 2000, buildings built after 2000 show the tendency of higher ratio of continuous use without repair, even the same damage level. However, more than 20% of D1 and 40% of D2, respectively, of the buildings built in the 2000s were demolished.

Fig.7 Status of wooden houses built before 1981

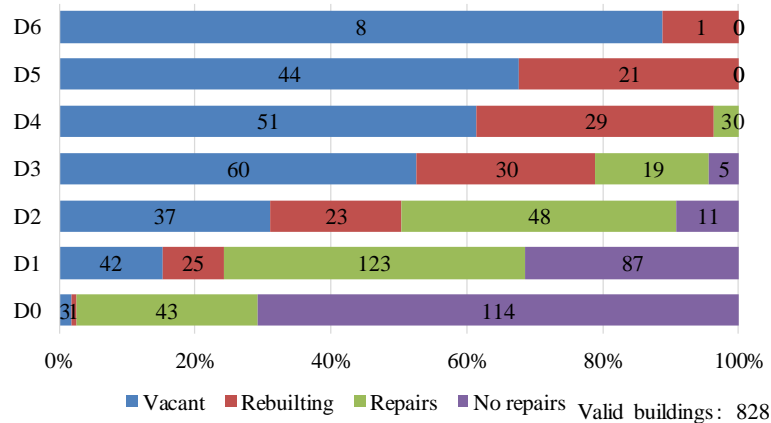
Fig.8 Status of wooden houses built with new seismic standard

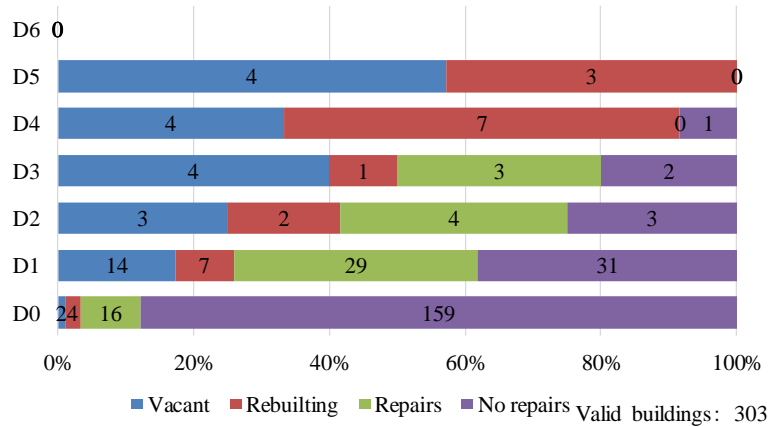
Fig.9 Status of wooden houses built after 2000

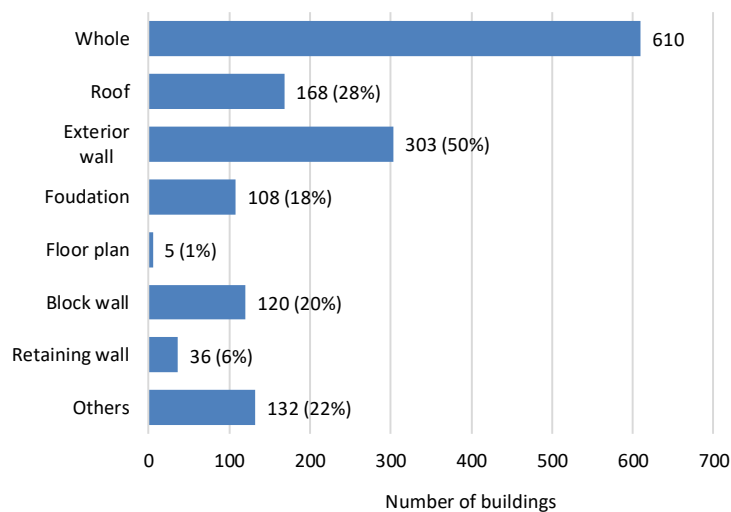
Fig. 10 shows the number of repairing content in the repaired building. If there were a building where multiple contents were repaired, the number of contents were simply added as the building. In Fig. 10, whole means the total number of buildings with any repairs, and the each content shows the number of repairing and the ratio to whole's number. The repaired or not of the building was determined by comparing with previous survey photos. Repairs of the roof, the exterior walls and the foundations were judged from the outside appearance. For example, if the exterior wall has been repainted compared to the previous survey photo, it included in "Repair of the exterior wall". In most cases, it was difficult to determine the repair status of the interior, the structural frame, the floor plan from outside appearance. The common repairing parts were the roof changing from roof tiles to slate, changing the exterior walls members, and repairing the foundations tiles and clack. And, there were the case of the condition of the building could not be checked sufficiently due to fences and block walls. Regarding repairs other than for buildings, there were many repairs for block walls and retaining walls, and around the entrance.

Fig.10 Number of repairing content in the repaired building

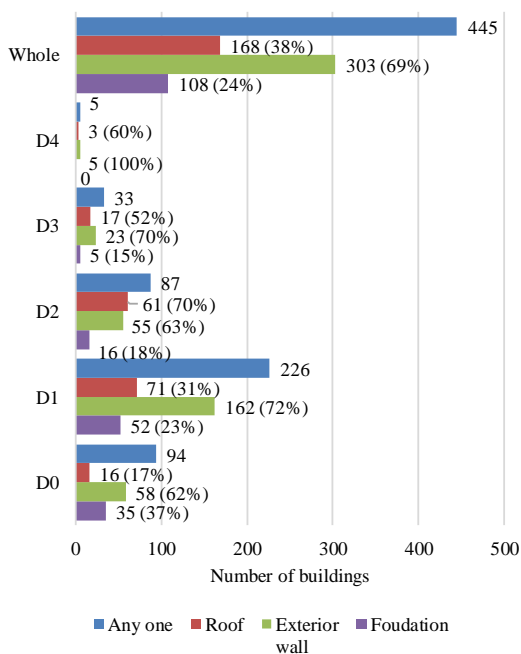
Fig. 11 shows the breakdown of repair contents by damage level. This section shows the results of a survey on a building whose roof, exterior wall, or foundation has been repaired. The breakdown of the repaired buildings was about 40% for roofs, 70% for exterior walls, and 24% for foundations. For roof repairs, the ratio of repairs trended to increase as the damage level increased, but for exterior walls, there was no significant difference in the ratio of repairs in the repair building from D0 to D3. Even for buildings classified as D0, some buildings have their roofs and exterior walls repaired. In this survey, even if it is not clear whether the roof or exterior wall has been damaged, it is counted as repairing in the case of any change. Therefore, it might include mere repainting. In addition, the damage of the foundation was not included in the damage level judgment at 2016, therefore an example in repaired the foundation with a D0 building is included.

Fig.11 Breakdown of repair contents by damage level

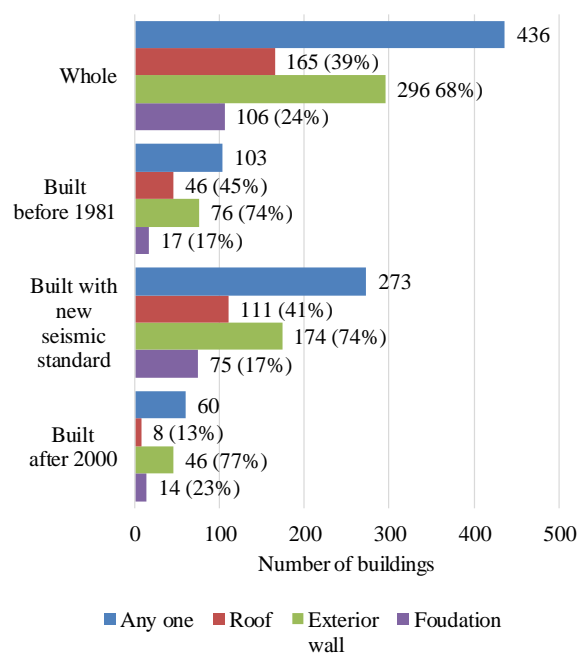
Fig. 12 shows the breakdown of the repair contents of the repair buildings by construction year. The ratio of repaired roofs was about 40% for buildings built before 1891, but it was shown about 10% for buildings built after 2000. The ratio of repaired roof trended to increase as the damage level increased. As a reason, the damage level of the building was smaller than before 2000. However, the ratio of exterior wall and foundation repairs did not differ significantly by construction year.

Fig.12 Breakdown of the repair contents of the repair buildings by construction year
