## DIRECTIVITY EVIDENCE FOR THE CONCEPCION CITY DAMAGE IN THE EL MAULE, CHILE 2010 EARTHQUAKE.

R. Ramos (1), G.R. Saragoni (2)

### **Abstract**

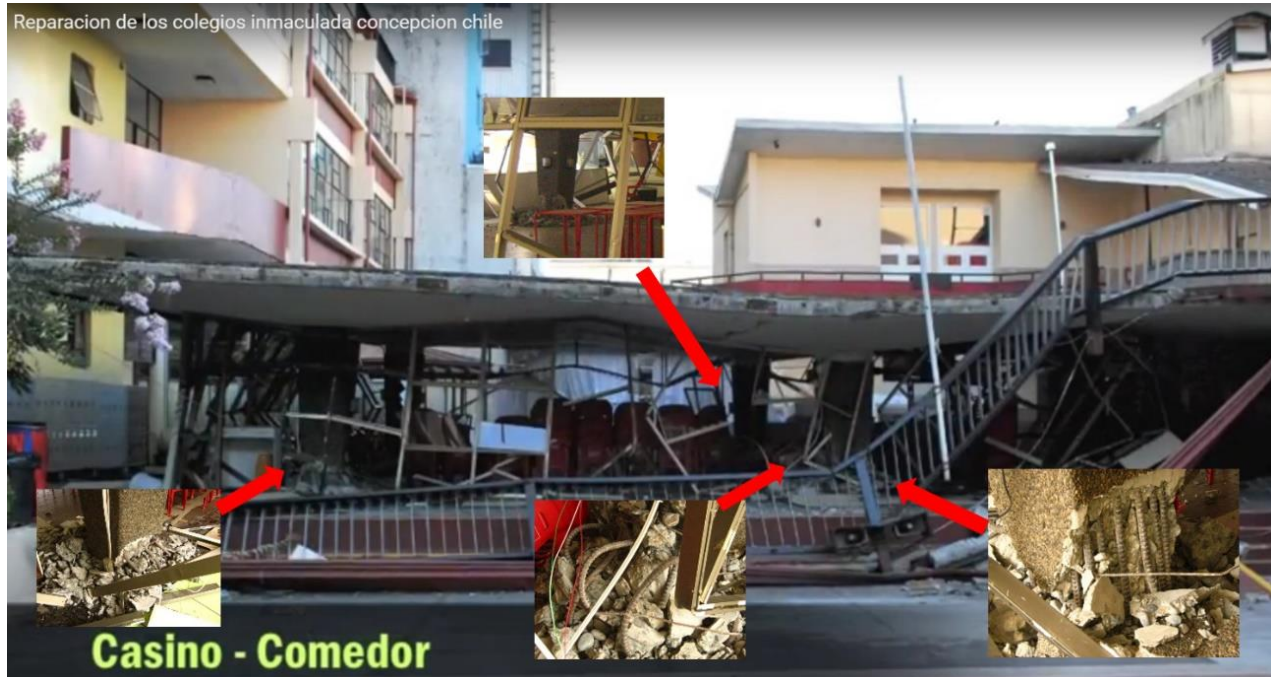
Fig. 3 - Collapsed structure and main damages. (Main photo taken from video <https://www.youtube.com/watch?v=QzJFbhYWmbw>. Small photographs Salvador Sáez)

- - Columns failed only at the base.
- - The central columns suffered damage in a wider length than the lateral ones. The centrals descended approximately 120 cm, while the lateral ones between 70 and 80 cm.

- - The structure descended less in the north axis given the presence of steel profiles of a window that they provided additional resistance.
- - The fault in the columns was of the fragile type: produced by a mechanism of failure of shear, or by compression of the concrete and lack of confinement.

- - There is evidence of a large displacement in the positive direction of  $N60^\circ E$  due to the collision with the surrounding chapel, and at some point it must reach a displacement of about 35 cm.

- The “explosive” detachment of the south-east railing seems to account for a clash between the canopy and the main building in the negative direction of  $N60^\circ E$ . Since, the railing was well anchored and it does not have enough mass to generate such a detachment.

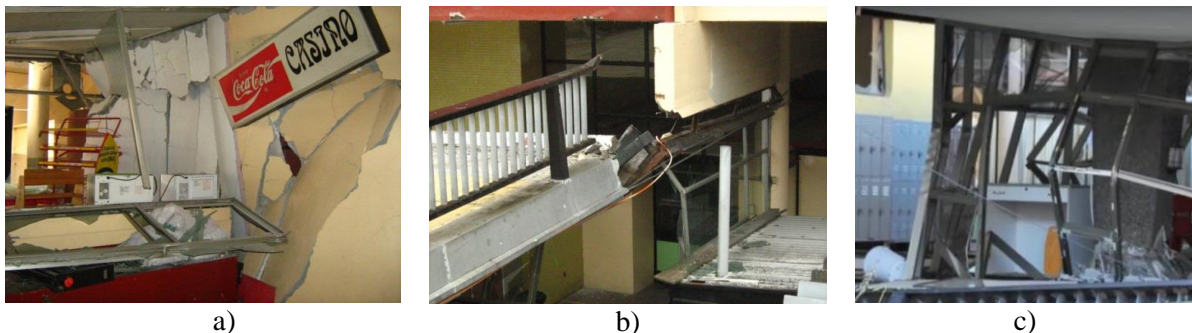
Fig. 4 - a) Partition type “Waffle”. b) Steel link in column "1-A". c) Aluminum corner in column "1-B".

The photographic background shows secondary elements that affect the behavior of the structure. The following elements that affected the response were detected:

- The "north" facade had a near and parallel partition "Axis 3" of type “Waffle” (Commercial "Covintec" or "Impac Panel") with steel box profiles that prevented a further fall of that axis (See Fig. 4 – a)..
- Around the column "1-A" there was a steel link of an old window between the main building of the school and the Canopy. The photos show that this link prevented a major fall from this corner (See Fig. 4 – b).
- Around Column "1-B", "South East", there was a corner conformation of four aluminum profiles of the window. This configuration allowed a certain degree of bracing between them, giving it axial resistance, which prevented a greater fall of the concrete column there located (See Fig. 4 – c).

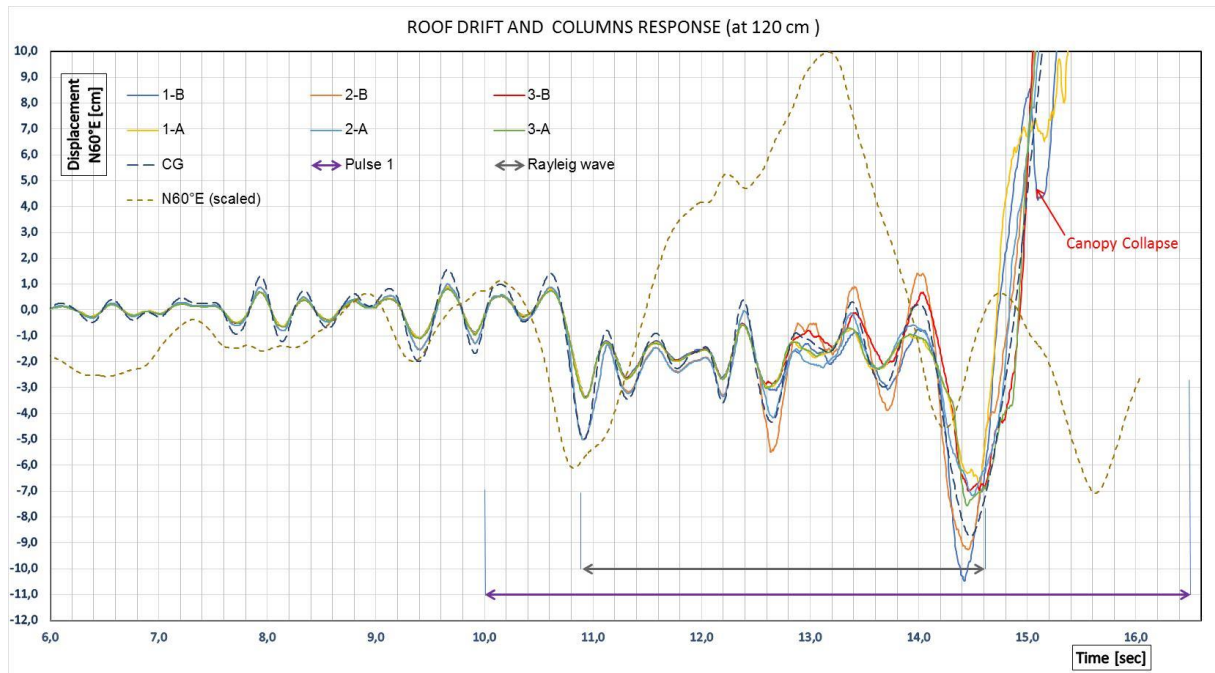
Fig. 7 - Roof offset in the N60°E direction and the columns at h=120cm.

As a reference and ease of reading, the structure behaves as elastic up to a drift 2.0 cm, after which the non-linear incursion begins, resulting in failure by shear when the roof drift greatly exceeds the previous displacement due to the Pulse 1.

An analysis of this graph indicates the beginning of the structure failure occurs in the central columns (A2, B2), failing these by shear and flexocompression during the start of the Rayleigh wave at 11 seconds. A decrease of the stiffness of the structure is also generated, which increases the period and decreasing therefore the seismic demand. However, the progress of the Rayleigh wave leads the edge remaining columns to the flexocompression failure at approximately 14 seconds.

Therefore, the graph shows a clear relationship between the arrival of energy during the Pulse1 from the seismic source and the Rayleigh wave associated as the reason of the collapse of this structure without participation of soil response.

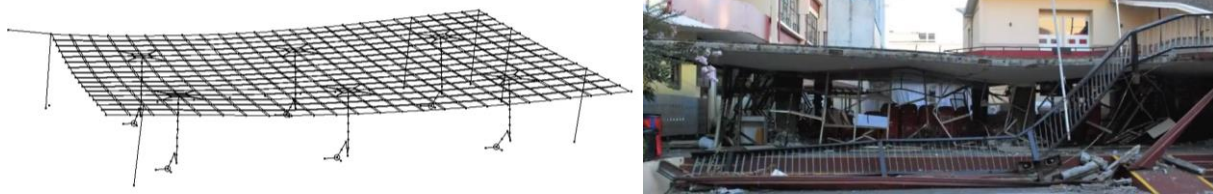
Fig. 10. Comparative of damage time response for the analysis with three-components.

The failure modes delivered by the structural model, shown in Fig. 10, are consistent with what was observed in the field, in terms of the types of failure and most damaged elements. The main aspects are summarized below:

- The central columns result in greater damage, including failure at 11 seconds due to shear and flexo-compression before the increase in height reinforcements to 1.20 m.
- The lateral columns collapsed due to the shear and flexocompression failure from 11.9 s to approximately 14 s.
- The structure descends less in the northern columns, by the support given by the metal columns of the window.
- The predominant direction in the model for the displacements in the failure is the positive direction N60 ° E, and a small component perpendicular to the west.

The coincidence between observed and the results are adjusted satisfactorily in direction, failure mode and direction; concluding that the failure mode of the real structure has been well captured by the model. With these results it can be examined which part of the seismic signal is the one that produces the failure.
