## EARTHQUAKE PERFORMANCE ASSESSMENT OF RENTAL LOW-COST HOUSING FLATS IN LOMBOK, INDONESIA

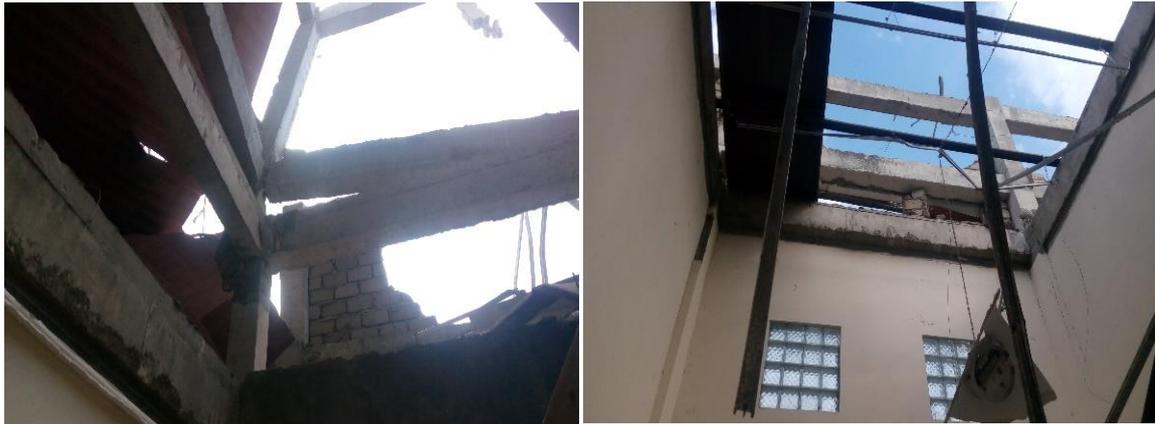
- Housing flat PP. Al Ikhlas, moderate damage level, conventional reinforced concrete structural system
- Housing flat Dalmas Polres Lombok Barat, North Lombok Province of NTB, major damage level, conventional reinforced concrete structural system

Fig. 3 – Example of major damage to structure caused by the earthquake: Crushing at beam-column joints at the North Lombok Police Station housing flat

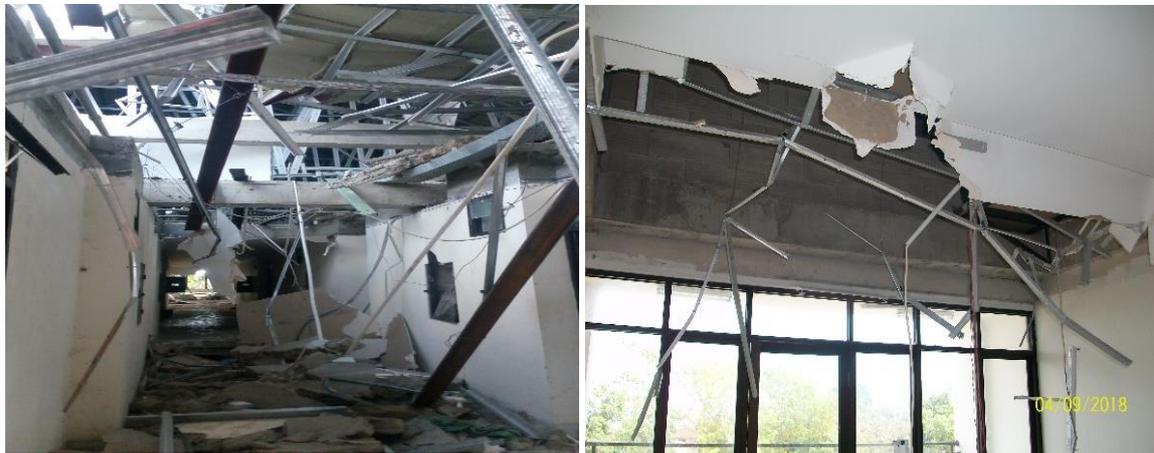
Fig. 4 – Example of architectural damage caused by the earthquake: Ceiling damage due to the falling of the material above it at the rental low-cost housing flats

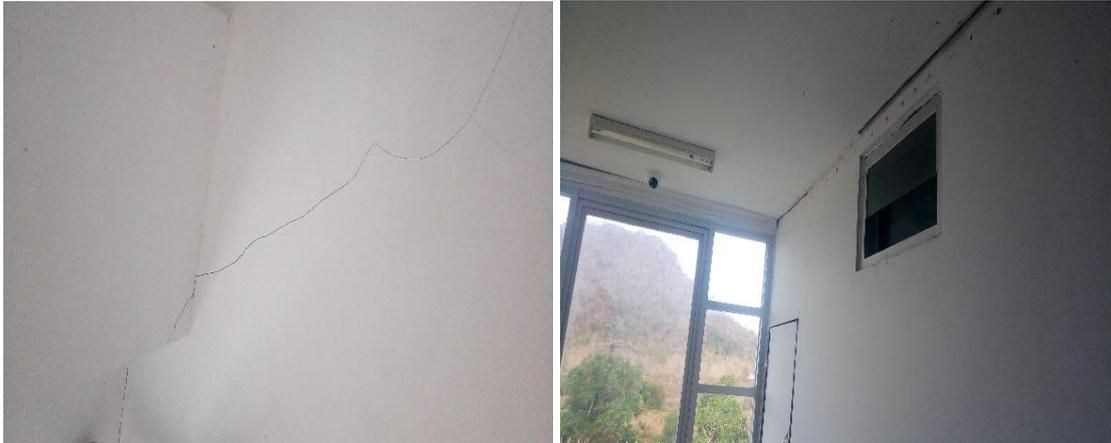
Fig. 5 – Example of minor damage caused by the earthquake: Hairline Cracks on the wall and falling of ceiling list at Sumbawa Technology University flats

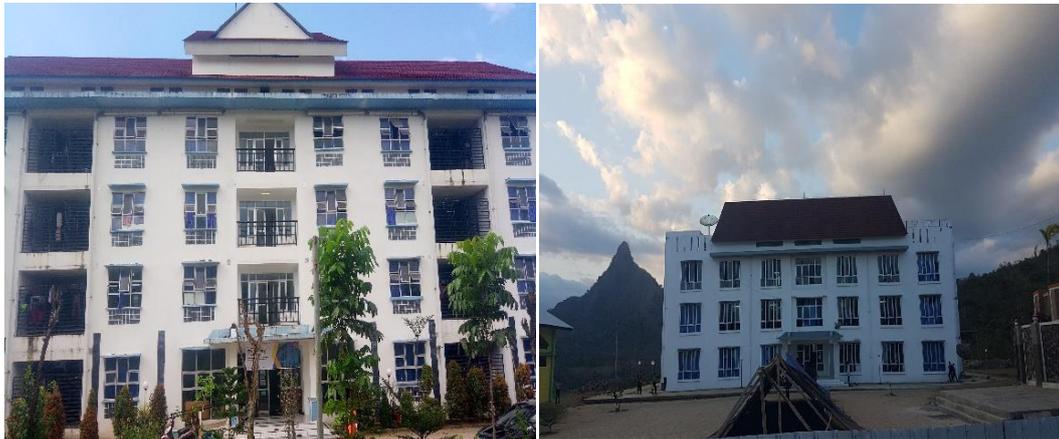
Fig. 6 – No earthquake damage to housing flats of (a) UTS and (b) Dea Malela Sumbawa

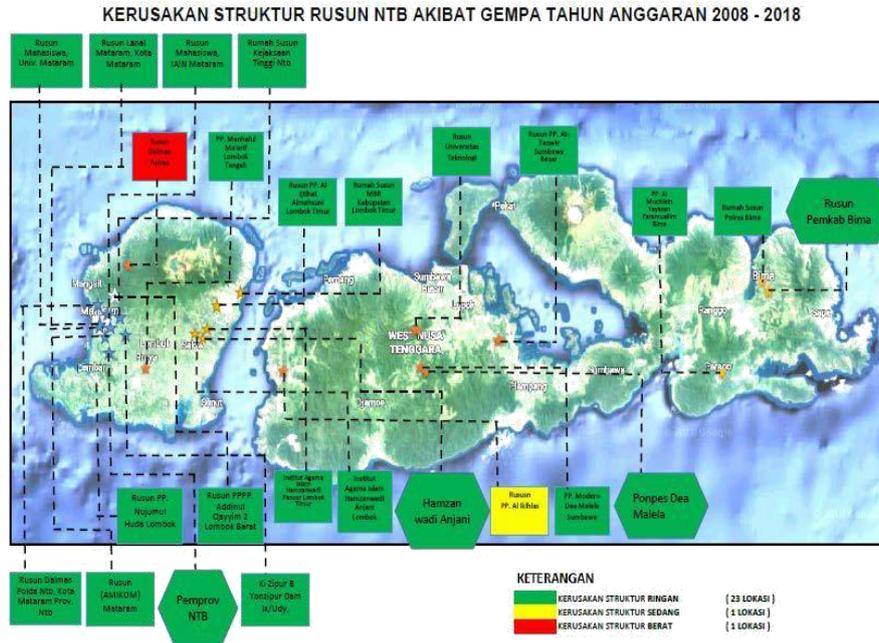
Fig. 7 shows distribution of 25 housing flats undergone structural damage. In general, the housing flats only have minor damage (92 %). These findings show that the structural performance of housing flats built by Ministry of Public Work and Housing in Lombok, Sumbawa, Bima and Mataram are quite good considering that many buildings in the surrounding area showed worse structural performance. In other word, these housing flats have proven to be earthquake resistance as designed. It should be noted that housing flats built using precast structural system show better structural performance compared to those built using conventional reinforced concrete structural system. Only housing flats built using conventional reinforced concrete system undergone moderate and major structural damage.

Fig. 7 – Map of structural damage on housing flats in Lombok, Sumbawa, Bima and Mataram due to earthquake

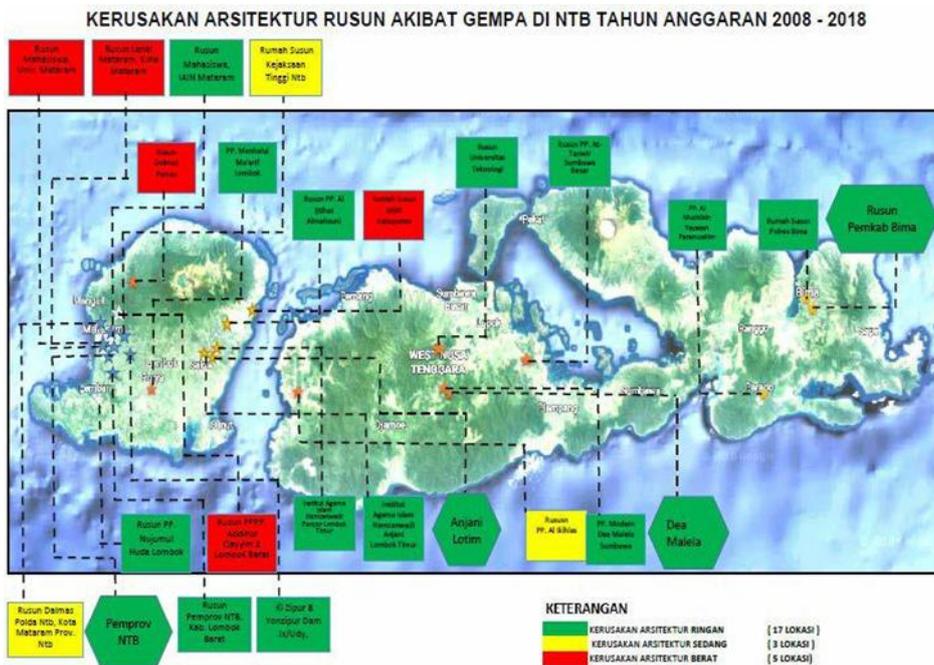
Fig. 8 shows distribution of 25 housing flats suffered architectural damage. As can be seen there are several housing flats underwent moderate (3 buildings) and major (5 buildings) damage. Meanwhile the other 17 buildings only suffered minor damages.

Fig. 8 – Map of architectural damage on housing flats in Lombok, Sumbawa, Bima and Mataram due to earthquake
