DAMAGE ASSESSMENT OF RENTAL LOW-COST HOUSING FLATS IN CENTRAL SULAWESI INDONESIA AFFECTED BY PALU EARTHQUAKE

Keywords: palu; vertical earthquake; retrofitting; precast; damage level

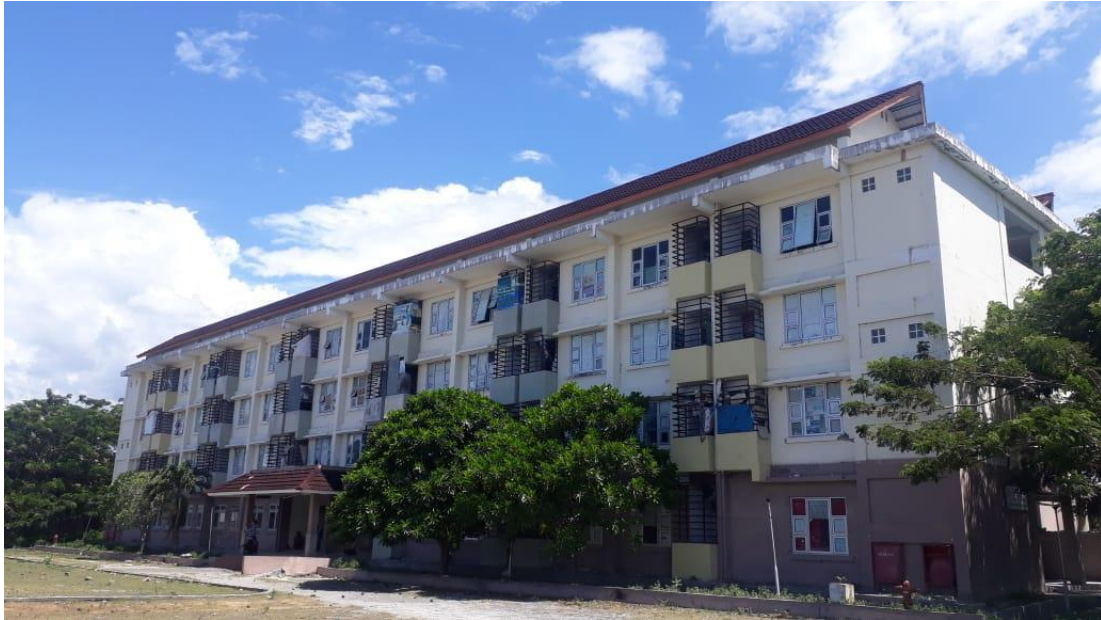
- Moderate damage (2 housing flats): MTs DDI Lonja and UPT Dinas PU Palu (Fig. 2)
- Major damage (1 housing flat): Univ. Tadulako – Palu (Fig. 3).

- Moderate damage (3 housing flats): Univ. Al-Khairat Palu, Rusunawa Pekerja Kota Palu dan UPT Dinas PU Palu
- Major damage (1 building): Univ. Tadulako – Palu

Fig. 2 – Front view of damage occurred on rental low-cost housing flat UPT Dinas PU Palu

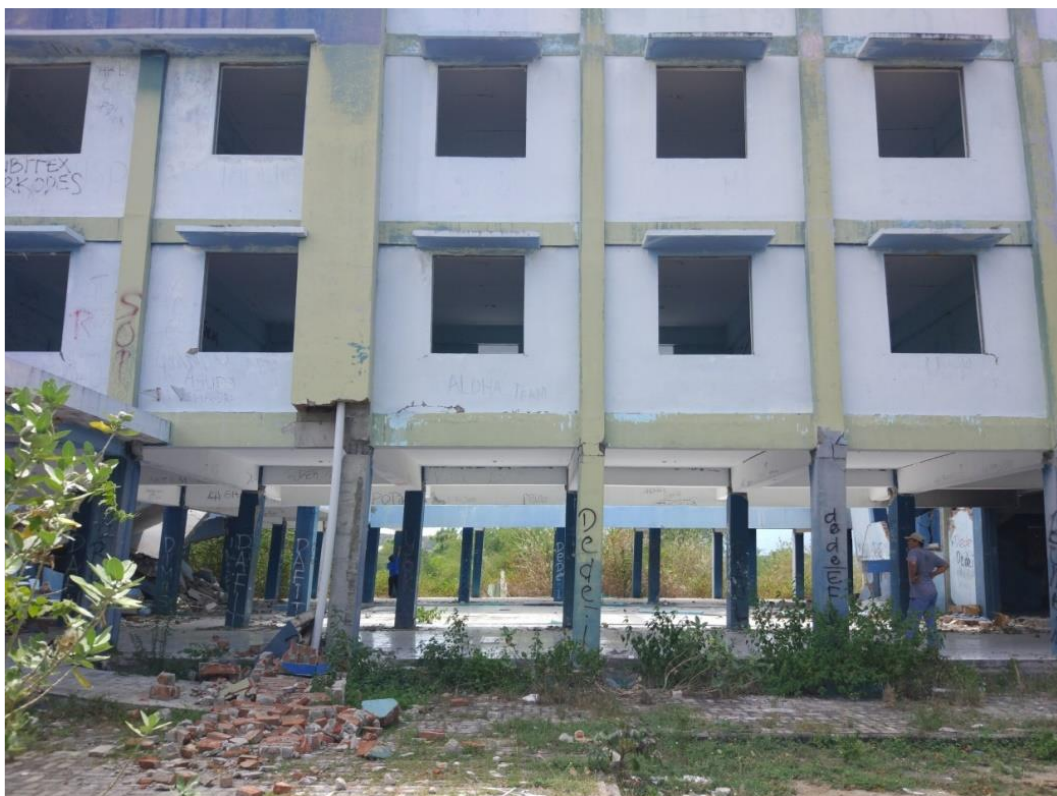
Fig. 3 – Front view of damage occurred on rental low-cost housing flat Univ. Tadulako

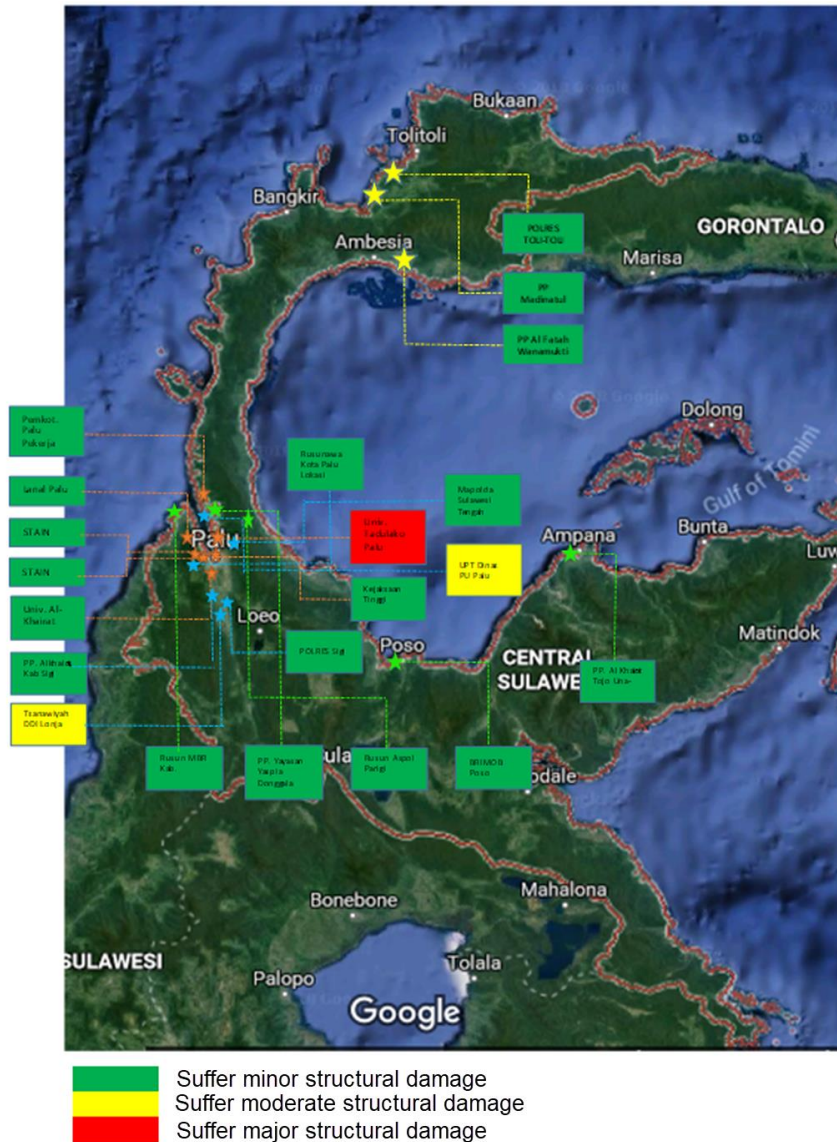
Figure 4 shows the distribution of 21 housing flats suffering various degrees of structural damage. These are housing flats built in the period of 2007-2017. As can be seen, most housing flats have only minor damage. This shows that the seismic performance of those housing flats are good as many buildings around them are severely damaged. In other words, the housing flats perform well against designed earthquake load. One housing flat that suffer major damage is housing flat Univ. Tadulako – Palu constructed using conventional reinforced concrete.

Fig. 4 – Mapping of housing flats suffering structural damage due to earthquake

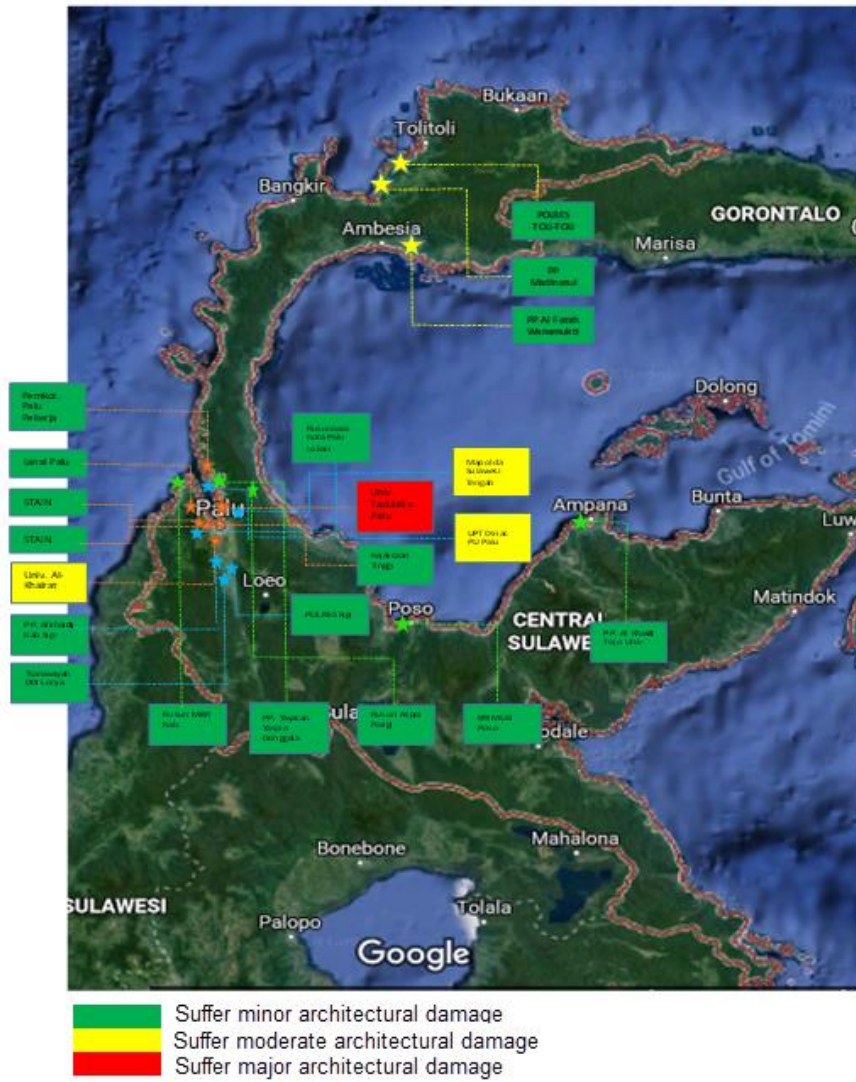
Distribution of 21 housing flats suffering various degrees of architectural damage is shown in Fig. 5. As can be seen, most housing flats have only minor architectural damage.

Fig. 5 – Mapping of housing flats suffering architectural damage due to earthquake
