USE OF VERTICAL UNBONDED POST TENSIONED ON PRECAST CONCRETE WALL TO COUNTERACT VERTICAL EARTHQUAKE

Abstract

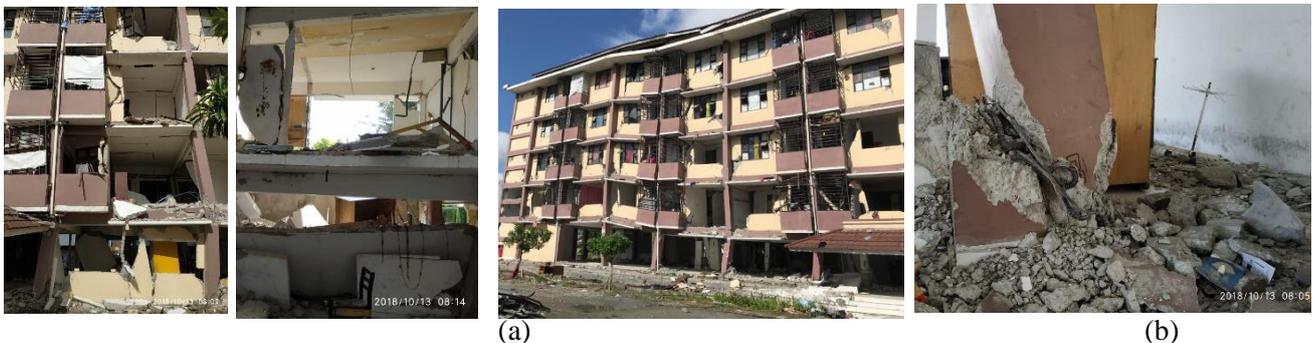
Post-earthquake assessment of building condition ^{[2][3][4]} of rental low-cost housing flat Lere in Palu was conducted on October 13th, 2018. Visual observation and analysis show that this housing flat suffered major damage in both structural and architectural components as can be seen in Figs 1.a and 1.b, respectively.

Fig. 1 – Pictures of damaged rental low-cost housing flat Lere: (a) major architectural damage, (b) major structural damage concentrated on base columns undergone compression failure and combined shear and tensile failure

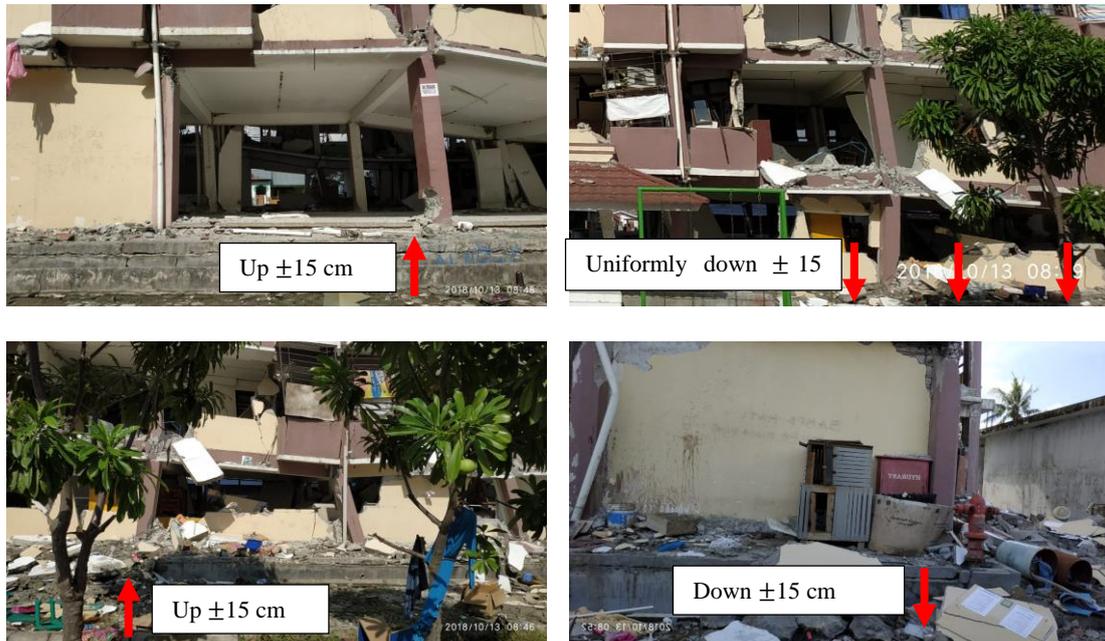
Failure mechanism of structure occurred at rental low-cost housing flat Lere was triggered by vertical earthquake load as dominant load in this earthquake. The wave of vertical load led to significant soil deformation and thus caused one point of structure deforming going down and the other point going up (forming wave-like vertical deformation along length of the building). This failure mechanism can be described using Fig. 2.

Fig. 2 – Soil deformation pattern due to vertical earthquake (pictures continuous along the length of building)

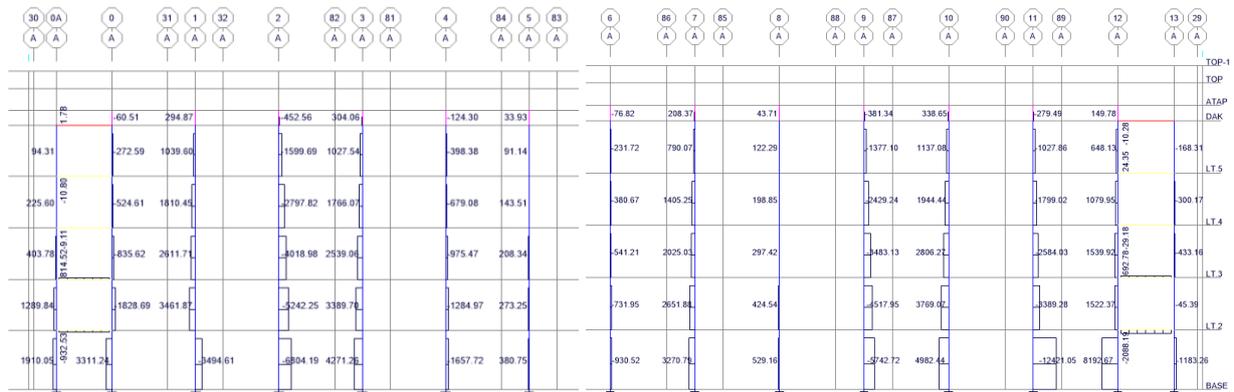
Fig. 4 – Output axial force due to ground displacement

From Fig. 4, it can be seen that vertical movement of ground surface can result in large axial forces in columns. These axial forces have different direction between two adjacent columns. For example, at column 2-A in which ground surface move upwards 15 cm, there is compression force of 6304.2 kN and at adjacent column (column 3-A) in which ground surface displace downwards 15 cm, the column has tensile force of 4271.3 kN. On another example, at column 12-A where the ground surface beneath it move downwards 20 cm, the column has axial compression force of 8192.7 kN and at column 11-A where the ground surface beneath it move upwards 20 cm, the column has axial tensile force of 12421.1 kN. Meanwhile, based on theoretical formula, the compressive and tensile capacity of reinforced concrete column can be evaluated as follows: compressive capacity = $0.85 f_c' A_g = 0.85 \times 29.05 (350 \times 500) = 4,321,187 \text{ N} = 4321.2 \text{ kN}$ and tensile capacity = $0.5 \sqrt{f_c'} A_g = 0.50 \times \sqrt{29.05} (350 \times 500) = 471,607.954 \text{ N} = 471.607 \text{ kN}$.

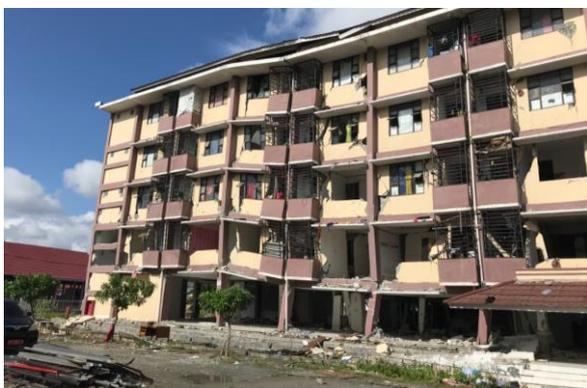
From the above discussion, it is clear that the axial forces, both in tension or in compression, exceed their capacities. As can be seen in Fig. 5.a, column 2-A underwent compression failure. On the other hand, Fig. 5.b shows that column 3-A suffered a combination of tensile and shear failure. Since the tensile capacity of column is much lower than the actual axial tensile force in column, the column was separated into two parts and then displaced to the side due to lateral force as shown in Fig. 5.b. Thus, from data and computer model simulation, considering that the large vertical earthquake load coming earlier than the of horizontal earthquake load, it explains the damage mechanism took place on building under investigation.

Fig. 5 – Structural damage: (a) compression failure in column, (b) tensile-shear failure in column

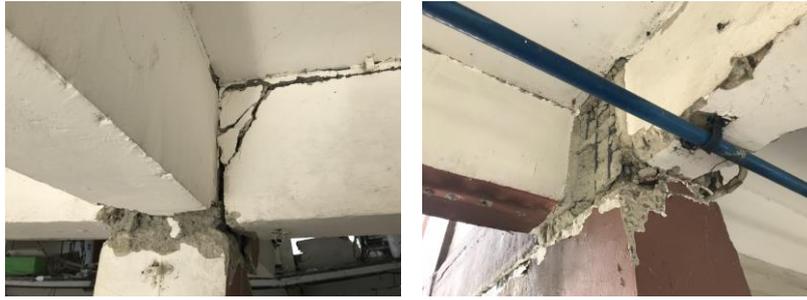
According to Indonesian seismic design code (SNI 03-1726-2002) and concrete building code (SNI 03-2843-2002), moderate moment resisting frame structure can still be used for region medium earthquake risk (zone 3, 4, 5), without using shear wall. Shear wall in this building is only provided in the first floor to prevent soft story effect. Damage mode of sway mechanism that was employed based on the assumption of the earthquake would not occur in this building with the dominant vertical earthquake load. Random column failure in the first-floor results in random failure mode on structure above the first floor. There is no clear damage pattern on every component of the structure. However, if one compares damage evolution from several components with those crack pattern from testing shown in Fig. 7, one can see similarity in pattern. Cracks started from beam and then go into the joint as can be seen in Fig. 8. Stirrups in column and joint were properly installed, but dominant vertical earthquake load led to concrete crushing as shown in Fig. 9.

Fig. 8 – Damage of beam-column joint due to earthquake

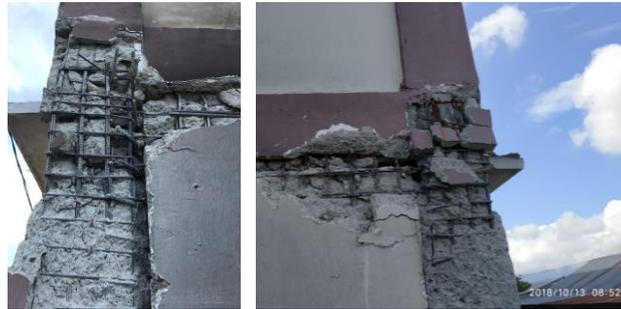
Fig. 9 – Stirrups installed properly in column, beam and joint, concrete crushing because of tension
