Damage analyses on the collapse of Aso-ohashi during the 2016 Kumamoto Earthquake

S. Hosokawa⁽¹⁾, S. Unjoh⁽²⁾

Abstract

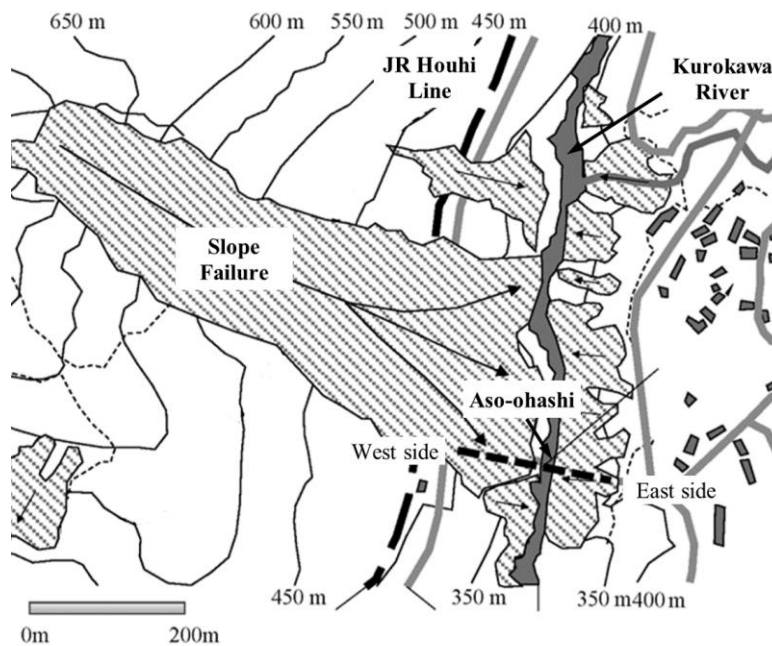
Fig. 1 – Slope failure and location of Aso-ohashi (modified from Ref. [1])

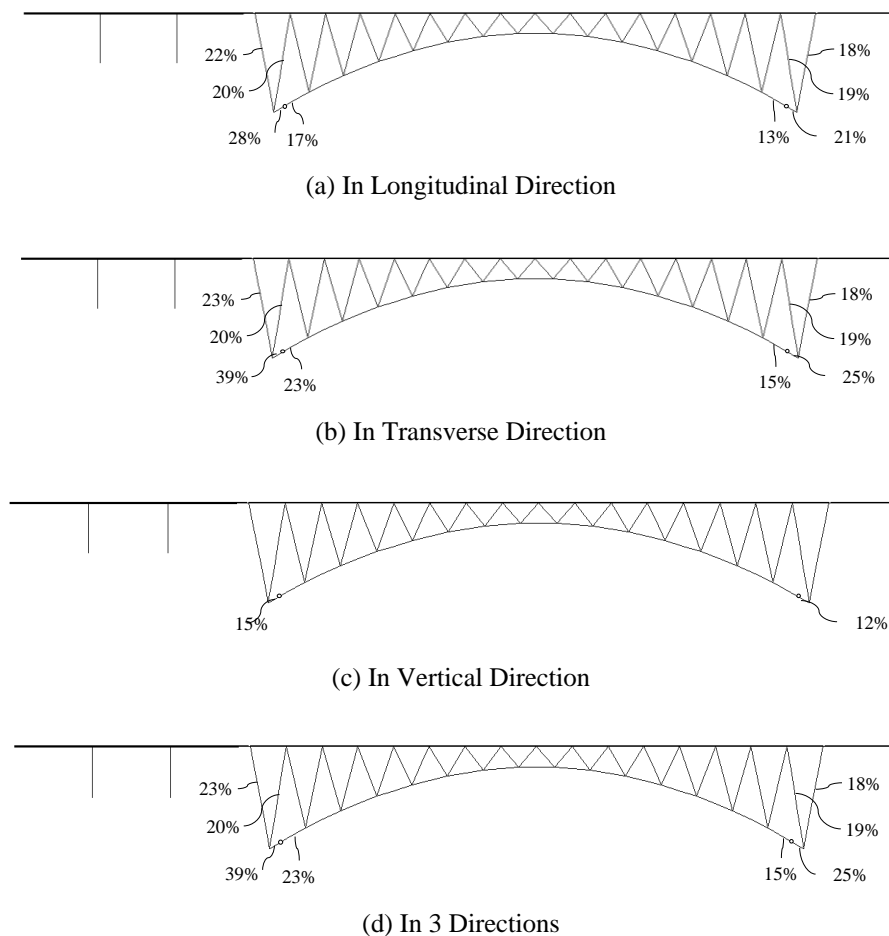
Fig.10 shows the maximum response curvatures depending on the directions of input ground motions. Ground motions were given as a single direction in the longitudinal, transverse, and vertical, as well as in 3 directions simultaneously. The rates of response curvature to the yield state of members which responded exceeding 10% are shown. In the case in which the ground motion was input in the longitudinal direction only, the maximum response was 28% at the springing sections of the arch ribs, and 22% in the end columns in the west side. In the case in which the ground motion was input in the transverse direction only, the responses indicated equal or larger totally than the former case, and the response at the springing sections became 39% in the west side. In the case in which the ground motion was input in the vertical direction only, not so much responses arose and only the members at the springing sections in the west side reached the rate over 15%. Based on these results shown in Fig.10 (a)-(c), the larger responses were observed at the springing sections but were not so much as the member failure. Since the responses of the case for the transverse direction and the case for 3 directions are almost the same on the whole, Aso-ohashi supposed to be most affected by the transverse ground motion. Since these analyses were made using observed earthquake records and there were no members of which curvature reached the yield state, the possibility that Aso-ohashi collapsed by only the strong ground motion seems to be low.

Fig. 10 – Maximum response curvatures depending on the directions of input ground motions in which members with relatively large response curvatures are shown (equal or large than 10%)

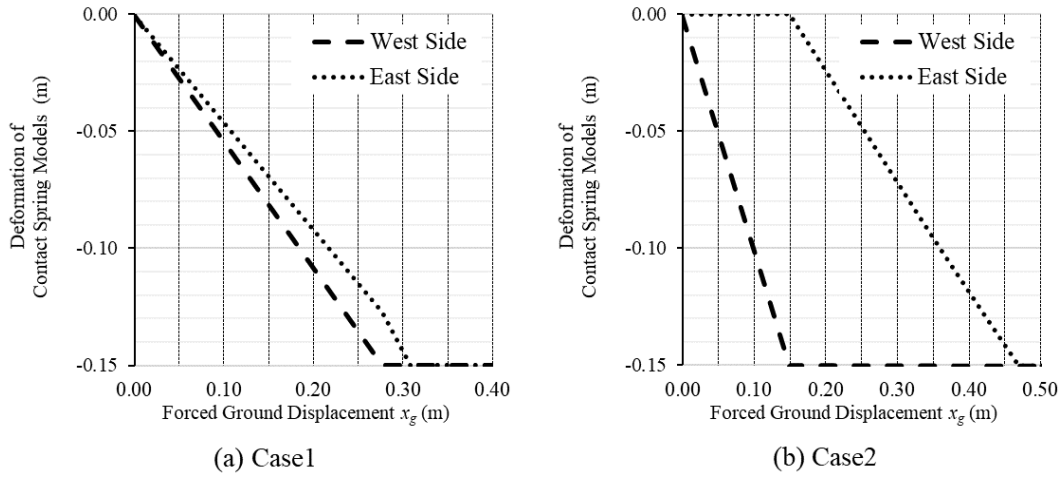
Fig. 11 – Collision or compression of explosion joint at east side abutment

For Case 2, the progress of the location of members of which the response curvatures exceeded the yield point is shown in Table.1(b). From Fig.11(b), it was confirmed that the contact spring model in the west side became rigid at $x_g=0.150m$ and the trussed arch bridge started to deform after the contact. At $x_g = 0.410m$, the springing sections of the arch ribs in the west side yielded at first. Following this, the contact spring model in the east side also became rigid at $x_g=0.460m$ and the superstructures became continuous in the longitudinal direction. When the displacement x_g reached $0.700m$, the springing sections of the arch ribs in the east side yielded. Fig.12(b) shows the locations of members which exceeded the yield point.

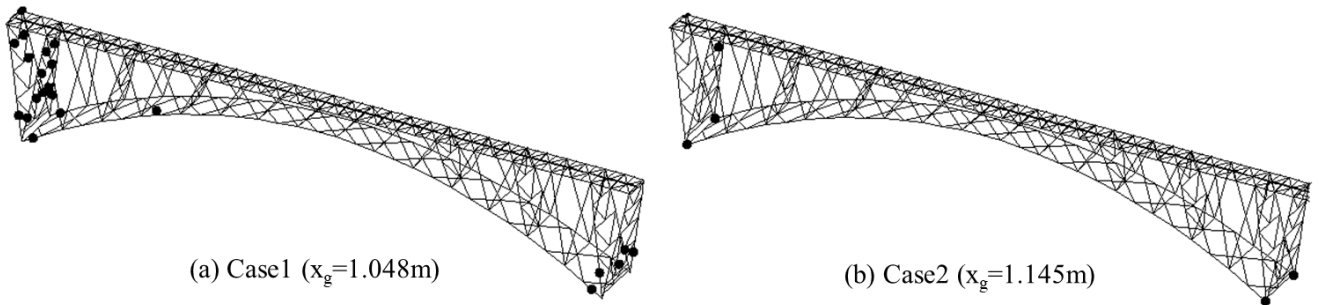
For Case 1, the springing sections of the arch ribs in the west side yielded first of all at the forced ground displacement $x_g = 0.155\text{m}$. Subsequently, the same sections of the arch ribs in the east side yielded at $x_g = 0.204\text{m}$. It was estimated that the response curvatures in these sections were easy to increase by the forced ground displacement because the springing sections of the arch ribs and end columns were fixed rigidly to abutments. Fig.11 shows the relations between the deformation of the contact spring models on the west and east sides and the forced ground displacement x_g for the Cases 1 and 2, respectively. In Case 1, the deformation of both side of contact models reached 0.150m , which was the gap between trussed arch bridge and girder bridge sections (ΔW) and the deformation became constant around at $x_g = 0.300\text{m}$. At $x_g = 0.370\text{m}$, the end columns yielded. It was supposed that these responses of the end columns became larger because the continuous girders pushed the trussed arch bridge and simple girder bridge sections from the west to the east by fixing at the joints, and the arch ribs deformed upward. Fig.12(a) shows the locations of members which exceeded the yield point.

Fig. 12 – Locations of members of which response curvatures exceeded yield point

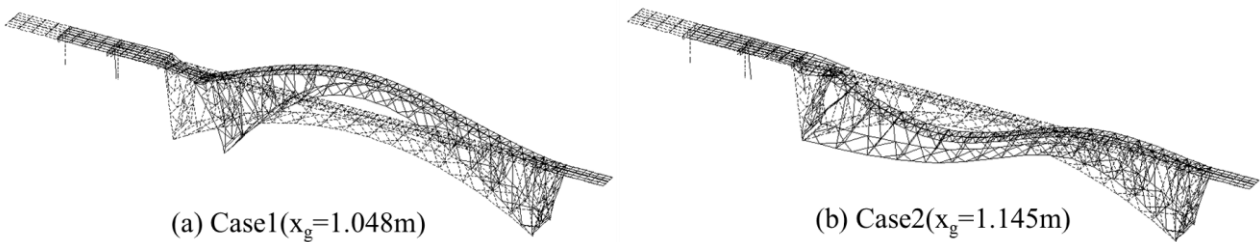
Fig. 13 – Deformation mode of whole bridge

Fig.13 shows the deformation modes of whole bridge for two cases. The deformation mode of arch bridge section of Aso-ohashi was bending upward for Case 1, while that was like the shape of a character 'S' for Case 2. Based on these results, it was found that the modes of deformation of whole bridge were quite different depending on the boundary conditions between giving the forced ground displacement to the arch abutment on the west side (slope failure side) or not. In both cases, the springing sections of the arch ribs in the west side yielded firstly and the damage was spread from the end columns.
