## CHARACTERISTIC OF EXISTING RESIDENTIAL BUILDINGS IN INDONESIA AND THEIR TYPICAL DAMAGE DURING EARTHQUAKES

### **Abstract**

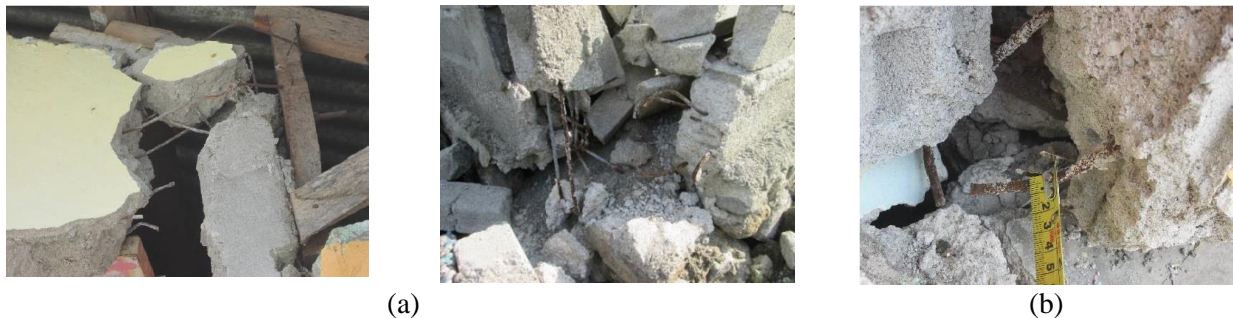
The separation of confining elements (i.e. column – beam, foundation – columns, column – plinth beam) was common due to poor seismic detailing (Fig. 5a), poor concrete strength and insufficient concrete capacity (Fig. 5b). Separation between concrete confining elements and the masonry wall was also commonly encountered (Fig. 6). A case was found where a wall panel without a top confining element led to splitting of the adjoining column that had to support all the lateral load at the adjoining wall (Fig. 7).

Fig. 5 – (a) poor seismic detailing and (b) poor concrete quality

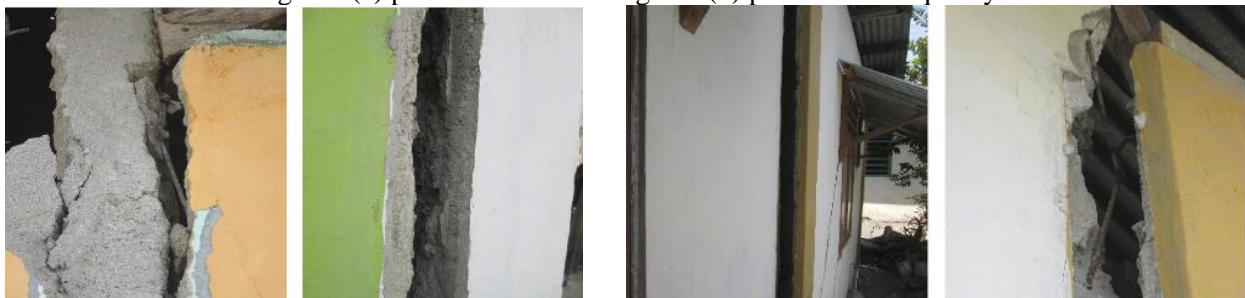
Fig. 6 – Separation of confining elements and masonry

Fig. 7 – Splitting column due to poor concrete quality

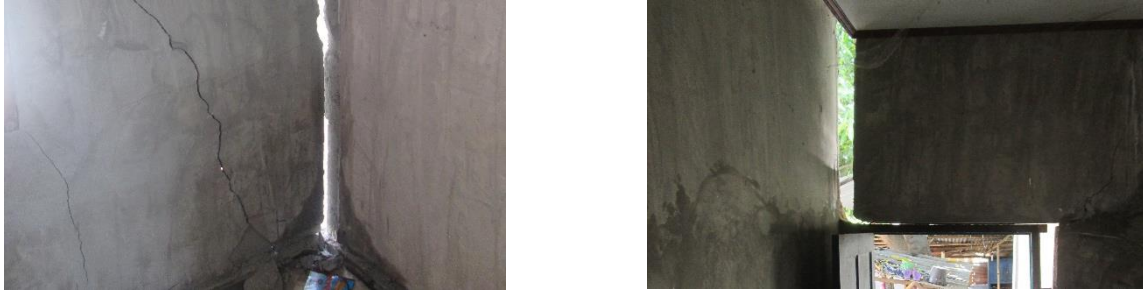
Especially for reinforced concrete frame with masonry infill, separation between reinforced concrete frame and the infill (Fig. 8) was prevalent.

Fig. 8 – Separation of confining elements and masonry

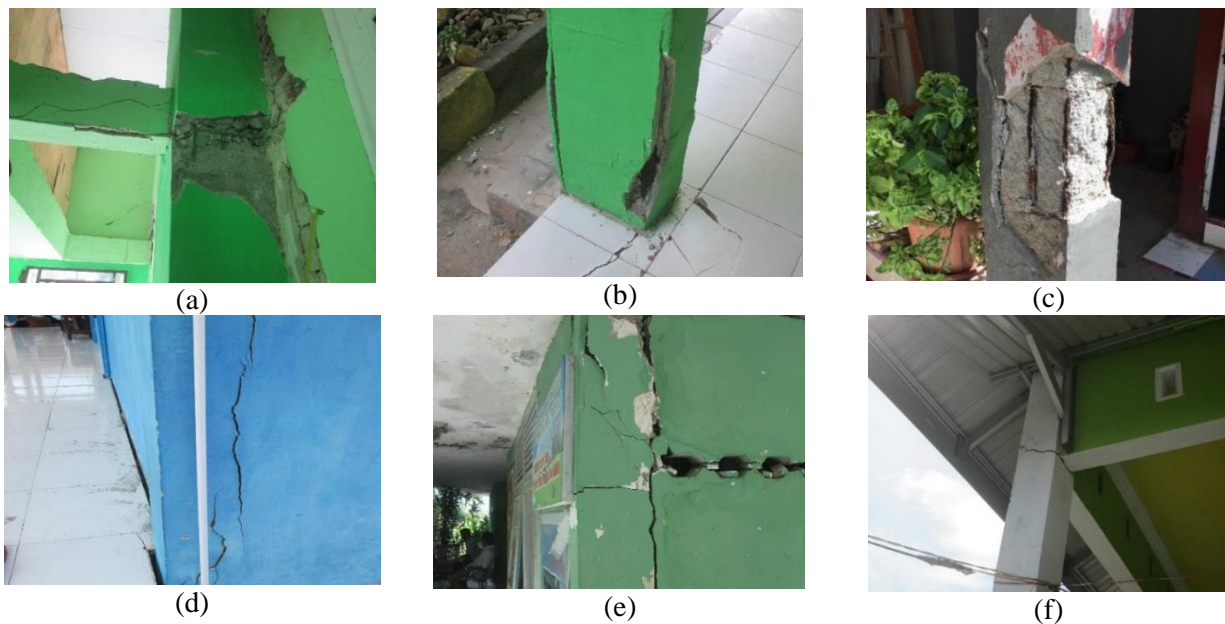
Several common cases of cracks on columns include crushing at joints (Fig. 9a), splitting cracks (Fig. 9b), cracks due to corrosion of rebar (Fig. 9c), diagonal cracks ((Fig. 9d), horizontal cracks (Fig. 9e) and cracks due to captive columns (Fig. 9f).

Fig. 9 – Types of cracks on columns

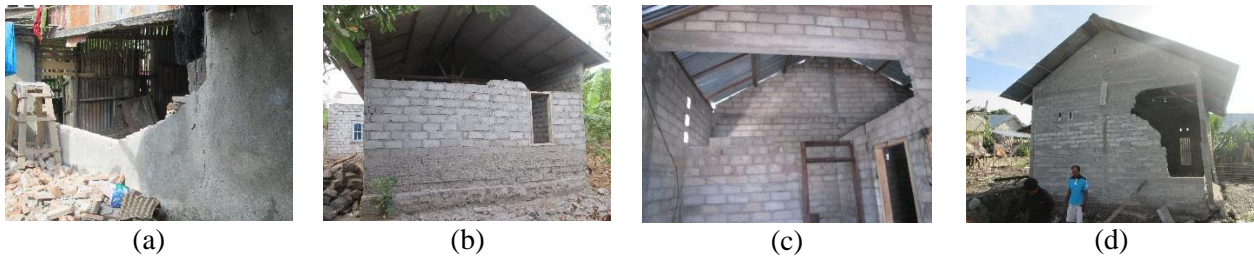
Out-of-plane collapse is one of the most common damage types encountered at masonry walls, especially where the roof and floor were timber frame. This is because the timber framing is relatively weak relative to the heavy infill and because there were only minimum connections provided between the timber framing and the masonry walls (Fig. 10a). Out of plane collapse was also common at unconfined masonry walls (Fig. 10b), where there was a lack of anchorage to the roof and no reinforcement to resist flexure of the wall. This type of damage was also prevalent for RCF with masonry infill, where the lack of connection between the frame members and the infill caused the infill to fall out of plane. In some cases, the infill collapsed even when the frame experienced little or no damage (Fig. 10c). There were also houses where there was out-of-plane collapse of confined masonry walls because of incomplete confining elements (e.g. absence of a reinforced concrete ring beam), masonry of poor quality (e.g. weak bricks and poor mortar quality, see Fig. 10d) or confining concrete tie elements that were of poor quality and failed to transfer the lateral load to the wall.

Fig. 10 – Out-of-plane collapse of wall
