NUMERICAL STUDY ON DAMAGE OF STEEL CHORD MEMBER IN SPACE TRUSS ROOF UNDER EARTHQUAKE

T.Wada⁽¹⁾, Z.Zhu⁽²⁾, K.Goto⁽³⁾, E.Tomokiyo⁽⁴⁾, M.Yamanari⁽⁵⁾

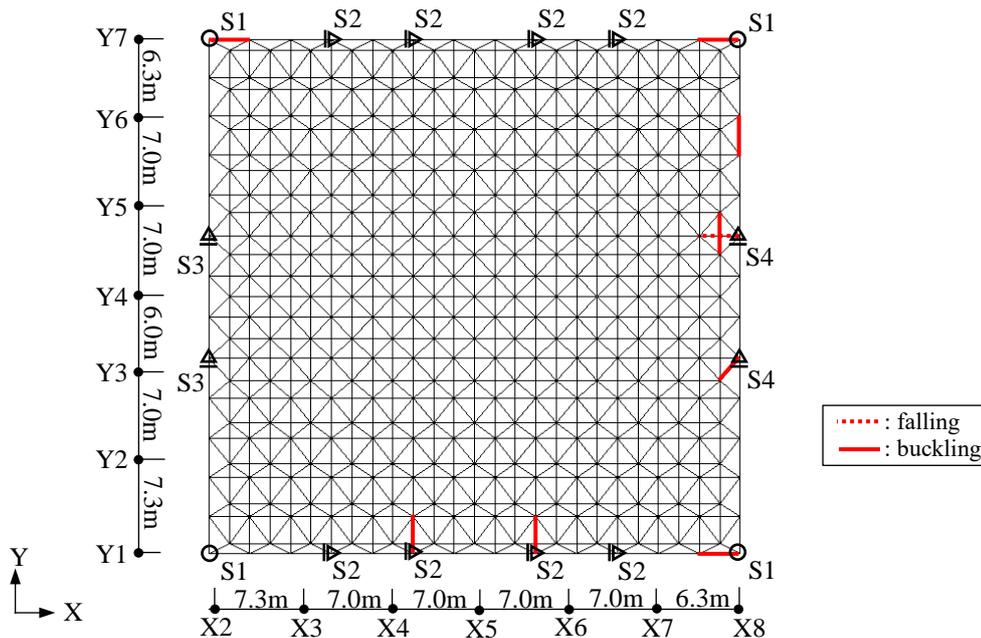
Fig. 4 - Damage location

The site of this gymnasium was shaken by twice strong earthquakes. The authors conducted surveys on the gymnasium in September and December 2016. So that they observed several buckling of truss members around the X8-line, breaking of truss members near the center of X8-line, sliding of roof bearing, and roof member falling as shown in Fig.4. Buckling of the space truss members around X8-line was caused by sliding of roof bearing which is roller bearing. Fig.5 shows each damage at the space truss roof and the roof bearing. From breaking of joint part in the space truss member as shown in Fig.5-(d), it turns out that the falling of the roof member is caused by breaking of the screw part.

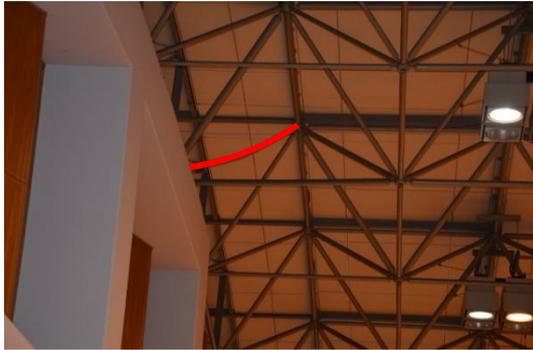
(a) buckling

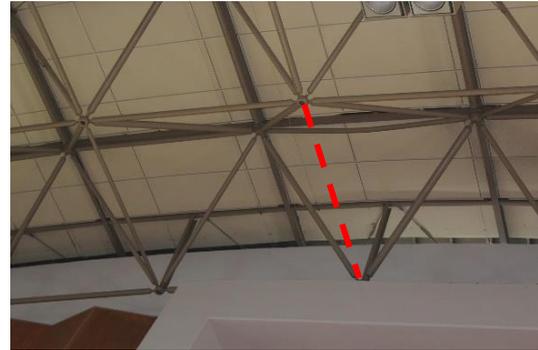
(b) falling

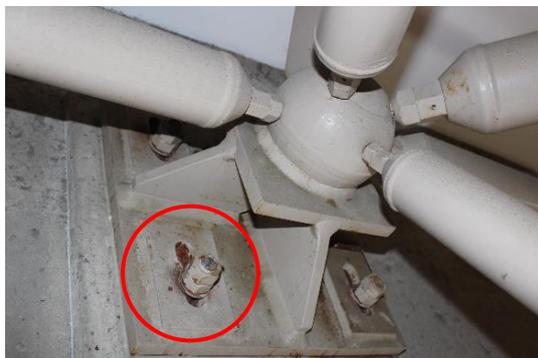
(c) sliding

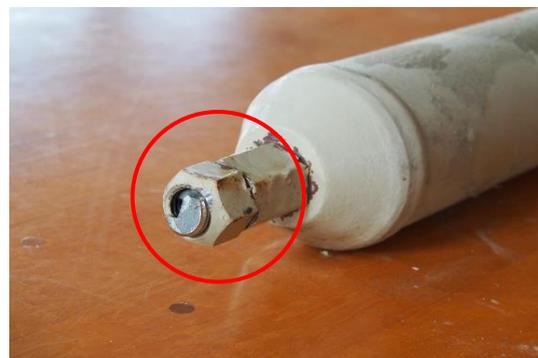
(d) falling down

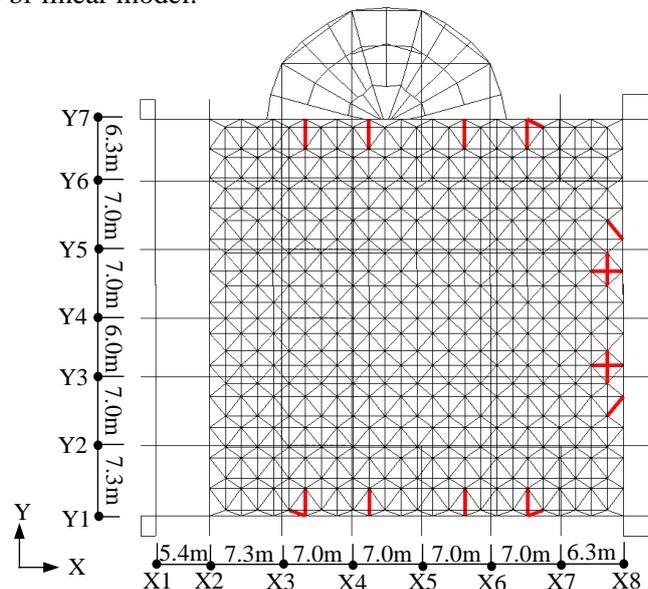
Fig. 7 – Yielded members

Fig.7 shows yielded members of the space truss obtained from calculation. The yielded members from the result and the members observed are the same. Consequently, it seems to be reliable that the seismic analysis was well done. Fig.8 shows 3rd and 4th eigen-modes of the frame viewed from Y axis. Also, Fig.9, shows 5th eigen-mode viewed from X axis. The deformed frame was drawn with thick lines. It can be recognized that out-of-plane deformation of the walls at on X2-line and X8-line occurs under the earthquake. It suggests that those modes derive the yielding of the truss members around X8-line. In addition, it can be also seen that there is out-of-plane deformation of wall on Y1-line as shown in Fig.9. The out-of-plane deformation on Y1-line was smaller than that on Y7-line. The fact that there was a low RC frame on Y7-line only, made the difference. From those eigen-modes, those modes have caused the yielding or buckling of the members in the space truss around Y1-line and Y7-line.

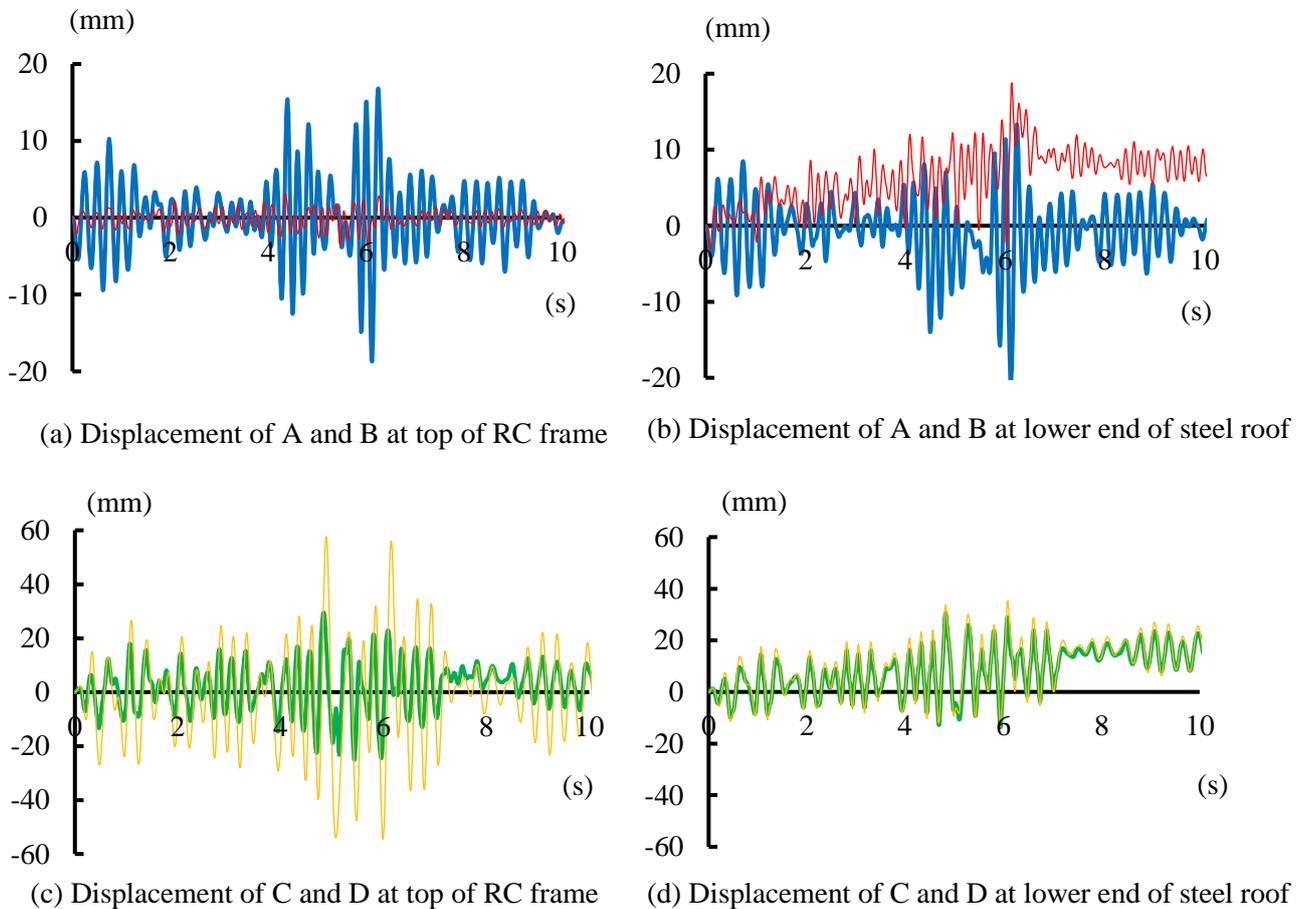
Fig. 11 – Displacement of opposite nodes

Fig.10 shows the representative positions of A, B, C and D in the space truss for examining the out-of-plane displacement under the earthquake. Fig.11 shows for recognizing the relative lateral displacement between A and B as well as C and D along the time line. A and B are the truss nodes that exist opposite point mutually in the plan. The history of the displacements of the opposite points insists that the truss chord members were under tensile or compressive stress. Eventually, some chord members broke or buckled because of exceeding their loading capacity.

Compared with (a) and (b) of Fig.11, the response of (b) is larger than (a). On the other hand, compared with (c) and (d), there is more difference between thick line and thin line than (d) because displacement of D at top of RC frame is larger. Then, calculation of the difference of lateral displacements between at the top of RC column and the bottom of the steel roof at each point was attempted. As a result, the maximum differences are 7mm, 19mm, 19mm, and 56mm, respectively. The maximum difference is over 50mm at the point D., It means that the difference exceeds the allowed length of loose hole. In addition, the calculated the difference between thick line and thin line in each graph, the maximum displacement is 7mm, 39mm, 50mm, and 7mm, respectively. In (b) and (c) of Fig.11, it reveals the maximum displacement of opposite node becomes large. It can be said that this out-of-plane deformation caused the pulling or pushing the space truss roof. From that those result, it is found that the out-of-plane response is one of reason that space truss is damaged.
