THE 2010 EARTHQUAKE IN CHILE – LESSONS AND ROAD MANUAL UPGRADE

V. Díaz⁽¹⁾, A. Unión⁽²⁾, S. Achurra⁽³⁾, L. Aravena⁽⁴⁾, P. Sepúlveda⁽⁵⁾, T. Cabrera⁽⁶⁾

Keywords: intense earthquake in Chile, bridges damages; lateral stopper; Seismic Design Criteria; Road Manual of Chile

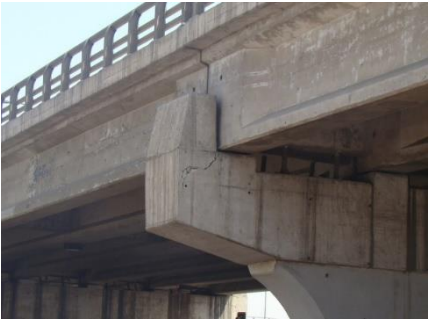
Fissures in the lateral stopper

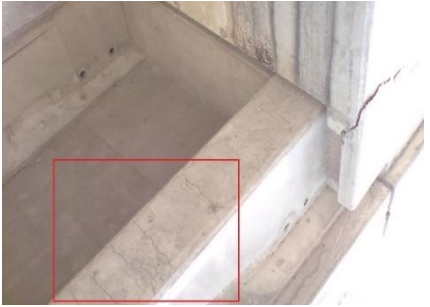
Fissures in beam

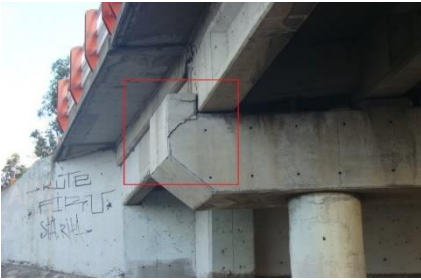
Crack in the lateral stopper

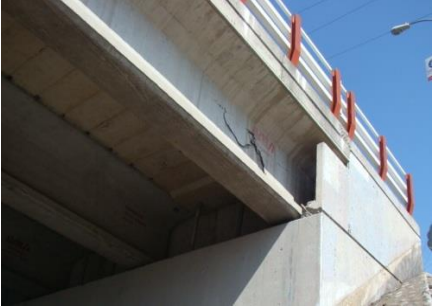
Crack in beam

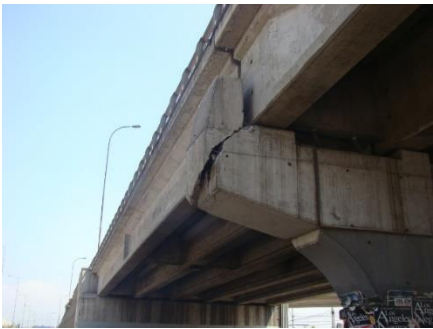
Fracture in the lateral stopper

The internal Lateral stopper must form a cutting key with the crossbars, so that no damage to the beams occurs, in a probable lateral movement that exceeds the design displacement, due to an important earthquake, the impact must be produce between the stops and the crossbar, generating some kind of repairable damage in them.

The minimum width of the lateral stopper must be 40 (cm) and the maximum 70 (cm). It is not recommended to place larger widths because being more robust they will not behave like a fuse and it is likely that when the impact on them occurs, important requests are transmitted to the infrastructure, and can cause cracks in the heads and walls of temper.

Lateral Stopper should be calculated considering a horizontal acceleration equal to AoS where S is the soil coefficient. Each internal or external lateral stopper must be able to withstand the horizontal force transmitted by the board divided by the total number of internal lateral stopper and the external lateral stopper that will oppose the direction of movement of the board.

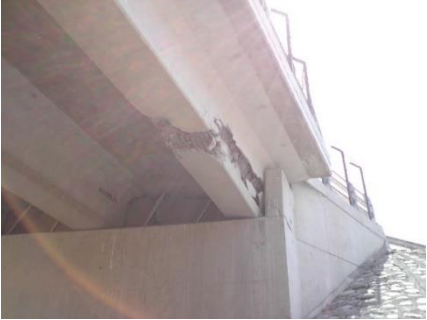
Fracture in beam

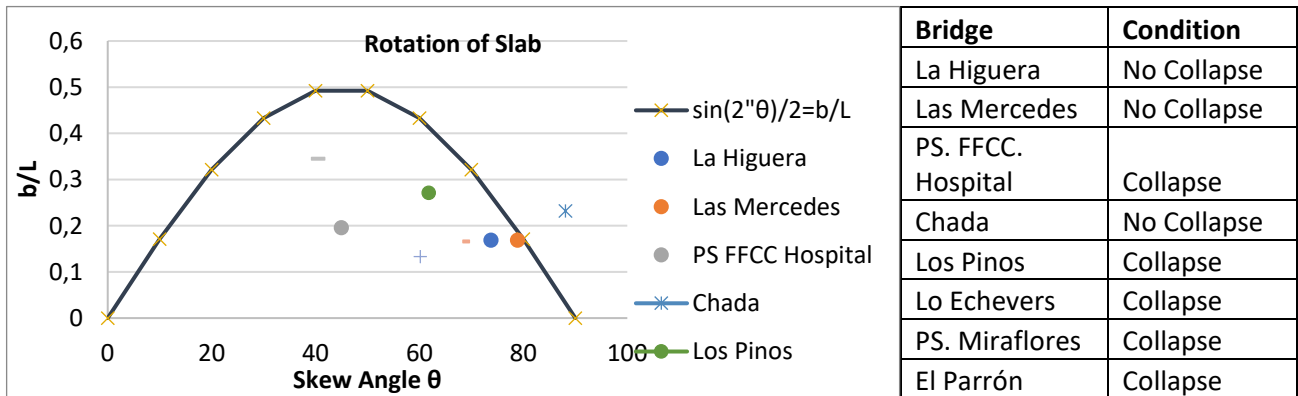
Graphic 2: Slab Rotation

The Graphic 2 shows the rotation slab of few structures in Metropolitan Region. The results are coincident with the condition of the bridge. If the bridge that are located outside the curve, as Chada Bridge or very near of curve, as La Higuera and Las Mercedes, didn't has big displacement.

Is necessary evaluate the geometry of the bridge. If the calculated point is under the curve, it means that there will be excessive lateral shifts of the board, due to to rotation. In that case will be necessary incorporate internal seismic stops according to section 5.4, in addition to the external stops.

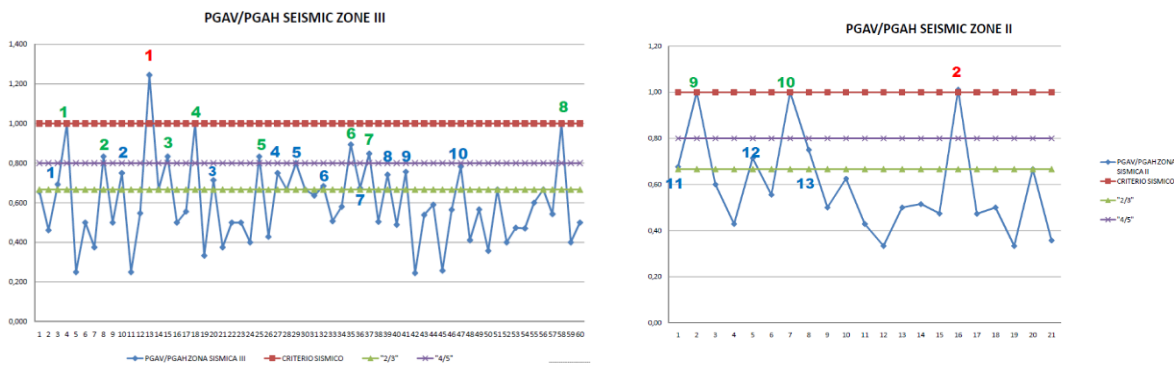
Fig. 2: PGA/PGH

The next graph show Ratio between Vertical Peak Ground Acceleration and Horizontal Peak Ground Acceleration. From 2010 earthquake data was possible to observe than several vertical acceleration value were similar to horizontal acceleration value.

In cases where there is a history that significant vertical accelerations have been measured in the soil, a spectrum of vertical accelerations must be generated. For the rest of the cases, the seismic bas must be calculated considering a vertical acceleration of the superstructure equal to $A_{VT} \cdot S$, where S is the soil coefficient and A_{VT} is equal to horizontal design acceleration A_o . It is obtained from the following table.
