Repair of hollow columns in rigid-frame PC bridge damaged by the 2016 Kumamoto Earthquake and examination of performance recovery by monitoring

F. Miyahara⁽¹⁾, T. Imamura⁽²⁾, H. Nishida⁽³⁾, M. Sawada⁽⁴⁾, J. Hoshikuma⁽⁵⁾

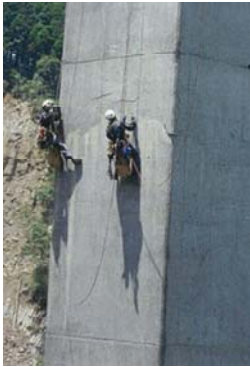
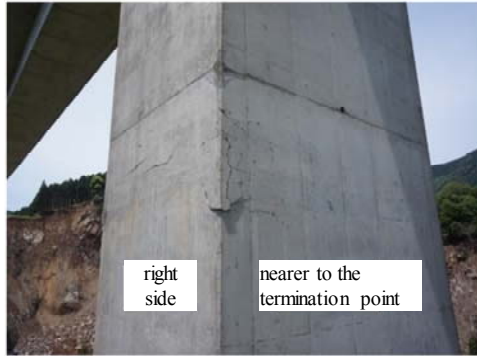
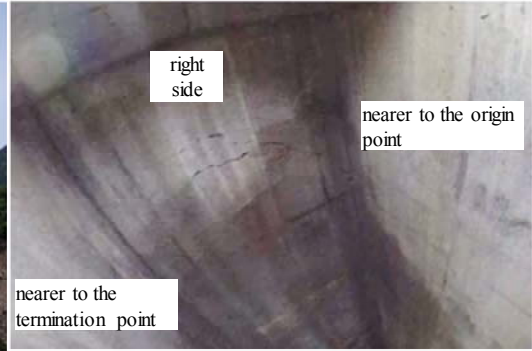
Fig. 3 – Rope access investigation

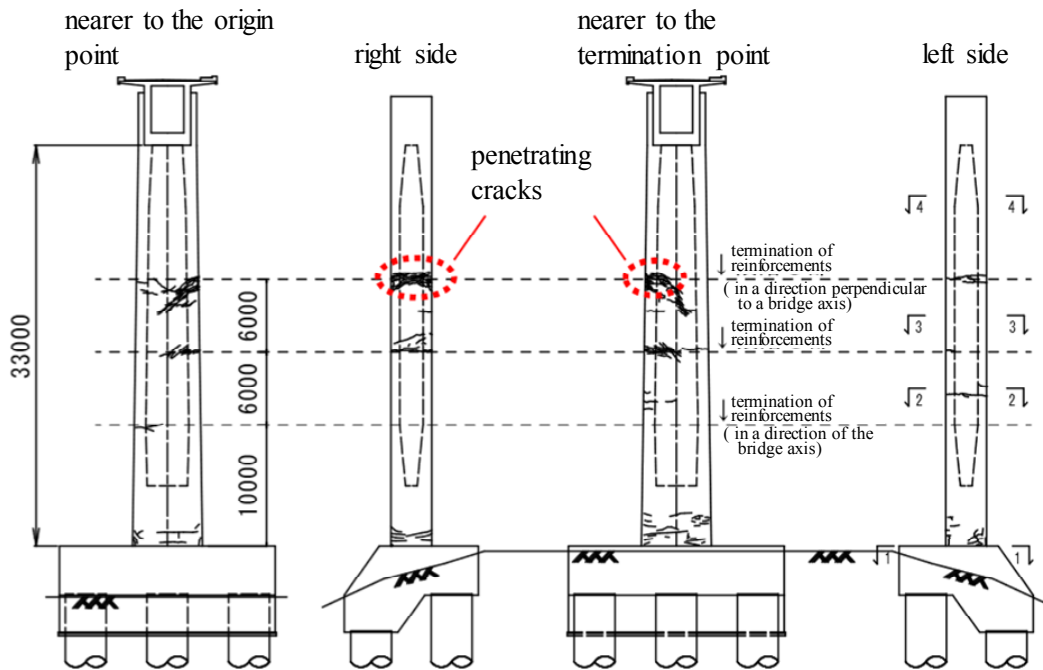
Fig. 5 – Penetrating cracks observed on P3 pier

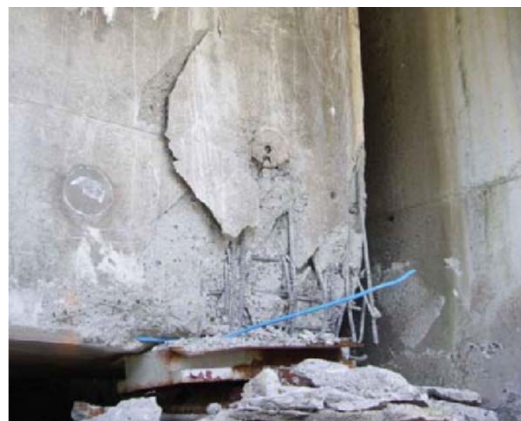
Fig. 6 – Damage of the PC box girder end supported on the A2 abutment

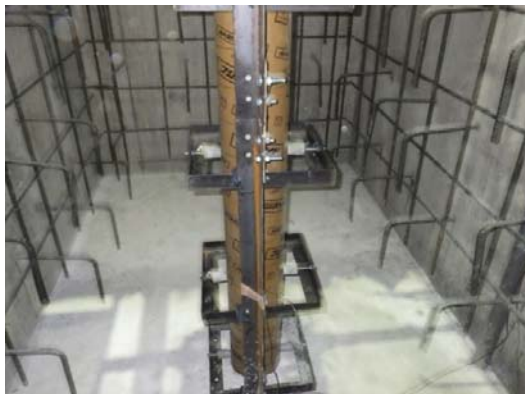
Fig. 7 – Arrangement of bars inside the pier

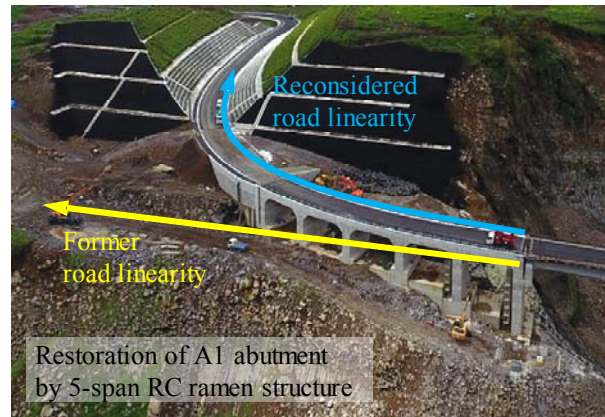
Fig. 10 – Full view of the restoration of the A1 abutment

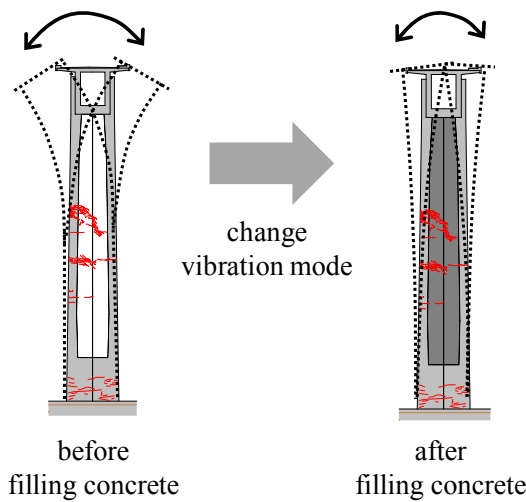
Fig. 11 – Change in vibration mode assumed for P3 pier

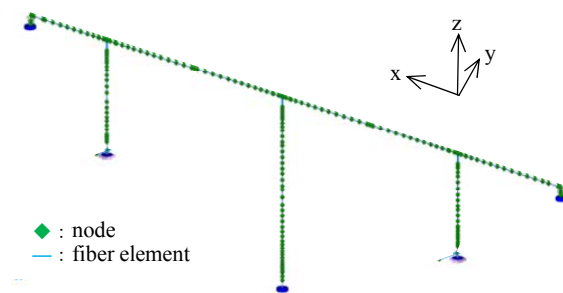
Table. 1 – Boundary condition for each support point

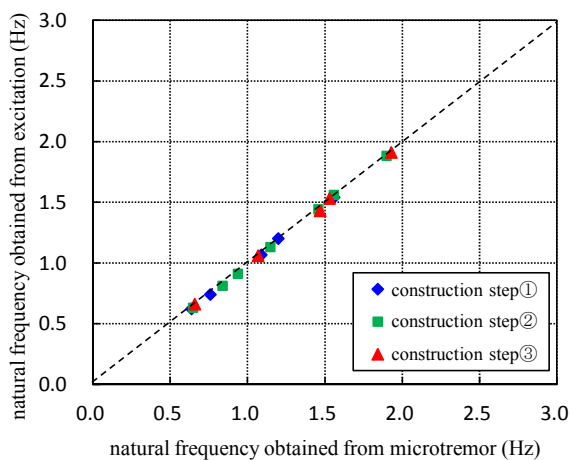
Fig. 15 – Comparison between the natural frequencies obtained from microtremor measurement and from artificial excitation test
