DAMAGE MECHANISM OF OHKIRIHATA BRIDGE DUE TO KUMAMOTO EARTHQUAKE

H. Nakao⁽¹⁾, K. Eguchi⁽²⁾, T. Yono⁽³⁾ and M. Ohsumi⁽⁴⁾

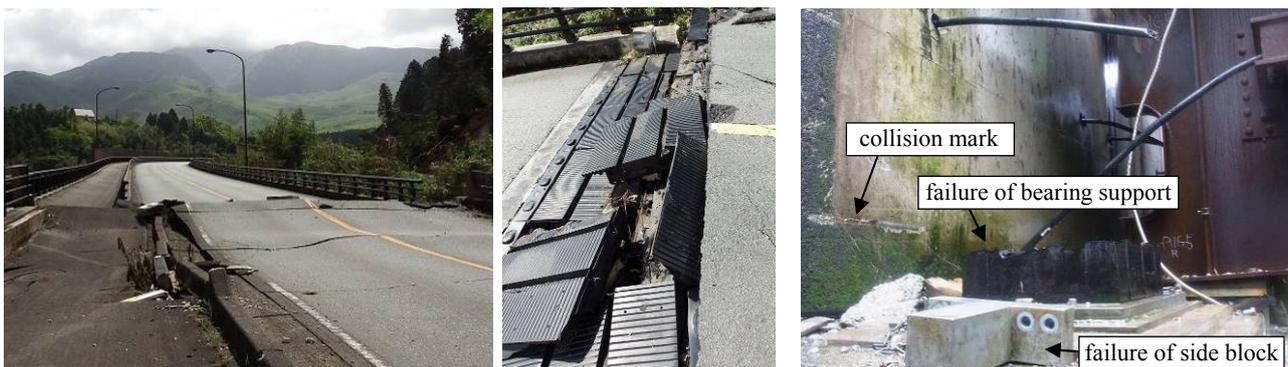
Photo 1 – Damage state at A1 abutment

In Ohkirihata Bridge, the pavement in back of the A1 abutment was raised, and the expansion joint was broken due to the earthquake as shown in Photo 1. At the A1 abutment parapet, the collided mark was found as shown in Photo 1. Most bearing supports were broken, and the superstructure was moved to the A2 abutment and the G1 girder side. Side blocks which are installed to prevent the lateral displacement at the A1 and A2 abutment were broken. The concrete crack was generated at the abutments and piers, but it did not reach to the catastrophic damage such as collapse.

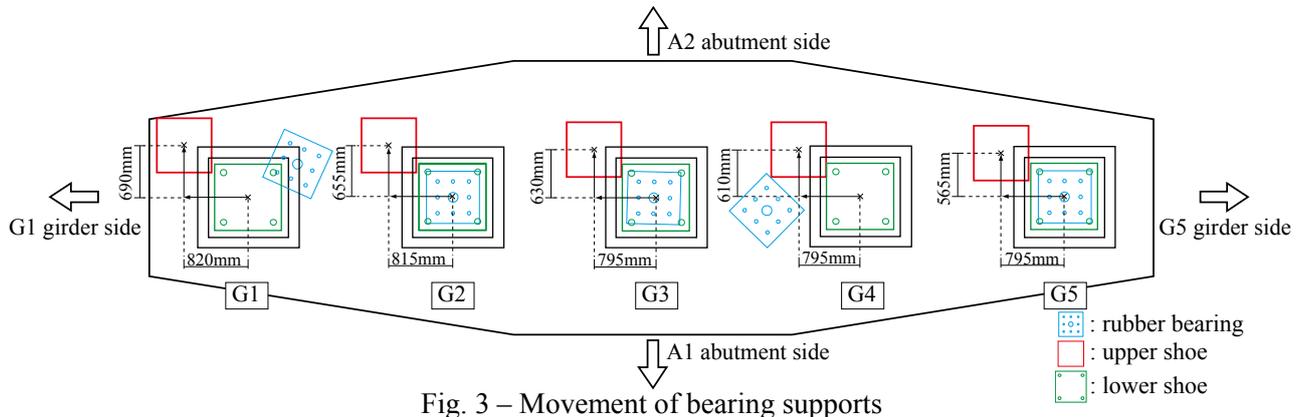
Fig. 3 – Movement of bearing supports

This study targeted the bearing support installed at the P1 pier, and investigated the behavior of bearing support estimated by the damage state. The main girder at the P1 pier moved to the A2 abutment side about 550mm ~ 700mm and the G1 girder side about 800mm as shown in Fig. 3. Furthermore, all bearing supports at the P1 pier were broken and main girders fell from the bearing support.

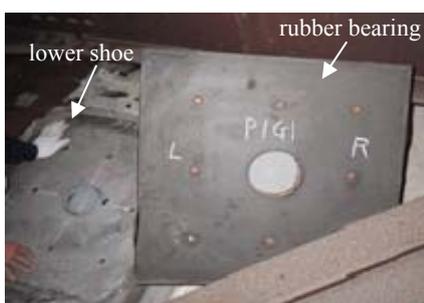
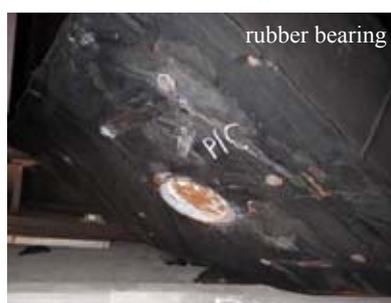
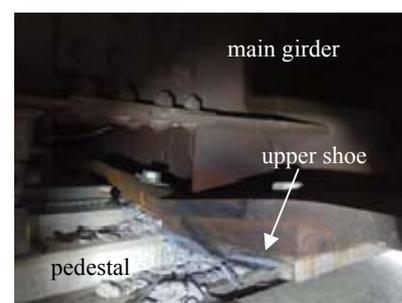
Photo 2 – Damage state (G1 bearing support)

Photo 2 shows the damage state of the bearing support installed at the G1 girder right after the earthquake. The upper and lower connecting bolts of the bearing support at G1 girder were damaged as shown in Photo 2(a) and (b). The rubber bearing moved to the A2 abutment and the G5 girder side and was turned over. The removed bearing shows in Photo 3. The upper shoe at the A1G5 corner was deformed as shown in Photo 3(a), because the main girder fell on the removed upper shoe on the pedestal as shown in Photo 2(c).

(a) Failure of rubber bearing

(b) Turnover of rubber bearing

(c) Falling of main girder

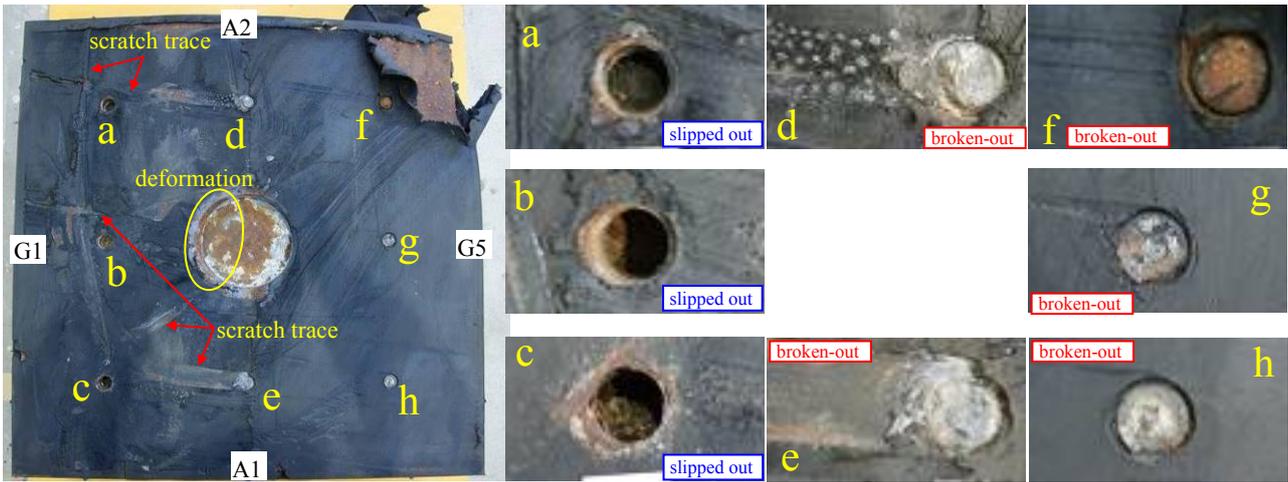
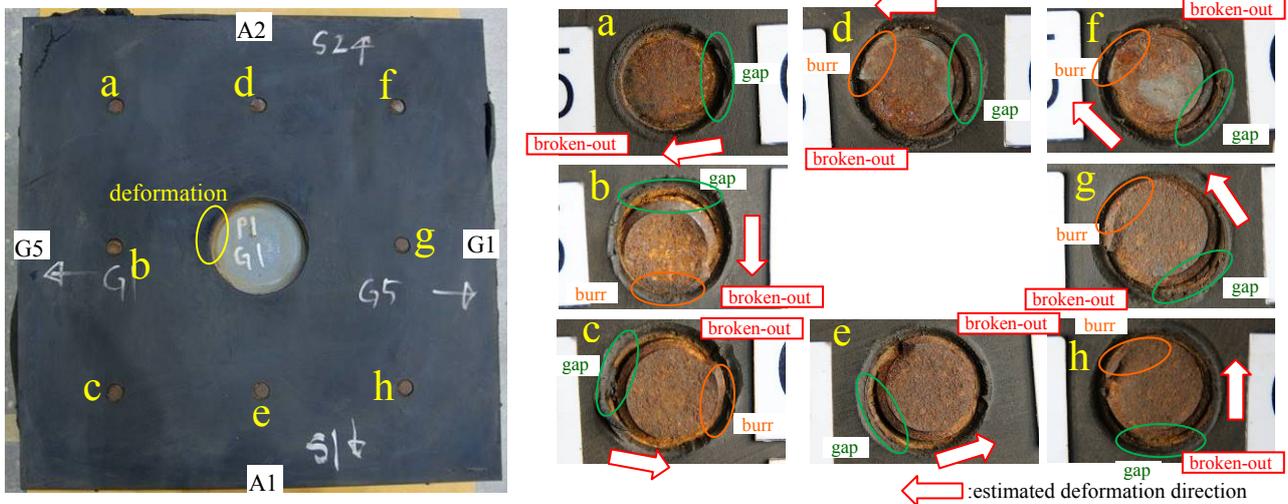
The top surface of the rubber bearing is shown in Photo 3(b). The upper connecting bolts at the G1 girder side (a-c) were slipped out, and other upper connecting bolts (d-h) were occurred the broken-out, it looks like the section appearing in the shear failure, and the hole which installs the shear key (named shear-key-hole) on the rubber bearing at the G1 girder side was deformed. According to the loading test of bearing support conducted by authors [7], it is found that the connecting bolt (p) in Fig. 4 was generated the tensile force and the shear-key-hole was deformed. From this knowledge, it is presumed that the upper connecting bolts at the G1 girder side were slipped out because the rubber bearing was excessively deformed to the G1 girder side, and the other upper connecting bolts were broken, because the shear key carried the shear force was come off the rubber bearing or the upper shoe.

The bottom surface of the rubber bearing is shown in Photo 3(c). The all lower connecting bolts were broken at the rubber bearing surface. Looking at the broken-bolt marks, there are the gap and the burr. According to the loading test of connecting bolts conducted by authors [8], it is confirmed that the gap and the burr are generated in the direction of the force when the connecting bolt was broken by the external shear force as shown in Fig. 5. From this knowledge, it is presumed that the lower connecting bolts were deformed in the direction of the arrow shown in Photo 3(c), and were broken at the rubber bearing surface. Looking at the lower shoe in Photo 4, there are scratch traces by the broken-out-bolt beside the bolt hole. And thus, it is presumed that lower connecting bolts were broken because the bearing support was excessive rotated around the shear-key-hole. In addition, the direction of the scratch trace was matched with the rotated direction found from the broken-out section of the connection bolt described above.

(b) Damage state at top surface of rubber bearing

(c) Damage state at bottom surface of rubber bearing
 Photo 3 – Removed bearing support (G1)

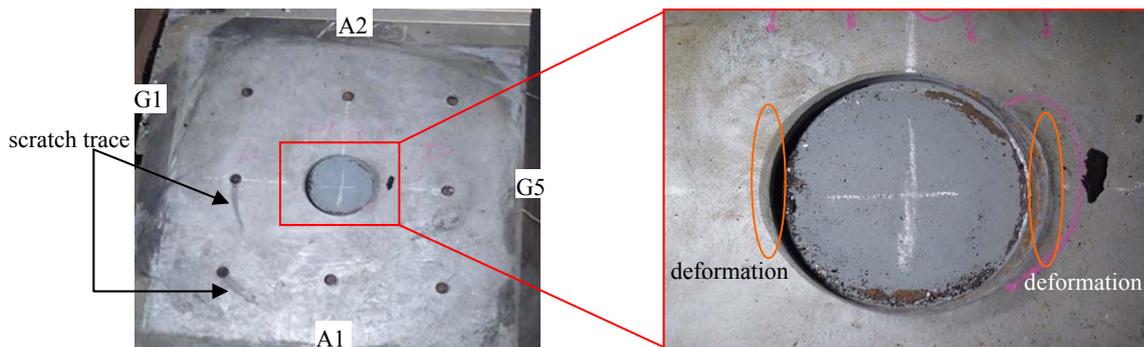
Photo 4 – Damage state of lower shoe

Therefore, it can be estimated that the lower connecting bolts were broken by the rotation of the bearing support before the failure of the upper connecting bolt, next the upper connecting bolts were broken by the deformation of the bearing support to the G1 girder side as shown in Fig. 6. Looking at the lower shoe in Photo 4, the shear-key-hole at the G5 girder side was deformed too, and thus it is estimated that the bearing support was deformed to the G5 girder side.

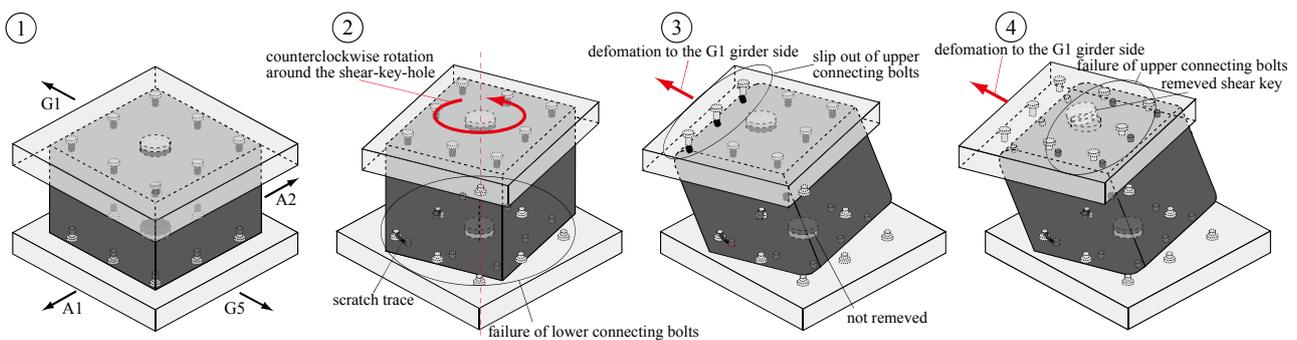
Fig. 6 – Estimated behavior of G1 bearing support

From these analyses, it is estimated that the bearing support installed at the G1 girder was broken by the behavior of the deformation to the G1 girder side and the rotation around the shear-key-hole. Next, we presume which one was damaged first. If the upper connecting bolt was broken before the failure of the lower connecting bolt, the rotation force did not generate at the rubber bearing. Therefore, it is not presumed that the upper connecting bolt was broken before the failure of the lower connecting bolt. On the other hand, in case of the lower connecting bolt was broken before the failure of the upper connecting bolt, the external force from the upper shoe can be transmitted to the lower shoe if the lower shear key was not removed. So the bearing support may be deformed such as Fig. 4.

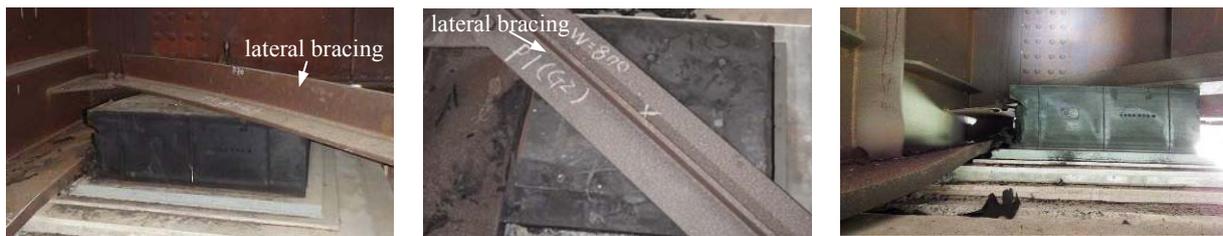
Photo 5 – Damage state (G2 bearing support)

Photo 5 shows the damage state of the bearing support installed at the G2 girder right after the earthquake. The upper connecting bolts of the G2 bearing support were broken, and the lateral bracing fell down on the bearing support. The removed bearing is shown in Photo 6. At the side of the bearing support shown in Photo 6(a), the upper shoe at the A1G5 corner was deformed, because the main girder fell down on the G1 girder side pedestal as shown in Photo 5. The cover rubber at the G1 girder side was damaged, it is presumed that the cover rubber was shaved by the lower flange when the girder fell from the bearing support. At the top surface of the rubber bearing, upper connecting bolts at the A1 abutment side (c,e,h in Photo 6(b)) were slipped out, and the other upper connecting bolts were broken at the rubber bearing surface. And the shear-key-hole at the A1 abutment side was deformed. At the bottom surface of the bearing support, there were not damage trace and the lower connecting bolts were not damaged. Referring to the past knowledge [7], it is estimated that the upper shoe of the G2 bearing support was moved to the A1 abutment side, and upper connecting bolts were broken by the excessive deformation of the rubber bearing as shown in Fig. 7.

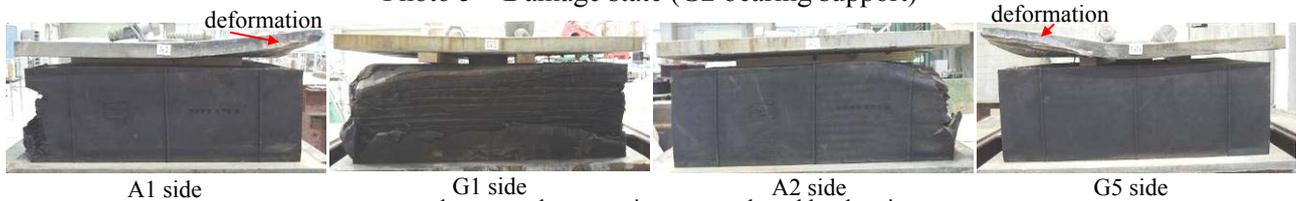
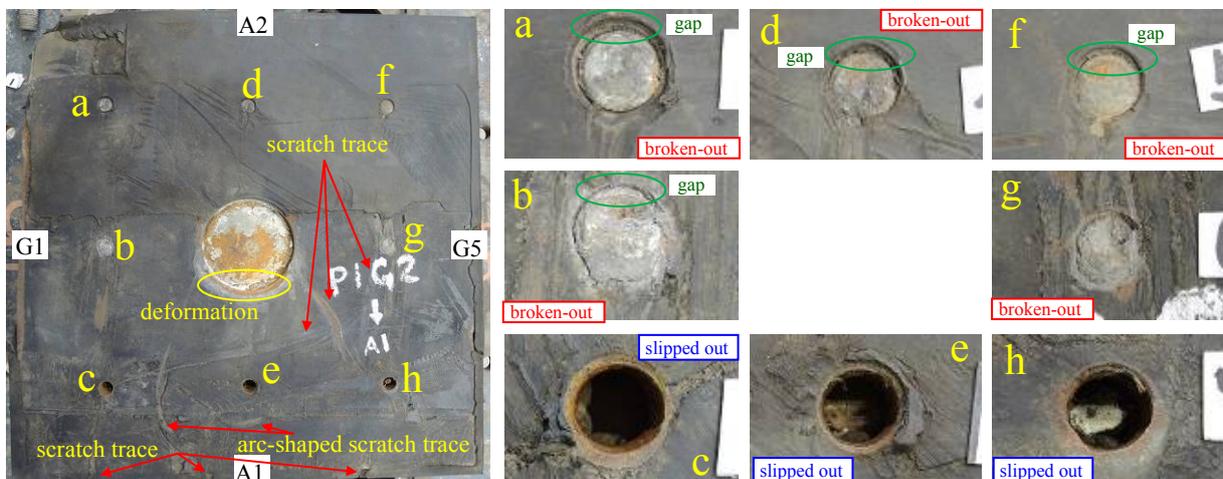
Looking at the Photo 6(b), there was the arc-shaped scratch trace at the A1 abutment side, and was almost matched with the shape of the shear key. Furthermore, there were scratch traces at the end of the A1 abutment side, and the interval of damage traces were almost matched with the interval of the upper connecting bolts. Therefore, it is presumed that the main girder might be moved to the A1 abutment side at least until the position of the arc-shaped damage trace.

note: the upper shoe were just put on the rubber bearings
(a) Damage state at side of upper shoe and rubber bearing

(b) Damage state at top surface of rubber bearing
Photo 6 – Removed bearing support (G2)

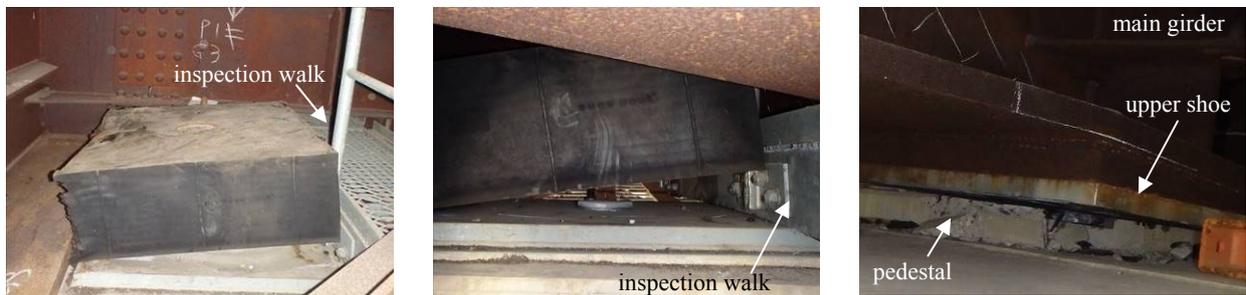
Photo 7 – Damage state (G3 bearing support)

Photo 7 shows the damage state of the bearing support installed at the G3 girder right after the earthquake. The upper and lower connecting bolts of the G3 bearing support were damaged, and the rubber bearing at the G5 girder side was raised by the collision with the inspection walk. The removed bearing support is shown in Photo 8. At the top surface of the rubber bearing, upper connecting bolts at the A2 abutment side (a,d,f in Photo 8(a)) were slipped out, and other connecting bolts were broken at the rubber bearing surface. In addition, the shear-key-hole at the A2 abutment side was deformed. Referring to the past knowledge [7], it is presumed that the bearing support was excessively deformed to the A2 abutment side. At the bottom surface of the rubber bearing, all lower connecting bolts were broken and there were scratch traces like drawing a circle. Referring to the past knowledge [8], it is presumed that the G3 bearing support was rotated counterclockwise around the shear-key-hole.

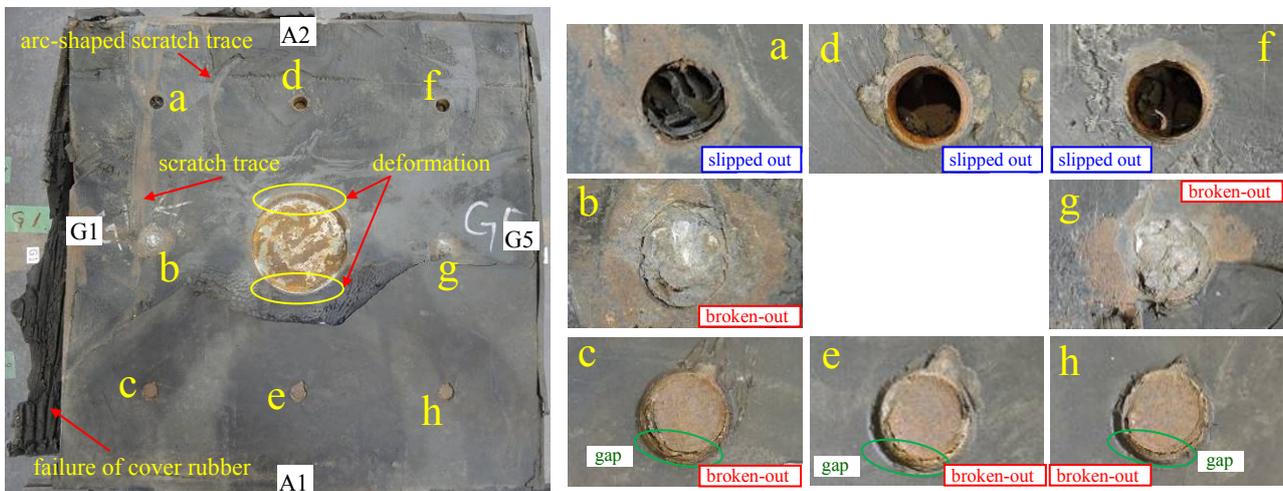
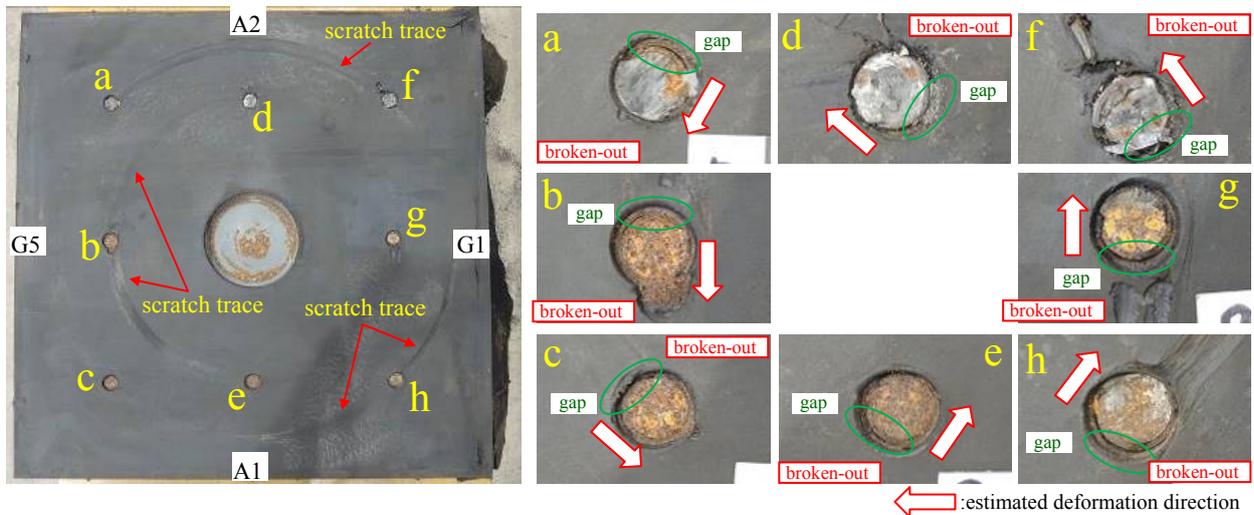
(a) Damage state at top surface of rubber bearing

(b) Damage state at bottom surface of rubber bearing
Photo 8 – Removed bearing support (G3)

Based on these analyses, the behavior of the G3 bearing support was estimated the behavior like the G1 bearing support. Also, there was the arc-shaped scratch trace on the top surface of the rubber bearing as shown in Photo 10(a). This scratch trace was almost matched with the shape of the shear key, and thus it is presumed that the G3 girder was moved at least to the A2 abutment side and to the G1 girder side.

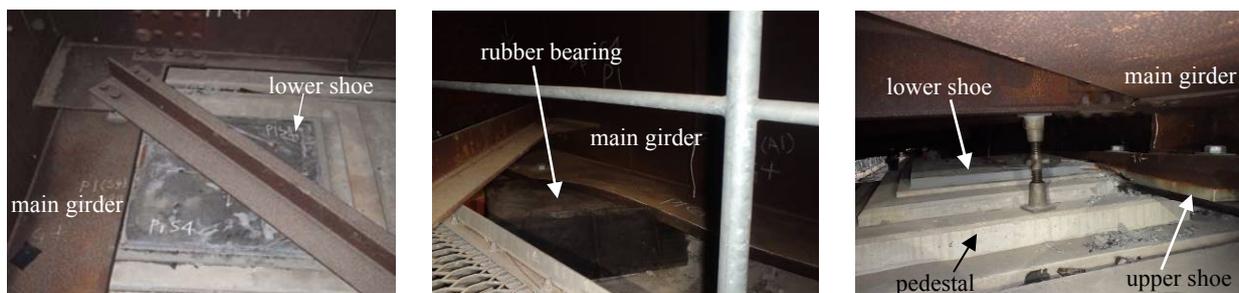
Photo 9 – Damage state (G4 bearing support)

Photo 9 shows the damage state of the bearing support installed at the G4 girder right after the earthquake. The upper and lower connecting bolts of the G4 bearing support were damaged, and the rubber bearing was ruptured. In addition, the rubber bearing moved to the A1 abutment and the G1 girder side as shown in Fig. 3, and the main girder fell down on the moved-rubber-bearing. The removed bearing support shows in Photo 10. At the top surface of the rubber bearing, there were gaps and burrs at the upper connecting bolt as shown in Photo 10(a). Referring to the past knowledge [8], it is presumed that the upper connecting bolts were deformed in the direction of the arrow shown in Photo 10(a). That is, it is presumed that the bearing support was rotated around the shear-key-hole. At the bottom surface of the rubber bearing, the lower connecting bolts at the A2 side (a,d,f,g in Photo 10(b)) were slipped out and other connecting bolts were broken at the rubber bearing surface. In addition, the shear-key-hole at the A2 abutment side was deformed. Referring to the past knowledge [7], it is presumed that the bearing support was deformed to the A1 abutment side.

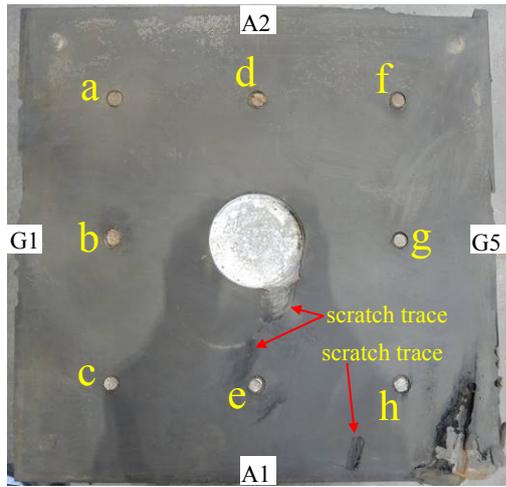
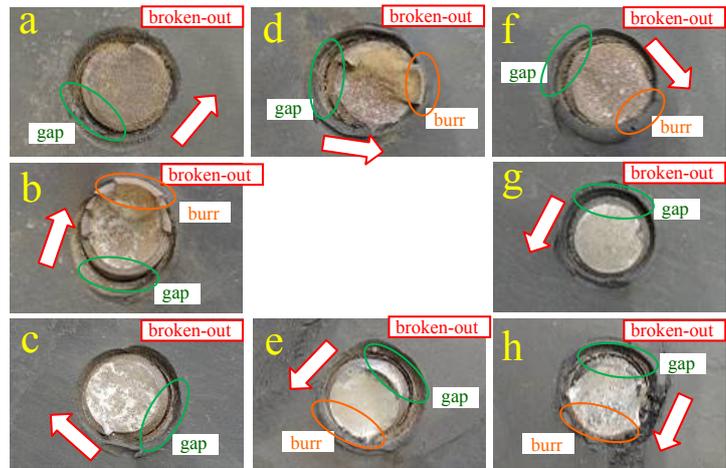
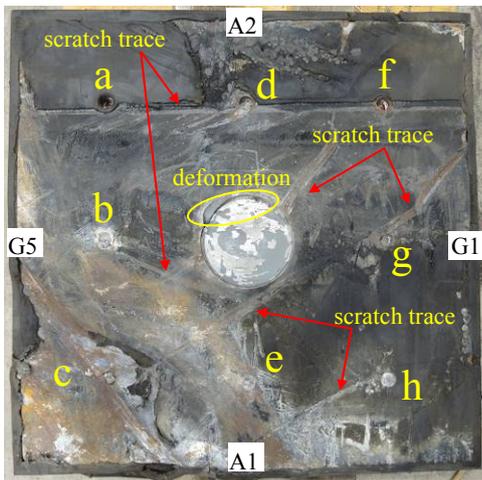
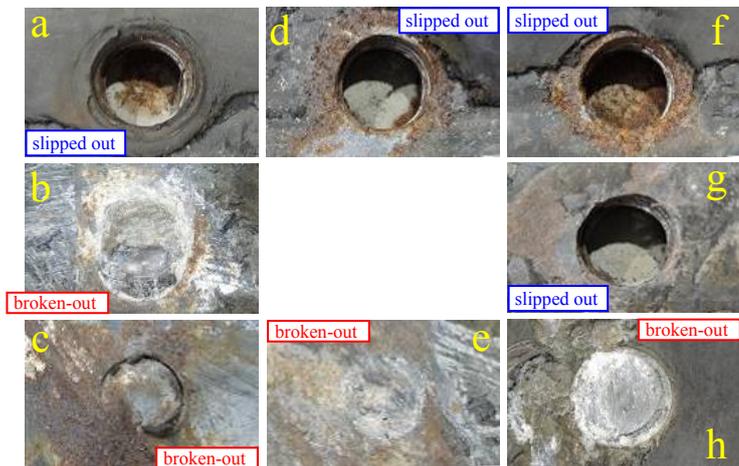
(a) Damage state at top surface of rubber bearing

(b) Damage state at bottom surface of rubber bearing
Photo 10 – Removed bearing support (G4)

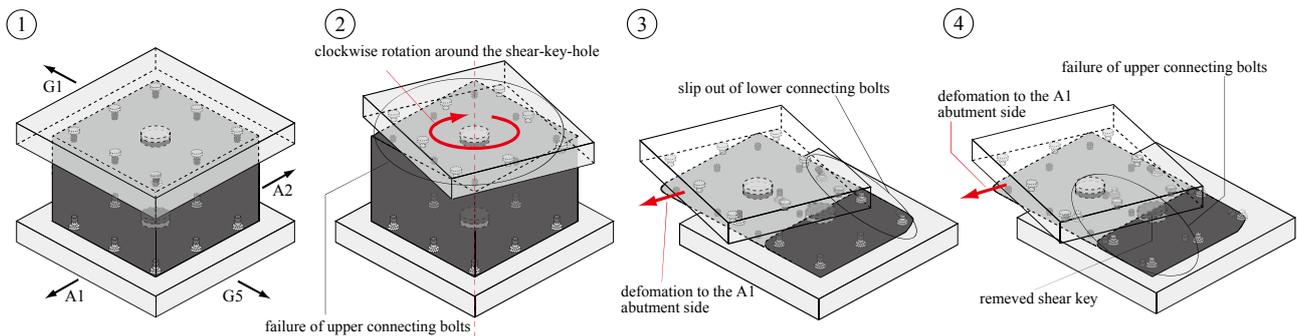
Fig. 8 – Estimated behavior of G4 bearing support

Based on these analyses, the upper shoe of the G4 bearing support is estimated rotated around the shear-key-hole, and was deformed to the A1 side as shown in Fig. 8. Incidentally, the relative direction of rotation is matched with the rotation of the bearing support at the G1 and G3 girder.

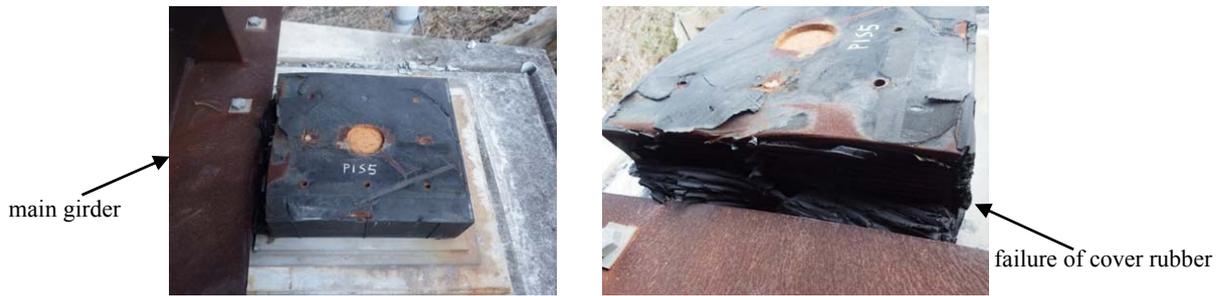
Photo 11 – Damage condition (G5 bearing support)

Photo 11 shows the damage state of the bearing support installed at the G5 girder right after the earthquake. The upper connecting bolts of the G5 bearing support were damaged. The cover rubber at the G1 girder side was damaged, it is presumed that the cover rubber was shaved by the lower flange when the girder fell from the bearing support. The removed bearing support is shown in Photo 12. At the top surface of the rubber

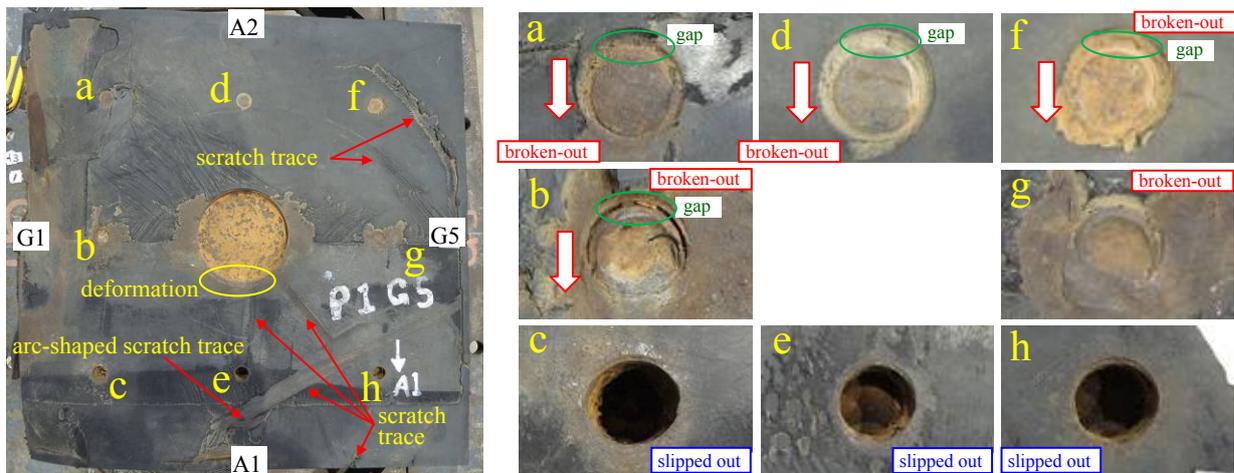
Photo 12 – Removed bearing support (upper surface of rubber bearing) (G5)

bearing, upper connecting bolts at the A1 abutment side (c,e,h in Photo 12) were slipped out and the other connecting bolts were broken at the rubber bearing surface. And the shear-key-hole at the A1 abutment side was deformed.

Referring to the past knowledge [7], it is estimated that the upper shoe of the G5 bearing support was deformed to the A1 abutment side. There was the arc-shaped scratch trace as shown in Photo 12. This scratch trace was almost matched with the shape of the shear key, and thus it is presumed that the shear key at least moved to the position of the arc-shaped scratch trace.
