## DAMAGE MECHANISM OF TAWARAYAMA BRIDGE DUE TO KUMAMOTO EARTHQUAKE

K. Eguchi<sup>(1)</sup>, N. Nakao<sup>(2)</sup>, T. Yono<sup>(3)</sup>, M. Ohsumi<sup>(4)</sup>

<sup>(1)</sup> Researcher, Public Works Research Institute, [eguchi-k573bt@pwri.go.jp](mailto:eguchi-k573bt@pwri.go.jp)

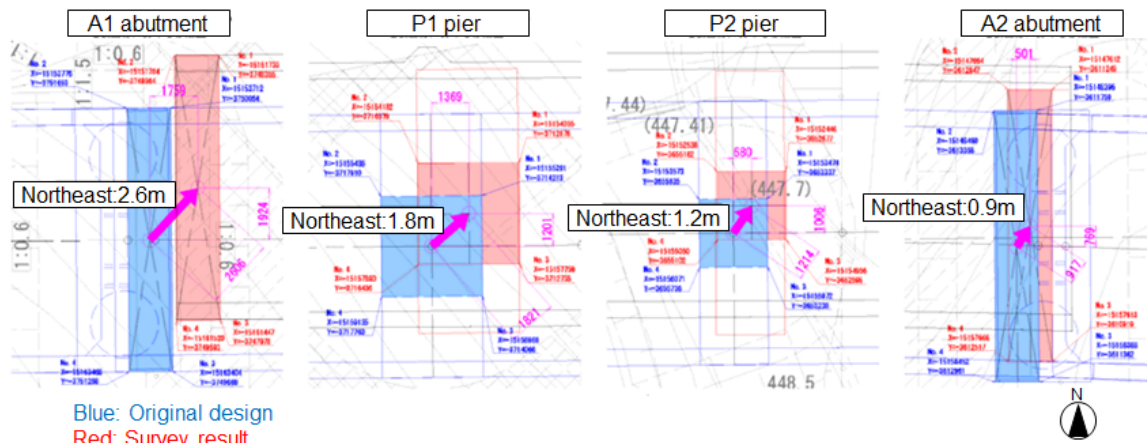
Fig.5 – Survey result of substructure displacement

According to the record, the displacement is large in the northeast and downward directions. It is also estimated that those displacements remained after the earthquake.

Tawarayama bridge is located in large ground displacement area. The horizontal and vertical displacement of the abutments and piers were surveyed. Fig.5 shows the displacement of the substructure. The substructures were moved northeastward up to 2.6m. In addition, amount of settlement was different at each location. In addition, the bearing and the superstructure were damaged due to the movement of the substructure. The summary of bridge damage state is shown in Fig.6. The lower part of the main girder between A1 and P1 was buckled as shown in Fig.7. And, the damage of A2 parapet was observed due to the collision of the girder as shown in Fig.8.

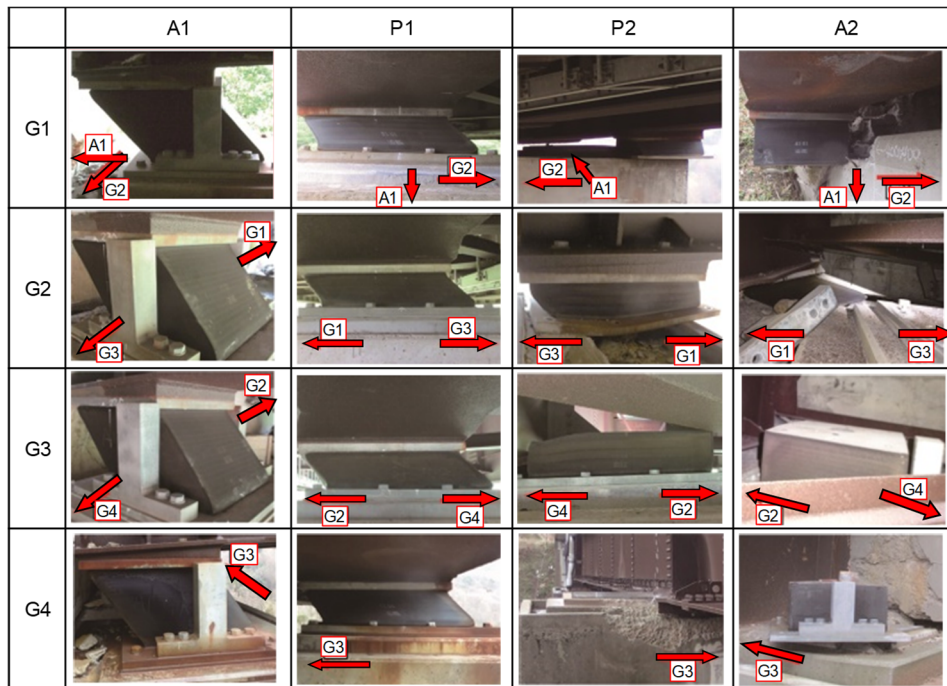
Fig.10 – Overview of the bearing after earthquake

Names of members of rubber bearing are shown in Fig.9. Fig.10 shows the state of the bearings right after the earthquake. Looking at the A1 bearing, all bearings showed residual deformation to the A1 side, but obvious damage such as rupture of the bearing was not found. Looking at the P1 bearing, there were residual deformation to the northeast direction, but the damage of rubber bearing was not observed same as A1 bearing.

Looking at P2 bearing, the set bolts or connecting bolts to the superstructure or substructure were broken, and girders were separated from the pier. Especially at G1, the bearing fell from the pier. In A2 bearing, the superstructure and substructure were separated due to the damage of bearing connecting bolts same as P2 pier.

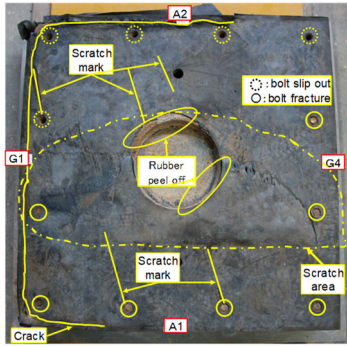
Fig.11 Overview of the P2G3 bearing (upper side)

The damaged bearings were collected and the damage states at upper and lower side were investigated. An example of overview of the damage is shown in Fig.11. Summary of the investigation results of bearing are shown in Fig.12 and Fig.13. In this paper, we analyzed focusing on damage of P2 bearings.

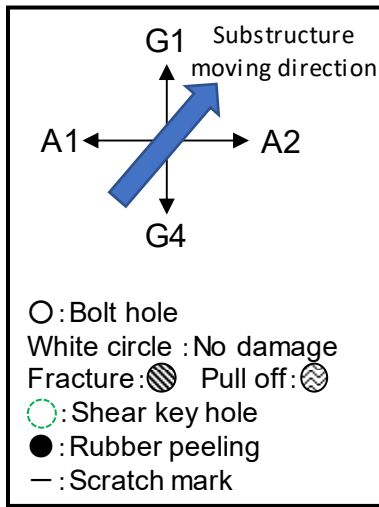
Fig.12 Damage outline of the bearing upper side

The bearings of the G1 and G2 moved with the lower shoe plate due to the damage of the lower set bolts. The deformation of bearing was observed at the under part of the rubber and lower shoe plate. It is estimated that the bearing was deformed due to fall on the pedestal when lower set bolts broke. Some of the lower connecting bolts were broken as shown in Fig.13. The lower connecting bolts breaking part is concentrated where the bearing was deformed. Therefore, it is presumed that the lower connecting bolts were broken by the horizontal force after moving with the lower shoe plate.

Looking at the G3 bearing, upper connecting bolts were pulled out or fractured as shown in Fig.13 and G3 bearing was separated from the girder. It is supposed that the upper part of the rubber deformed because the superstructure fell on the bearing.

The G4 bearing dropped from the pier due to upper and lower bolts broke. And rubber bearing deformation was observed. Looking at the damage state of bearing upper side, the scratch marks observed in opposite direction with the G3 bearing. It is considered that the lower set bolts broke and bearing deformed same cause as the G1 and G2 bearing. And scratch marks were made opposite direction with the G3 bearing by later shaking. Finally, it is estimated that the bearings dropped from the pier due to damage to all upper connecting bolts.

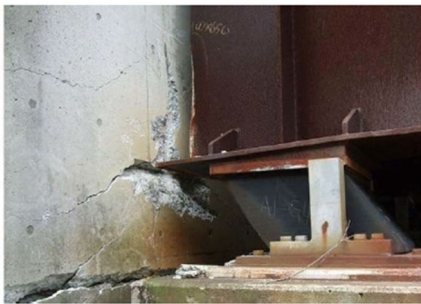
Fig.15 – Girder collided with A1 abutment

It was observed that the girder of A1 and A2 contact with the parapet as shown in Fig.15 and Fig.16. In addition, A2 girder observed displaced to transverse direction. Fig.17 shows damage state of the A2 abutment. Looking at the damage diagram of the parapet, collision marks matched the position of the lower flanges of the girders in the design. In addition, the damage depth of the concrete at the lower part is larger than at the collision point. From this, it is estimated that the bearing was not damaged when girder collided to the parapet, after that, parapet damaged while the girder dropped on the abutment due to the damage of the connecting bolts of bearings.

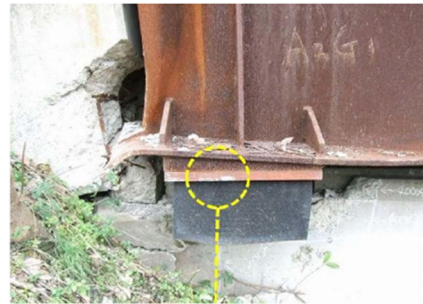
Fig.16 – Girder collided with A2 abutment

On the other hand, if the A2 bearings are damaged by the seismic vibration, girder will separate from parapet by the elasticity of the A1 and P1 bearings. However, each end of the girder was contact with the parapet, and in addition, the survey results that the distance between A1 and A2 abutments became shorter suggest that the damage is due to ground displacement.

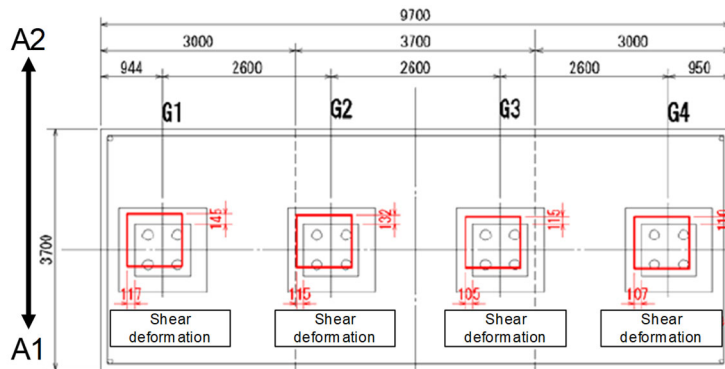
Fig.18 – Position of the upper side of P1 bearing after earthquake

It is assumed that the distance between A1 and A2 became shorter and compressive force acted to the girder when the substructure moves by ground displacement. Looking at end of the girder, they are contacting with the parapet. In addition, the direction of deformation of the A1 bearing (see Fig. 15) and the P2 bearing (Fig. 18) were in the direction to compress A1-P1 span. Thus, it is estimated that the compressive force acted the girder between A1 and P1 as shown in Fig.19.

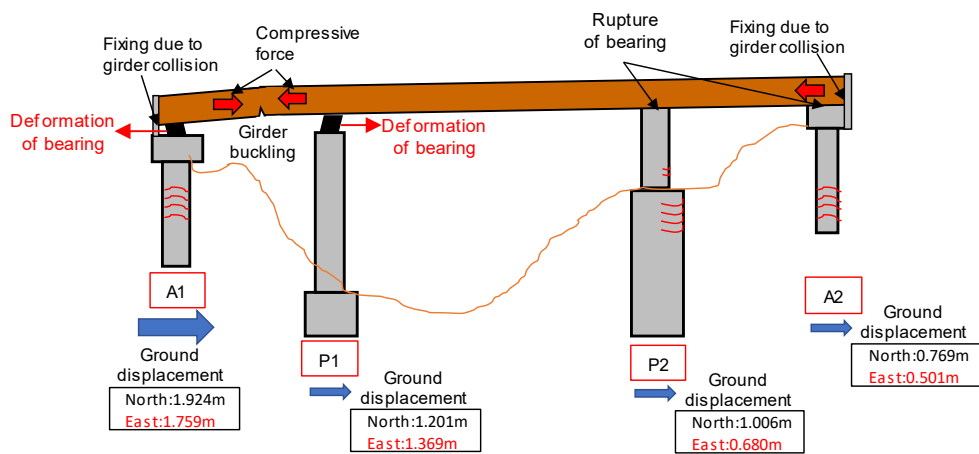
Fig.19 – Image of the girder buckling mechanism

In this section, we try to clear the cause of buckling of the girder is whether collision due to seismic vibration, reaction force of bearing or ground displacement. If the girder collides with the parapet due to seismic vibration, the end of the girder is expected to buckle. However, end of the girder at the A1 side did not buckle. Therefore, it is not presumed that the girder buckled by only seismic vibration.

If the reaction forces of the bearings are strong enough to buckle the girder, the bearings are also expected to be damaged. However, obvious damage was not found of the A1 and P1 bearings. Therefore, the acted force is estimated that smaller than the designed external force, and it is not presumed that the girder buckled due to the reaction force of bearing.
