ANALYSIS OF DAMAGE MECHANISM OF ROAD BRIDGE DAMAGED BY KUMAMOTO EARTHQUAKE

M. Ohsumi⁽¹⁾, H. Nakao⁽²⁾, K. Eguchi⁽³⁾

⁽¹⁾ Chief Researcher, Public Works Research Institute, m-oosumi@pwri.go.jp

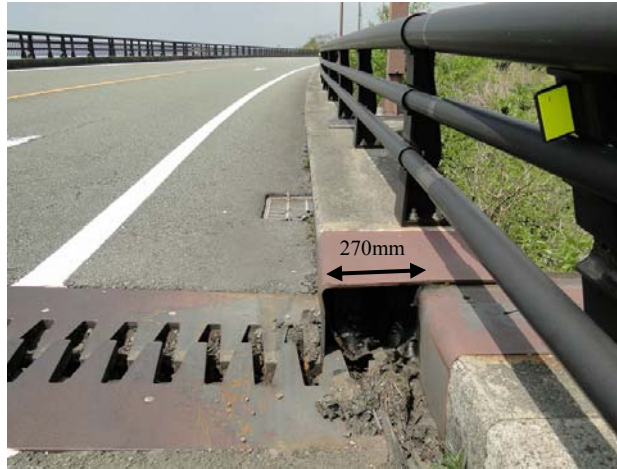
Photo 1 – Finger-joint device of A1 abutment

As shown in [Photo 1](#), the parts of finger-joint device of A1 abutment engaged each other over the girder had shifted 240 to 270 mm to the valley side in the direction perpendicular to the bridge axis, and the joint gap extended 30 to 165 mm in the bridge axis direction compared to the standard width. The girder side of the joint device settled, and a step of 20 to 50 mm was generated from the abutment side, but no damage was found.

From the fact that the expansion joint device engaged each other with the superstructure displaced, it is presumed that the distance between the A1 abutment and A2 abutment opened once due to the ground displacement, and the superstructure rotated due to the ground displacement etc. while the joint device was removed, after that, the distance between A1 and A2 abutments narrowed, and the joint device engaged again.

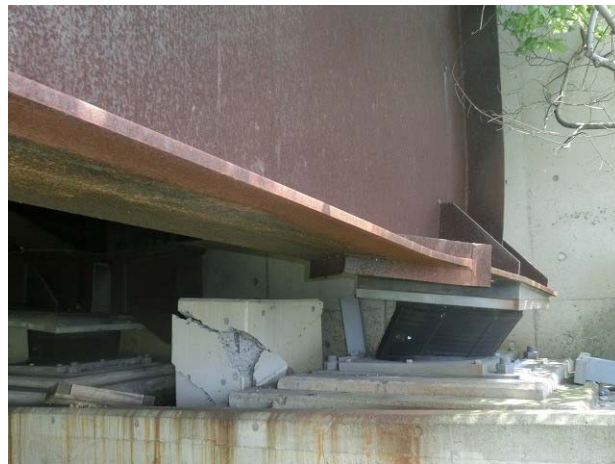
Photo 2 – Deformation of A1 support point of main girder

At the support point on the A1 side of the main girder, deformation of the web, stiffener, and flange was observed as shown in [Photo 2](#). There was no other major damage to the superstructure between A1-P1.

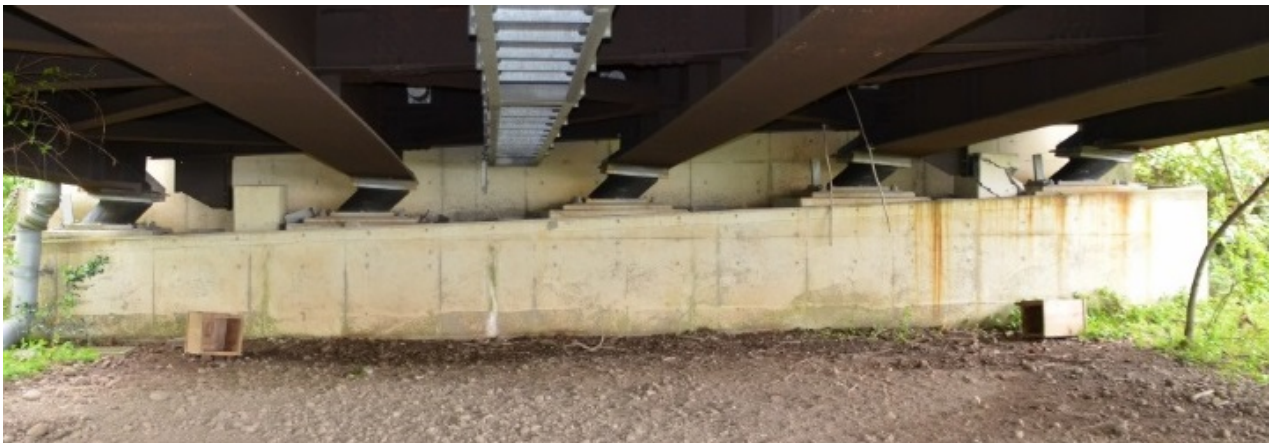
Photo 3 – A1 abutment

All the bearings on the A1 abutment had a residual deformation of about 20 cm on the valley side, and the mounting bolts on the side blocks on both sides of the bearing designed as joint protectors were damaged. However, as shown in [Photo 3](#), some bolts remained on the side blocks on the valley side of G1, G2, and G5 without breaking and those side blocks had not fallen down. In the center of each upper shoe plate, there were scratches on both sides with the side blocks. [Photo 4](#) shows the scratches on the upper shoe plate of A1G1 bearing. As shown in [Photo 5](#), one of the two lateral displacement restraint structures had shear fracture.

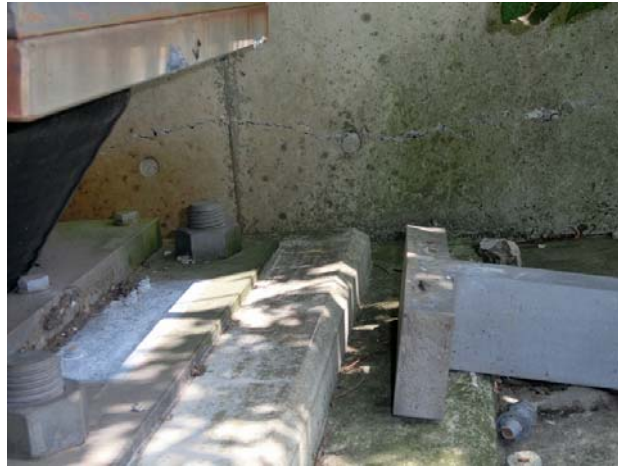
Photo 4(a) – Scratches on the upper shoe plate of A1G1 bearing (Valley side)

Abrasion marks between the upper shoe plate and the side block of the A1G1 bearing were located at the center of the upper shoe plate on both the valley side and the mountain side, indicating that there were many contacts. The scratch marks are located on the entire height of the upper shoe plate, and are considered to be the contact when the side blocks are upright. The gap between the upper shoe plate and the side block in the design is 5 mm, which is considered to have been caused by vibration in the direction perpendicular to the bridge axis from the beginning of the seismic motion.

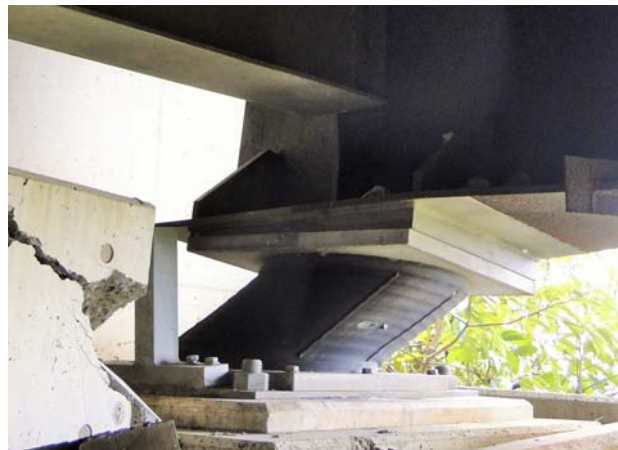
Photo 4(b) – Scratches on the upper shoe plate of A1G1 bearing (Mountain side)

The abrasion marks on the mountain side, in addition to those at the center of the upper shoe plate, are present along the lower side of the upper shoe plate from the center to the entire A1 abutment side. This suggests that the side block and the upper shoe made relative displacement while contacting at an angle.

Although the mounting bolts of the side blocks were damaged, the side blocks remained standing, and the length of one side of the upper shoe plate was 630 mm, and the length of the scratch marks was more than 500 mm. Since the clearance of the expansion joint device in the bridge axis direction is 105 mm, the device did not resist, and it can be said that only enough force was exerted to leave the side block standing. On the other hand, on the valley side, in addition to the abrasion mark on the center of the upper shoe plate, there was a collision mark on the A1 side end, and the side block fell down. These results indicate that a relative displacement of 500 mm or more occurred between the A1 abutment and the superstructure in the bridge axis extension direction, during which the superstructure was greatly displaced from the mountain side to the valley side. Since the clearance in the bridge axis direction of the expansion joint device is 105 mm, the ground displacement occurred during this period, and the spacing between A1 and A2 abutments was widened, which is consistent with the results of 3.4.1 and 3.4.2.

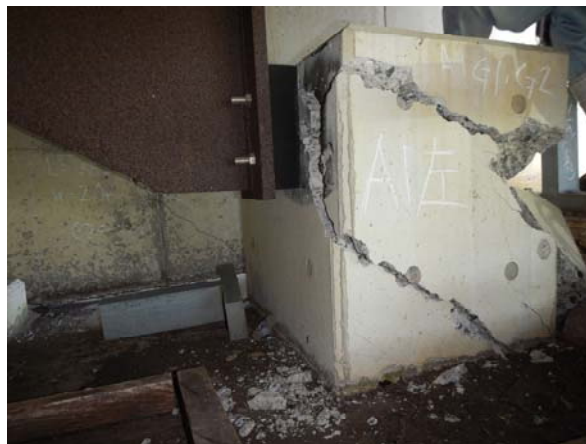
Photo 5 – Damage of the lateral displacement restraint structure on A1 abutment

A total of four lateral displacement restraint structures were installed, but only one on the A1 abutment had shear failure. **Photo 5** shows the sheared RC block. This RC block was considered to have been destroyed by the collision with the bracket. Considering the fact that the joint device was almost no damage even after the earthquake and was taking a reaction force in the direction perpendicular to the bridge axis, in order for the RC block to be damaged, the engagement of the finger joint must have been disengaged by displacement in the vertical direction or pulling in the bridge axis direction. The height of damage position of the RC block almost matched the state where the girder was slightly lowered due to deformation of the rubber bearings after the earthquake, indicate that it was not hit while the expansion joint had gap in the vertical direction. On the other hand, it is presumed that the bracket was displaced toward the valley side when the bracket was displaced toward the end point from the horizontal damage position of the RC block.

Considering that the clearance in the bridge axis direction of the finger joint is 105 mm, while the width of the rubber pad of the bracket is 150 mm, it is presumed that the RC block was destroyed after the displacement in the bridge axis direction of 150 mm or more between the A1 abutment and the superstructure due to the ground displacement occurred, and then the displacement in the bridge axis direction returned.

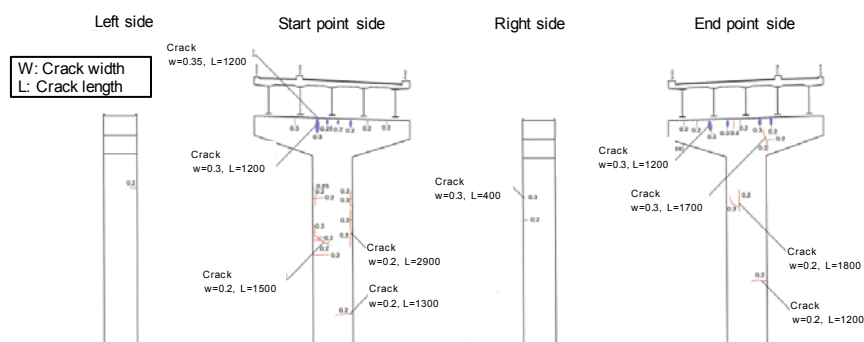
Fig. 5 – Crack diagram of P1 pier

The bearing on the P1 pier had a residual deformation of about 5 cm on the mountain side. As shown in Fig. 5, the pier had some cracks at the top and the middle of the column, but no crack at the base. The rebar was not considered to have yielded. The P1 foundation was confirmed with a borehole camera and found no damage.

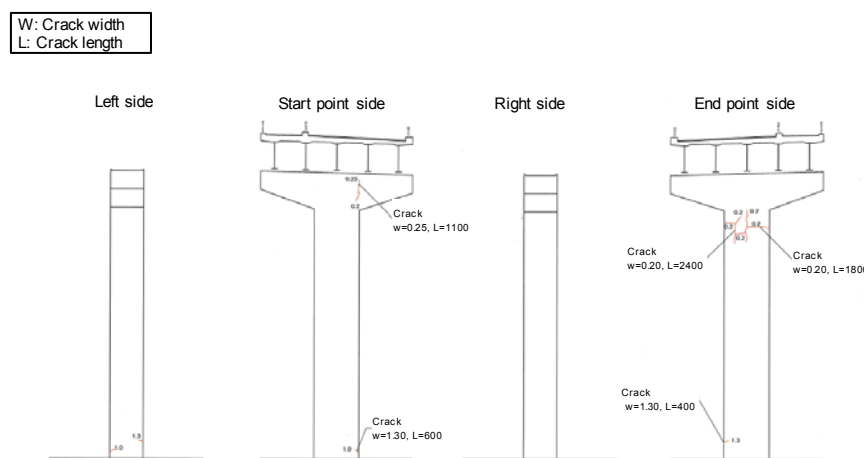
Fig. 6 – Crack diagram of P2 pier

The bearing on the P2 pier had a residual deformation of about 4 cm on the valley side. As shown in Fig. 6, the pier had some cracks in the upper and lower parts of the beam and column, but the rebar is not considered to have yielded. As a result of confirming the P2 foundation with a borehole camera, there was no damage.
