INDOOR DAMAGE AT HIGH-RISE RESIDENTIAL BUILDINGS FROM QUESTIONNAIRE SURVEY AFTER RECENT EARTHQUAKES

M. Nagano⁽¹⁾

Abstract

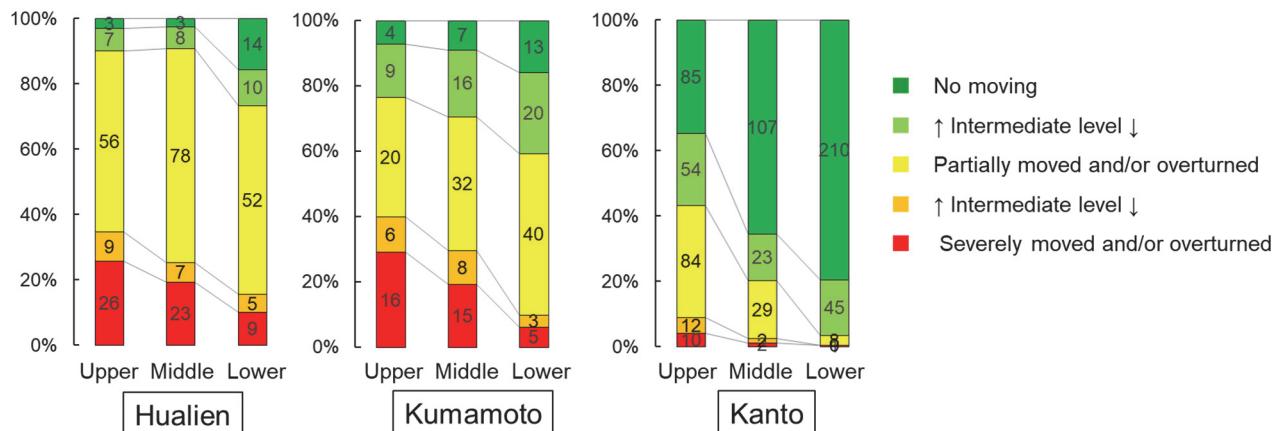
The moving and/or overturning of furniture in Fig. 3 commonly increased from lower to upper floors for any earthquake. Although not shown here, the same trend was observed for seismic intensity felt during the main shock and for action difficulty.

Fig. 3 – Moving and/or overturning of furniture during three major earthquakes.

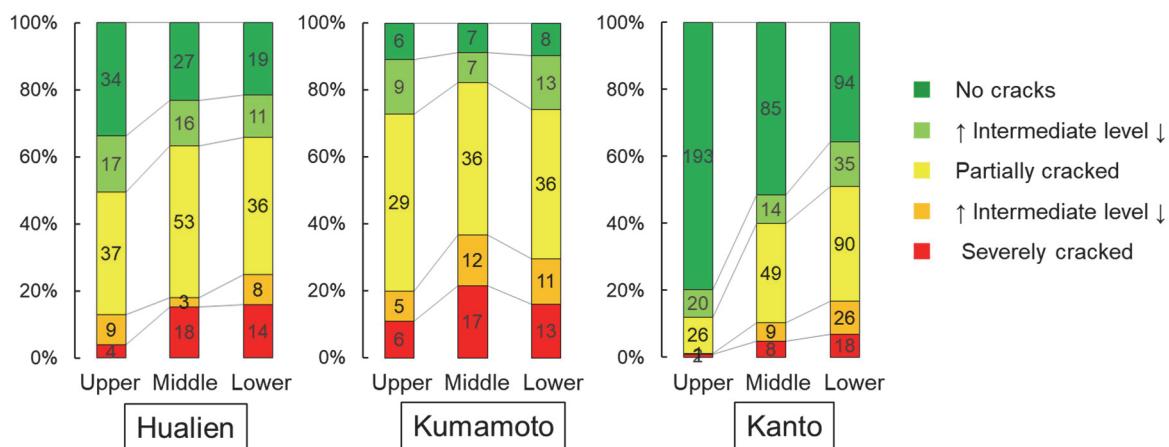
During the 2011 Tohoku earthquake, however, cracks in the wallpaper (Fig. 4) were the most serious on lower floors. During the 2016 Kumamoto and 2018 Hualien earthquakes, cracks in the wallpaper were concentrated not only on lower but also on middle floors. During inland crustal earthquakes, nearby buildings are subjected to pulse-like ground motions with a predominant period of 1 to 3 seconds, resulting in large inter-story drift in middle and/or upper stories.

Fig. 4 – Cracks in wallpaper during three major earthquakes.

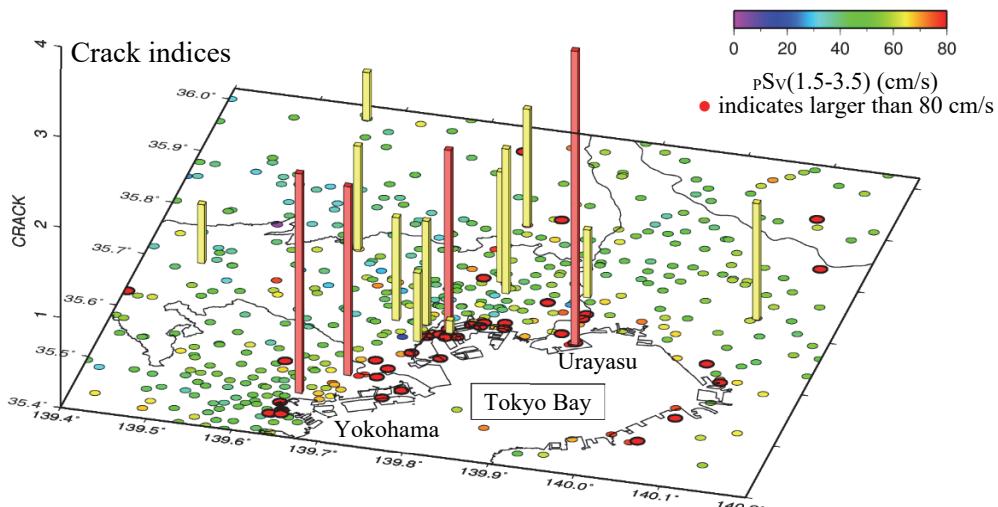
In the Tokyo metropolitan area during the 2011 Tohoku earthquake, strong motion records indicate that the long-period component affecting high-rise buildings’ responses was greater in the Tokyo Bay area than in the inland area [2]. Interior cracks were the largest on lower floors (Fig. 4). Spatial distribution of cracks in the wallpaper on lower floors is plotted in Fig. 5 for buildings A to V in Fig. 2(a). An index of cracks in wallpaper was evaluated by averaging scores in Table 2. The color-filled circles in Fig. 5 are peak values of pSv ($h=5\%$) in a period ranging from 1.5s to 3.5s of observed ground motions, denoted as $pSv(1.5–3.5)$.

Values for buildings in the Tokyo Bay area from Urayasu to Yokohama are clearly larger than those for inland buildings. This trend is the same as distribution of $pSv(1.5–3.5)$ of strong motion records. The spatial distribution of long-period ground motions in and around the Tokyo Bay area during the 2011 Tohoku earthquake was highly variable, perhaps due to differences in the shallow subsurface structure including nonlinear behavior.

Fig. 5 – Spatial distribution of indices for crack in wallpaper on the lower floors of high-rise residential buildings, A-V, in the Tokyo metropolitan area during the 2011 Tohoku earthquake. Red bars indicate those larger than 1.8. Colored circles are peak values of pSv ($h=5\%$) in period range between 1.5s and 3.5s, $pSv(1.5-3.5)$, of observed ground motions.

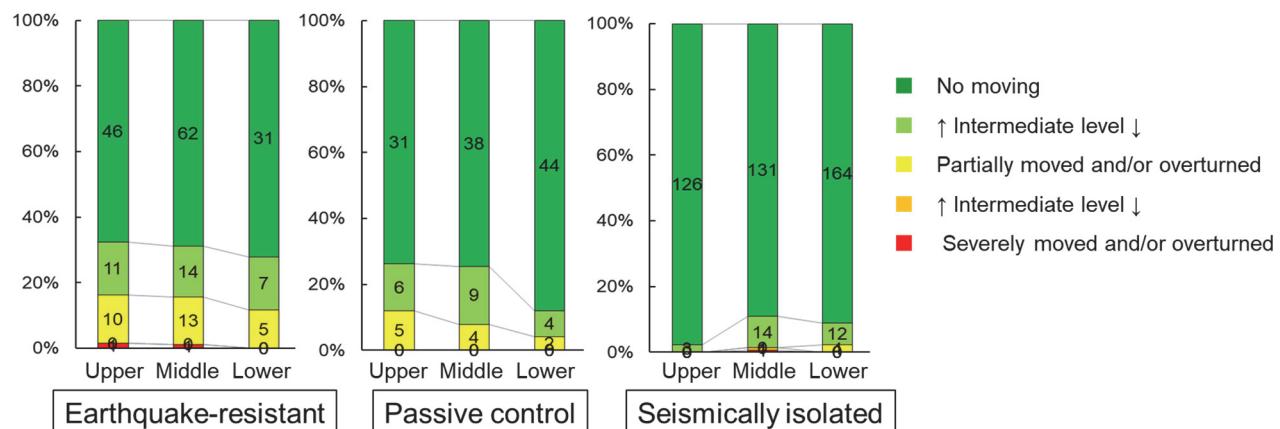
Figs. 6 and 7 compare the moving and/or overturning of furniture and cracks in wallpaper, respectively. The height-wise trend of these two indoor damage types is the same as those in Figs. 3 and 4. Indeed, the amount of indoor damage decreased in the order of seismic resistance, seismic control, and seismic isolation. Especially in seismically isolated buildings, more than 90% of respondents answered that nothing had moved at all, unlike in seismic resistant and seismically controlled buildings. To some extent, however, seismically controlled buildings also contributed to reduced indoor damage.

Fig. 6 – Moving and/or overturning of furniture for three types of buildings.

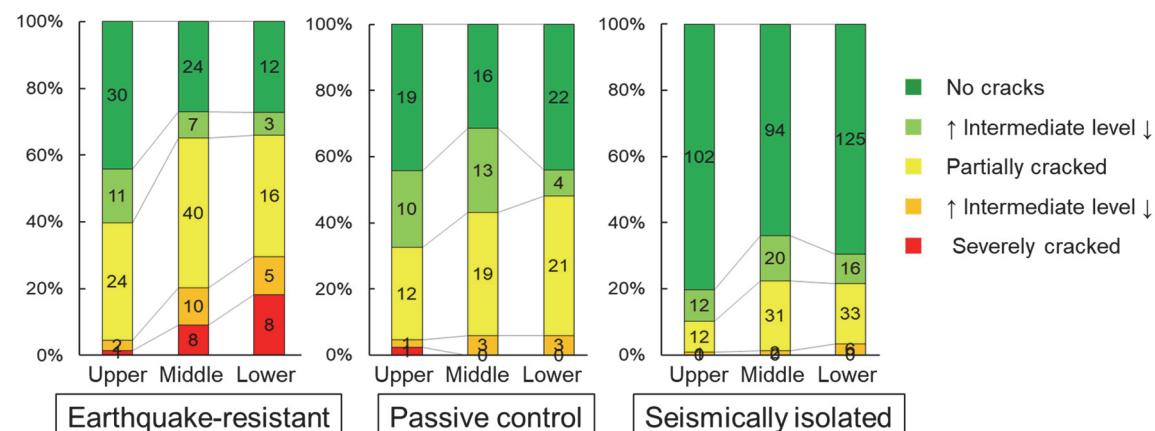
Fig. 7 – Cracks in wallpaper for three types of buildings.

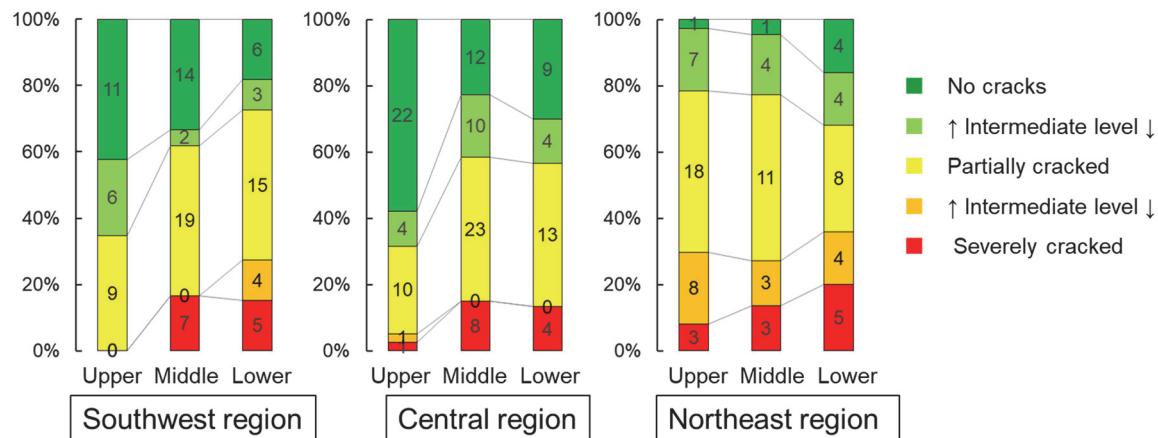
Results for cracks in wallpaper are compared in Fig. 8. Indoor damage indices among the three groups of buildings differed, even though the distance from the Milun fault is almost the same, attributed to site amplification characteristics. In general, indoor damage was prominent in northeast region buildings. Additionally in the northeast region, many cracks were observed on exterior walls of building GH's low-rise portion in Fig. 9. We confirmed that many cracks were repaired on exterior walls when we conducted on-site microtremor measurement.

Fig. 8 – Cracks in wallpaper during the 2018 Hualien earthquake.

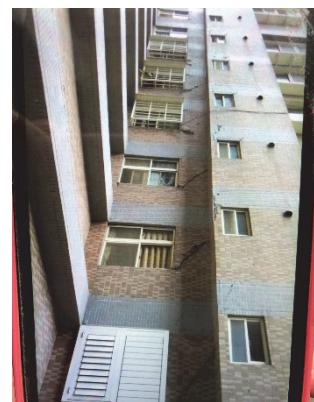
Although no strong ground motion was recorded in the northeast region during the 2018 Hualien earthquake, presumably, earthquake motion that caused cracks in interior materials did occur in this area.

Fig. 9 – Cracks in exterior walls of the low-rise part of the building GH.
