EVALUATION OF DAMAGE CHARACTERISTICS OF WATER DISTRIBUTION PIPELINES AFTER RECENT EARTHQUAKES IN JAPAN

Y. Maruyama⁽¹⁾, Y. Taguchi⁽²⁾

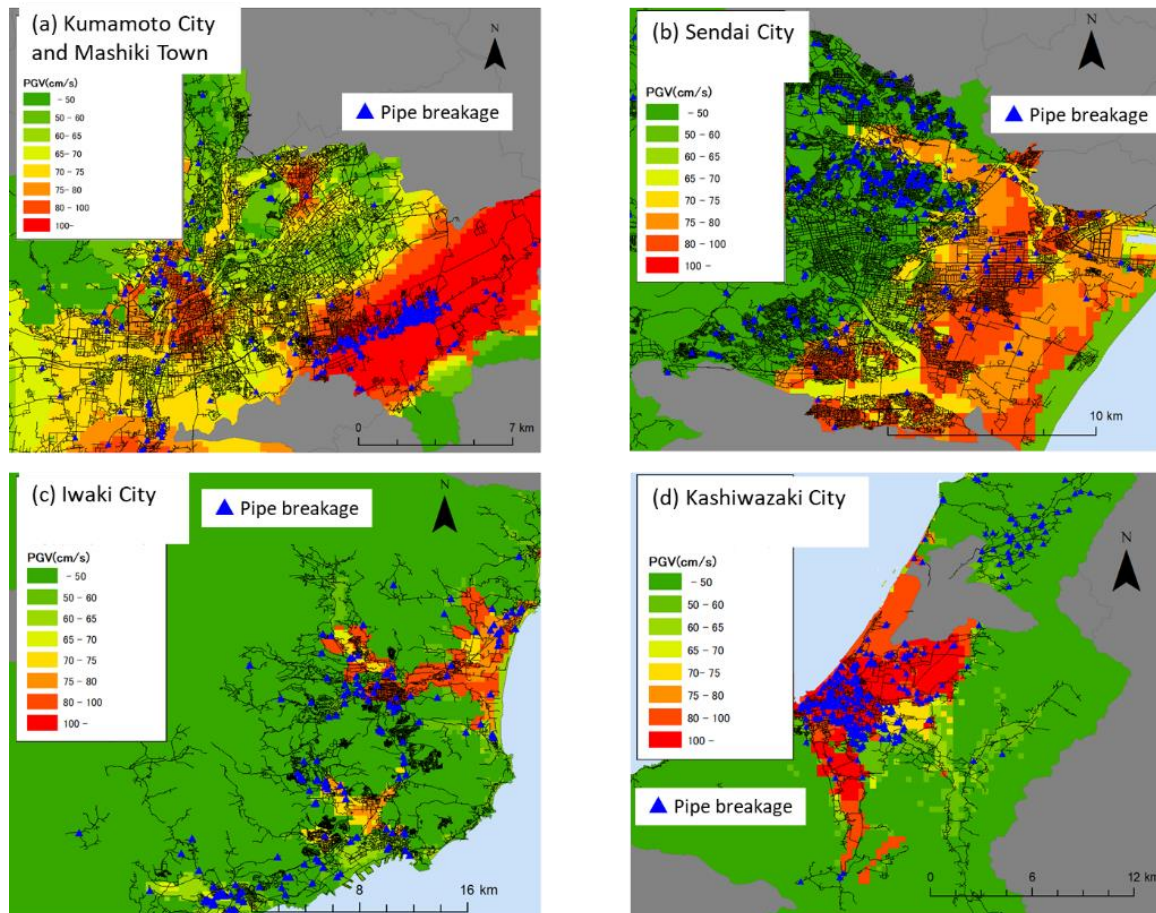
The damage datasets of water distribution pipelines employed in this study are shown in Fig. 1. The distributions of the peak ground velocities (PGV) and the locations of damage incidents are illustrated in Fig. 1. Table 1 summarizes the earthquake events and damage ratios of the water distribution pipelines. The damage ratio is defined as the number of damage incidents divided by the pipe length (km).

The 2011 off the Pacific coast of Tohoku earthquake with a M_w of 9.0 caused severe damage to lifeline facilities. The water supply system was interrupted at approximately 230 thousand households in Sendai City. Figure 1(b) shows the locations of damage incidents to water distribution pipes in Sendai City. The vinyl pipes (VP) and ductile cast iron pipes (DIP) without earthquake resistant joints were mainly affected. The seismically induced damage to water distribution pipelines concentrated in the hilly residential areas developed with cutting and leveling the hills and then filling the valleys for the past several ten years [7]. The water supply systems were disrupted by the ground motion and tsunami, and pipe breakages were found in Iwate, Miyagi, Fukushima, Tochigi, Ibaraki, and Chiba Prefectures [8]. In Iwaki City, Fukushima Prefecture, the water supply was disrupted approximately one month. Figure 1 (c) shows the locations of pipe breakages in Iwaki City. The damage ratio of water distribution pipelines was 0.09 [9].

Fig. 1 – Locations of damage incidents to water distribution pipes in (a) Kumamoto City and Mashiki Town after the 2016 Kumamoto earthquake, in (b) Sendai City and (c) Iwaki City after the 2011 off the Pacific coast of Tohoku earthquake, and in (d) Kashiwazaki City after the 2007 Niigata Chuetsu-oki earthquake

The 2007 Niigata Chuetsu-oki earthquake with a Mw of 6.6 occurred in the northwest Niigata region of Japan. In Kashiwaki City, Niigata Prefecture, severe ground motion with an intensity scale of upper 6 on the JMA scale was observed. The water supply was disrupted at approximately 61,000 households, and it lasted approximately 40 days. The number of damage incidents to the water distribution pipelines was 524, and the total length of the water pipes was 852.6 km [10]. The locations of damage incidents to water distribution pipes in Kashiwazaki City are shown in Fig. 1(d).

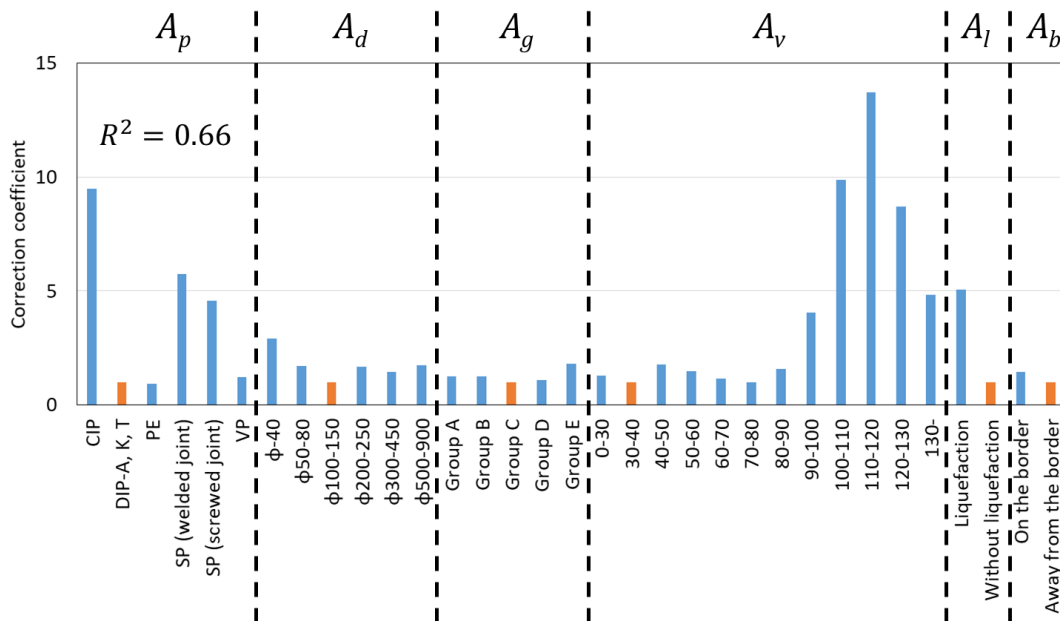
Hayashi's quantification method I was performed by taking the common logarithm of both sides of Eq. (4) [15]. Figure 2 shows the correction coefficients A of Eq. (4) obtained in this study. The coefficient of determination R^2 was 0.66. As for the correction coefficients for pipe material and joint, that for CIP was the largest. The coefficient for SP with welded joint was the second largest although the correction coefficient determined by the JWRC is small. The SPs with welded joint show large damage ratio under the 2016

Fig. 2 – Correction coefficients based on Hayashi's quantification method I. The orange bars show the references of categorical variables.

Kumamoto earthquake mainly due to deterioration over time. Hence, the result of this study shows larger correction coefficient for the SP with welded joint. The correction coefficient for the PE is as large as that for the DIP-A, K, or T.

The correction coefficients for the PGV show almost similar values under the PGV of smaller than 90 cm/s. When the PGV becomes larger than 90 cm/s, the coefficients for the PGV become drastically larger. The damage ratio in the liquefied area is approximately five times larger than that in the area where liquefaction is not caused.

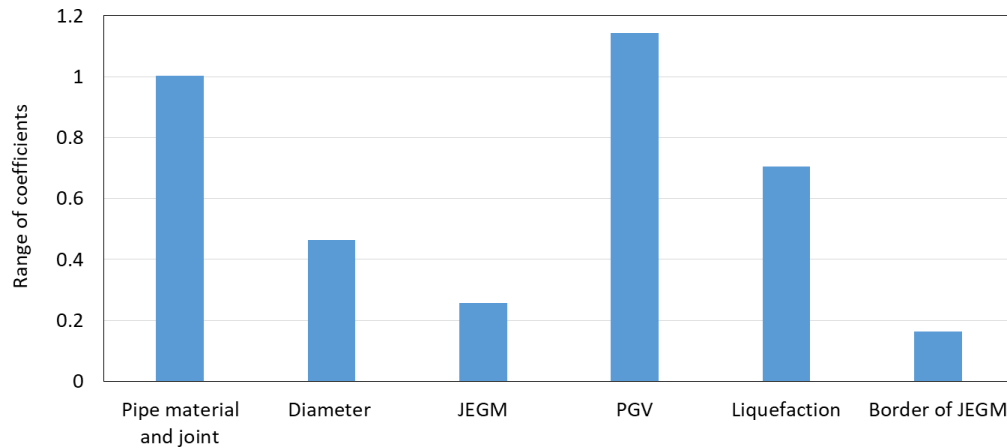
Fig. 3 – Ranges of coefficients with respect to the categorical variable based on Hayashi's quantification method I

as the range is larger. Figure 3 compares the ranges of coefficients among the categorical variables. The PGV, pipe material and joint, and liquefaction occurrences show large contributions to the damage ratios of water distribution pipes.
