SEISMIC DAMAGE OBSERVATIONS OF WINE STORAGE TANKS AND CATWALKS

M. Yazdanian⁽¹⁾, J. Ingham⁽²⁾, D. Dizhur⁽³⁾

Abstract

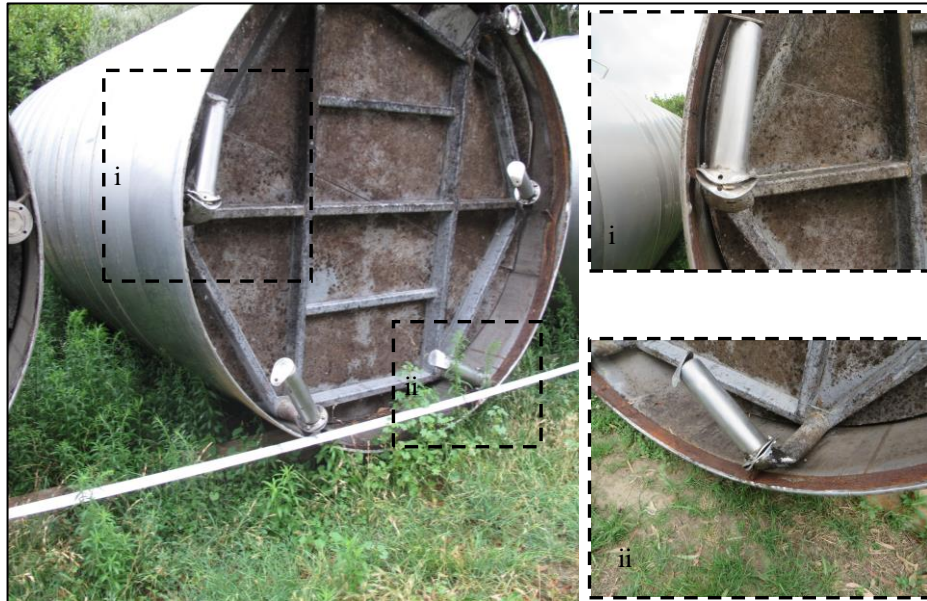
Figure 2 – An example of 22kL unbraced damaged legged wine tanks sustaining leg buckling

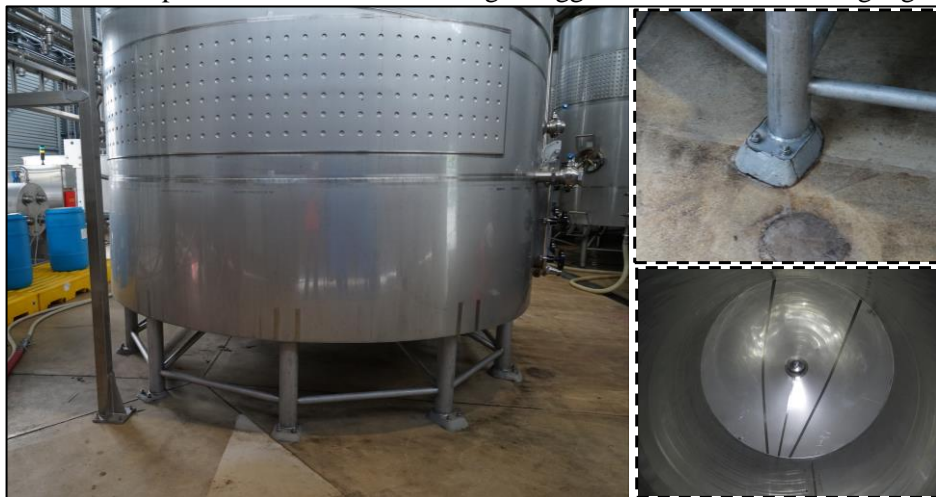
Figure 3 – An example of 50kL braced and anchored legged tank with no evidence of damage

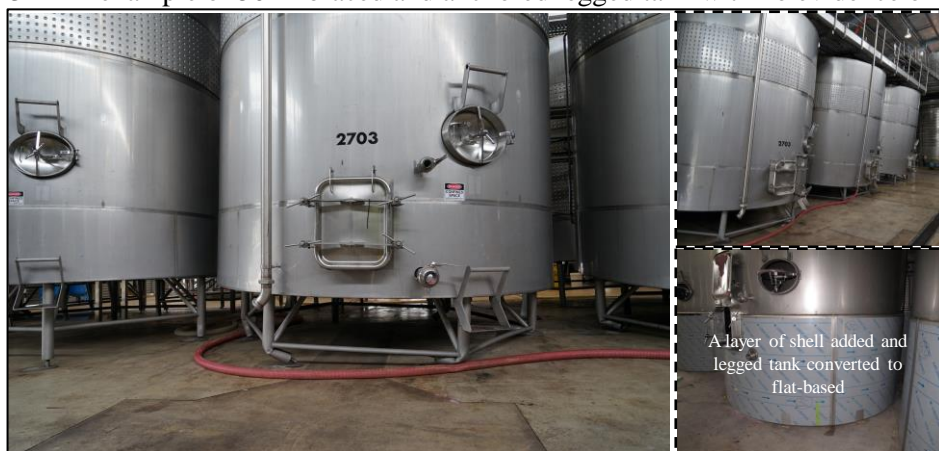
Figure 4 – Damaged legged tanks converted to the flat-based tanks following the 2016 earthquake

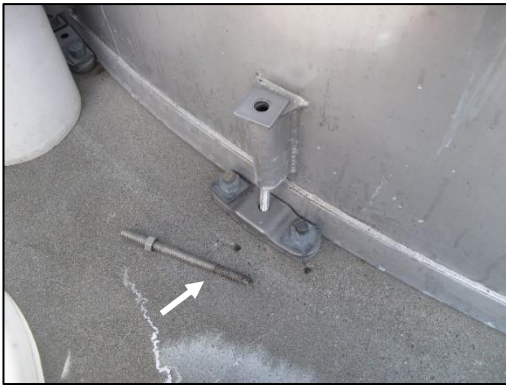
(a) Rupture of anchor rod

Figure 5 – Damage to tank anchorage systems during the 2016 earthquake

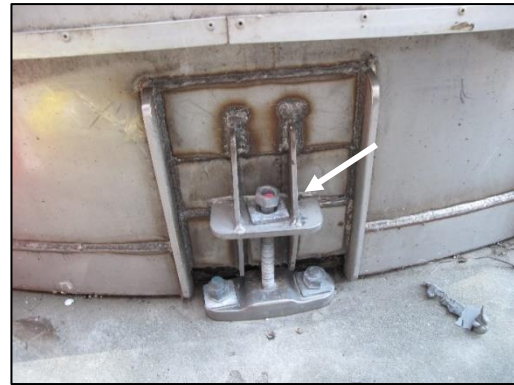
(b) Anchor rod thread shearing

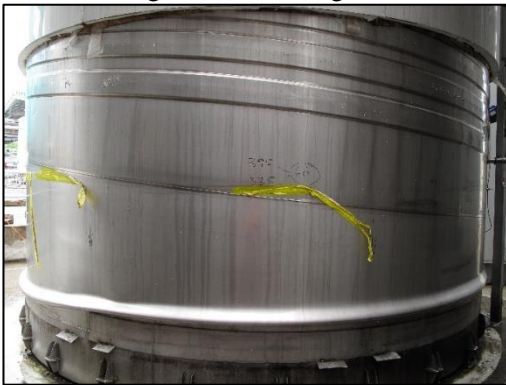
(a) Elephant-foot buckling

Figure 6 – Two types of buckling of tank wall observed following the 2013 and 2016 earthquakes

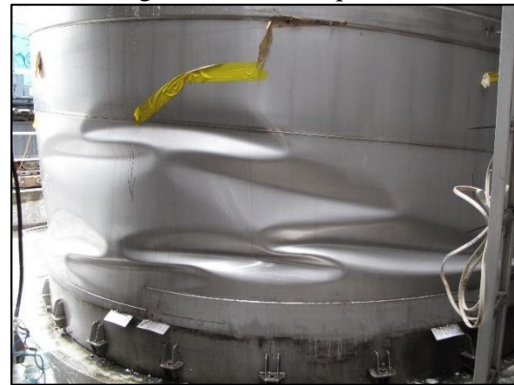
(b) Diamond-shaped buckling

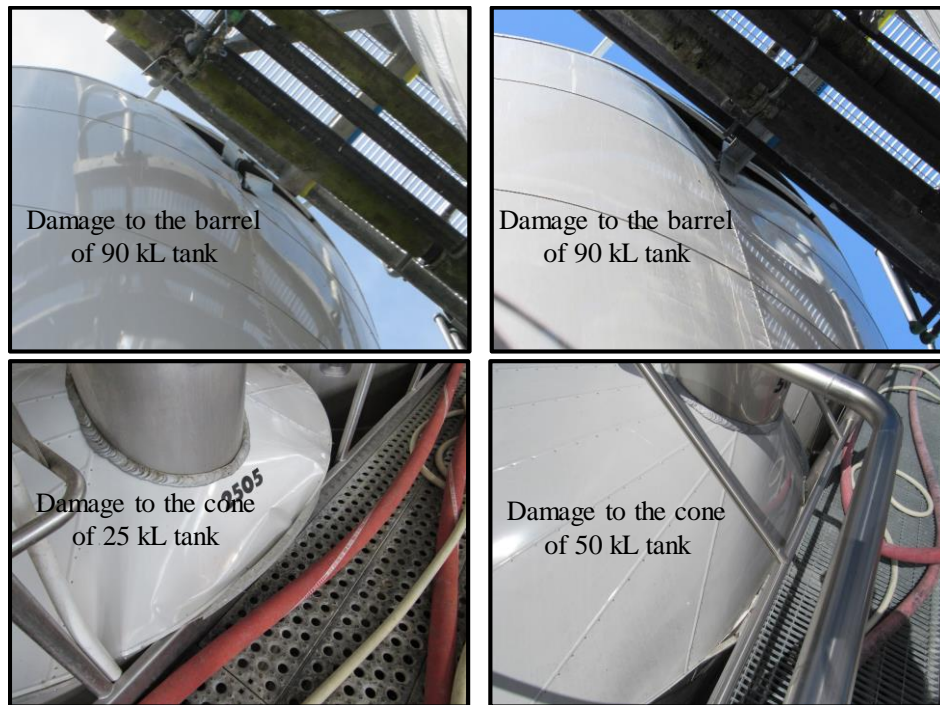
In summary, analysis of damage statistics following the 2016 earthquakes in New Zealand have also revealed that indenting of the tank wall by catwalk was the most frequent tank damage type to the barrel of the tanks [6], where 26% of 1150 flat-based and legged tanks with both self-supported and tank-supported catwalks sustained damage on their barrel or cone due to catwalk indentation (see Figure 13). It is to note that the majority of damage percentage to the tanks (25%) due to catwalk indent was for the tank-supported catwalks and only 1% of the tanks within the inventory sustained damage from self-supported catwalks.

Figure 13 – Example of different flat-based tanks sustaining catwalk indent damage following the 2016 earthquake
